# 90 Lee Road 2009, Phenix City, Alabama 36870

Date Inspected  
Aug 15, 2024

# INSPECTION REPORT

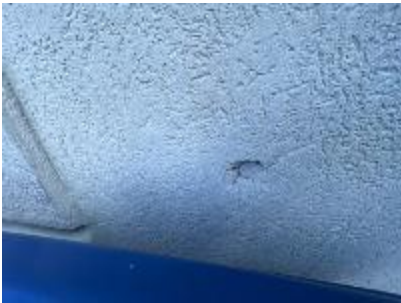
SIDING

Material is damaged

With damaged siding, the home lacks protection from insects, animals and the elements and it may negatively affect the thermal boundary of the home

Replace the damaged area

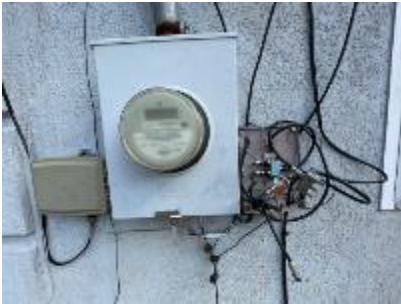
JUNCTION BOX

Cover plate is missing

Without a cover plate, electrical shock may result if touched

Install a cover

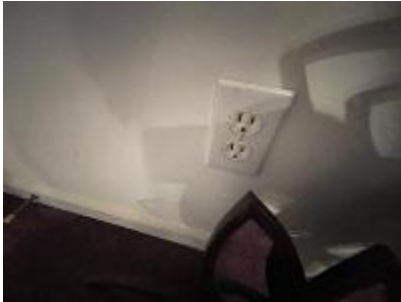
## OUTLET

Appears to have no power

Have repaired by a licensed electrical technician

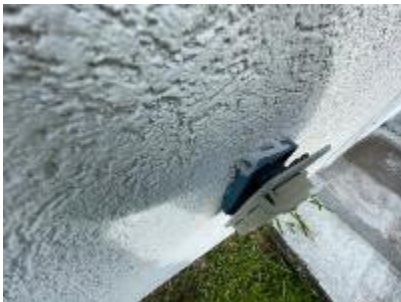
Not full secured on wall

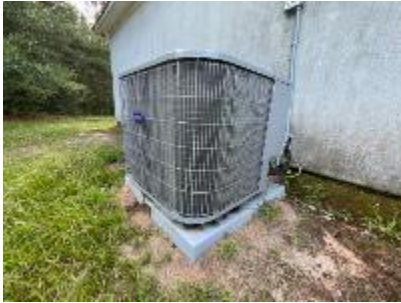
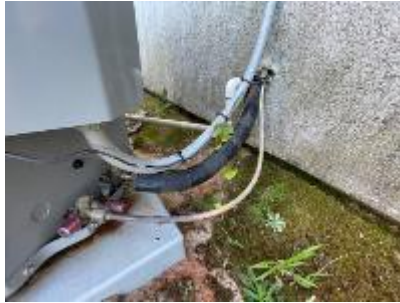
#### AIR CONDITIONER

Unit is in good condition

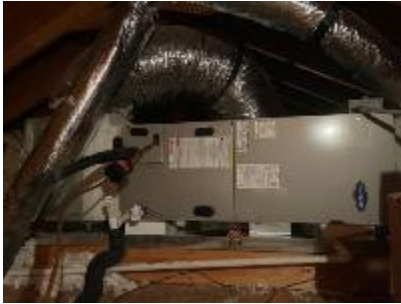
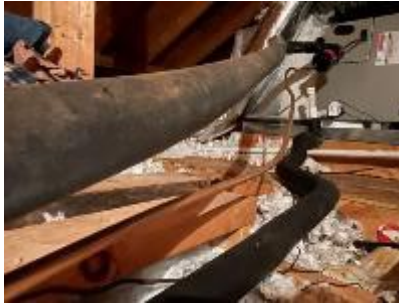
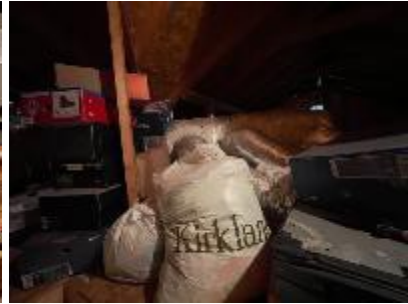
## DUCTWORK

Random items are on the insulation.

Remove items off of the insulation.

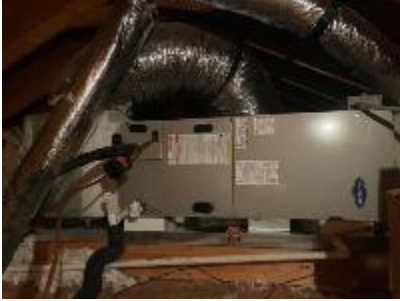
## FURNACE

Unit is in good condition

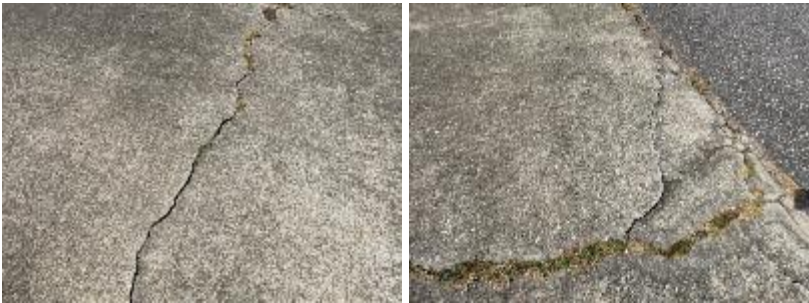
DRIVEWAY

Concrete is settling with minor cracks

The cracks allow for water intrusion, which may cause the surrounding surfaces to also deteriorate possibly requiring a complete driveway replacement

Seal the crack(s) with weather-resistant pliable concrete sealer

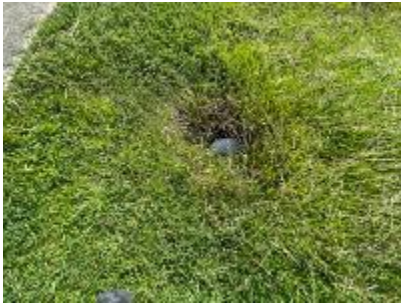
## OTHER LANDSCAPING AND HARDSCAPING

Hole in the ground

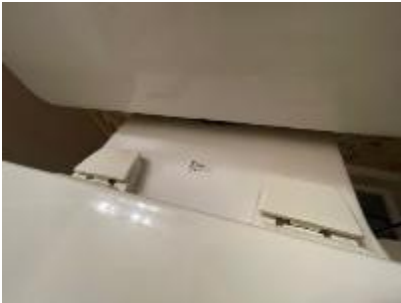
TOILET

Leaking from the bowl at the time of the inspection

The leak may cause moisture damage to surrounding material

First, attempt to tighten all nuts. If that does not resolve the leaking, have a plumber evaluate the unit for repairs.

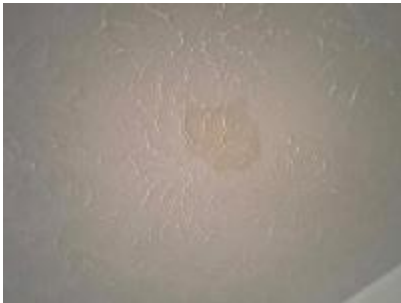
### CEILING

Signs of previous leak.

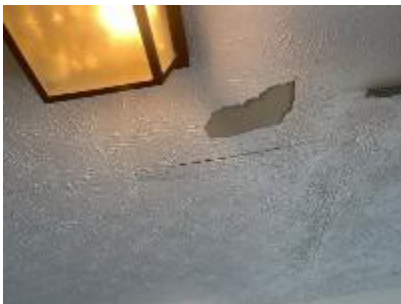
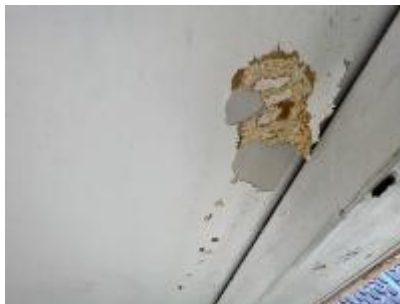
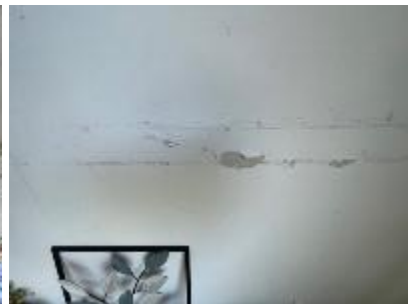
Paint damage

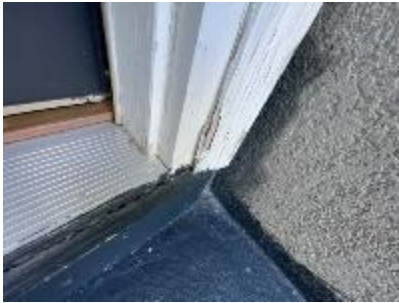
## EXTERIOR DOOR

Damaged

Repair the damage or replace the door depending on your preference

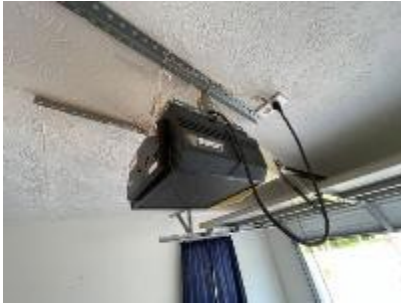
## GARAGE DOOR OPENER

Not working

Replace the garage door opener

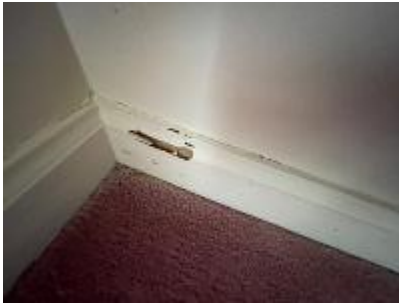
## INTERIOR TRIM

Damaged

The damage may allow for moisture or insect intrusion which if not corrected provides an environment for mold growth or structural damage

Replace the damaged trim

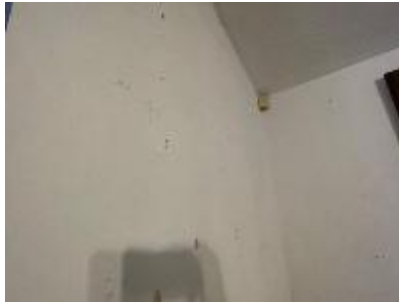
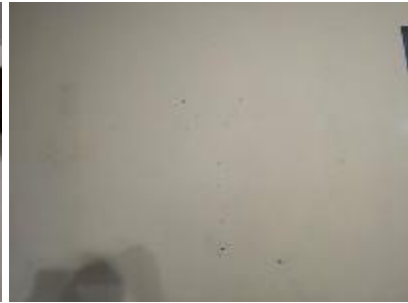
## WALL

#### Drywall has nail pops

Remove the nail and insert a screw and repair with drywall compound When repainting

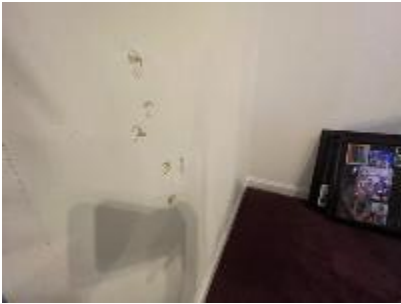
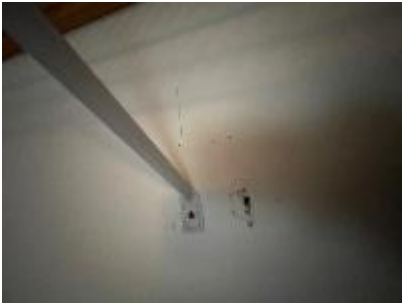
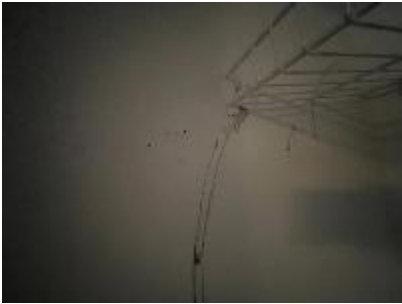
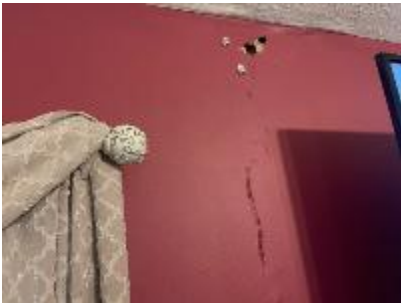
#### Drywall has damage

Beyond being an aesthetic issue, the lack of the gaps in the wall affect the thermal boundary of the home

Replace the damaged areas of the wall

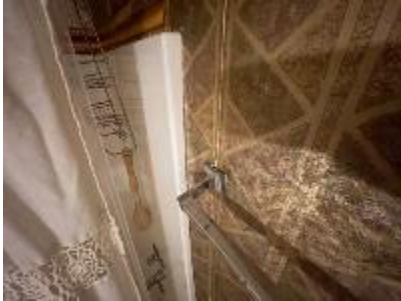
## WALL 1

Towel rack is loose

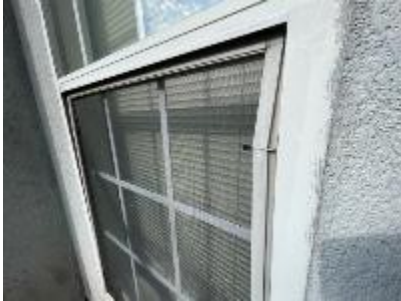
## WINDOW

Slight Damage
