## INSPECTION REPORT

735 North Greenwood Street,  
LaGrange, Georgia 30240

Prepared for  
Uncommon  
Date Inspected  
Sep 30, 2024

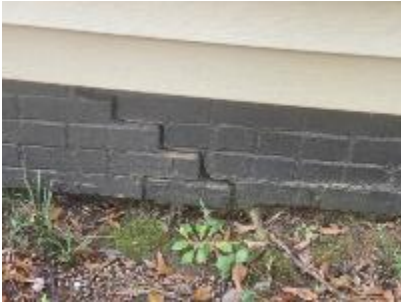
FOUNDATION WALL

3. Floor: Unlevel

4. Foundation Wall: Exhibits moderate step cracks
5. Ductwork: Contains debris
6. Driveway: Asphalt is cracking
7. Floor: Tile is loose

Exhibits moderate step cracks

| IMPACT | The cracking may allow moisture intrusion |

| SUGGESTED ACTION | Have epoxy injected into the crack by a licensed waterproofing contractor |

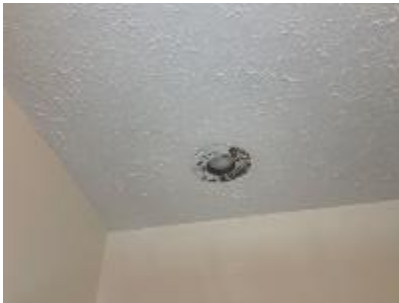
### ✓ LIGHT FIXTURE

Rusted light fixture

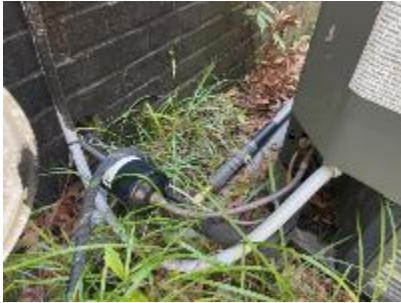
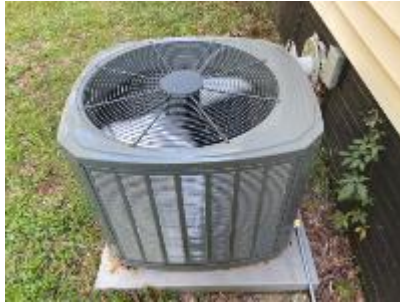
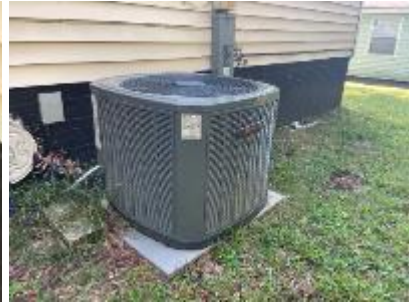
#### AIR CONDITIONER

Unit is in good condition

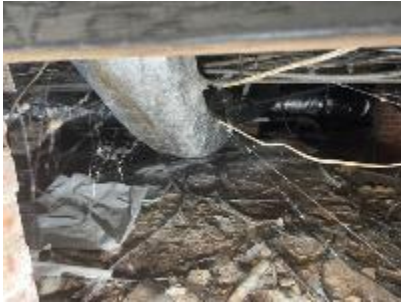
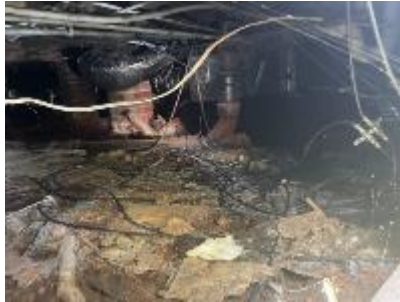
## DUCTWORK

**Contains debris**

The debris could affect air flow potentially causing poor air quality

Have cleaned by a ductwork cleaning technician

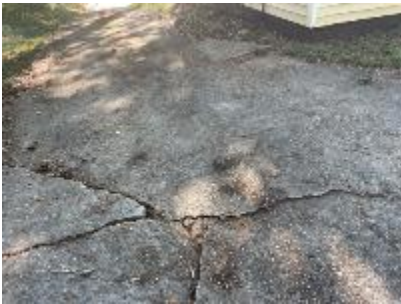
DRIVEWAY

Asphalt is cracking

The crack allows water intrusion, which may cause the surrounding surfaces to also deteriorate possibly requiring a complete driveway replacement

All asphalt surfaces, that are not regularly seal-coated, dry out and fissure

Sealcoat the driveway with an oil-based asphalt sealer and consult with a seal coating contractor for a regular maintenance program based on the traffic and weather conditions

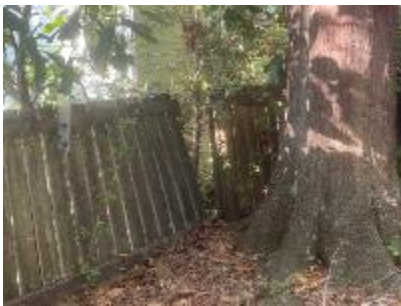
## FENCE

Leaning

If not addressed, over time, portions of the fence may fall

Have the fence repaired by a fence contractor

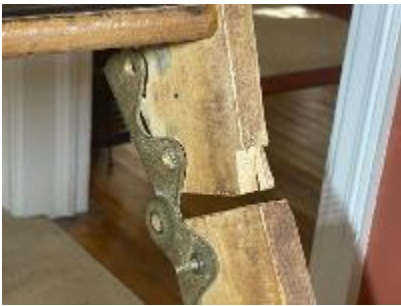
## ATTIC LADDER

Damaged

| IMPACT | The damage may render the ladder unusable |

| SUGGESTED ACTION | Either repair the damage or replace it with a new ladder |

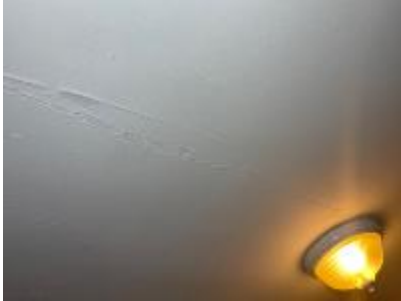
## CEILING

Crack from possible previous water leak.

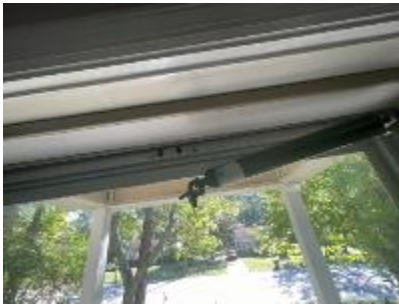
## EXTERIOR DOOR

Damaged

Repair the damage or replace the door depending on your preference

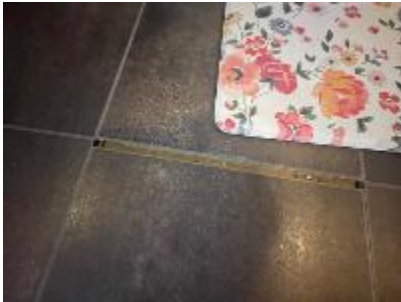
## FLOOR

#### Tile is loose

Replace the loose tile

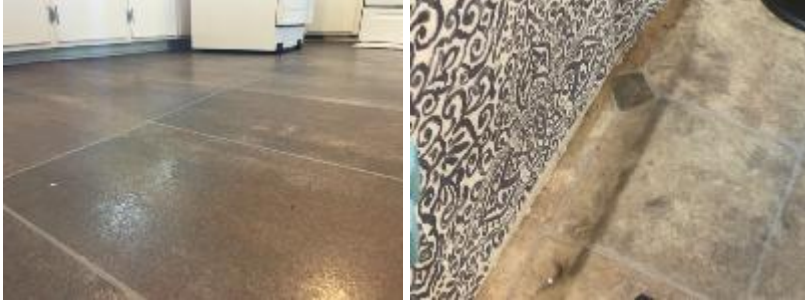
#### Unlevel

The structural integrity of the entire home is in question

An unlevel floor is an indication that the support structure of the affected area is insufficient or is failing

Have the home evaluated by a structural engineer

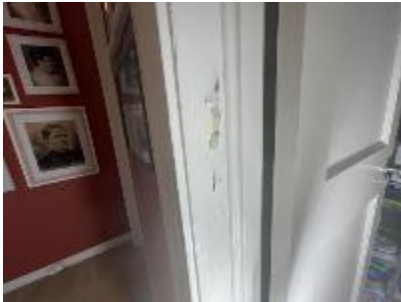
## ✓ INTERIOR DOOR

Paint damage

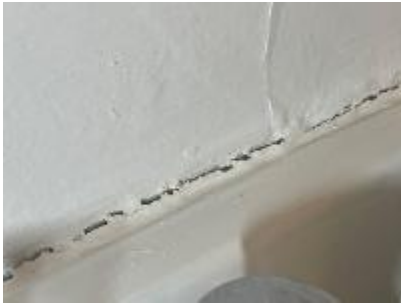
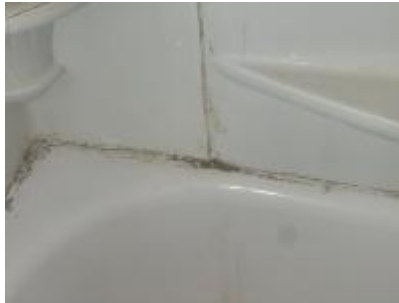
## INTERIOR TRIM

### Caulking or sealant deteriorated

Without consistent weather-tight sealant, moisture intrusion may occur causing long-term damage to surrounding trim and structure

Remove deteriorated caulking and replace with a weather-resistant color-matched flexible sealant

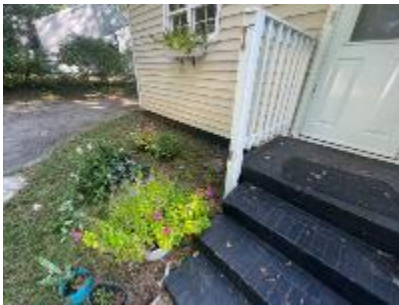
## ! STAIR

#### Handrail is missing

A missing handrail could hinder the stair user an opportunity to stop or reduce the extent of a fall

Install a handrail

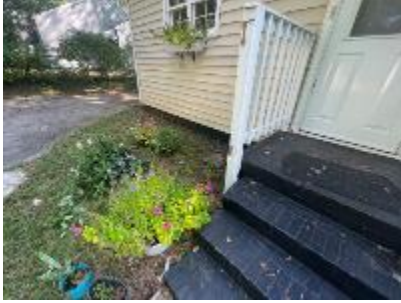
#### Handrail is damaged

A damaged handrail could hinder the stair user an opportunity to stop or reduce the extent of a fall

Replace the railing

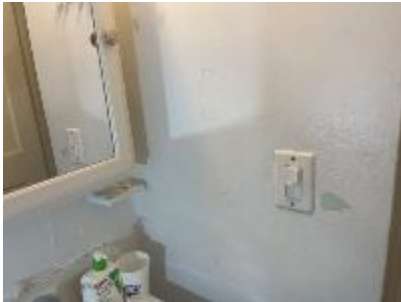
## ✓ WALL

Paint damage
