## INSPECTION REPORT

109 Lee Road 2115,  
Phenix City, Alabama 36870

Prepared for  
Uncommon  
Date Inspected  
Oct 2, 2024

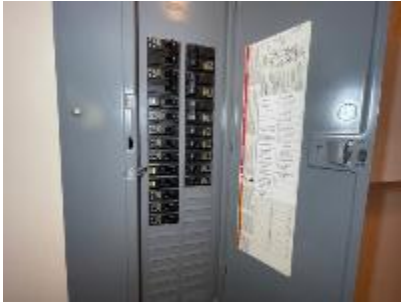
## ✓ ELECTRIC SERVICE PANEL

Good condition

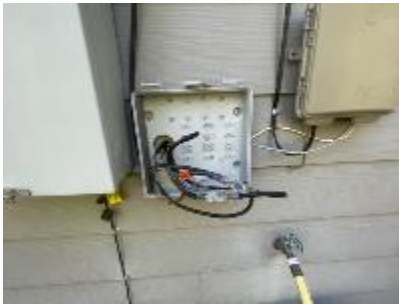
## JUNCTION BOX

1. Junction Box: Cover plate is missing

Cover plate is missing

Without a cover plate, electrical shock may result if touched

Install a cover

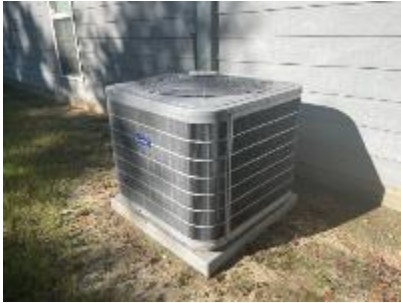
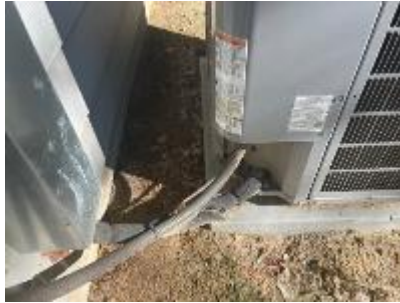
### AIR CONDITIONER

Unit is in good condition

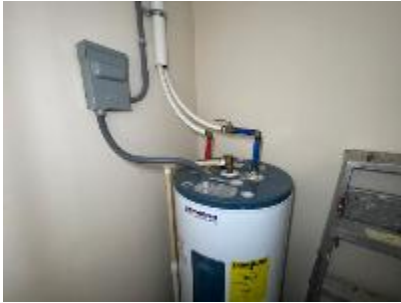
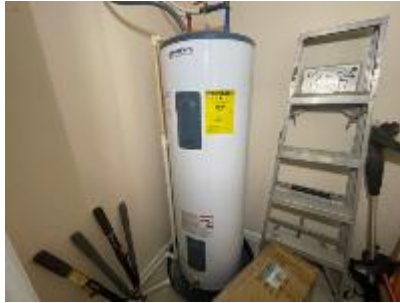
#### ✓ WATER HEATER

Unit is in good condition

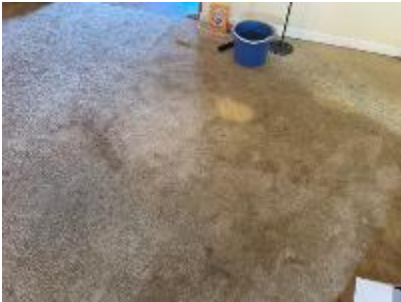
FLOOR

Showing signs of wear

| SUGGESTED ACTION | Consider repairing or replacing the flooring |

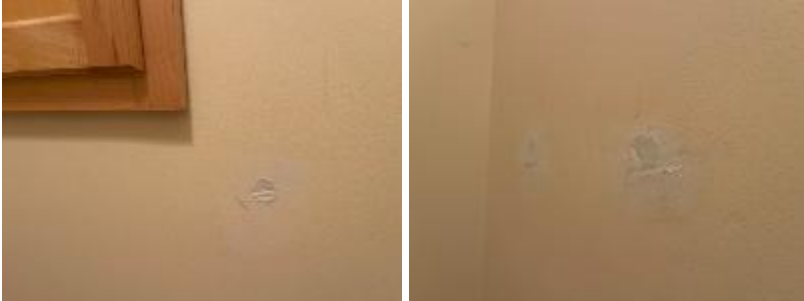
## WALL

Signs of previous wall damage.
