## INSPECTION REPORT

705 King Drive,  
Phenix City, Alabama 36869

Prepared for  
Uncommon  
Date Inspected  
Nov 2, 2024

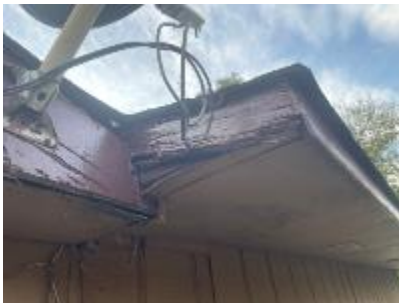
## Wood fascia is damaged

With damaged fascia, the home lacks protection from animals entering

Replace the damaged area

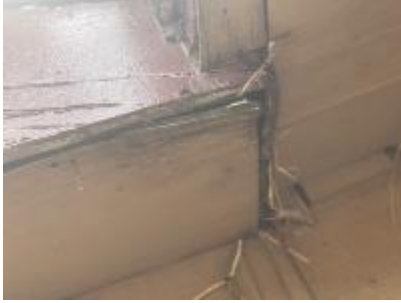
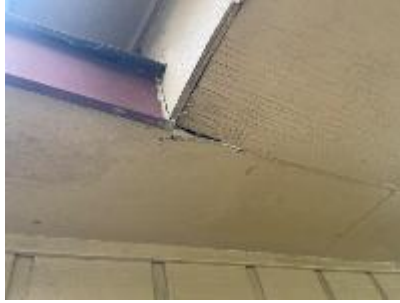
## Wood soffit is damaged

With damaged fascia, the home lacks protection from animals entering

Replace the damaged area

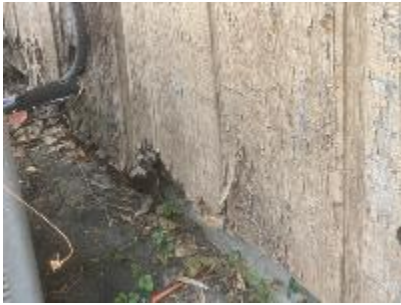
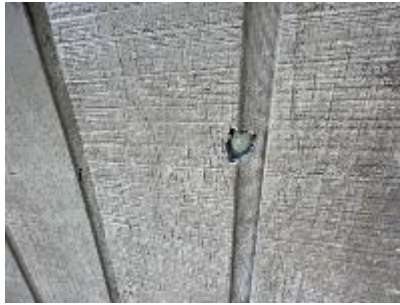
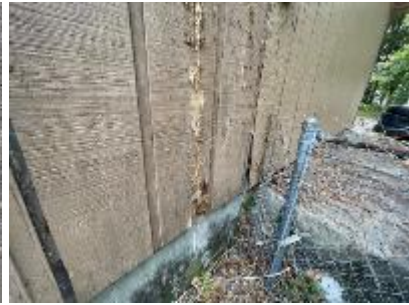
#### Material is damaged

With damaged siding, the home lacks protection from insects, animals and the elements and it may negatively affect the thermal boundary of the home

Replace the damaged area

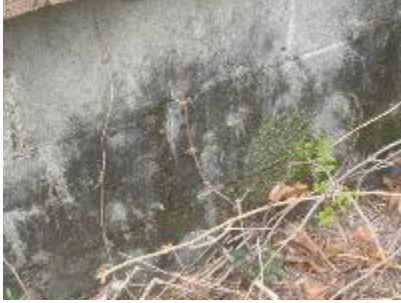
#### Has moss growth on the brick

It may lead to deterioration of the brick or mortar

Have a qualified mason assess for the source of moisture intrusion and recommend repairs

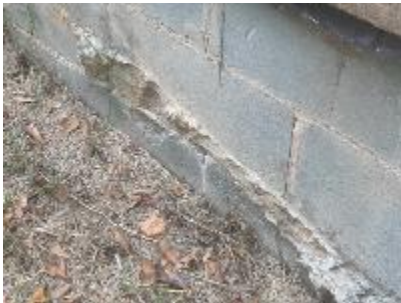
**Shows evidence of previous repair**

Monitor for moisture intrusion. If you see new leaks further evaluation by a qualified mason is recommended.

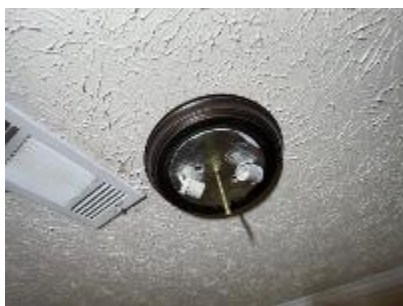
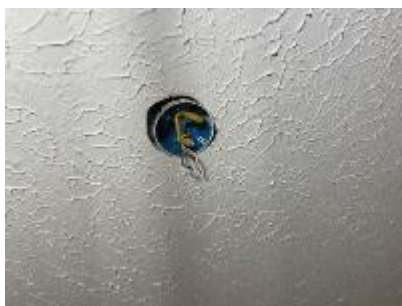
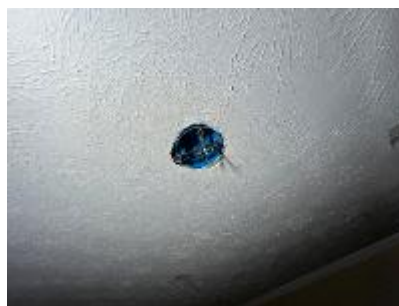
Light cover is missing

Add a cover to the light

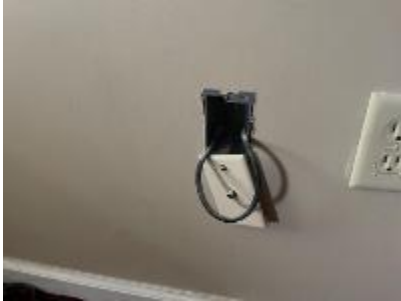
Not full secured on wall

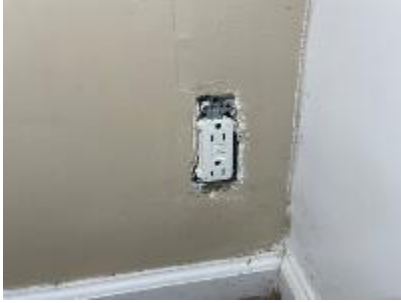
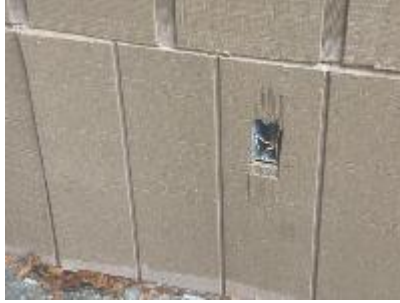
Cover plate is missing

Without a cover plate, can cause electrical shock if touched

Install a cover

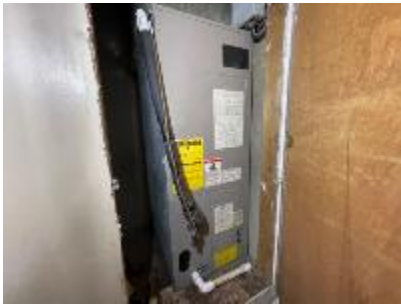
Unit is in good condition

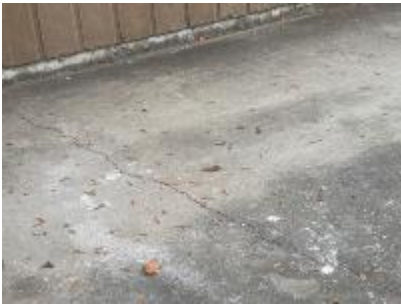
Asphalt is cracking

The crack allows water intrusion, which may cause the surrounding surfaces to also deteriorate possibly requiring a complete driveway replacement

All asphalt surfaces, that are not regularly seal-coated, dry out and fissure

Sealcoat the driveway with an oil-based asphalt sealer and consult with a seal coating contractor for a regular maintenance program based on the traffic and weather conditions

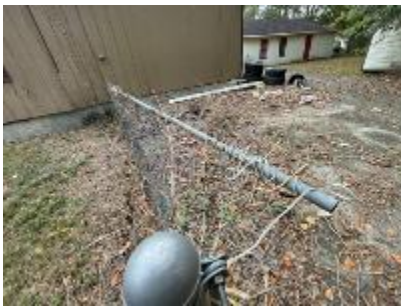
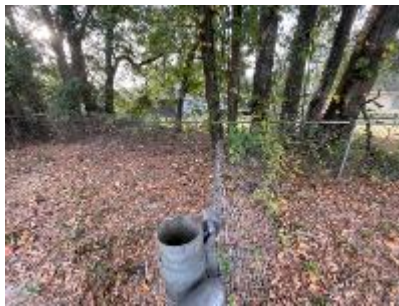
Leaning

If not addressed, over time, portions of the fence may fall

Have the fence repaired by a fence contractor

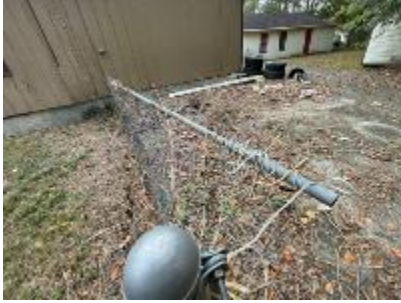
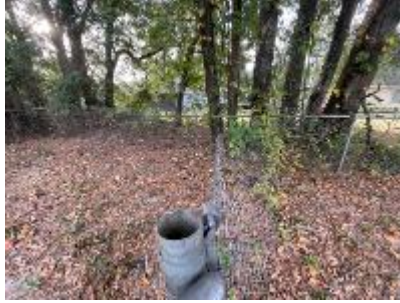
Damaged

Repair the damaged areas of the fence

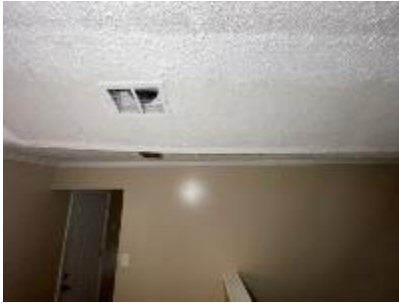
Slight "bowing" on ceiling

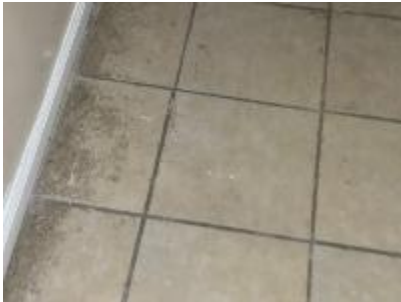
Showing signs of wear

Consider repairing or replacing the flooring

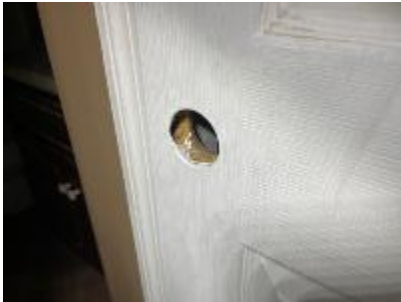
Handle is missing or broken

Replace the door handle assembly
