INSPECTION REPORT

**626 West Main Street,  
Hogansville, Georgia 30230**

Prepared for  
Date Inspected  
Aug 22, 2024

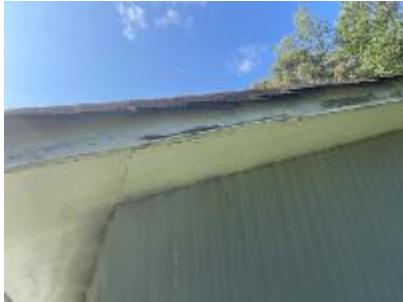
#### Fascia paint is chipped, faded or worn

Untreated fascia is at risk of premature aging due to exposure to the elements

Repaint

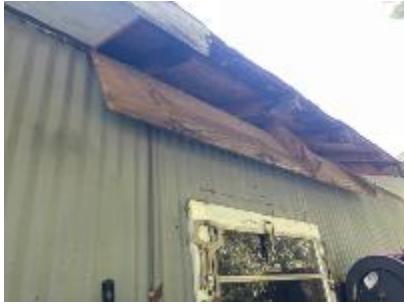
#### Wood fascia is damaged

With damaged fascia, the home lacks protection from animals entering

Replace the damaged area

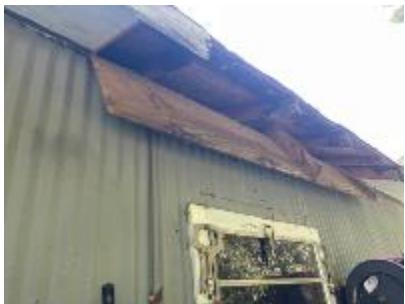
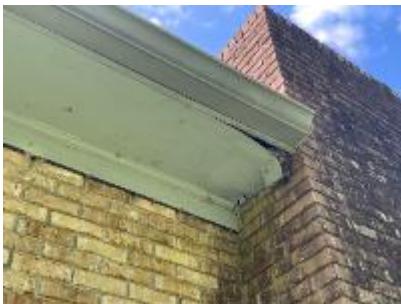
**Wood soffit is damaged**

With damaged fascia, the home lacks protection from animals entering

Replace the damaged area

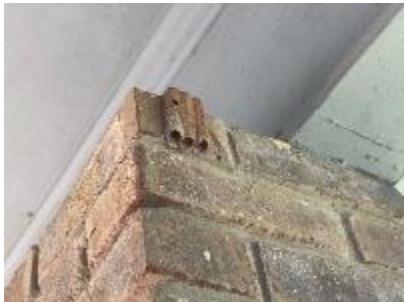
Possible live insect mound growth.

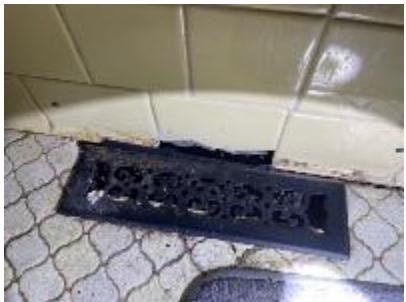
Improperly secured

Resecure the register cover

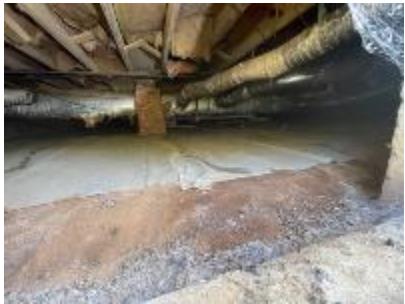
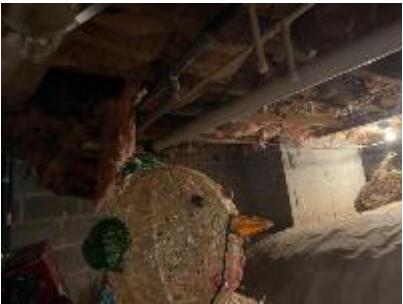
Insulation is slightly damaged and not properly secure in a few spots.

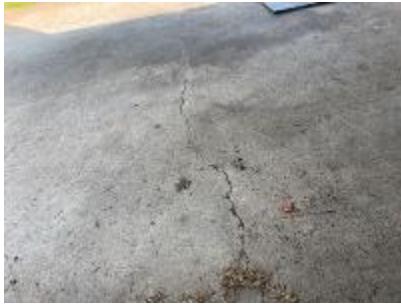
Asphalt is cracking

The crack allows water intrusion, which may cause the surrounding surfaces to also deteriorate possibly requiring a complete driveway replacement

All asphalt surfaces, that are not regularly seal-coated, dry out and fissure

Sealcoat the driveway with an oil-based asphalt sealer and consult with a seal coating contractor for a regular maintenance program based on the traffic and weather conditions

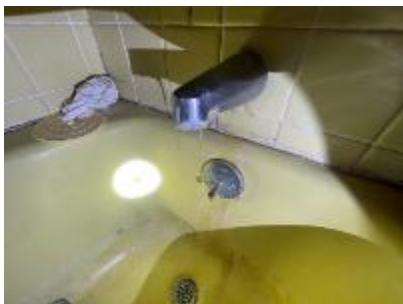
Faucet is leaking

The leak may cause excessive water usage

Check all seals and replace them as necessary. If that does not work, replace the valve assembly.

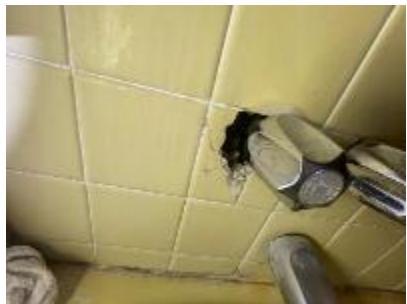
Damaged

The damage may allow moisture to leak into the wall cavity and cause moisture damage

Repair the tub

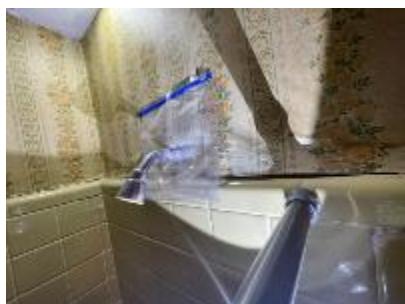
**Shower head stem is not secured**

The loose shower stem may allow water penetration behind the wall

Either install a shower stem collar with a set screw. If this does not hold, consider consulting a plumber for repair.

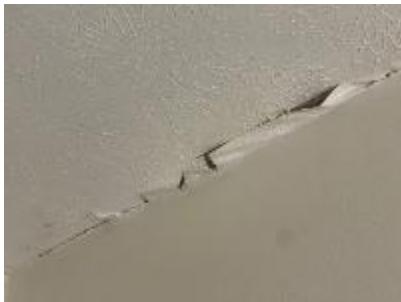
**Paint is bubbling, possibly due to moisture intrusion**

If the cause of the peeling paint is not repaired, further damage may result

Have repaired by a qualified contractor

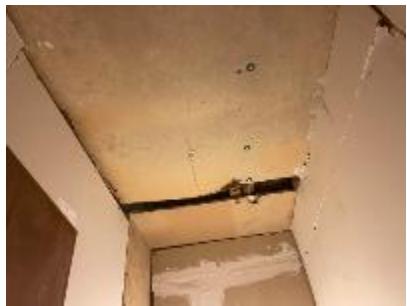
**Damaged**

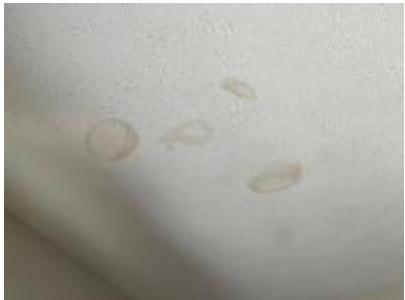
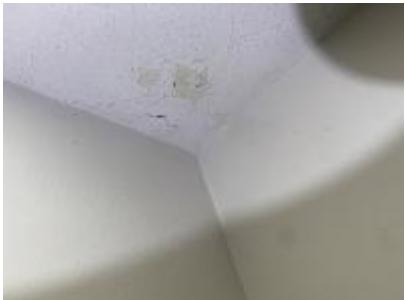
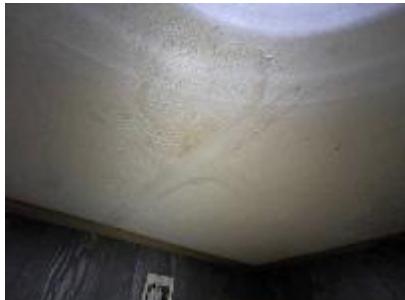
Signs of previous leak.

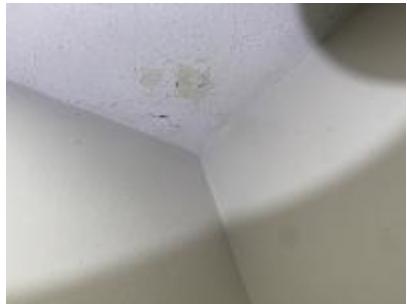
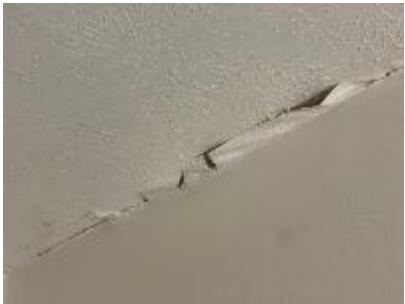
Paint damage

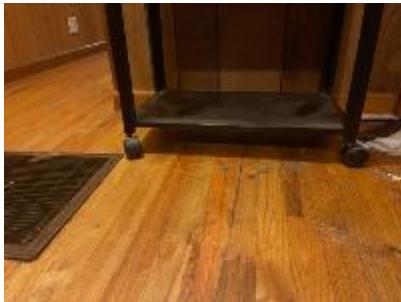
Slight hump in hall way floor near basement entry.

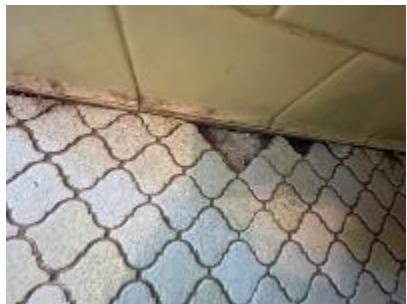
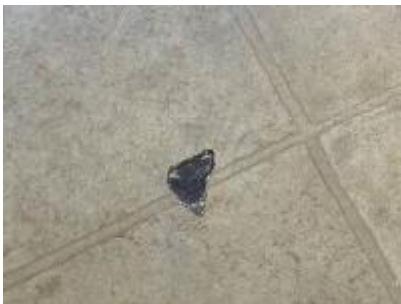
Tile is damaged

If not repaired, the tile may become loose

Damaged tiles may be an indication of impact from the surface or air pockets between the tile and the sub floor

Replace the damaged tile. Be careful not to damage the surrounding tile during the process.

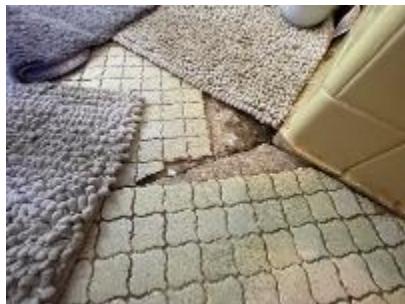
**Tile is cracked**

The tiles could come loose and cause either a trip or a sharp edge cutting hazard

Replace the broken tiles

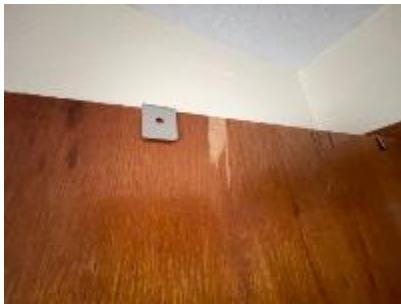
Damaged

Replace the door as desired

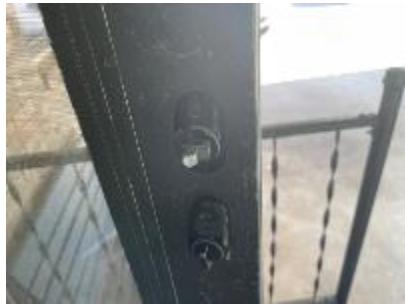
Handle is missing or broken

Replace the door handle assembly

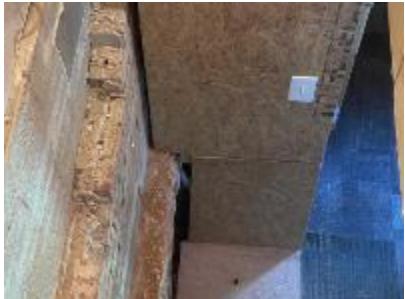
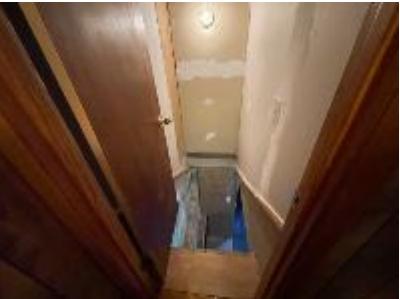
Stairs have been removed

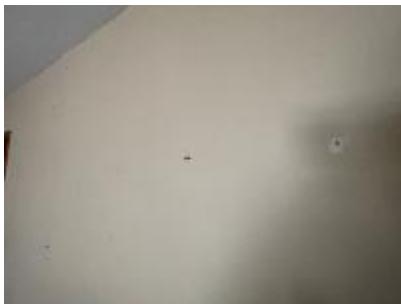
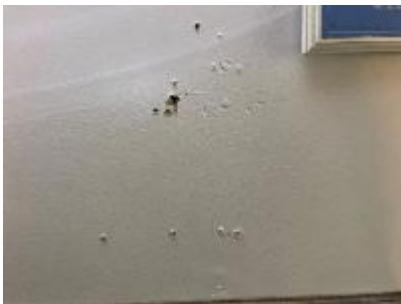
Drywall has nail pops

Remove the nail and insert a screw and repair with drywall compound When repainting

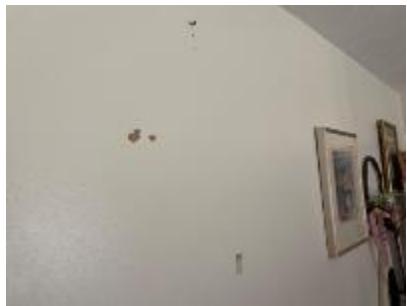
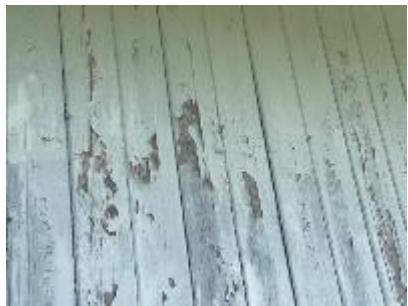
Paint damage

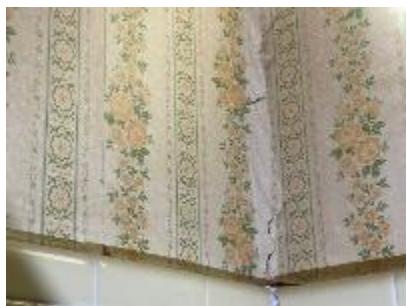
Wall paper damage, possible crack in drywall

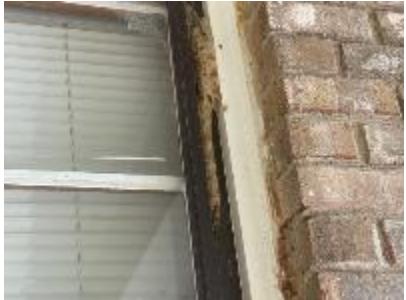
Possible live insect mound growth.
