## INSPECTION REPORT

**5237 Village Way,  
Columbus, Georgia 31907**

Date Inspected  
Dec 9, 2024

Inspected by  
Brandon Crittenden

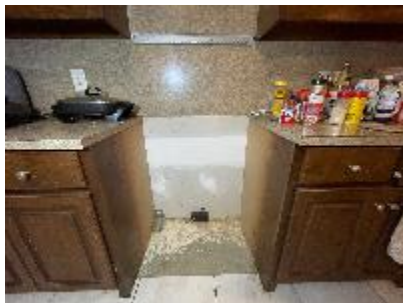
Kitchen

**COOK TOP**

NOT WORKING

No stove

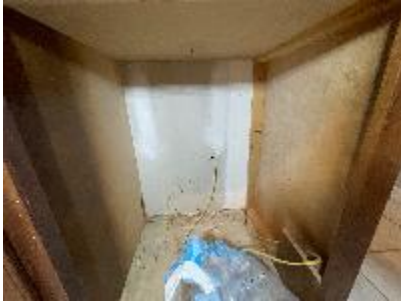
Kitchen

## DISHWASHER

COSMETIC

Missing

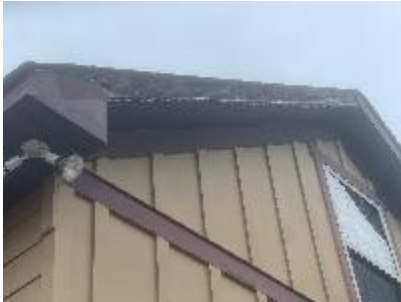
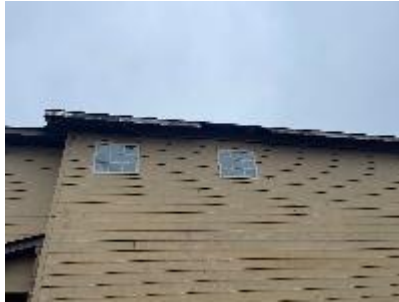
**MINOR CONCERN****Wood fascia is damaged****IMPACT**

With damaged fascia, the home lacks protection from animals entering

**SUGGESTED ACTION**

Replace the damaged area

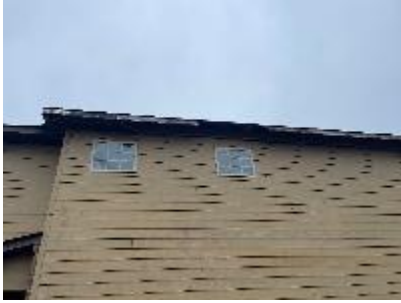
**MINOR CONCERN****Wood soffit is damaged****IMPACT**

With damaged fascia, the home lacks protection from animals entering

**SUGGESTED ACTION**

Replace the damaged area

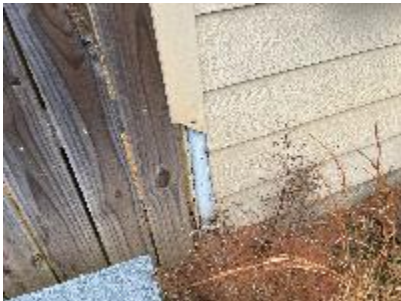
Exterior: Ground View

## EXTERIOR TRIM

MODERATE CONCERN

Damaged

SUGGESTED ACTION

Replace the damaged trim

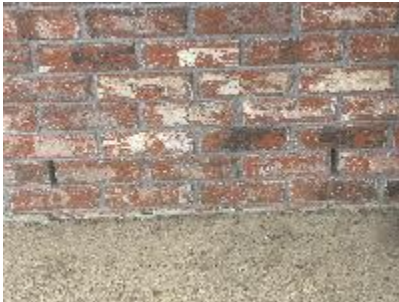
Exterior: Ground View

### MODERATE CONCERN

**Mortar has cracks, voids or is loose**

#### IMPACT

If not repaired, the cracking may worsen resulting in moisture intrusion which could lead to further problems such as insect nesting and damage to the siding material

#### INFORMATION

This could be caused by shifting of the siding material and/or improper installation

#### SUGGESTED ACTION

Have a qualified mason repair the affected area

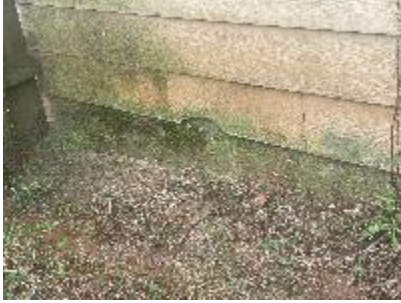
### MODERATE CONCERN

**Has moss growth**

#### IMPACT

It may lead to deterioration

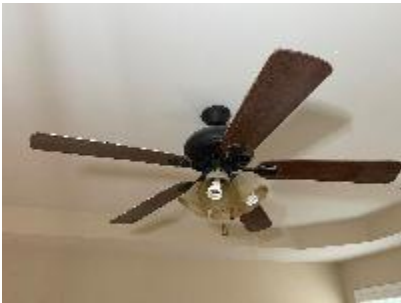
**CEILING FAN**

NOT WORKING

Not working

SUGGESTED ACTION

Replace the unit

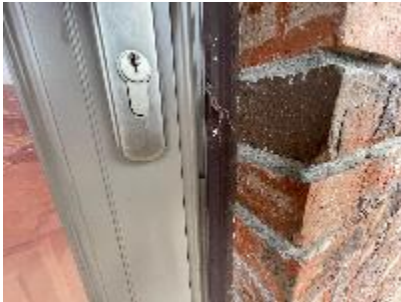
Exterior: Ground View

## DOOR BELL

MINOR CONCERN

Wiring is exposed due to missing doorbell

SUGGESTED ACTION

Install a door bell

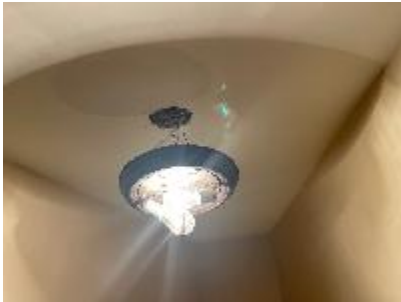
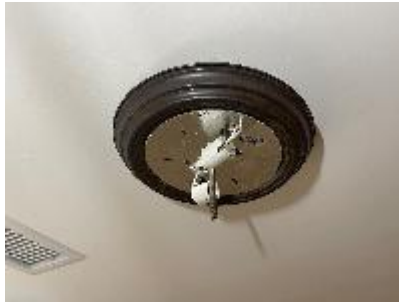
## LIGHT FIXTURE

COSMETIC

Light cover is missing

SUGGESTED ACTION

Add a cover to the light

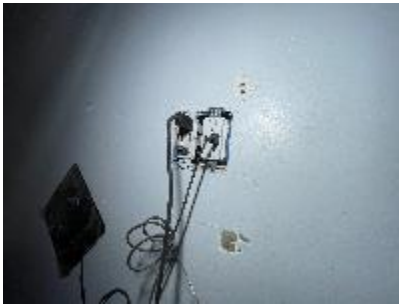
## ! OUTLET

### SAFETY CONCERN

Cover plate is missing

### IMPACT

Without a cover plate, can cause electrical shock if touched

### SUGGESTED ACTION

Install a cover

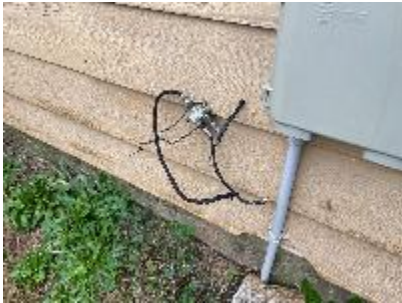
# ! WIRING

**SAFETY CONCERN**

**Exposed**

| IMPACT | Exposed wiring can cause electrical shock if touched |
| INFORMATION | Exposed wiring should be capped and in a junction box with a cover plate or removed |

| SUGGESTED ACTION | Place the wiring in a junction box with a cover plate |

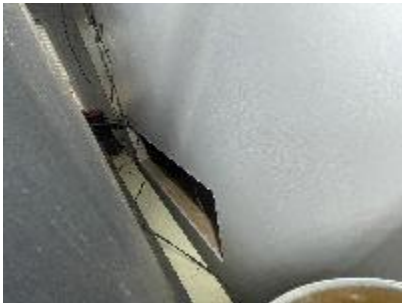
FIREPLACE

NOT WORKING

Not Working

SUGGESTED ACTION

Have repaired by a chimney company

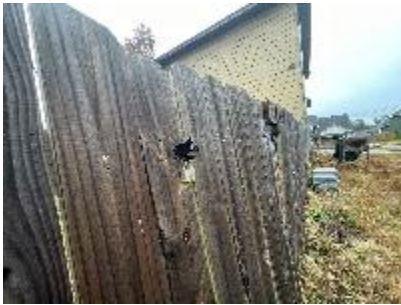
Exterior: Ground View

## FENCE

COSMETIC

In need of normal staining

### IMPACT

Wood fences need to be sealed regularly to prevent premature wear

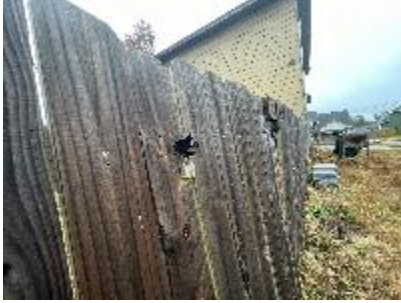
MINOR CONCERN

Leaning

### IMPACT

If not addressed, over time, portions of the fence may fall

### SUGGESTED ACTION

Have the fence repaired by a fence contractor

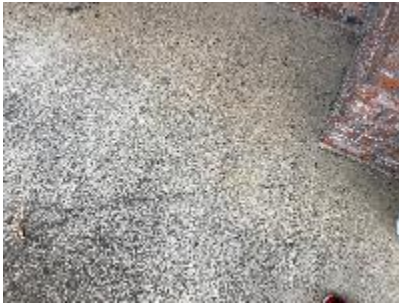
Exterior: Ground View

## PATIO AND WALKWAY

### MINOR CONCERN

#### Settling with minor cracks

##### IMPACT

The cracks allow for water intrusion, which may cause the surrounding surfaces to also deteriorate possibly requiring a complete replacement

##### SUGGESTED ACTION

Seal the crack(s) with weather-resistant pliable concrete sealer

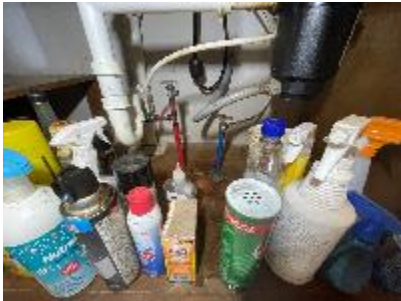
### OBSERVATION TO MONITOR

Signs of previous leak

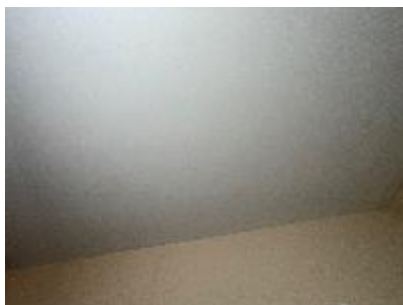
### ✓ CEILING

COSMETIC

Signs of previous leak.

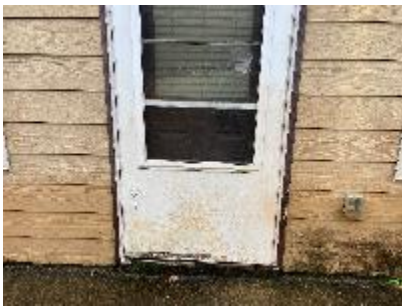
Exterior: Ground View

# EXTERIOR DOOR

MINOR CONCERN

Screen door handles are broken

IMPACT

Without a handle, the door is difficult to open

SUGGESTED ACTION

Replace the handle

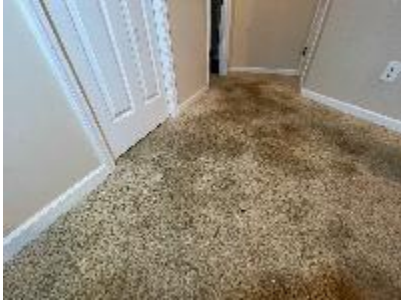
### COSMETIC

#### Showing signs of wear

##### SUGGESTED ACTION

Consider repairing or replacing the flooring

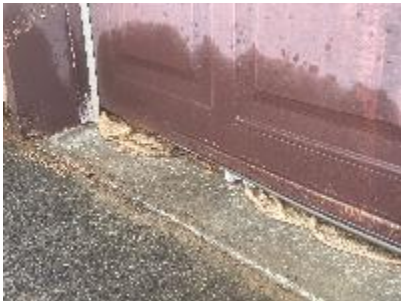
Garage

## GARAGE DOOR OPENER

NOT WORKING

Not working

SUGGESTED ACTION

Replace the garage door opener

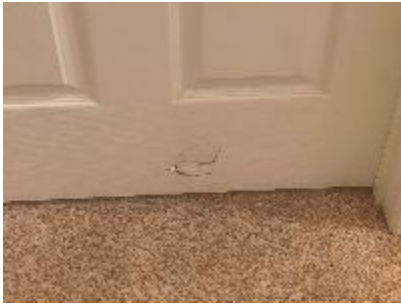
## ! INTERIOR DOOR

COSMETIC

Damaged

SUGGESTED ACTION

Replace the door as desired

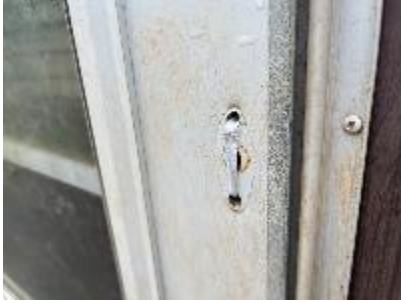
MODERATE CONCERN

Handle is missing or broken

SUGGESTED ACTION

Replace the door handle assembly

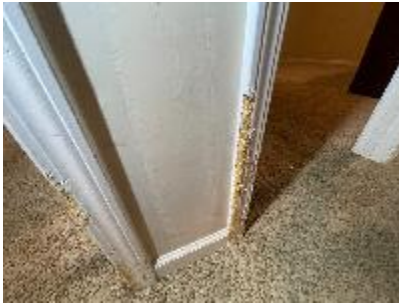
## ! INTERIOR TRIM

MODERATE CONCERN

Damaged

### IMPACT

The damage may allow for moisture or insect intrusion which if not corrected provides an environment for mold growth or structural damage

### SUGGESTED ACTION

Replace the damaged trim

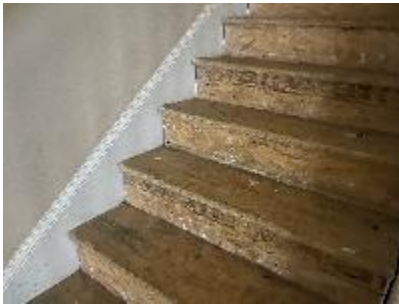
## ! STAIR

### SAFETY CONCERN

Tread covering is damaged, loose or missing

#### IMPACT

The damaged tread covering creates a possible trip hazard

#### SUGGESTED ACTION

Have the covering repaired or replaced

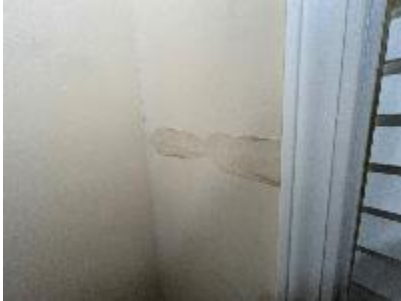
## ! WALL

### COSMETIC

Signs of previous wall damage.

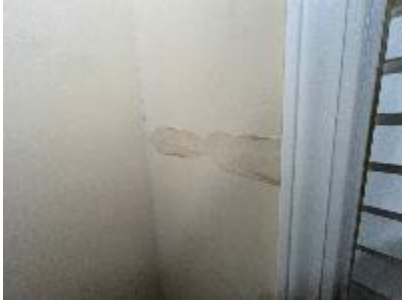
### MINOR CONCERN

Paint is bubbling, possibly due to moisture intrusion

#### IMPACT

If the cause of the peeling paint is not repaired, further damage may result

#### SUGGESTED ACTION

Have repaired by a qualified contractor

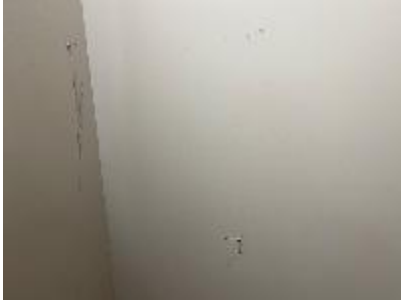
**MODERATE CONCERN**

**Drywall has damage**

**IMPACT**

Beyond being an aesthetic issue, the lack of the gaps in the wall affect the thermal boundary of the home

**INFORMATION**

The finished aspect of the wall is a component in creating a thermal boundary of a home which controls the transfer of energy (heat) between the interior and the exterior

**SUGGESTED ACTION**

Replace the damaged areas of the wall
