INSPECTION REPORT

**10039 AL-51,
Opelika, Alabama 36804**

Prepared for
Uncommon

Date Inspected
Jul 11, 2025

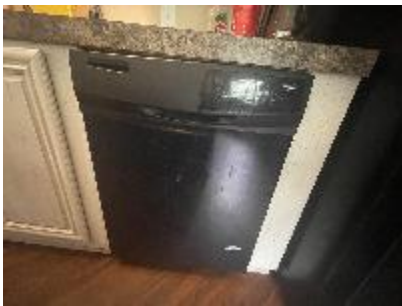
Kitchen

**DISHWASHER**

NOT WORKING

Not working

Repair or replace the unit

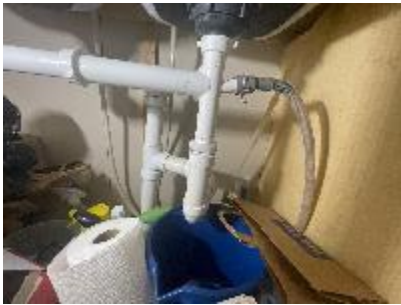
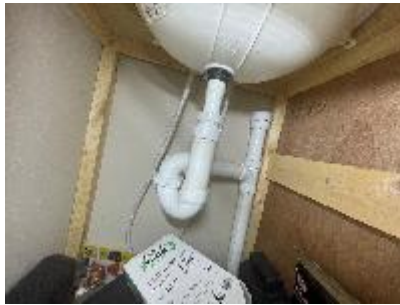
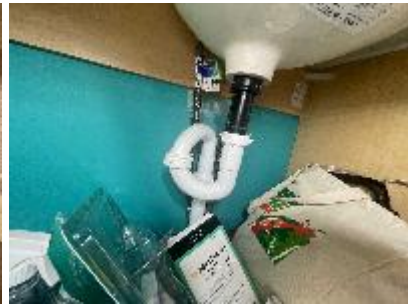
✓ SINK

Good condition. No signs of previous leak.

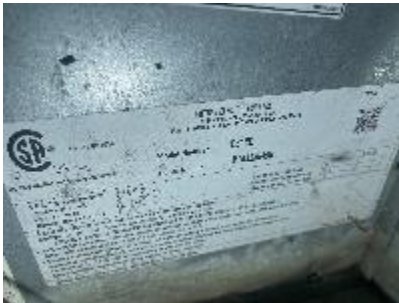
FURNACE

Manufacturer data plate

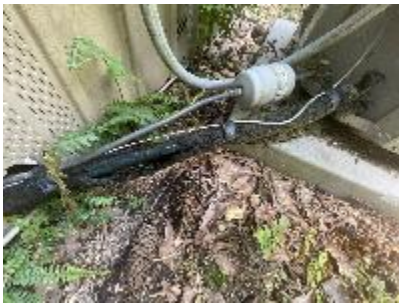
Exterior: Ground View

AIR CONDITIONER

MODERATE CONCERN

Refrigerant line is damaged

The refrigerant is essential for cooling and damage may limit or restrict the cooling capacity

Have repaired by an HVAC service professional

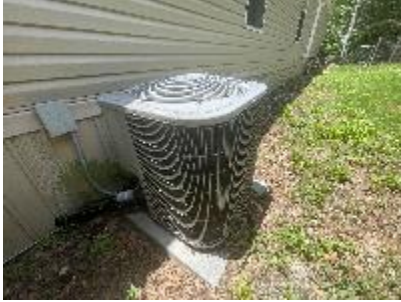
Unit is in good condition

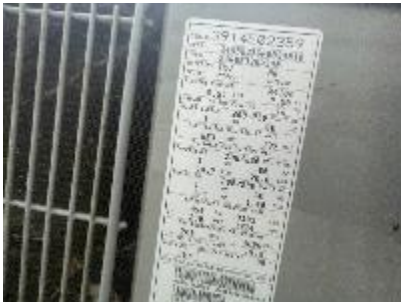
Manufacturer data plate

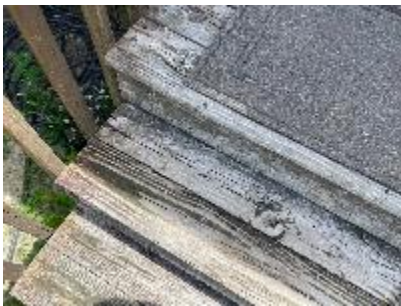
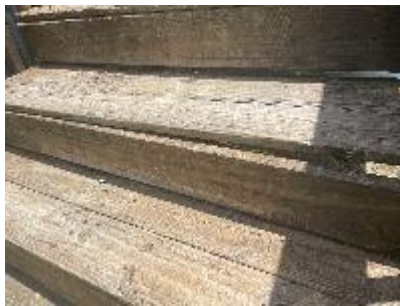
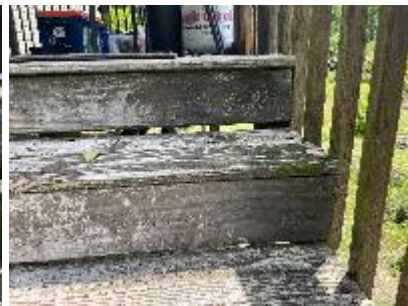
Exterior: Ground View

STAIR AND STOOP

MODERATE CONCERN

Damaged

The damage may worsen and become a trip hazard

Repair or replace the damaged steps

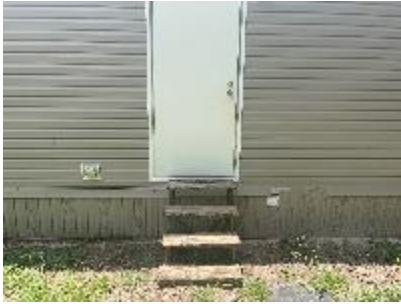
NOT WORKING

Handrail is missing

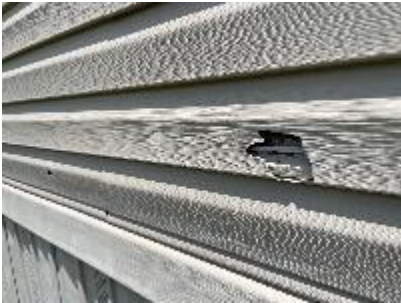
Exterior: Ground View

SIDING

MODERATE CONCERN

Material is damaged

With damaged siding, the home lacks protection from insects, animals and the elements and it may negatively affect the thermal boundary of the home

Replace the damaged area

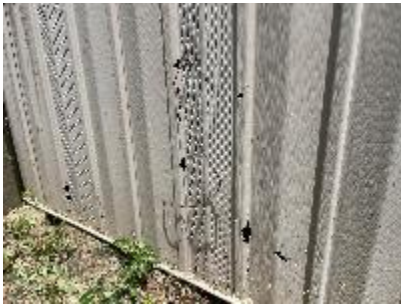
Exterior: Ground View

FOUNDATION WALL

POSSIBLE CONCERN

Damaged

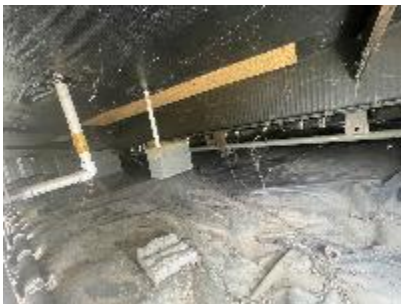
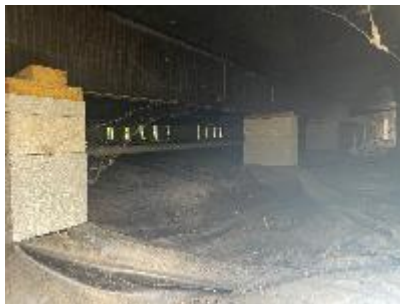
Good condition (crawl space)

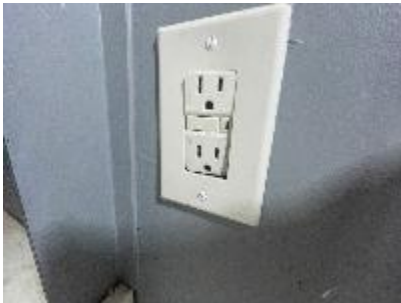
! OUTLET

POSSIBLE CONCERN

Not full secured on wall
