## INSPECTION REPORT

# 164 Robert Taylor Rd, Lagrange, Georgia 30240

Date Inspected  
Jul 11, 2025

Inspected by  
Brandon Crittenden

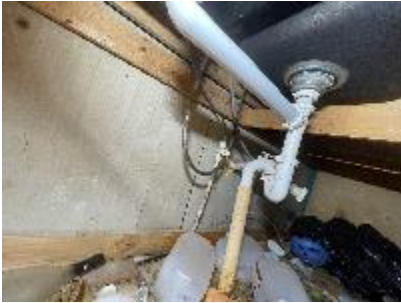
SINK

S-Trap pipe installed incorrectly.

With an incorrect installation, proper and sanitary drainage may not occur.

Have S-trap(s) installed correctly by a licensed plumber

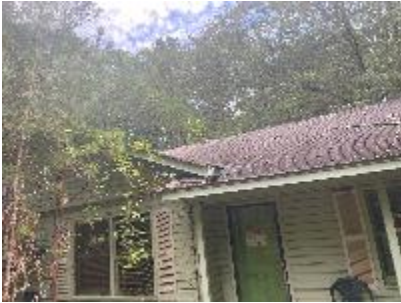
ROOF MATERIAL

Damaged in isolated areas

The damaged areas may expose the underlying sheathing to potential water damage

Replace the roof material in the damaged areas

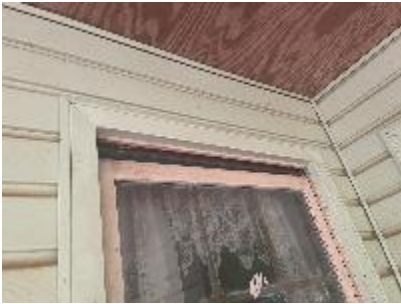
WINDOW

Frame is out of square

The deficient frame makes it difficult to open the window

Have the frame repaired by a carpenter

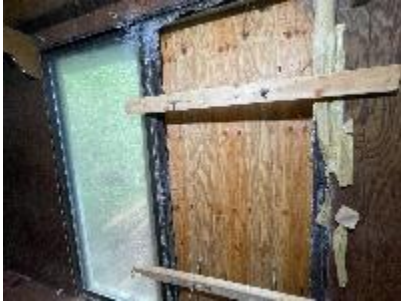
## EXTERIOR DOOR

**Glass pane is broken/cracked.**

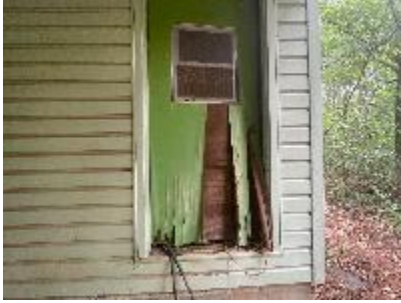
**Damaged**

Repair the damage or replace the door depending on your preference

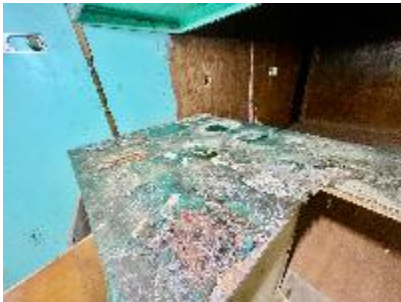
## ✓ COUNTERTOP

Excessively worn and/or damaged

While still functional, it lacks aesthetics

Consider replacing the countertops

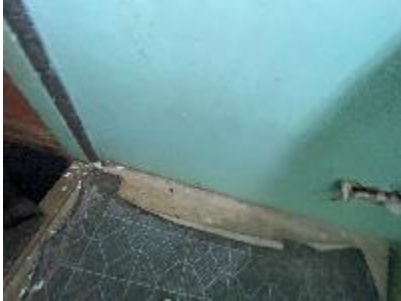
## FLOOR

Vinyl/Laminate is not aligned/damaged

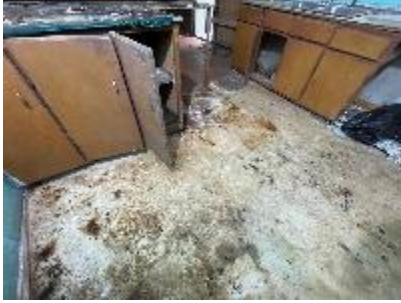
Shows sign of potential mold

Mold may cause a variety of health effects to those exposed depending on your sensitivities

Evaluation by a licensed certified mold re-mediation contractor

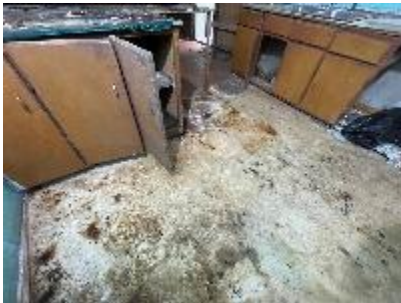
Showing signs of wear

Consider repairing or replacing the flooring

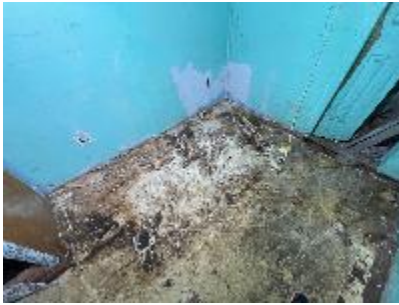
Spongy

The structural integrity of the affected area is in question

A spongy surface indicates a potential concern with the subfloor

Have repaired by a flooring professional

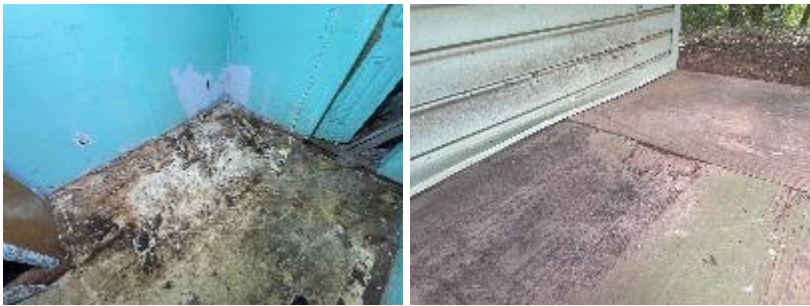
**OBSERVATION TO MONITOR****Squeaking**

Squeaky floors may be caused by a number of different situations including gaps between the subfloor and the joist, warped joists, noisy joists, and the floor rubbing against the sub-floor.

Depending on the cause and the access to the joists or subfloor from the floor below, a number of solutions are available, including inserting shims into gaps, filling gaps with construction adhesive, sistering a joist for additional support, and securing the subfloor with screws or nails to eliminate squeaks or flexing.

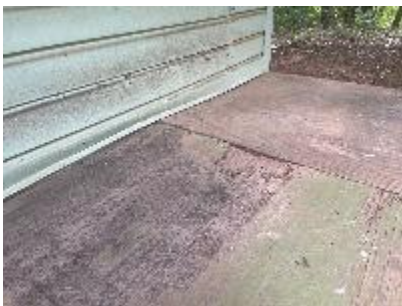
MAJOR CONCERN    Unlevel

IMPACT	The structural integrity of the entire home is in question
SUGGESTED ACTION	Have the home evaluated by a structural engineer
INFORMATION	An unlevel floor is an indication that the support structure of the affected area is insufficient or is failing

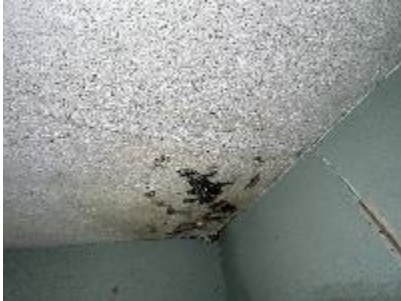
## ! CEILING

Signs of previous leak.

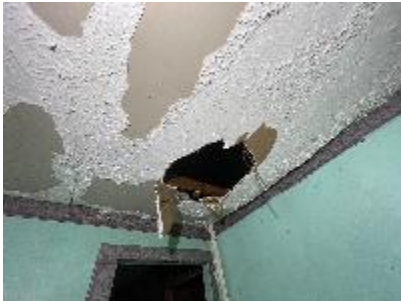
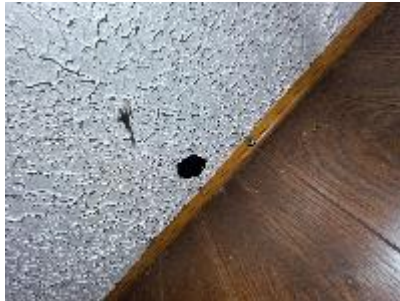
Damaged

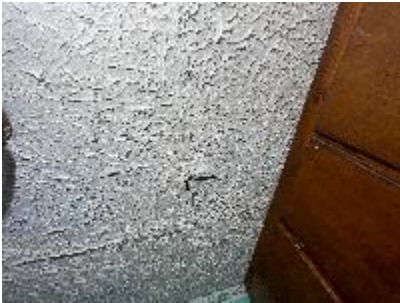
**Multiple cracks in the ceiling**

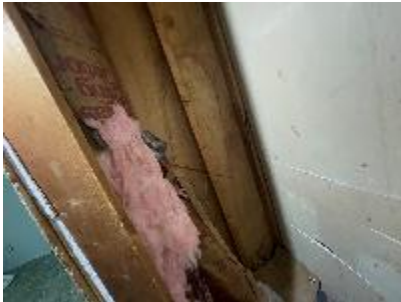
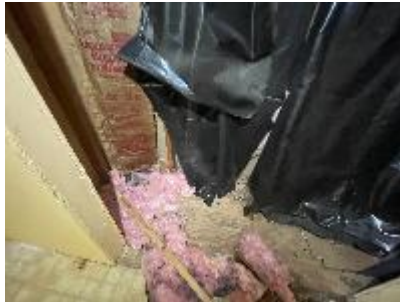
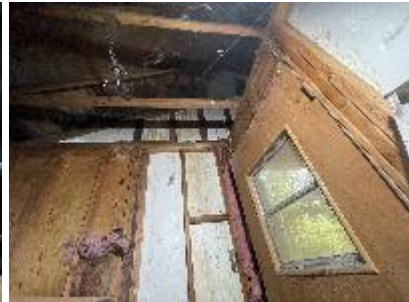
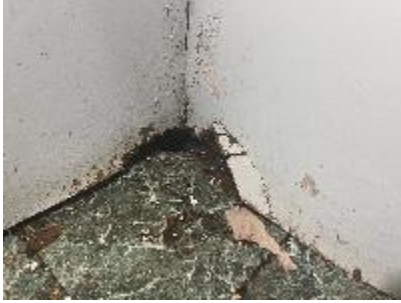
## ! WALL

### Drywall has damage

Beyond being an aesthetic issue, the lack of the gaps in the wall affect the thermal boundary of the home

Replace the damaged areas of the wall

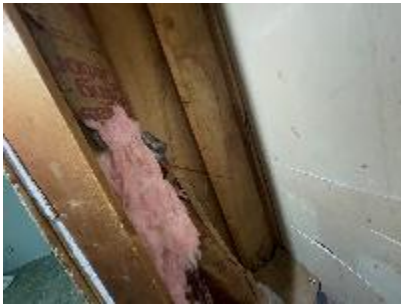
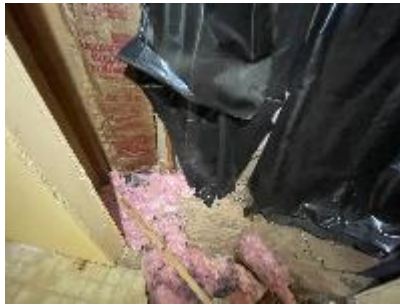
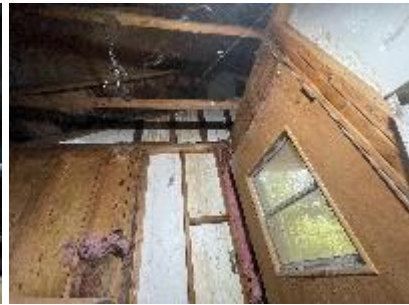
Wood panel damage

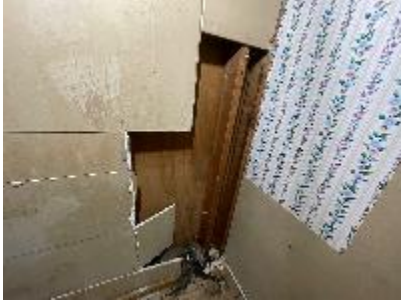
No drywall or plaster in place. Inner wall structure exposed

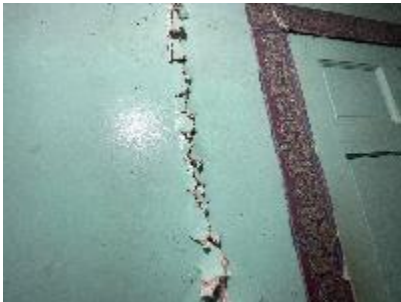
Shows signs of settling cracks

With cracks, the wall lacks aesthetic appeal

Some degree of settling cracks should be expected in every home

Repair the cracked areas using drywall compound

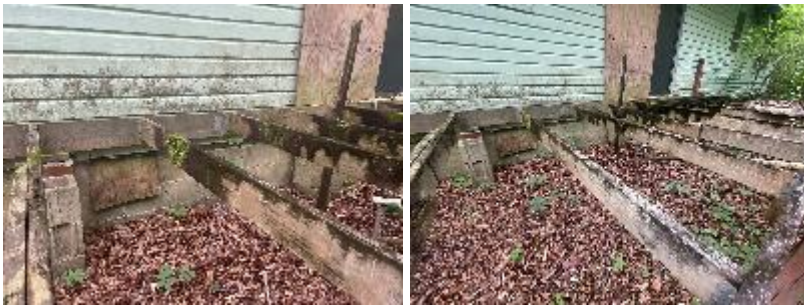
## BALCONY, DECK OR PORCH

#### Boards are deteriorated

The splintering diminishes the structural integrity of the planking

Replace the deteriorating boards

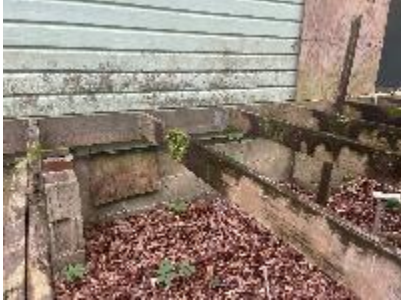
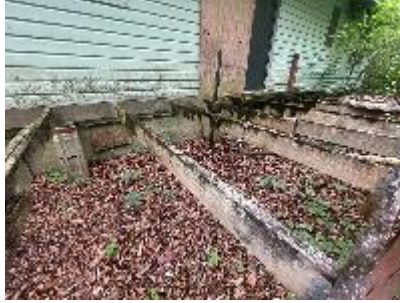
#### Bracing is damaged or missing

Without proper bracing, the porch, deck or balcony is unstable

Determine if support piers are level. If they are level, re-secure bracing. If they are not level, level as needed and re-secure bracing.

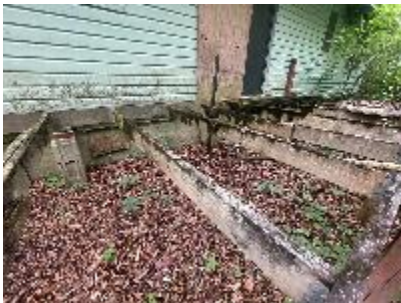
**Balusters are damaged or missing**

Deficient balusters reduce the stability of the railing

Replace the missing component

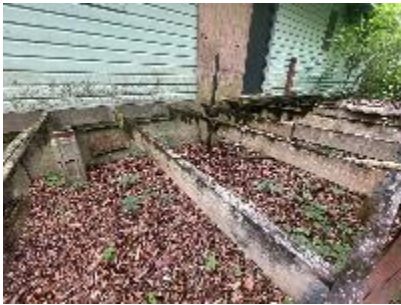
**Decking has organic growth**

With excessive exposure to moisture, the wood may prematurely deteriorate

The moss is a sign that the deck is regularly exposed to moisture.

Remove the moss and ensuring the water source is remediated

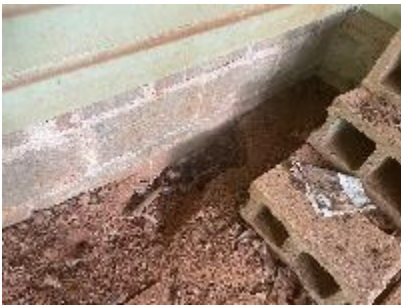
LANDSCAPE FEATURE

Soil level is too low

IMPACT	When soil levels are low against the face of the foundation it promotes shifting or movement of the structure and insect infestation
SUGGESTED ACTION	Adding soil to provide the proper exposure of the foundation face
INFORMATION	It is generally accepted that a brick veneer house should have about 6 inches of clearance. Wood siding houses should have more clearance

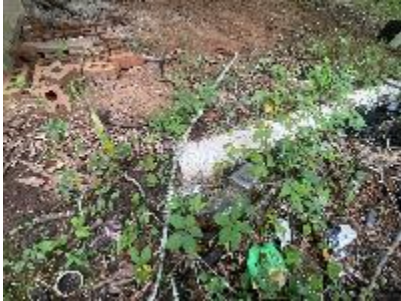
## DRAINAGE AND GRADING

Improper drainage in yard. (possible pipe issues underground)

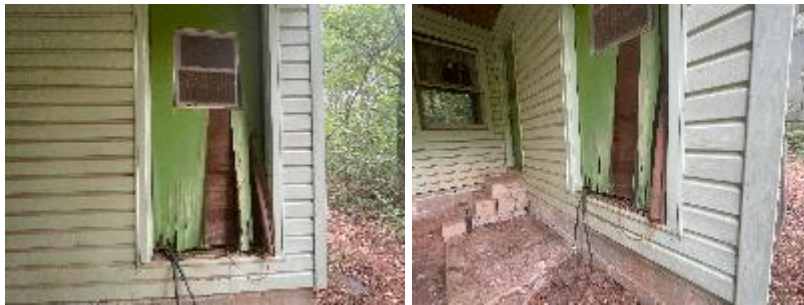
## STAIR AND STOOP

**Missing**

Without a stair or stoop, the entrance and exit from the home is a safety hazard

Add steps or a stoop

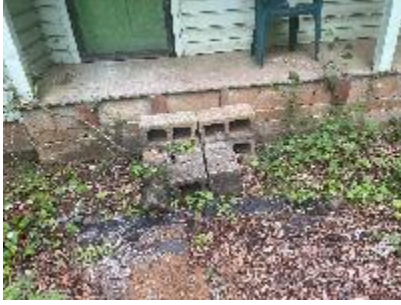
**Damaged**

The damage may worsen and become a trip hazard

Repair or replace the damaged steps

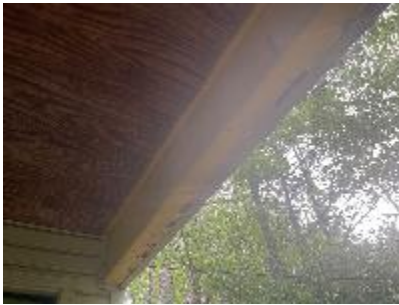
### EAVE

Wood fascia damage (possibly from birds, bees, or termites).

Have a licensed termite inspection to access.

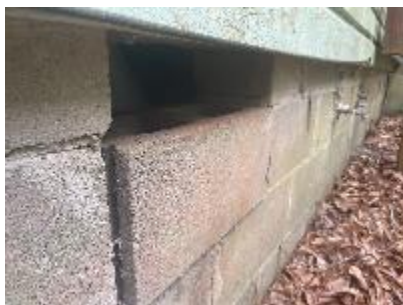
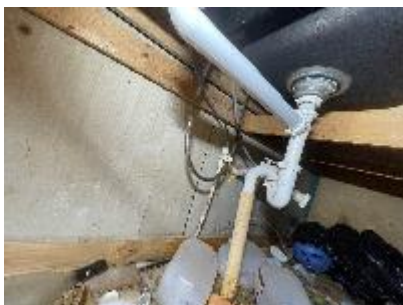
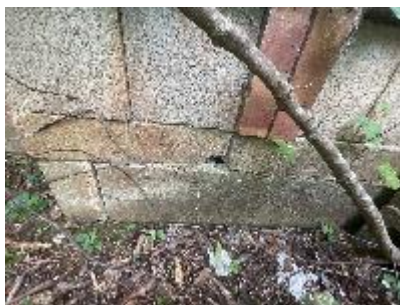
### FOUNDATION WALL

Damaged

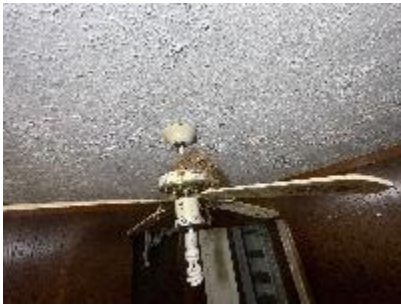
### ! CEILING FAN

Bird Nest is on the ceiling fan

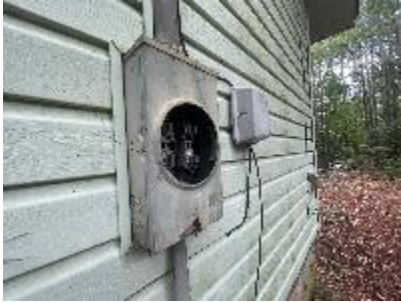
## ELECTRIC SERVICE PANEL

**Meter cover is damaged.**

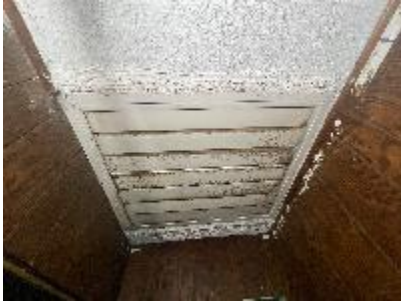
## WHOLE HOUSE FAN

OLD

Whole house fan

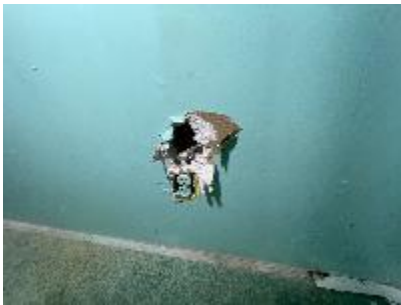
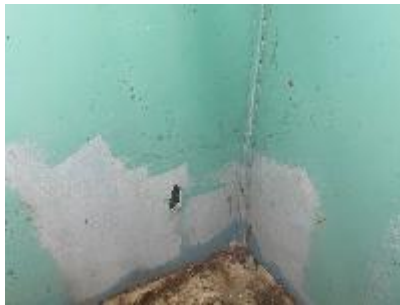
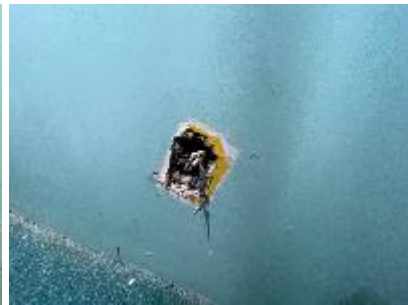
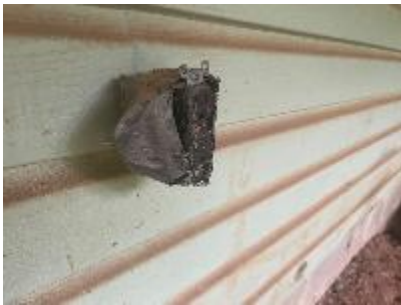
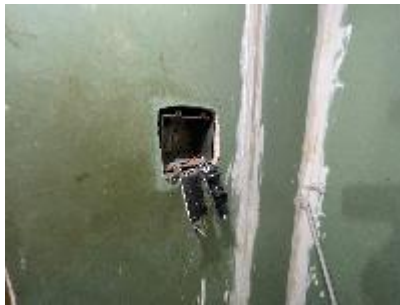
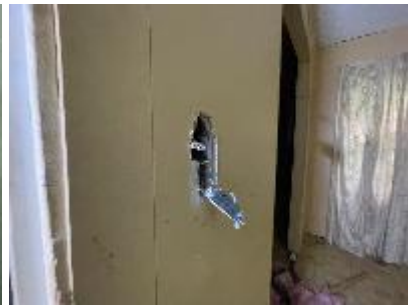
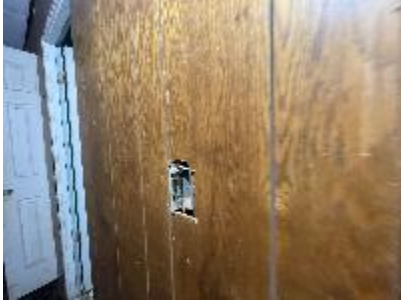
## ! OUTLET

Cover plate is damaged and missing in parts

With missing parts of the cover plate, electrical shock may result if touched

Replace the cover

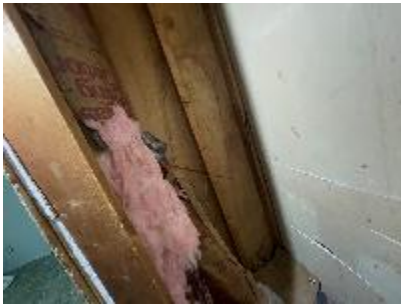
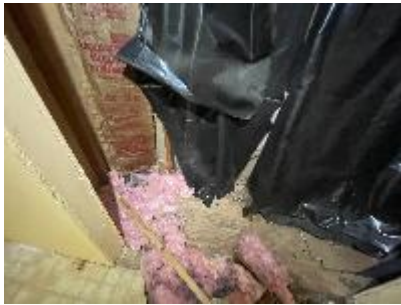
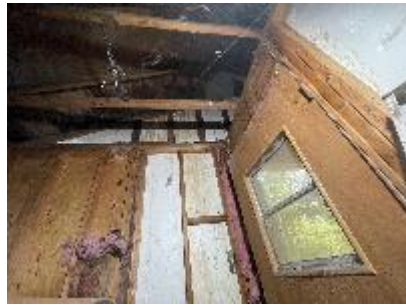
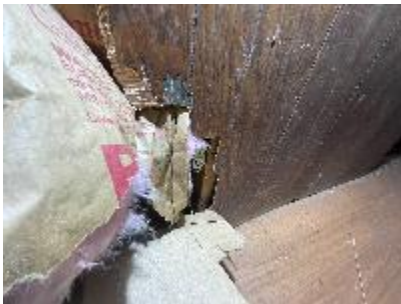
### ! INSULATION Attic

Loose/damaged insulation
