# RiverCity Property Inspections

**134 W 32nd St, Jacksonville, FL 32206**

Report date: 2026-02-12

**Overall condition:** Poor (full rehab recommended)

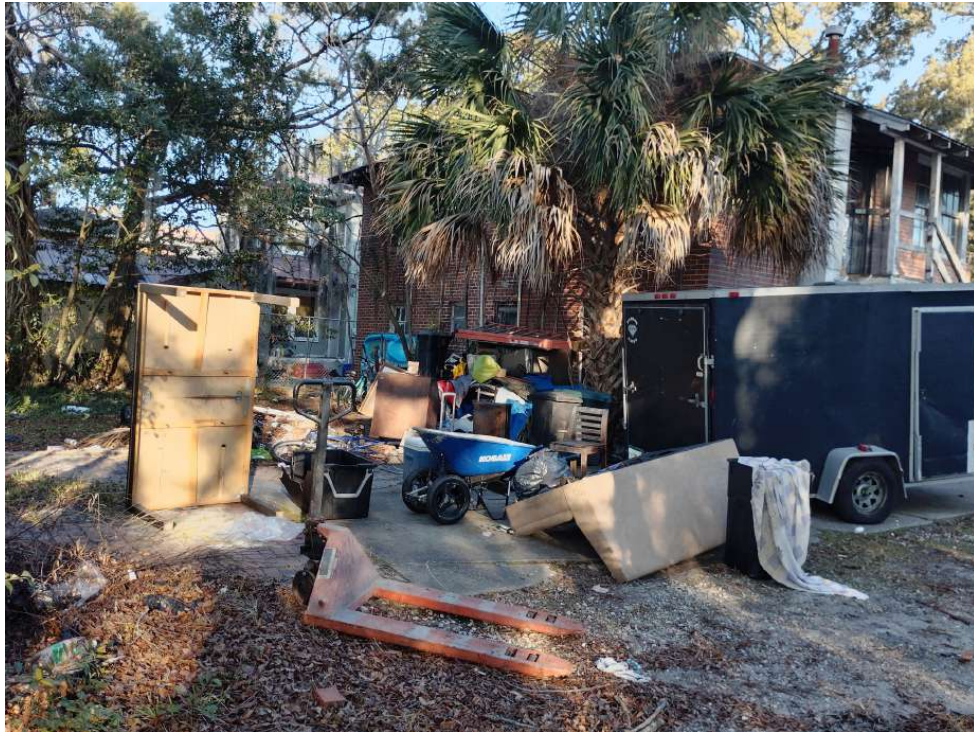
**Key observation:** Significant site clutter/cleanout needs observed; access and safety controls will be required before rehab.

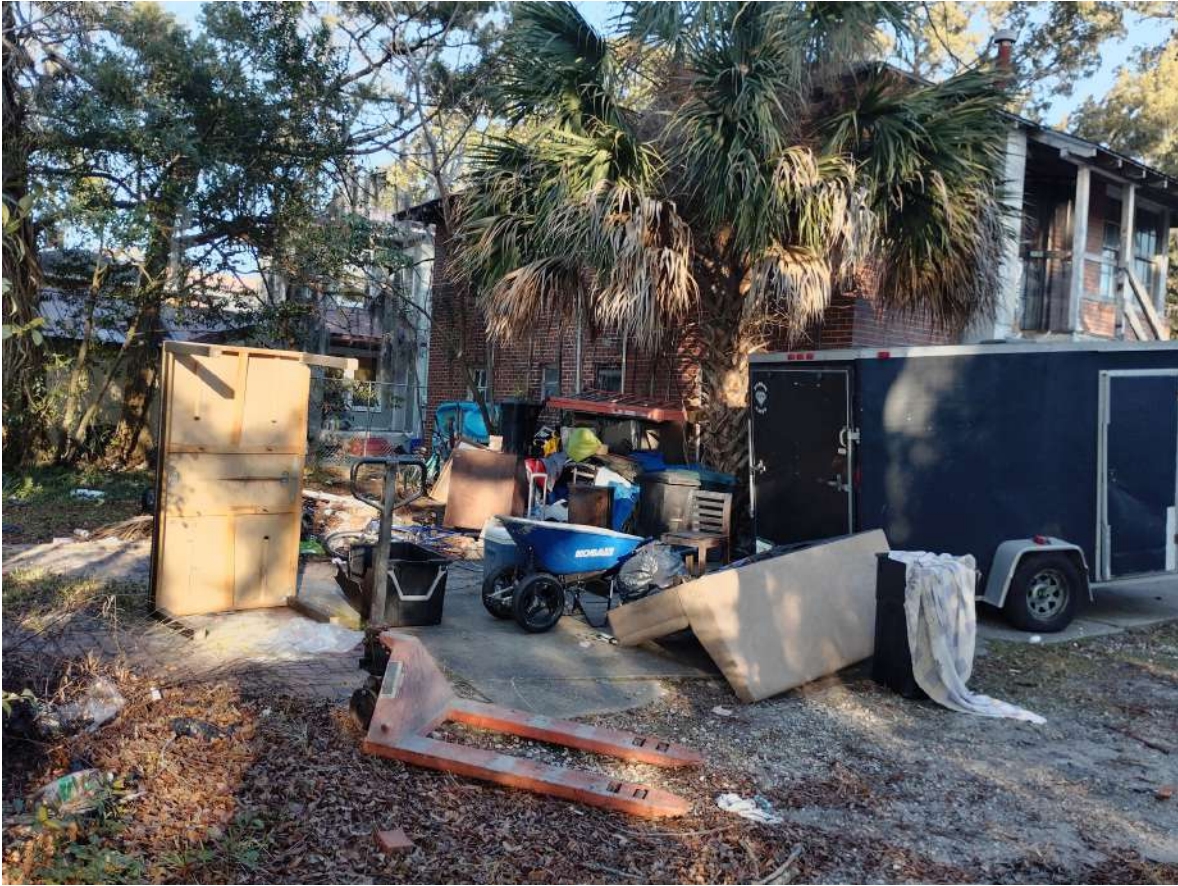
**Photo:** Exterior / yard condition: heavy debris and cleanout needed

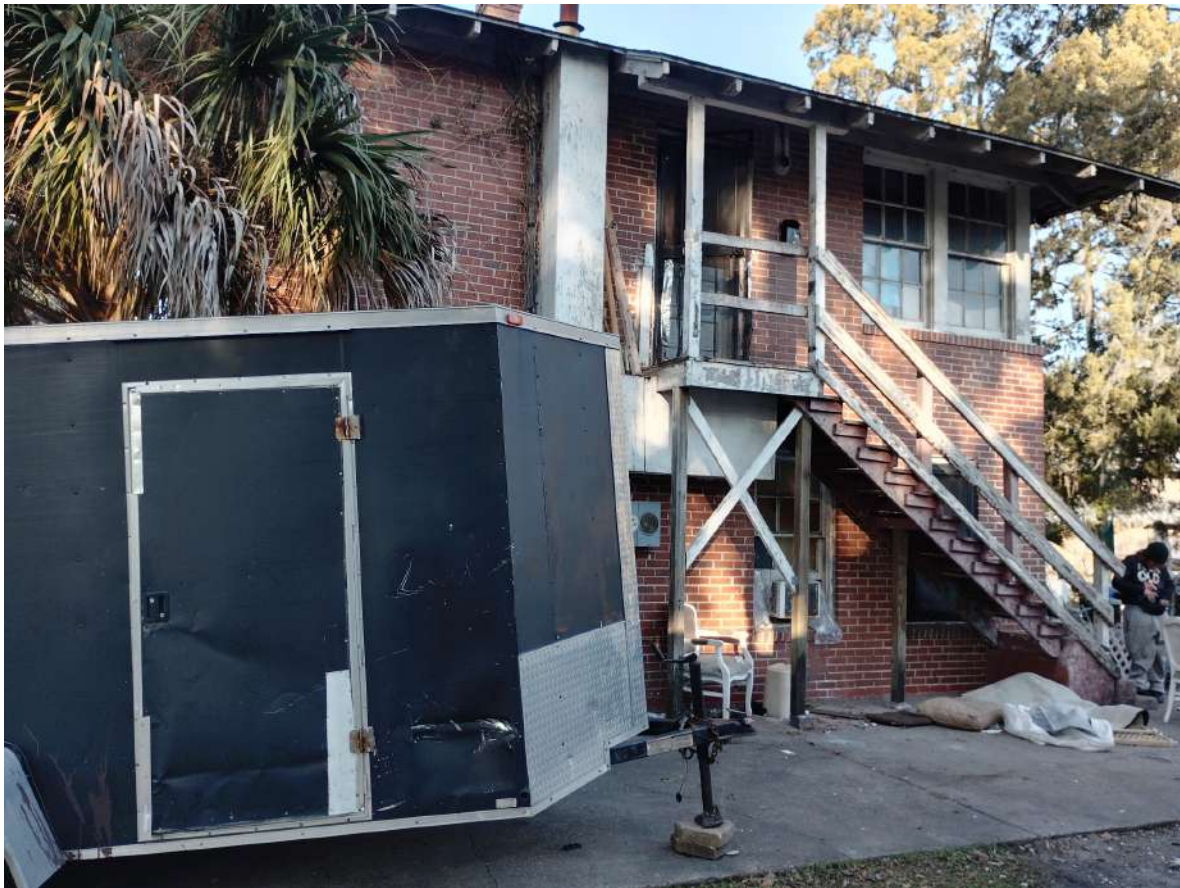
**Photo:** Rear/side elevation: exterior stair and balcony show deterioration

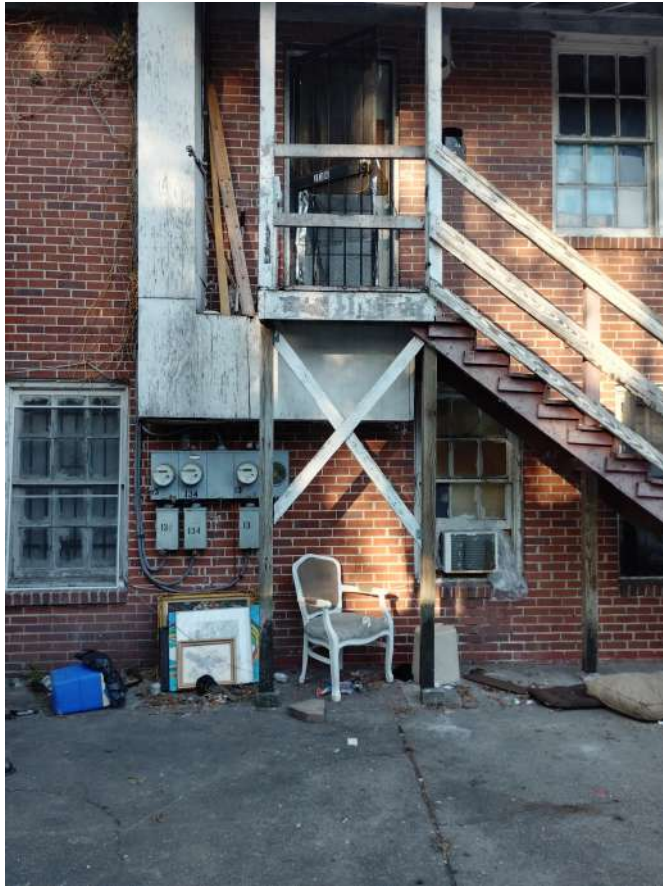
**Photo:** Meter bank and exterior framing: aged components, wood exposure

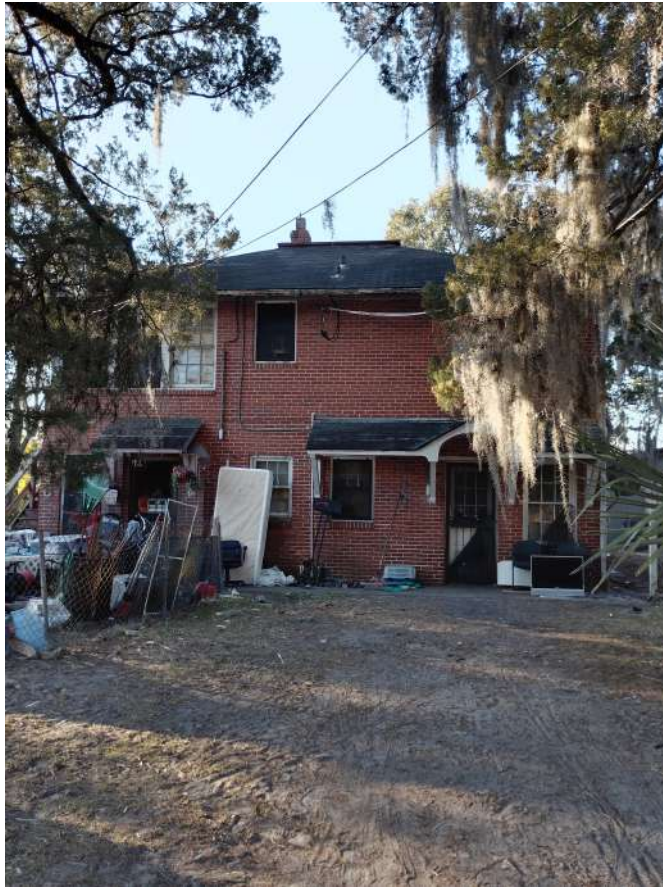
**Photo:** Front elevation: missing/broken upper windows and aged roof covering

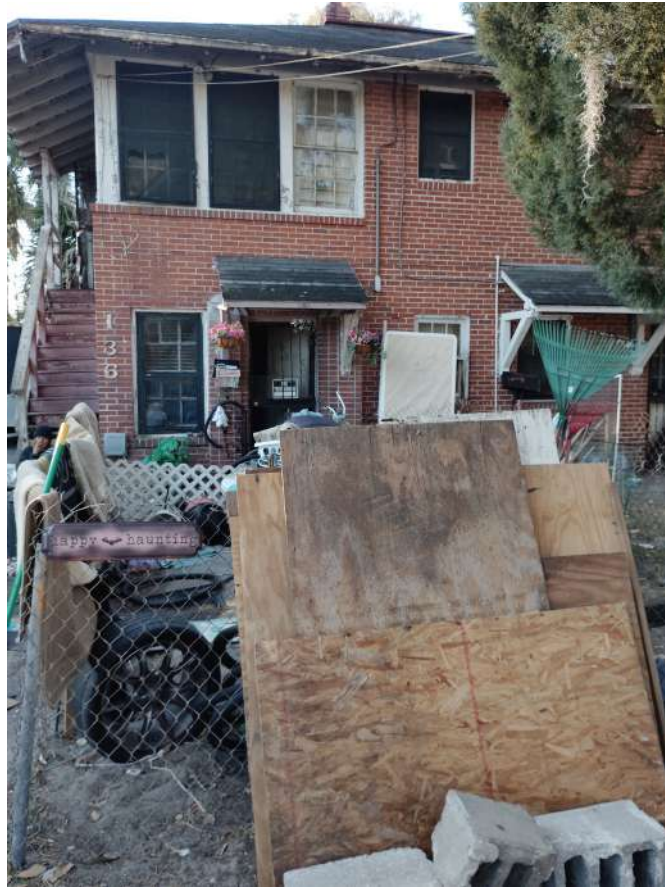
**Photo:** Front/side: site clutter, security concerns, aged windows/trim

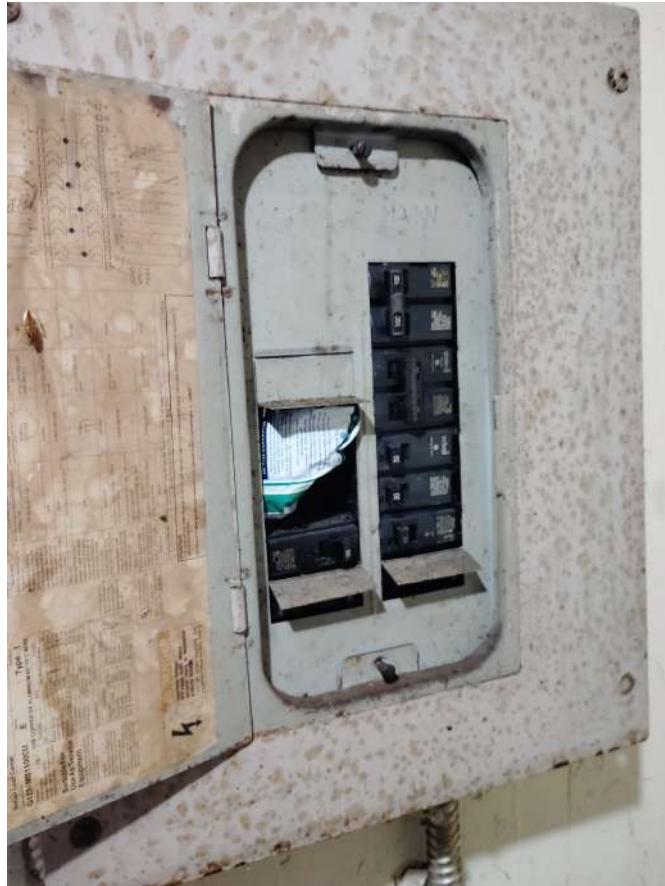
**Photo:** Electrical panel: corrosion and missing dead-front/cover plates observed

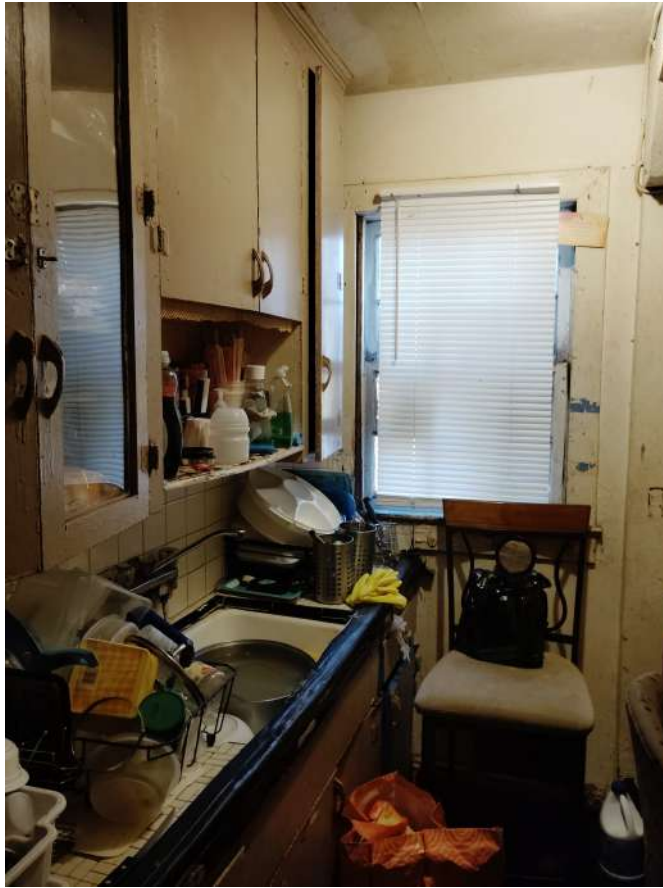
**Photo:** Kitchen: dated cabinets/finishes and signs of wear around sink/window

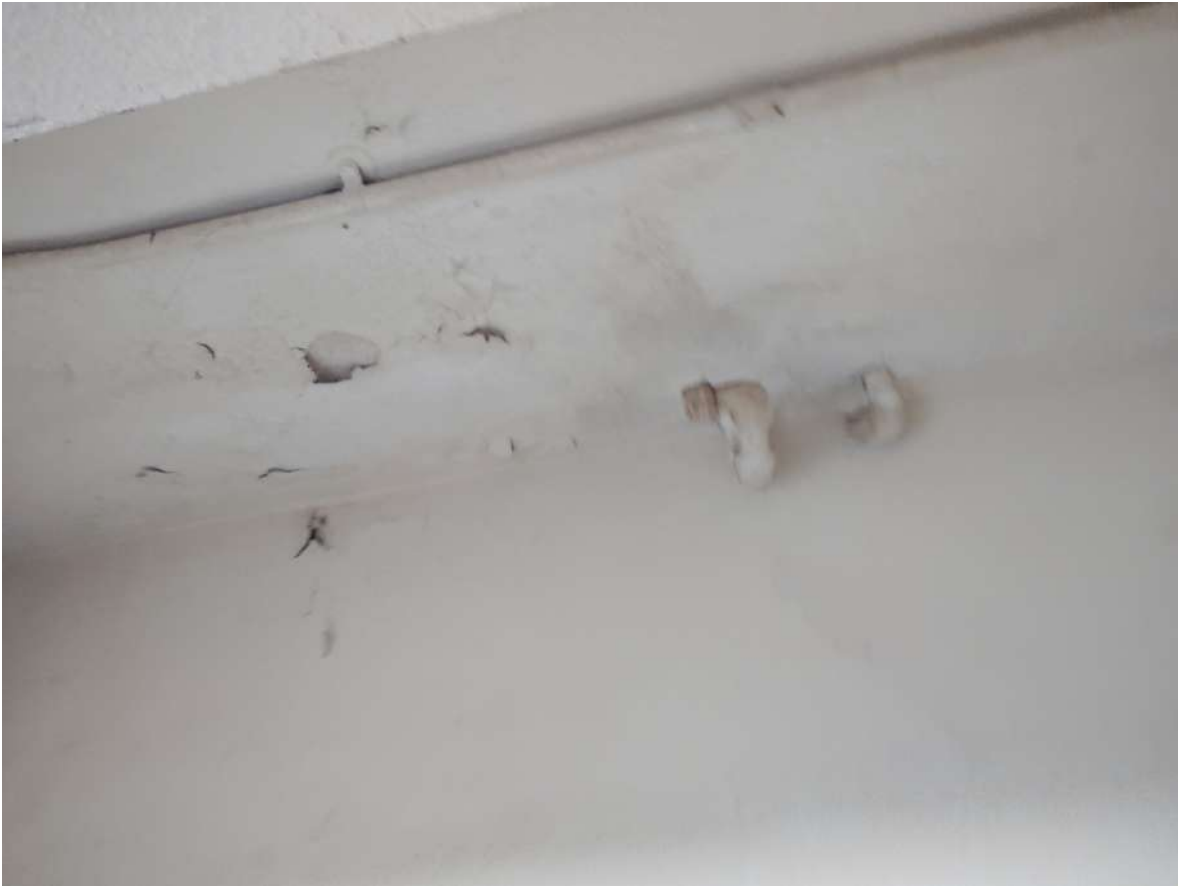
**Photo:** Interior ceiling: staining consistent with prior moisture intrusion

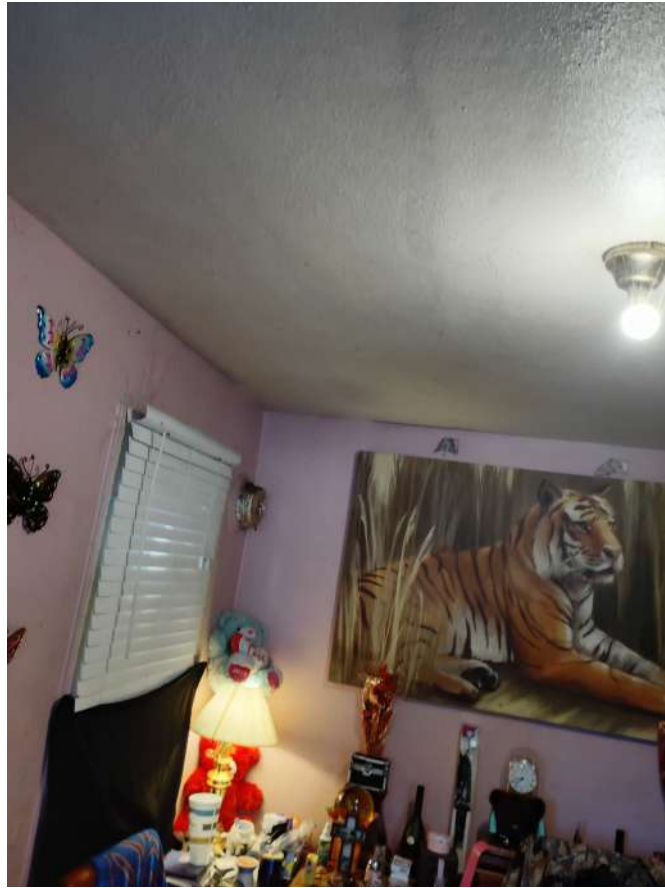
**Photo:** Interior ceiling: generalized discoloration; further moisture/mold screening recommended
