# 11732 Triskett Rd Cleveland, Ohio 44111

Client	<b>Josh Usher</b>
Type	<b>Major System Plus Report</b>
Scheduled	<b>May 12, 2026, 12:00 PM EDT</b>
Completed	<b>May 12, 2026, 1:16 PM EDT</b>

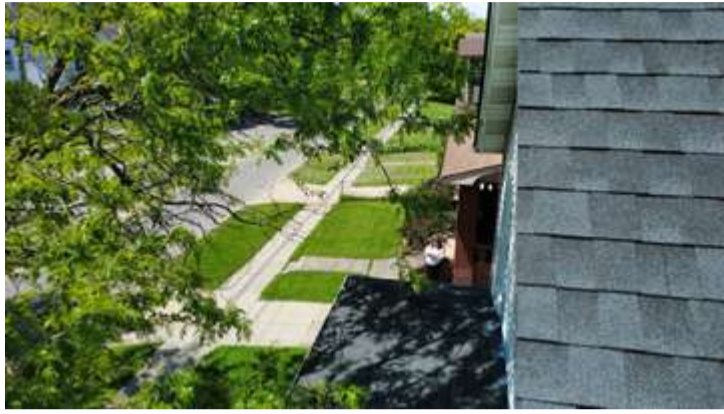
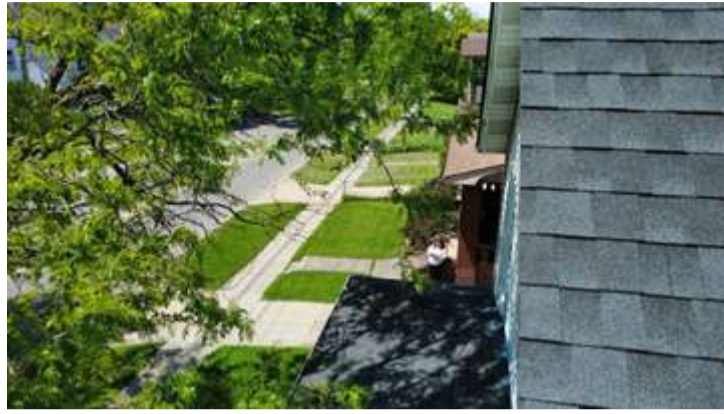
### Tree Overhanging the Roof

One or more tree branches(s) are overhanging the roof. Recommend repairs or replacing by a qualified professional.

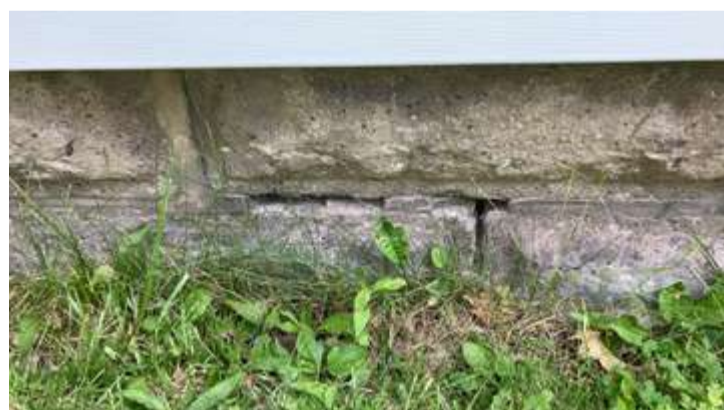
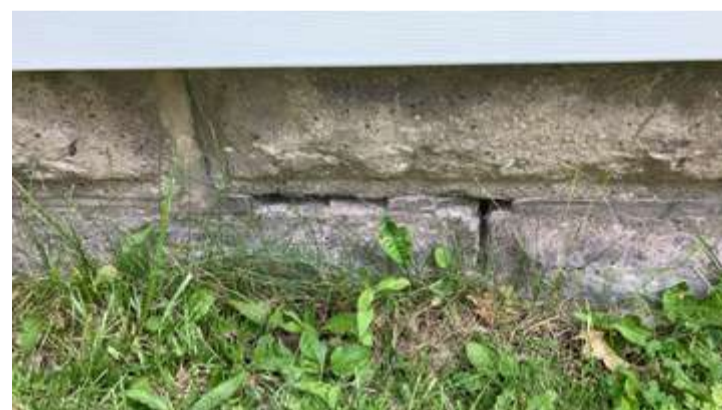
#### Damaged Brick Mortar

The mortar is cracked / damaged in one or more areas. Recommend repairs or replacing by a qualified professional.

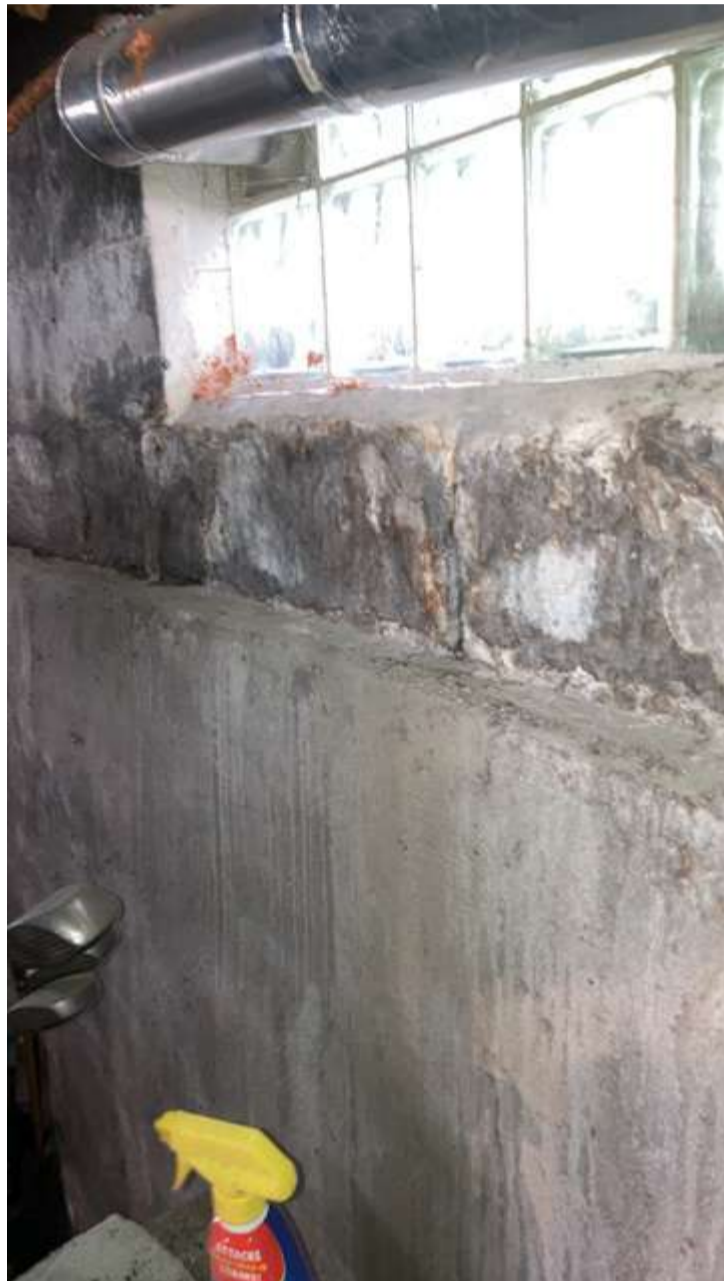
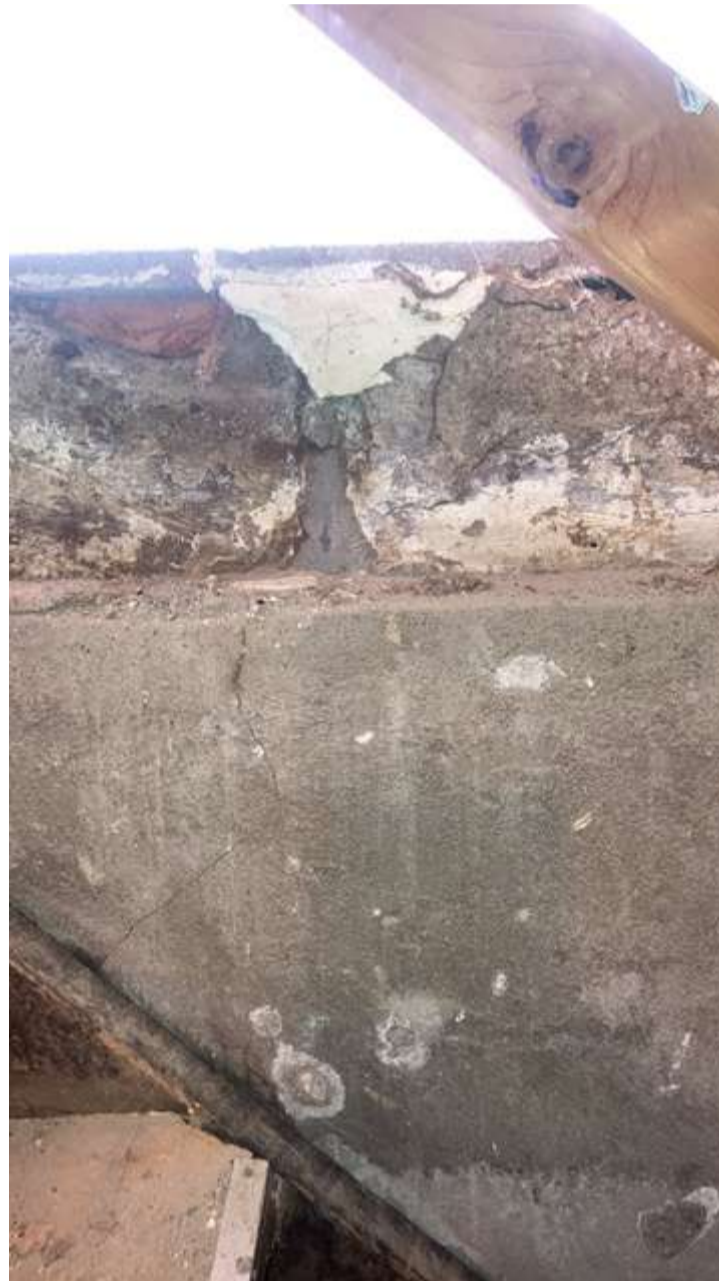
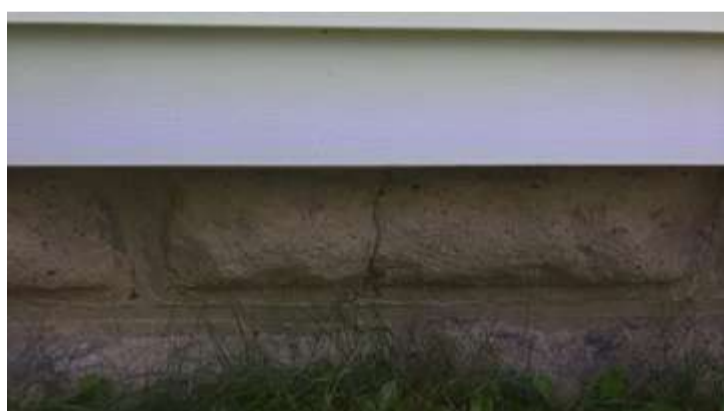
### Minor Foundation Cracks

One or more areas of the foundation have minor cracking. Recommend repairs or replacing by a qualified professional.

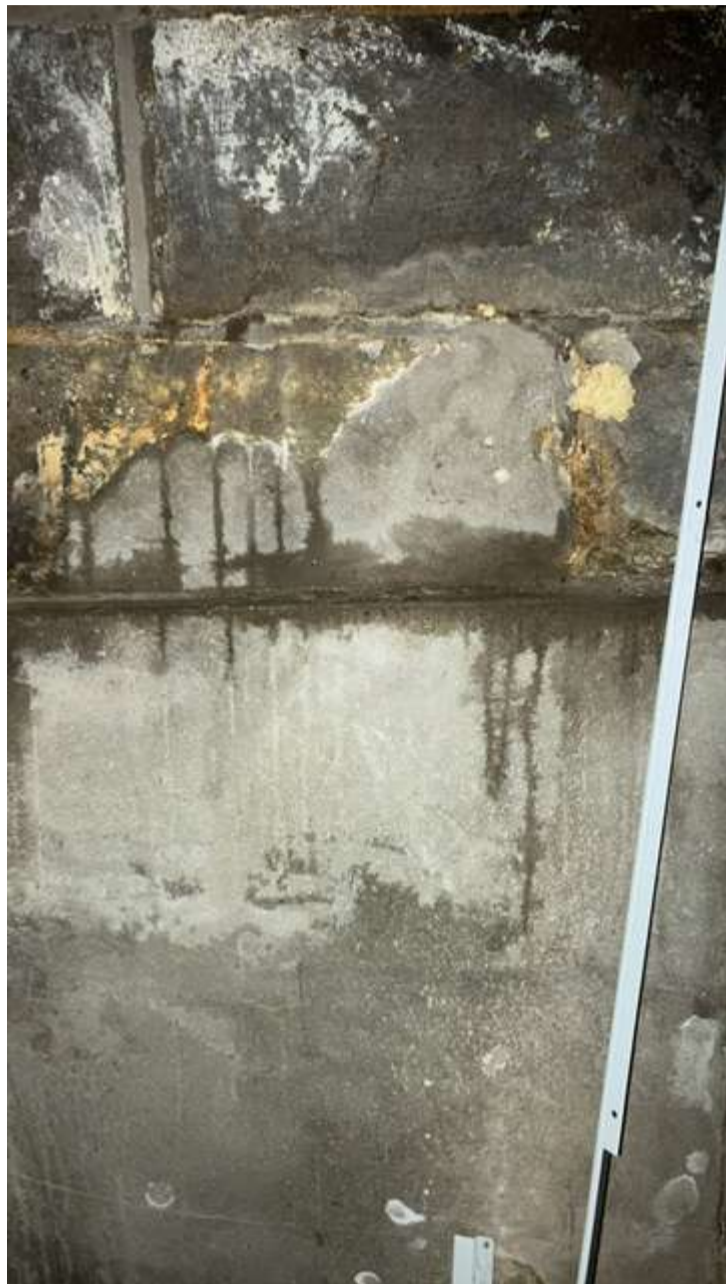
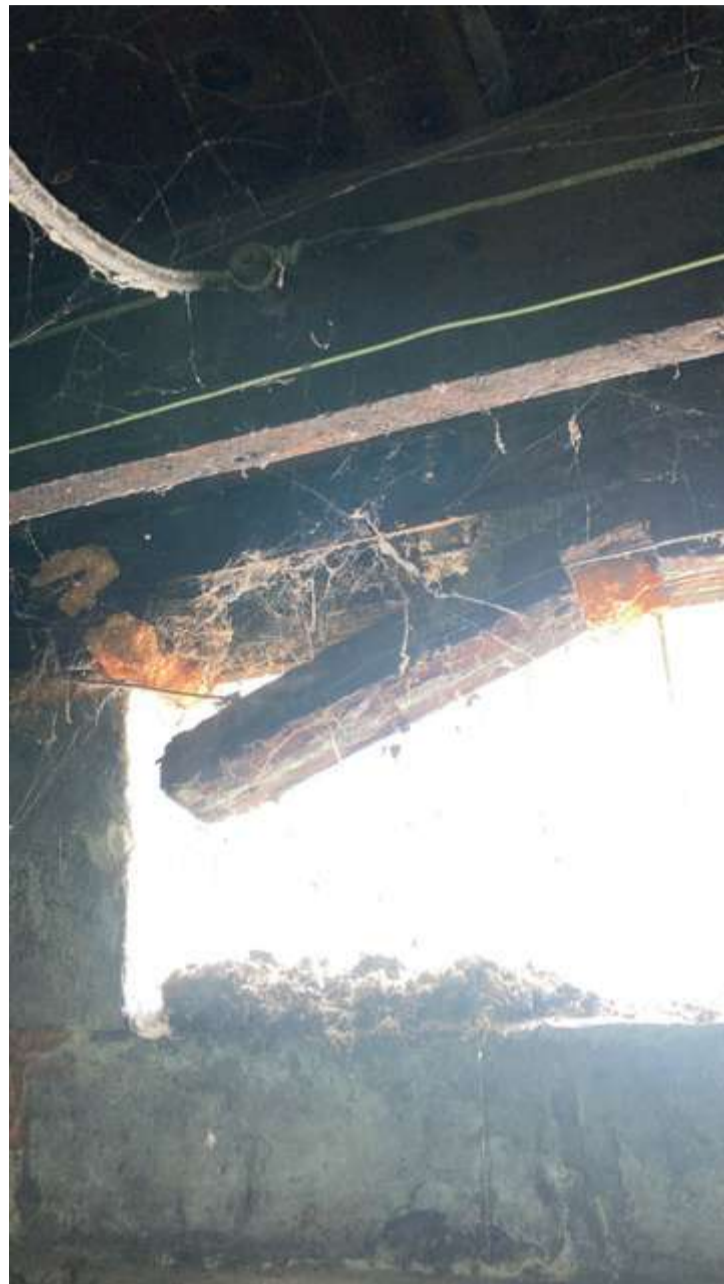
### Basement Walls & Ceilings in Poor Condition

The basement walls & ceilings are in poor condition. Recommend repairs or replacing by a qualified professional.

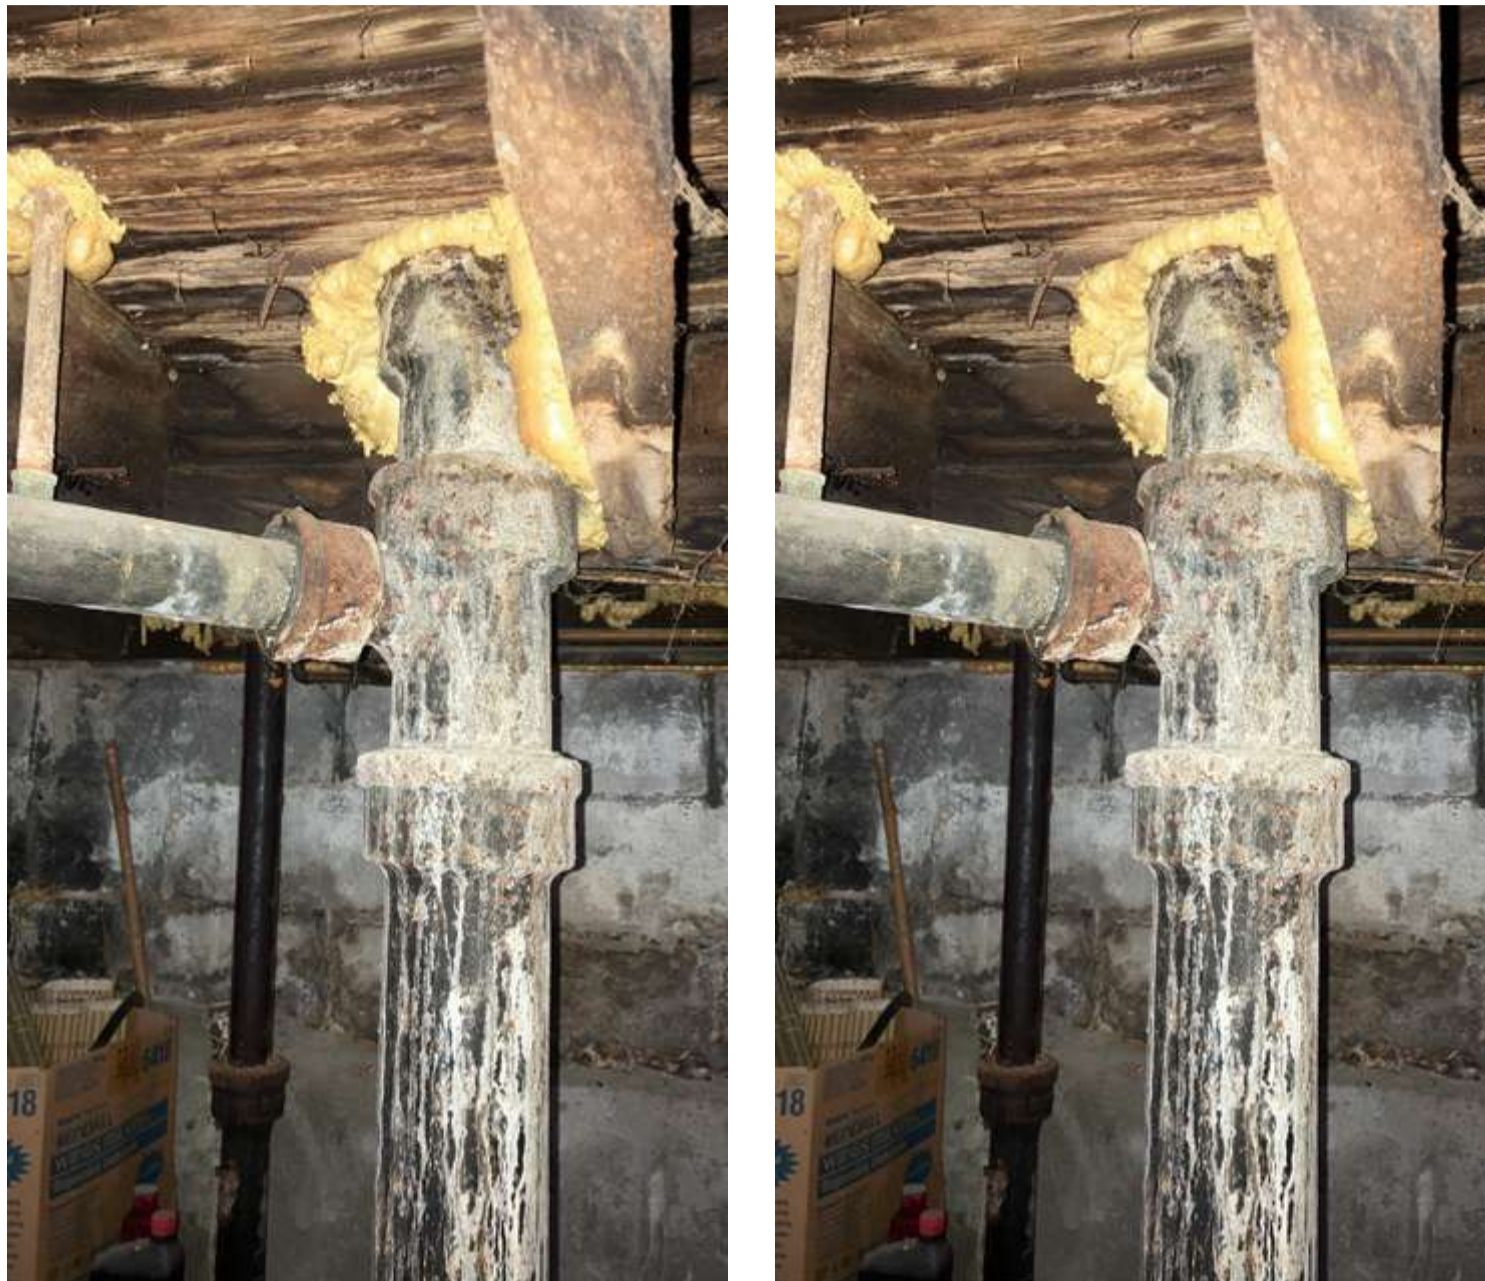
**Damaged Cast Iron Drain Line**

The cast iron drain lines may be damaged. Recommend repairs or replacing by a qualified professional.

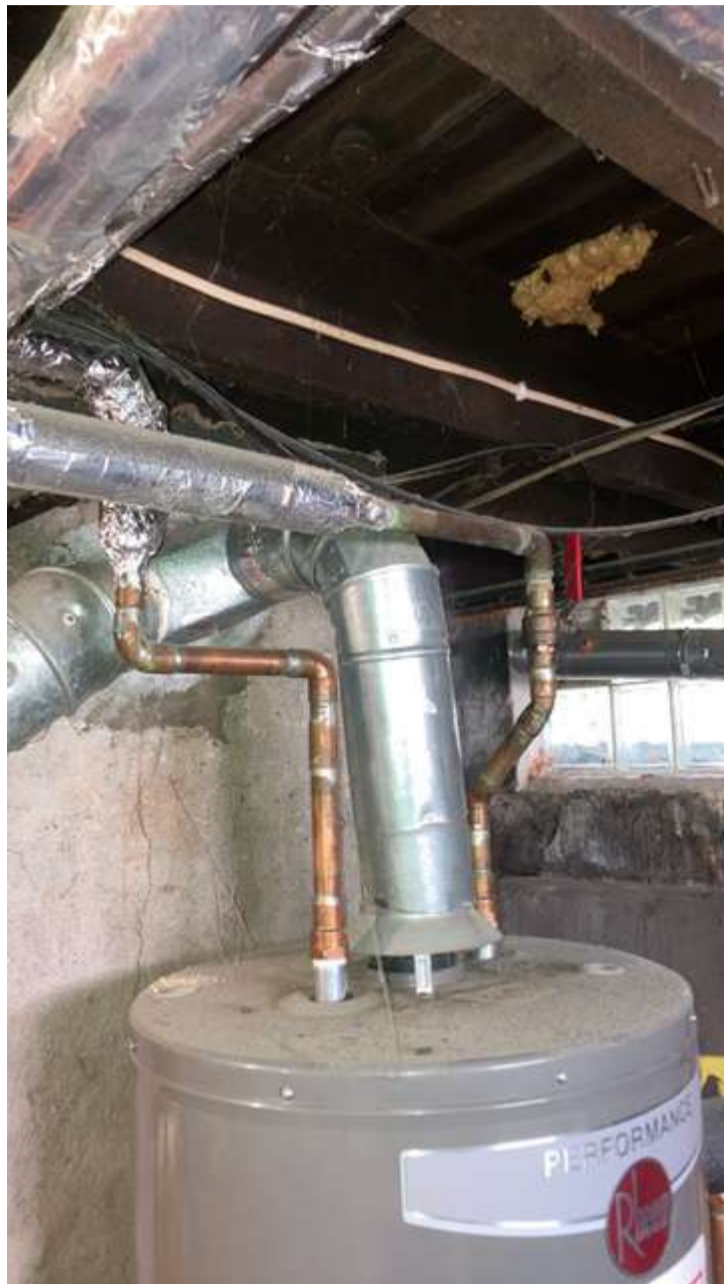
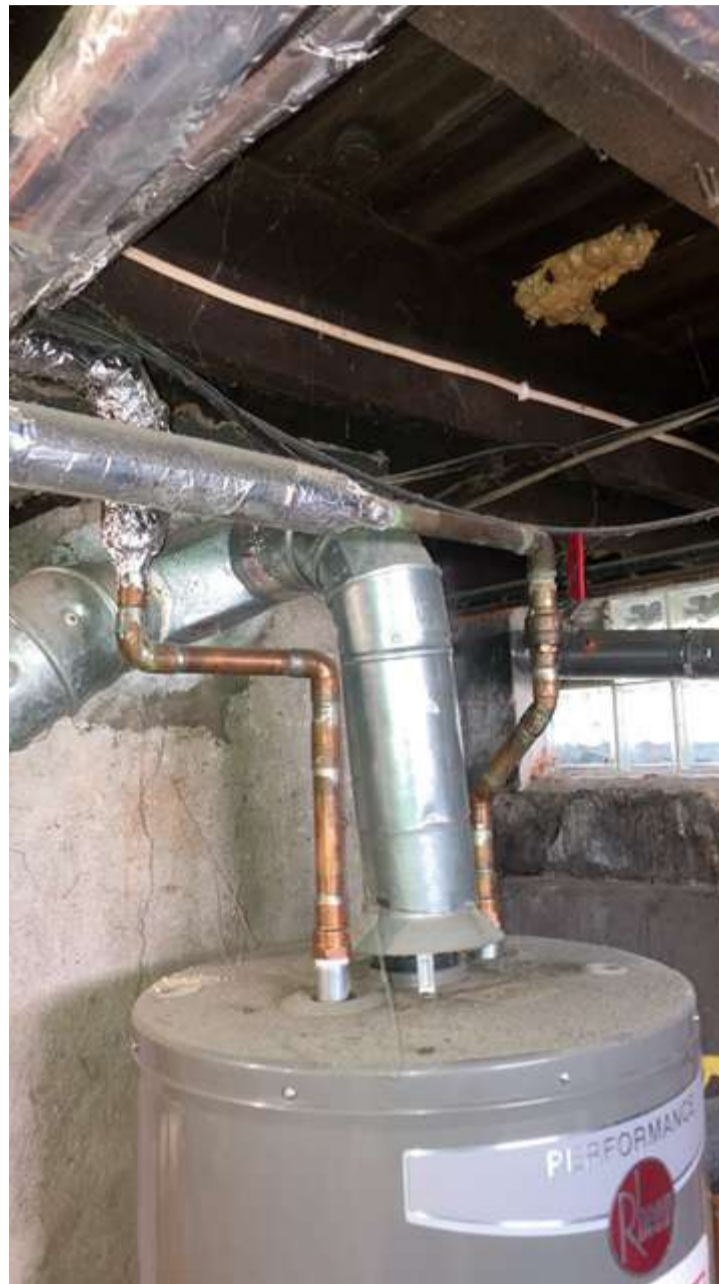
### Missing Expansion Tank for Water Heater

There is no expansion tank for the water heater. Recommend repairs or replacing by a qualified professional.

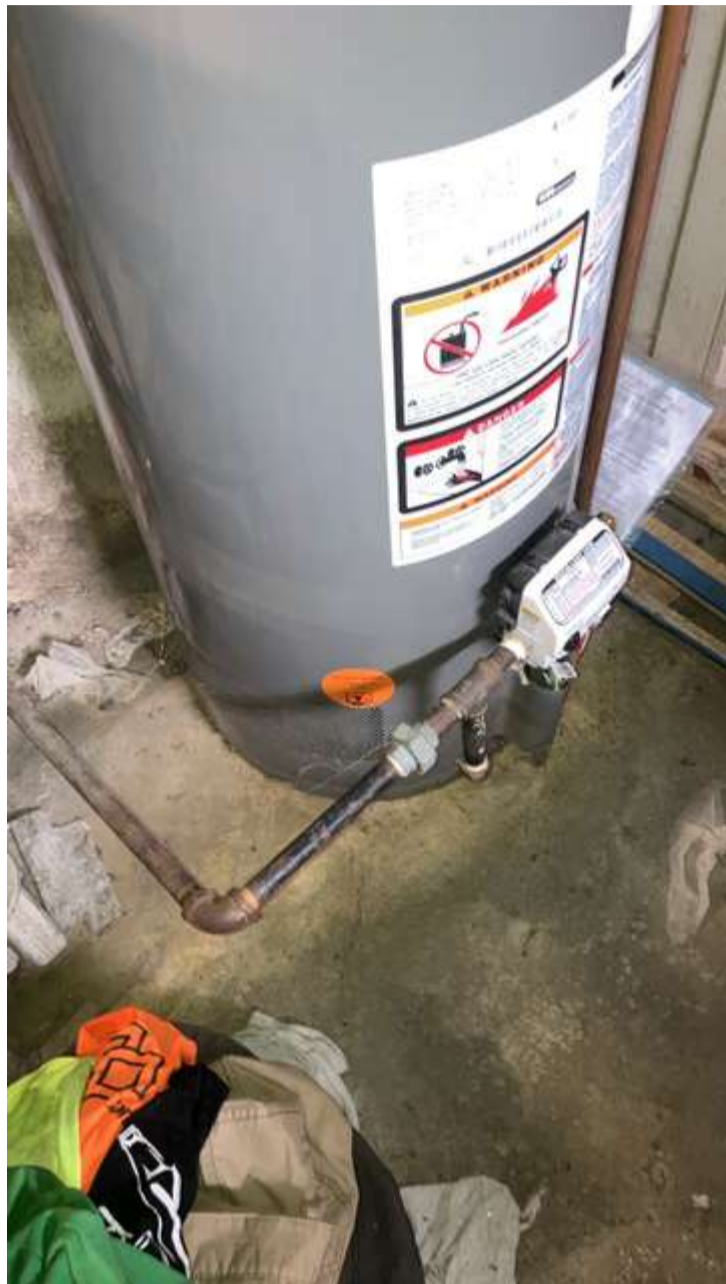
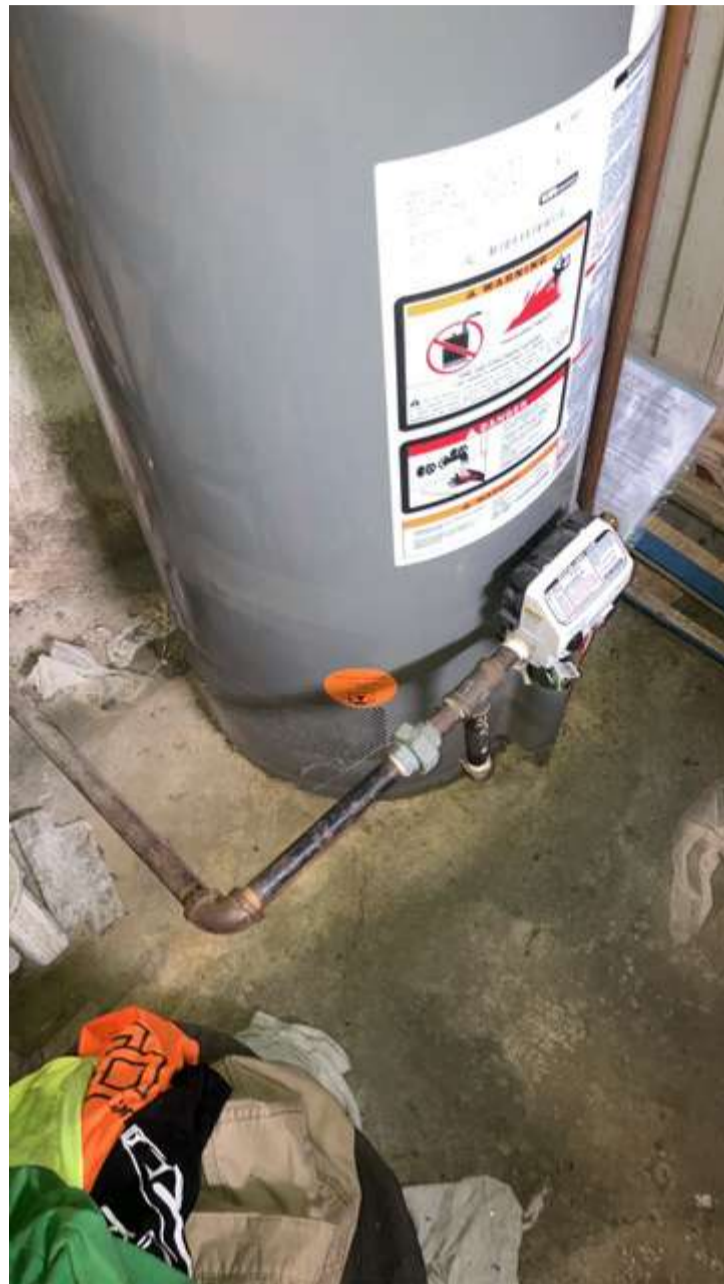
### Missing Water Heater Drip Pan

There is no drip pan under the water heater. Recommend repairs or replacing by a qualified professional.

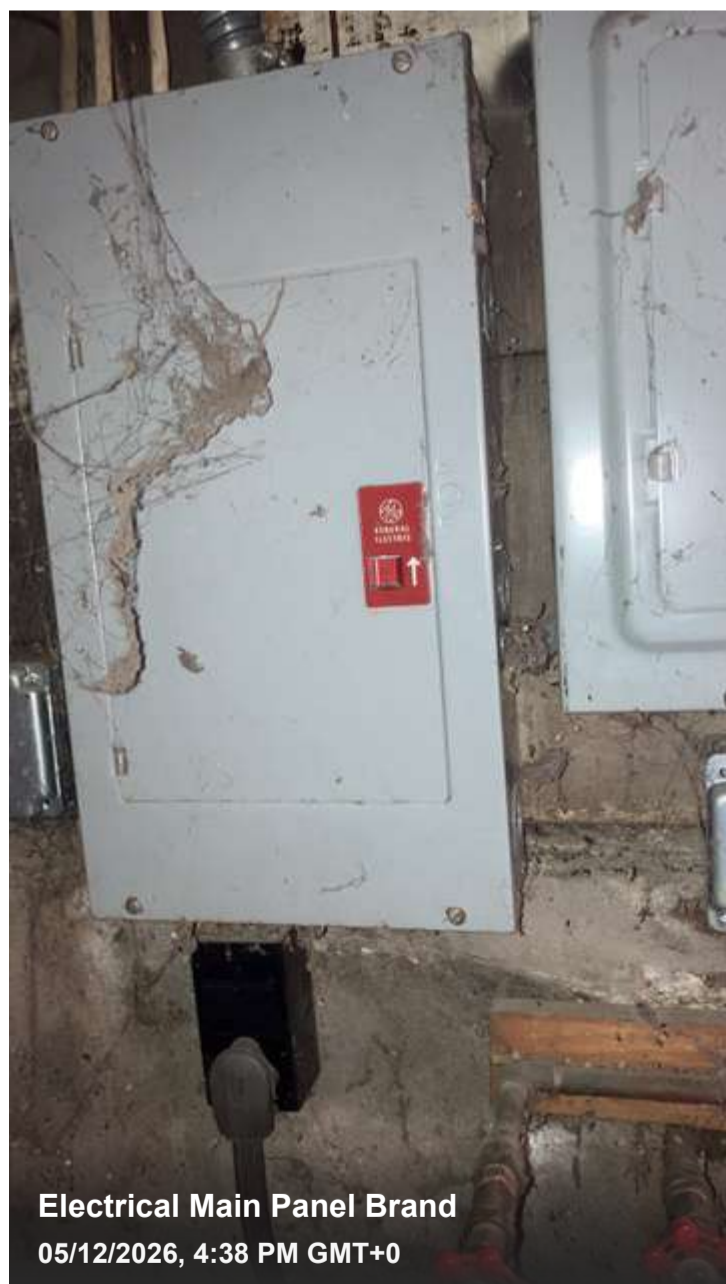
**Main Panel Wiring Type: No Access**

I cannot access the object / room. No workspace at panel

**Inadequate Workspace at Panelboard**

I observed inadequate workspace at the panelboard. A clear working space for accessing all of the electrical equipment is needed. A clear space that is 3 feet deep, 30 inches wide, and 6' 6" in height should be provided in front of the equipment.
