# 1449 E 172nd St

## Cleveland, Ohio 44110

| Type | Major Systems Plus Report - |

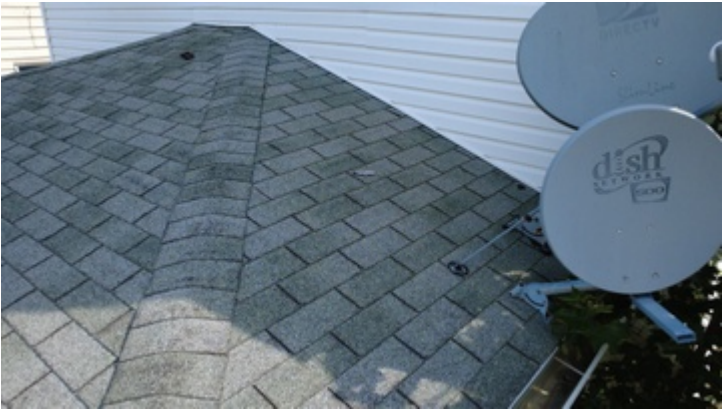
Moss Growth on Shingles

There is moss, algae or vegetation growth on the shingles. Recommend repairs or replacing by a qualified professional.

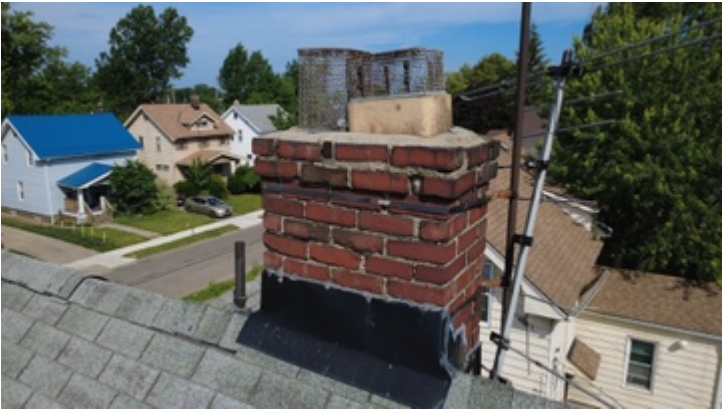
Missing Chimney Cap

The chimney cap is missing. Recommend repairs or replacing by a qualified professional.

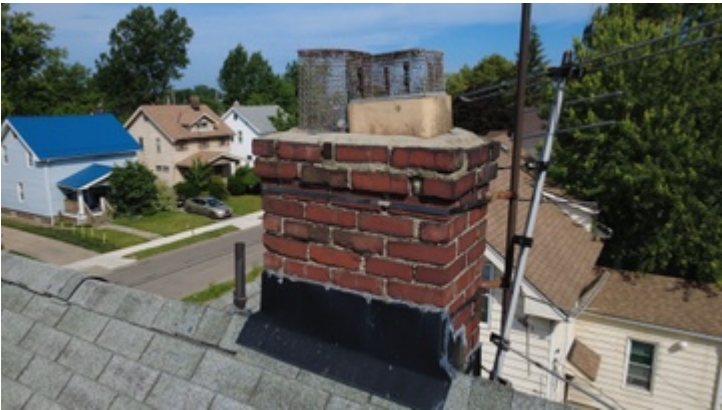
Missing Chimney Cap

The chimney cap is missing. Recommend repairs or replacing by a qualified professional.

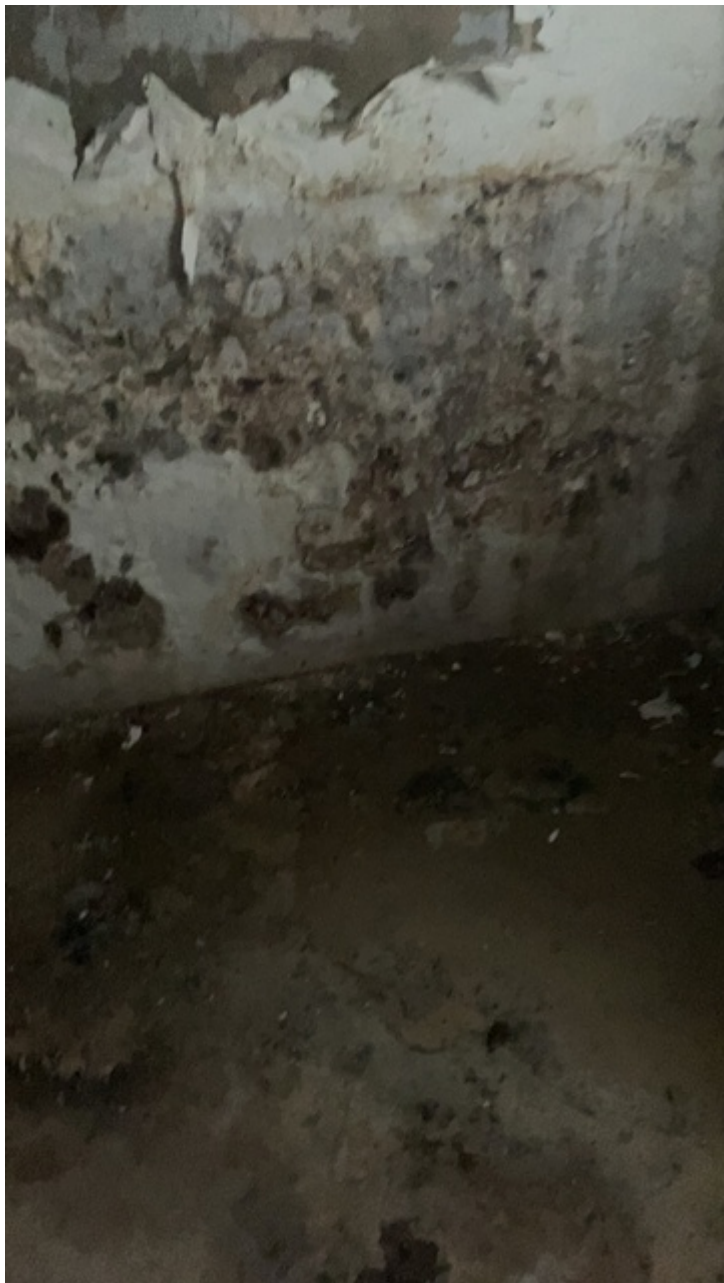
Water Intrusion in Walls

The wall structure showed signs of water intrusion. Recommend repairs or replacing by a qualified professional.

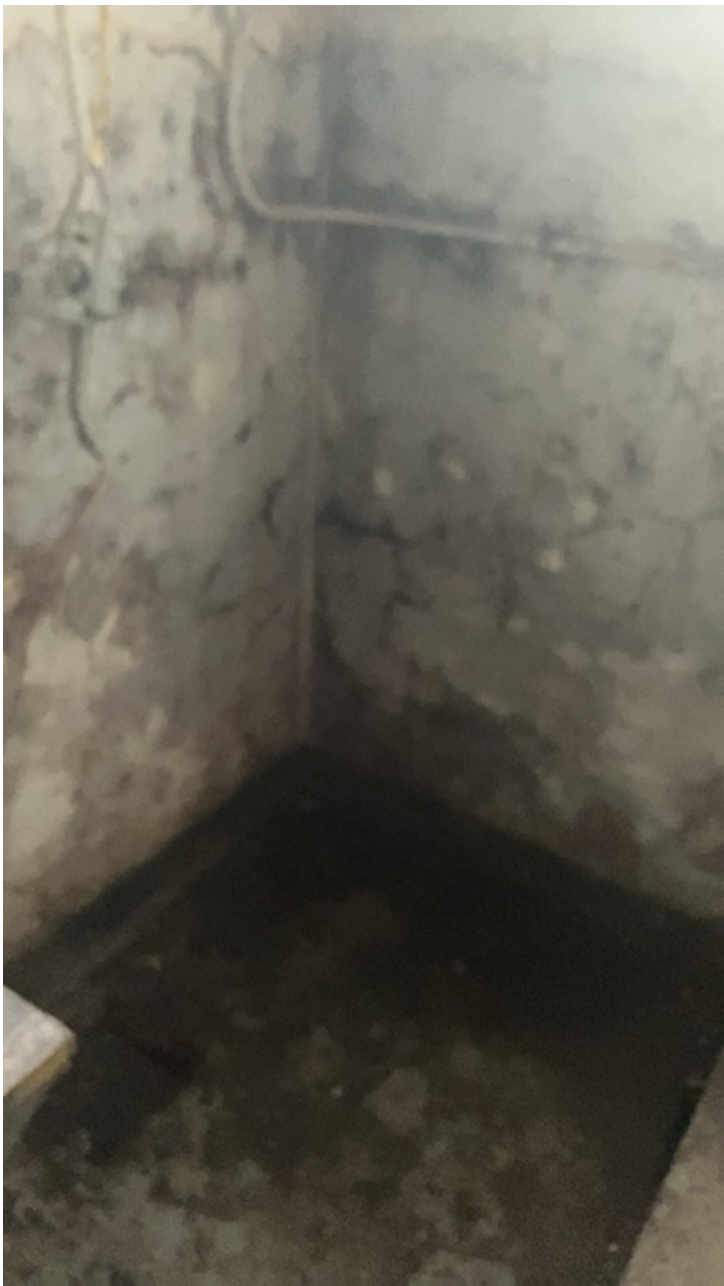
### Foundation in Poor Condition

The foundation is in poor condition. Recommend repairs or replacing by a qualified professional.

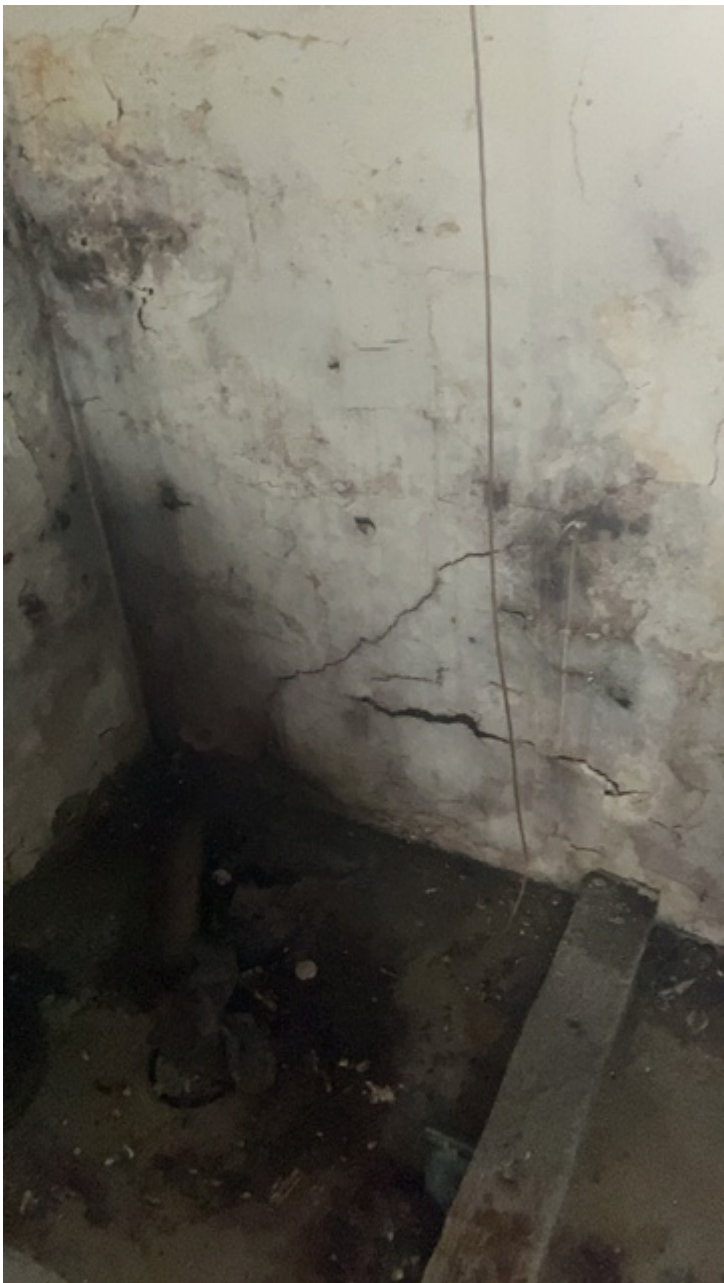
### Minor Foundation Cracks

One or more areas of the foundation have minor cracking. Recommend repairs or replacing by a qualified professional.

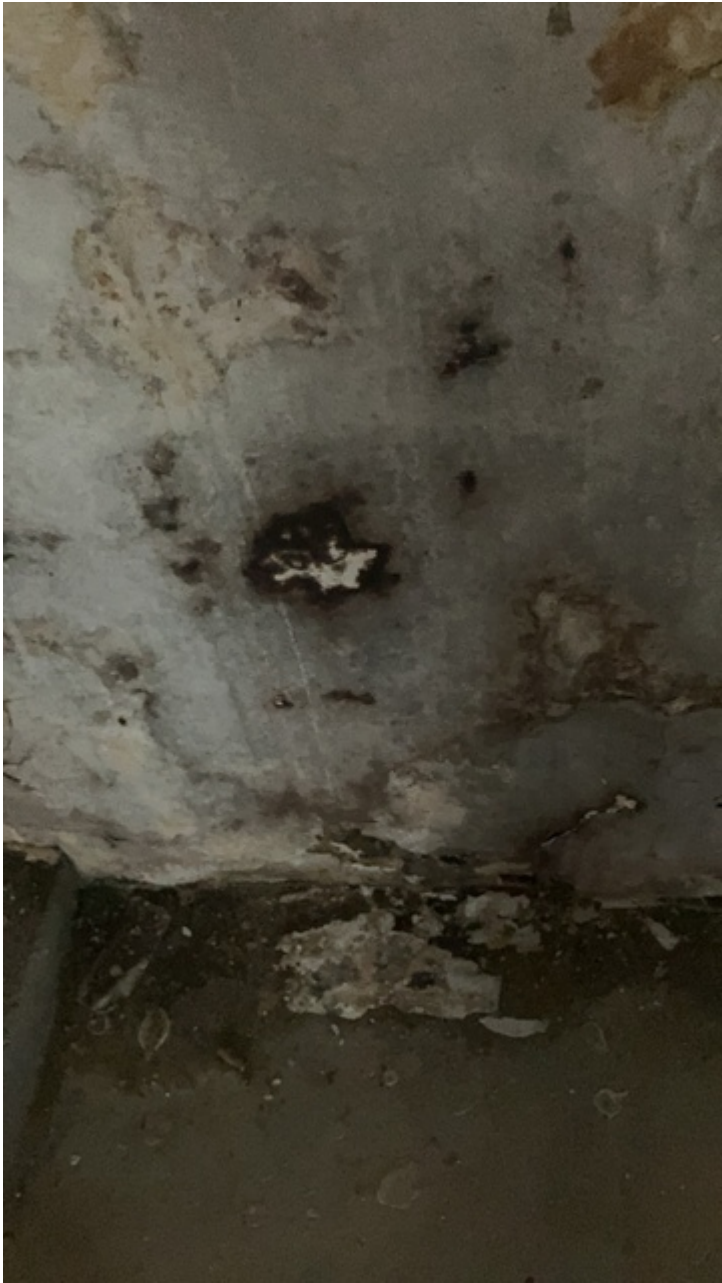
Mold-Like Substance on Walls

There is a mold-like substance on one or more areas of the wall(s). Recommend repairs or replacing by a qualified professional.

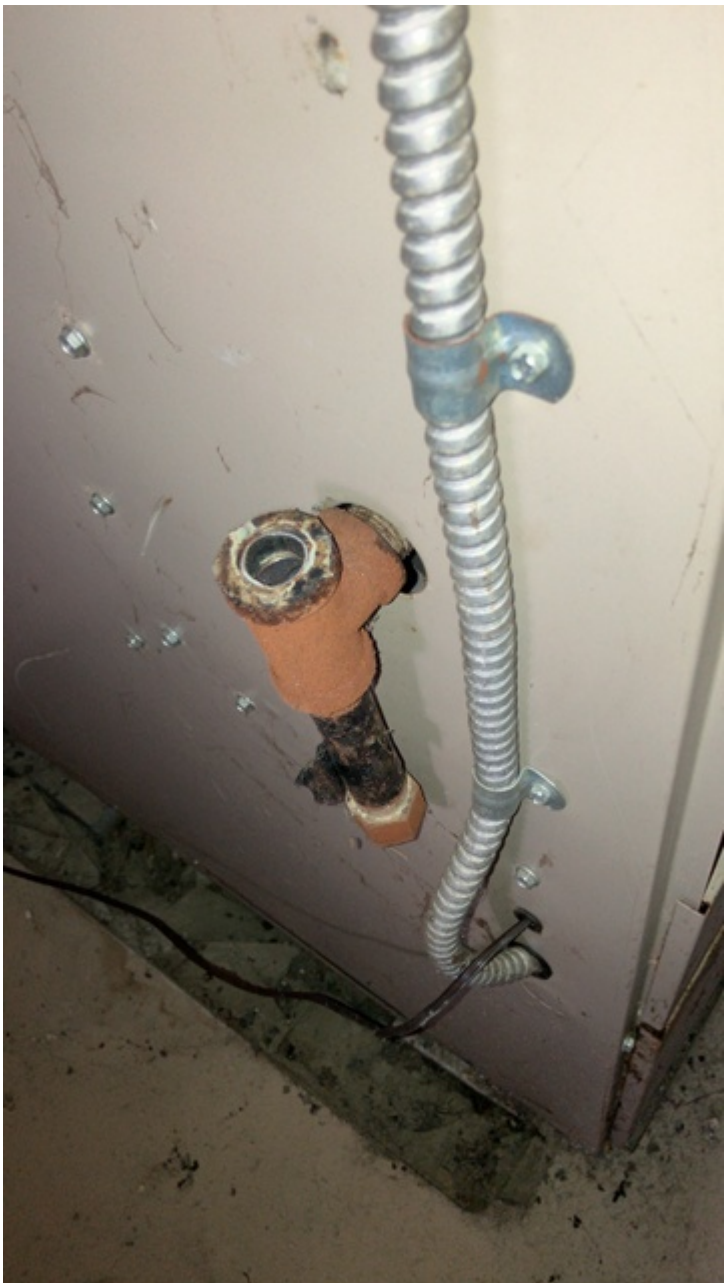
Inoperable Heating System

The furnace / boiler / heater is inoperable. Recommend repairs or replacing by a qualified professional.

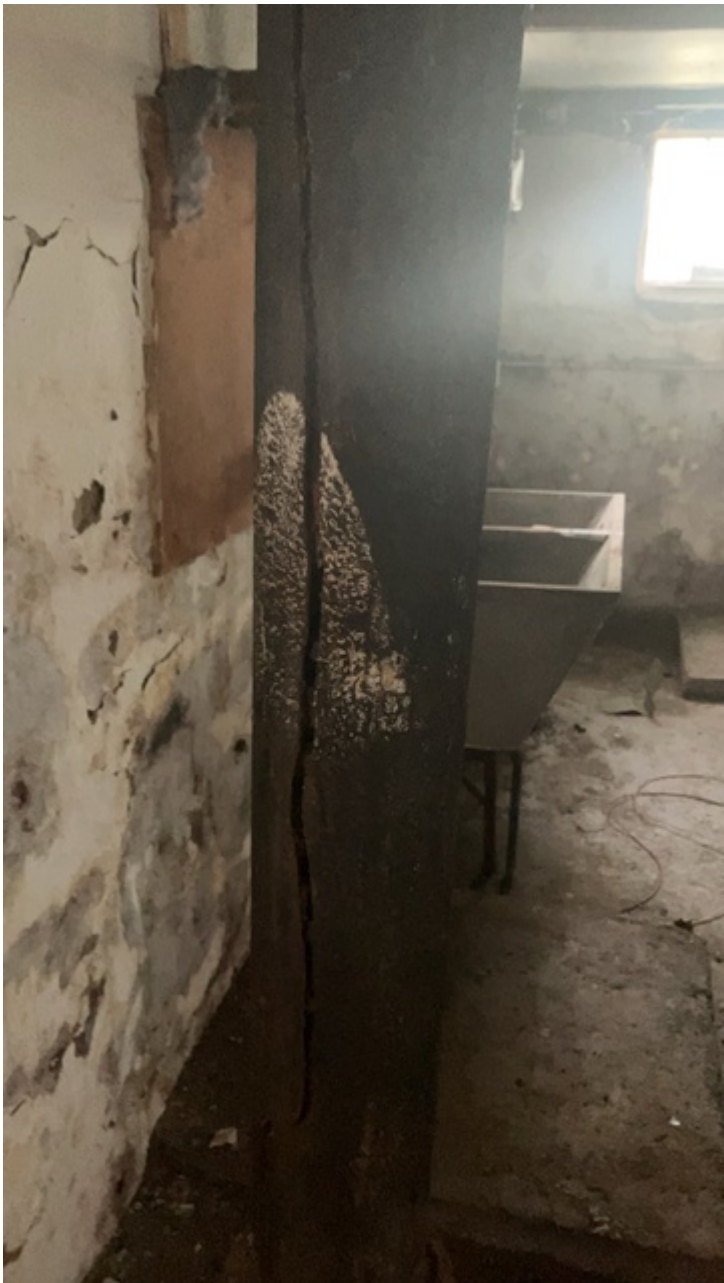
### Damaged Cast Iron Drain Line

The cast iron drain lines may be damaged. Recommend repairs or replacing by a qualified professional.

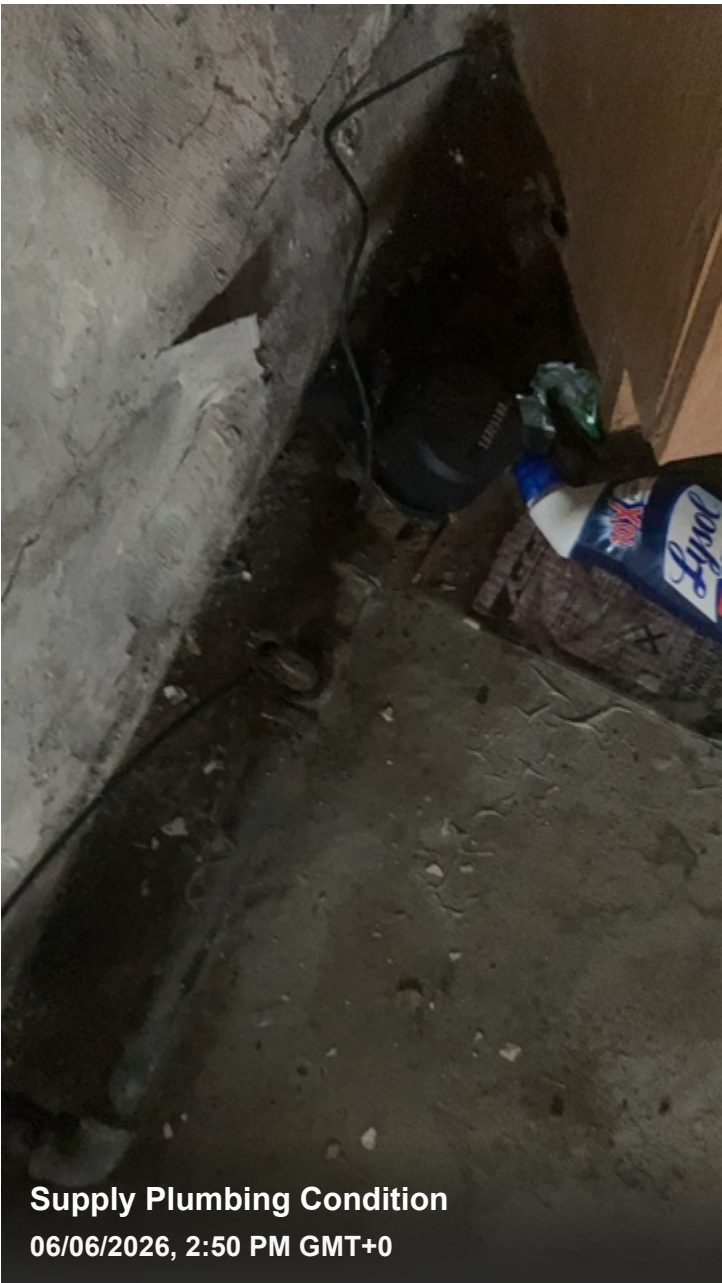
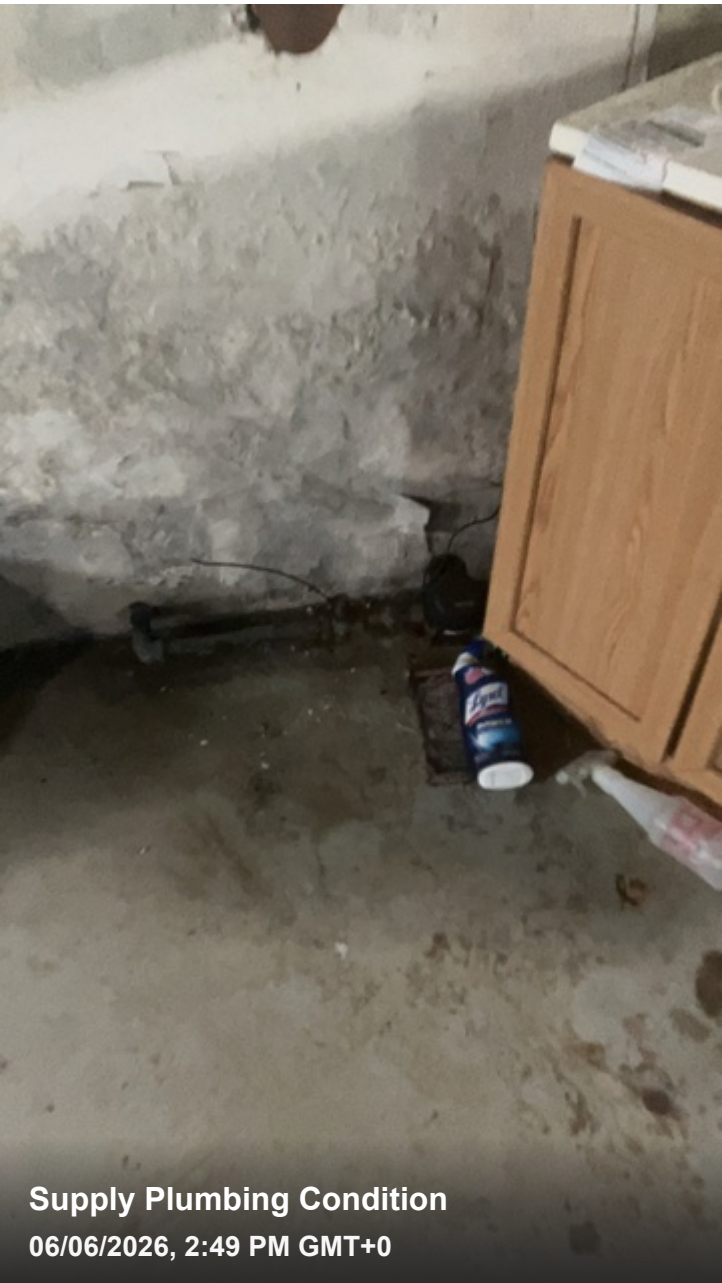
**Piping has been ripped out**

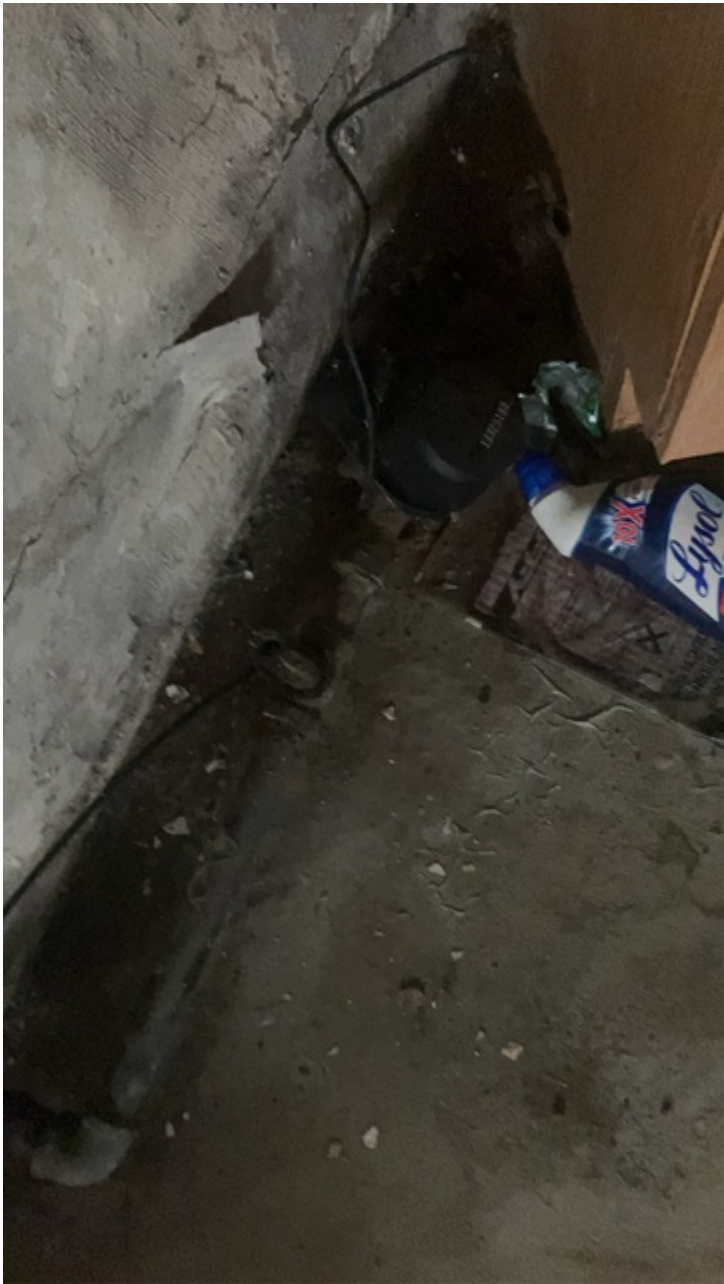
No Water to Property

The property does not currently have running water. Recommend repairs or replacing by a qualified professional.

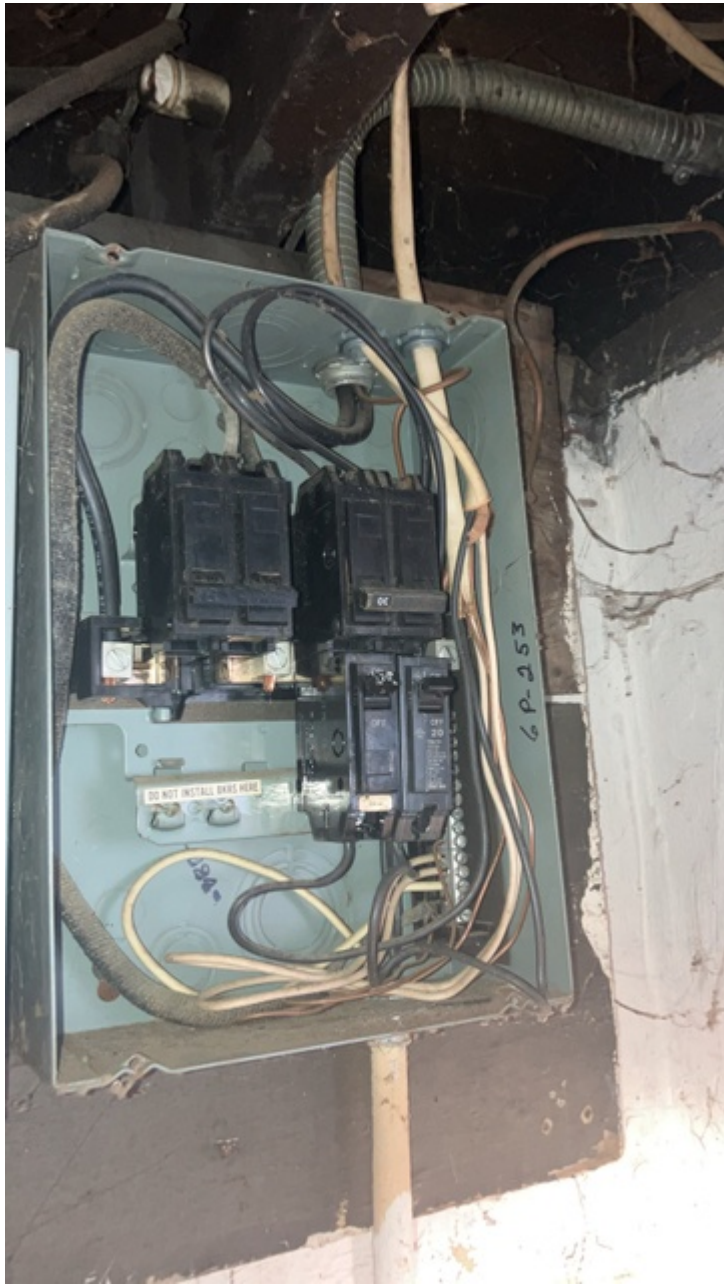
### Missing Electrical Panel Cover

The electrical panel dead front is missing. Recommend repairs or replacing by a qualified professional.

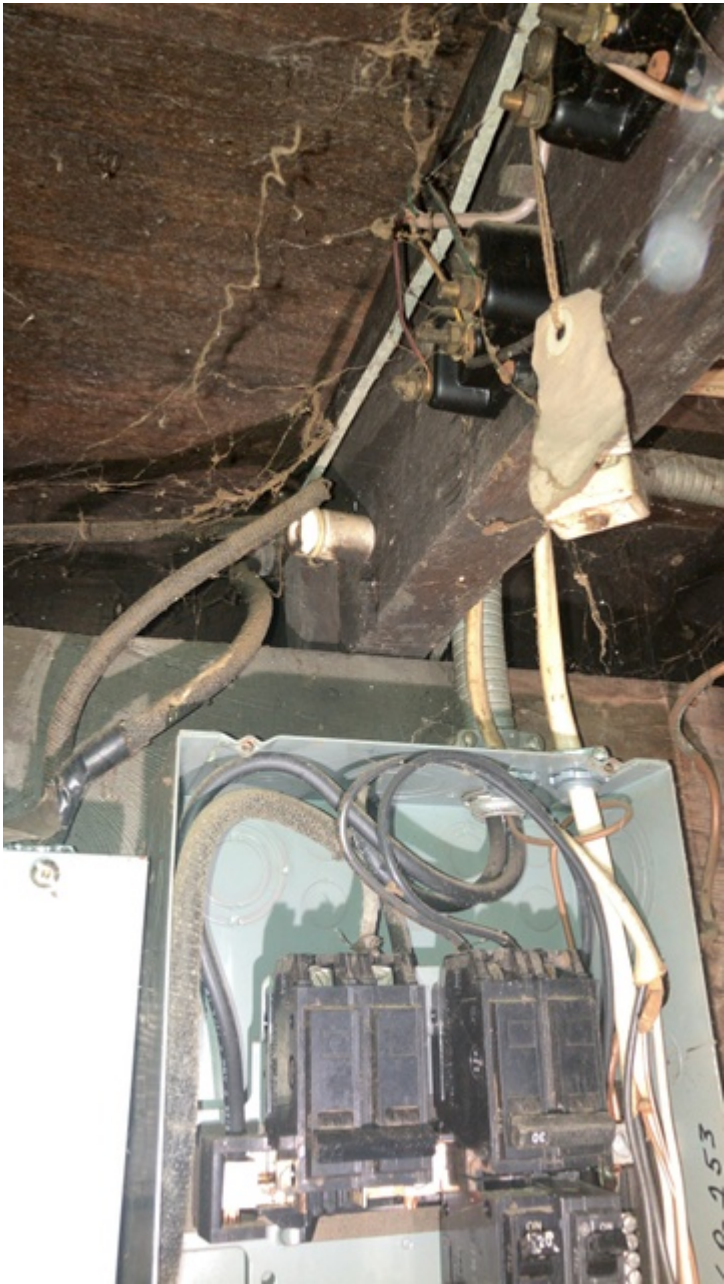
## Knob and Tube Wiring in Branch Circuits

There is knob and tube wiring present. Recommend repairs or replacing by a qualified professional.

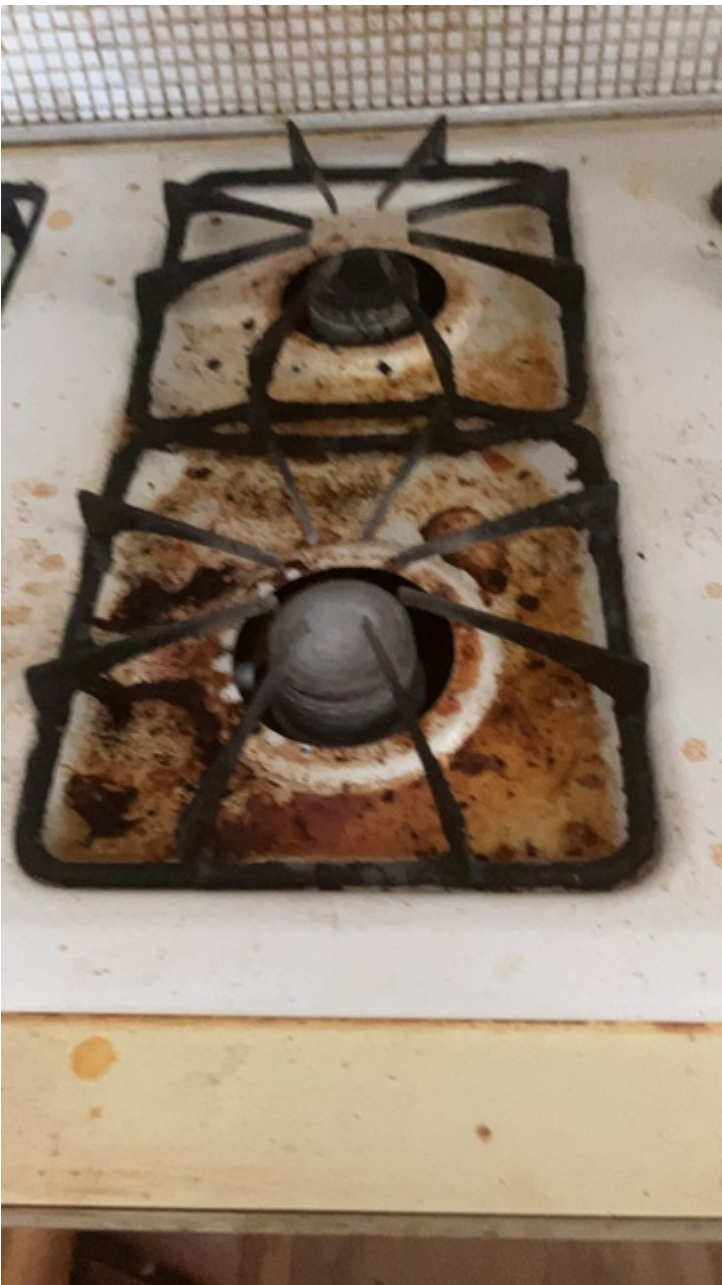
Inoperable Burners

One or more burners are not turning on or are inoperable. Recommend repairs or replacing by a qualified professional.
