# 2323 W Chestnut St

## Tampa, Florida 33607

**Major Systems Plus Report -  
2323 W Chestnut St**

**June 9, 2026, 3:00 PM EDT**

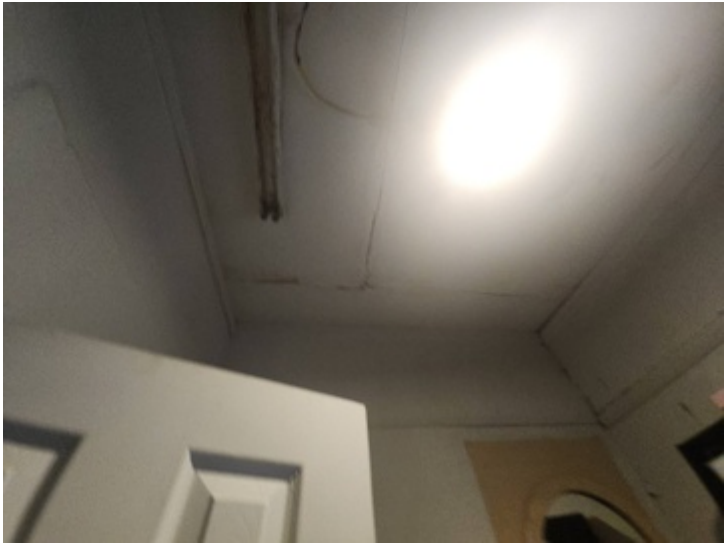
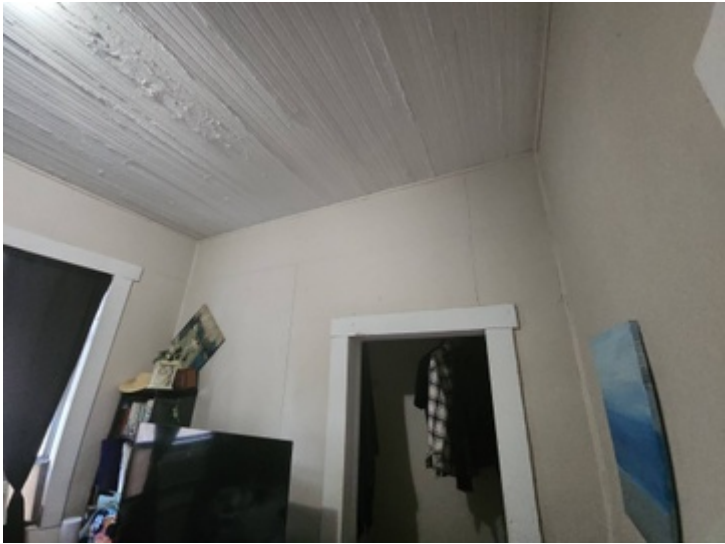
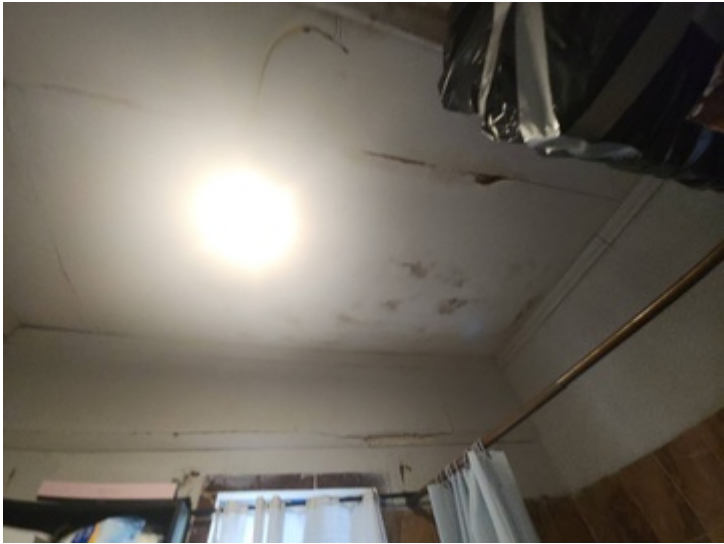
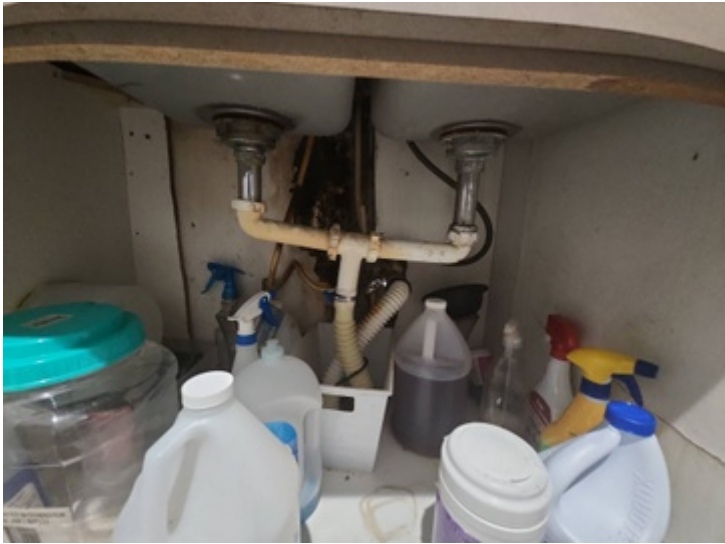
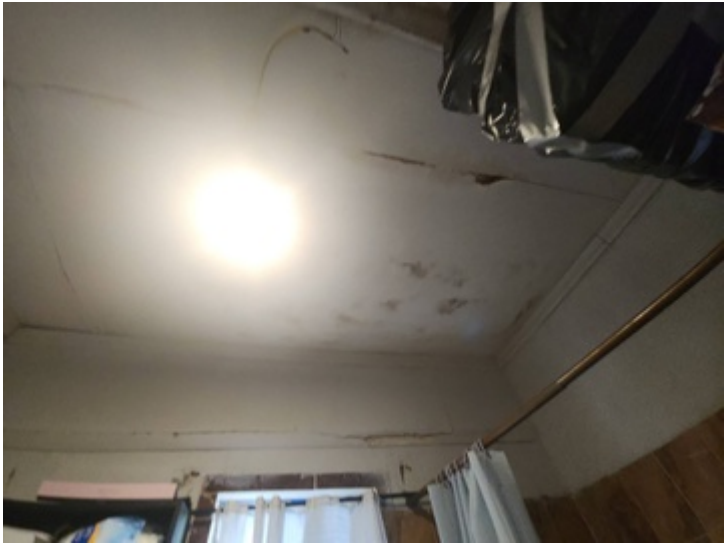
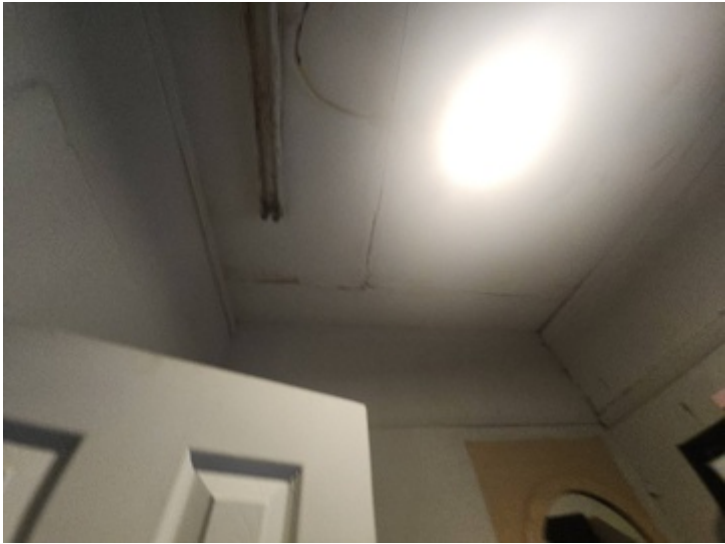
## Mold-like Substance on Property

There are signs of biological growth, mold, or mildew on the property. Recommend further evaluation by a qualified professional.

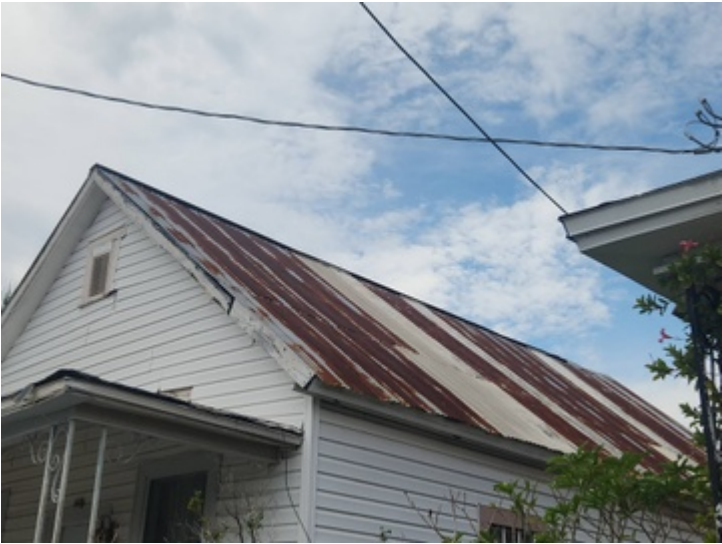
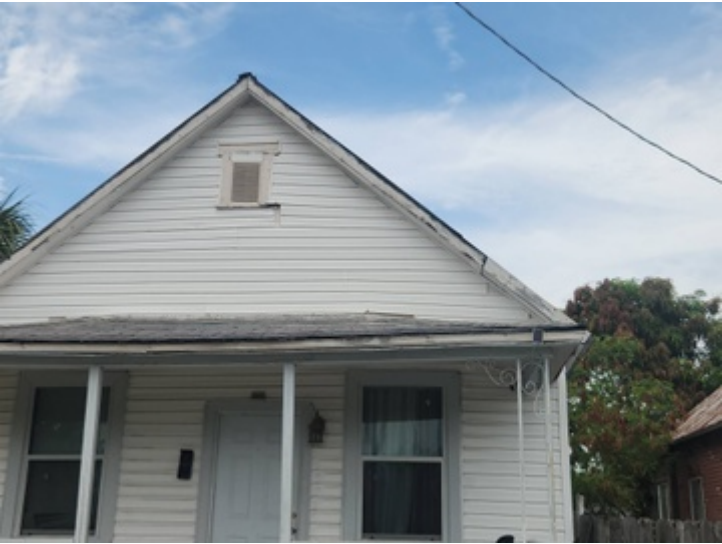
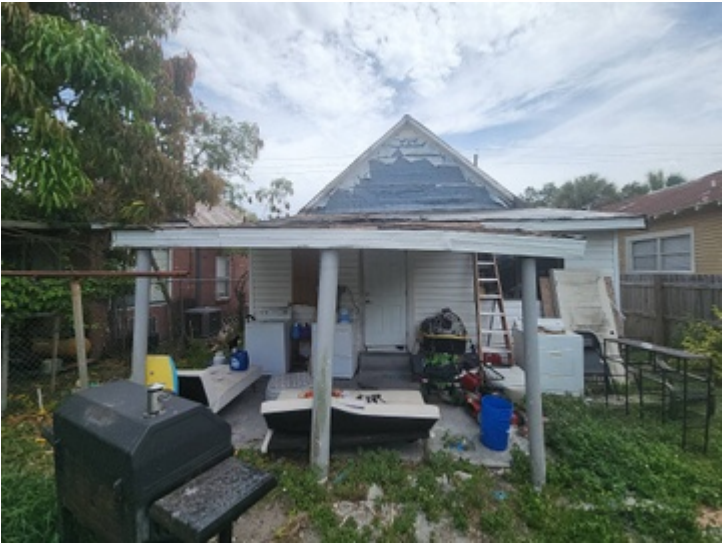
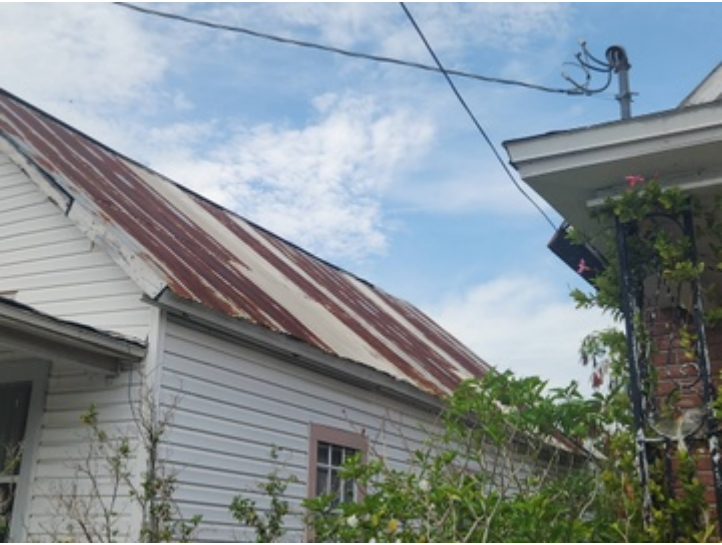
**Poor (Significant Repairs)**

Roof Shingles Nearing End of Life

The roof shingles are nearing their end of life. Recommend further evaluation by a qualified professional.

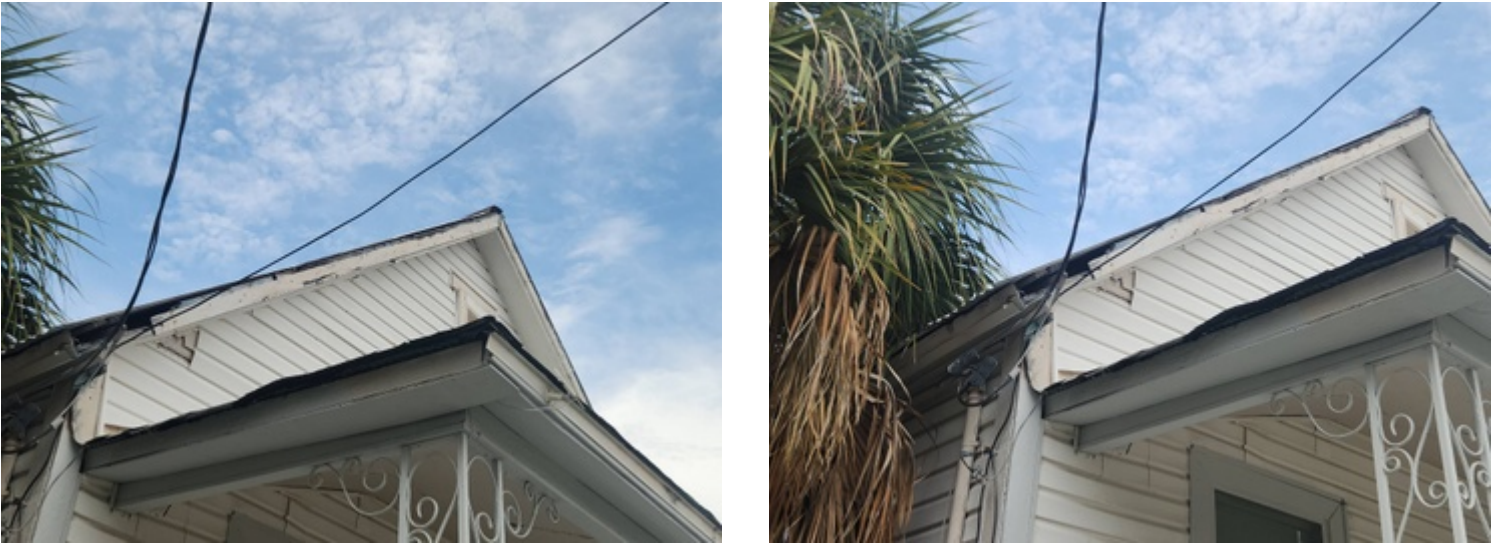
**Damaged Flashing**

The flashing is damaged.

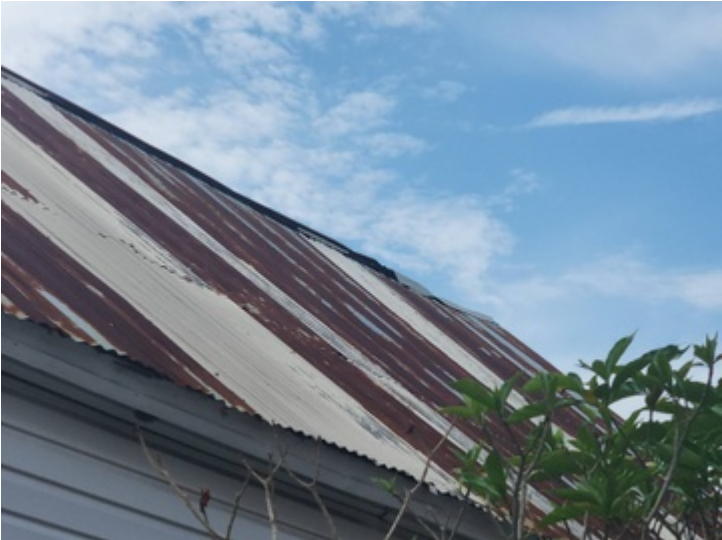
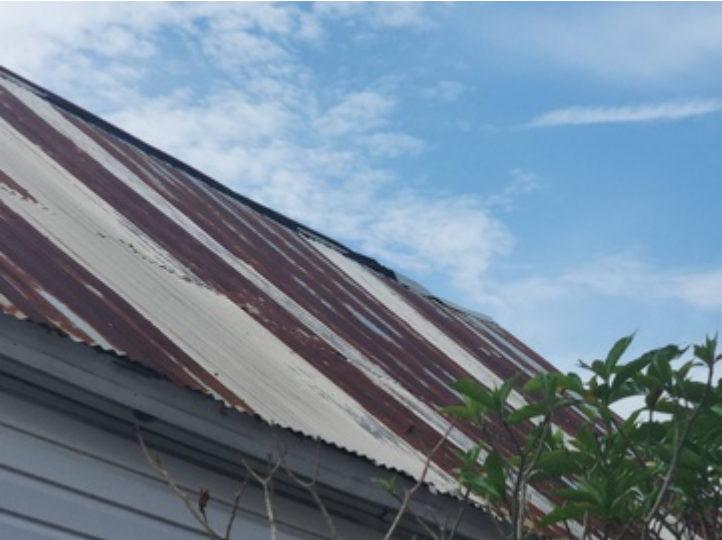
**Damaged Vent**

One or more roof vents are damaged. Recommend further evaluation by a qualified professional.

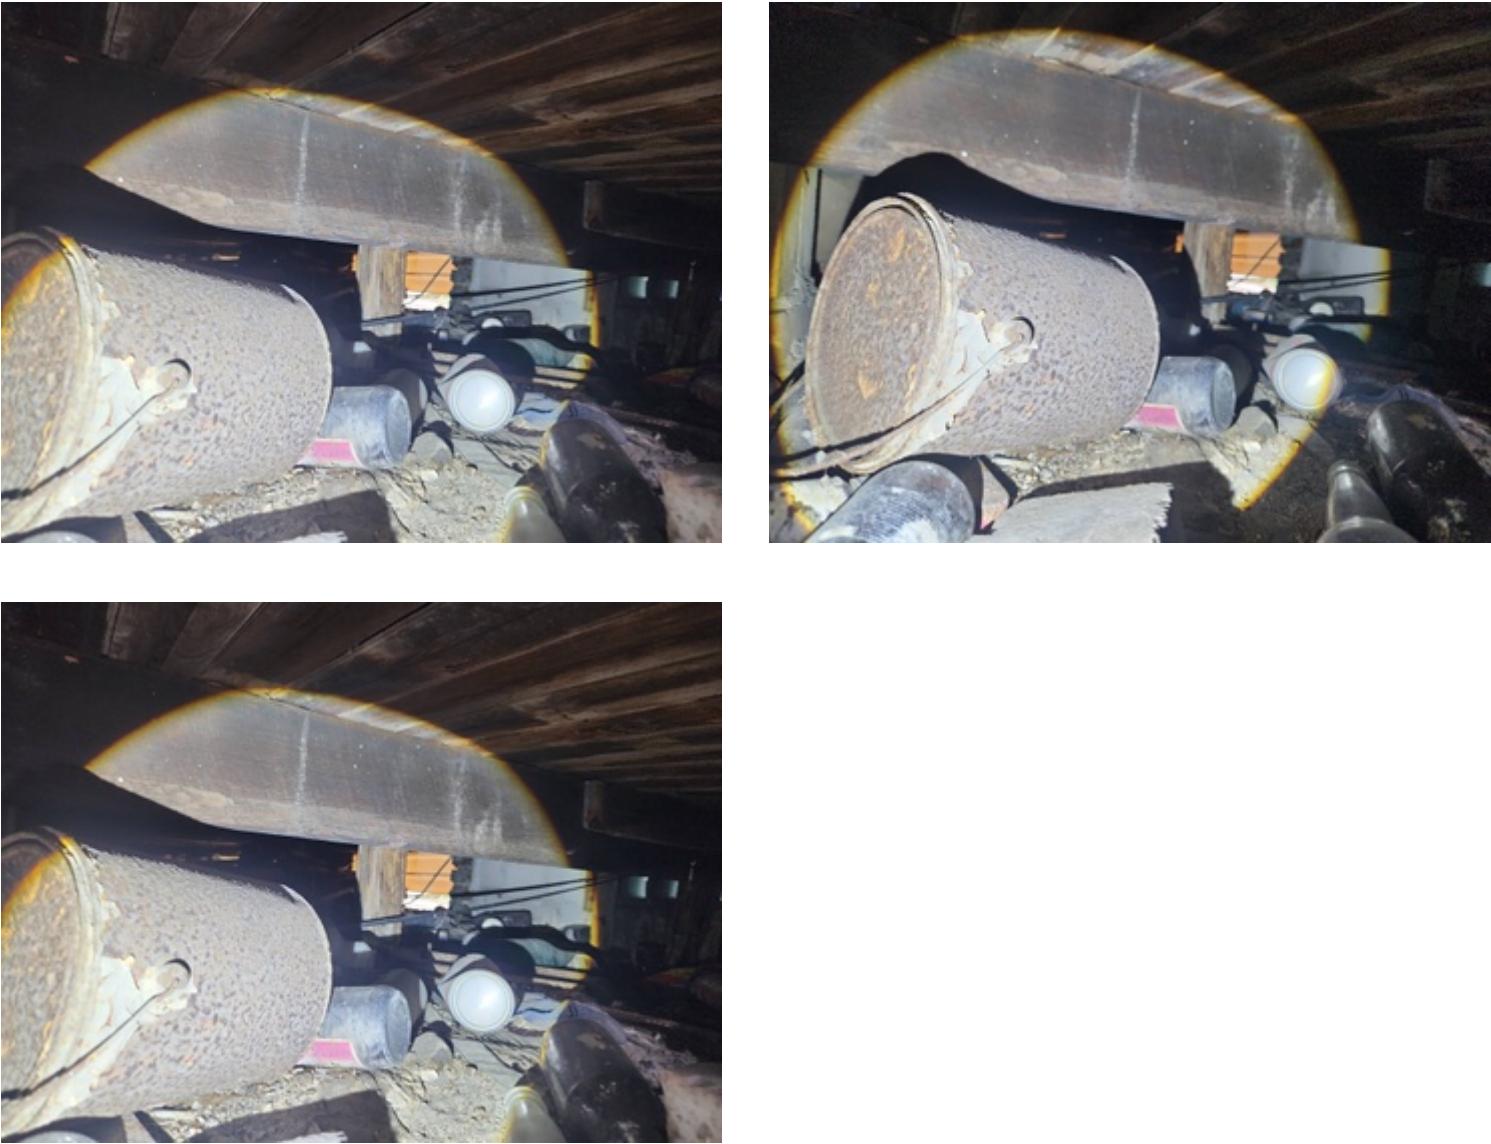
Wooden Support Touching Ground

A wooden support is touching the ground, which is conducive to wood-destroying organisms. Recommend further evaluation by a qualified professional.

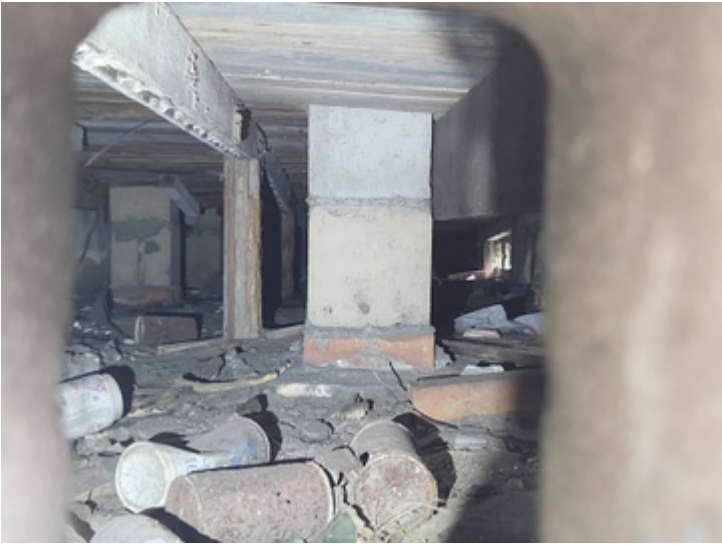
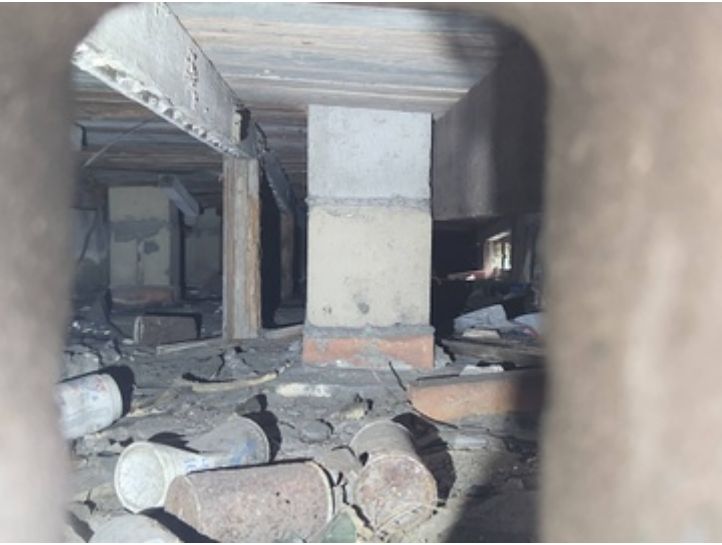
**Wood Rot Observed**

Wood rot is observed on / in the property. Recommend further evaluation by a qualified professional.

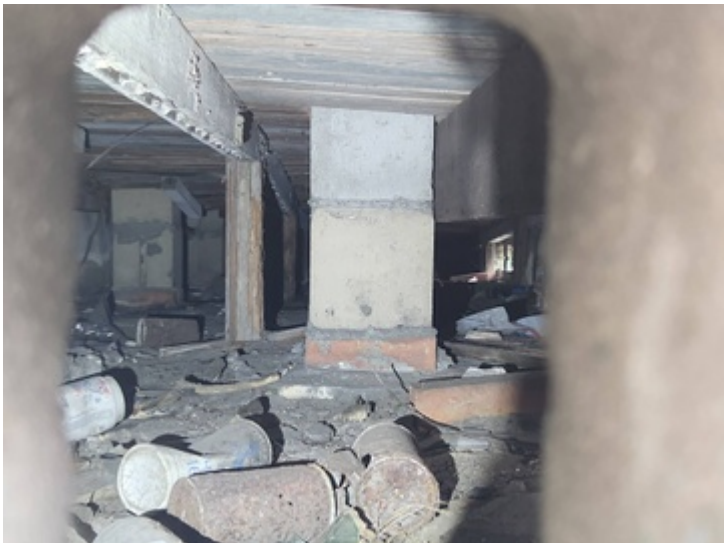
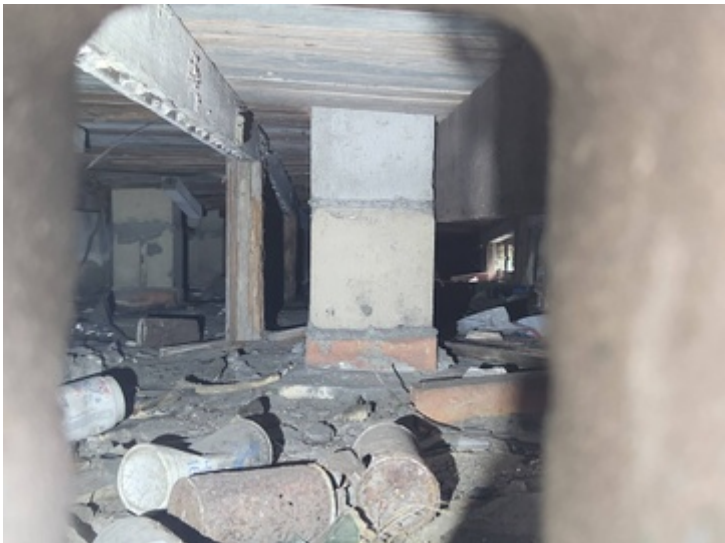
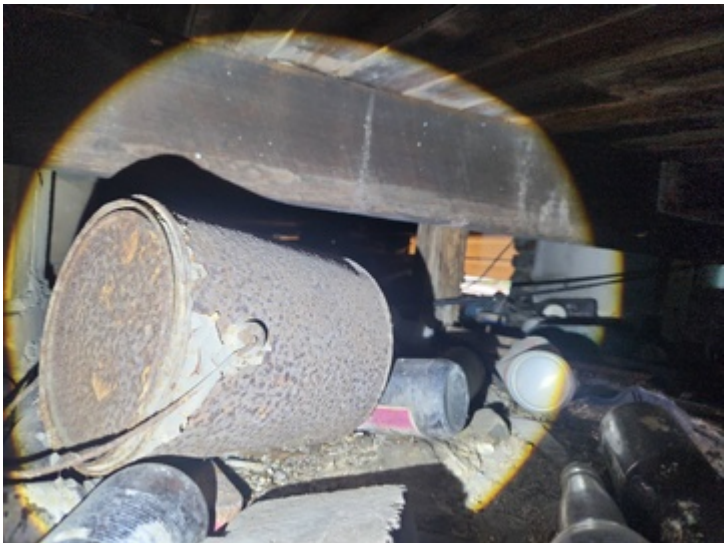
**Missing Vapor Barrier**

The vapor barrier is missing.

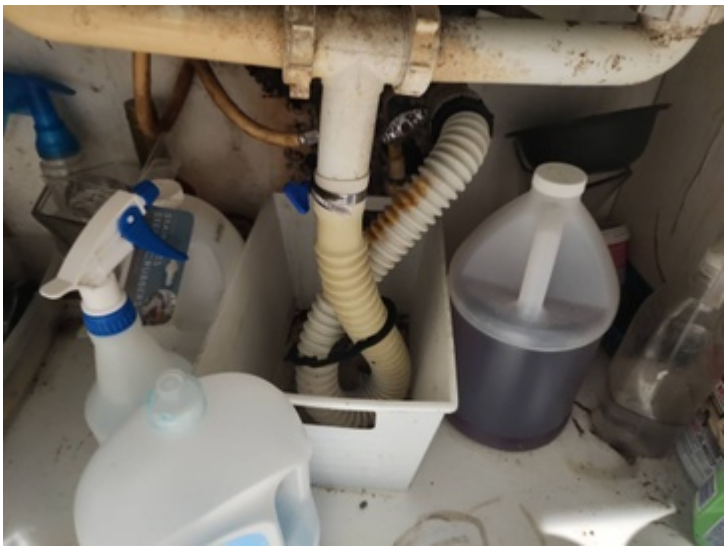
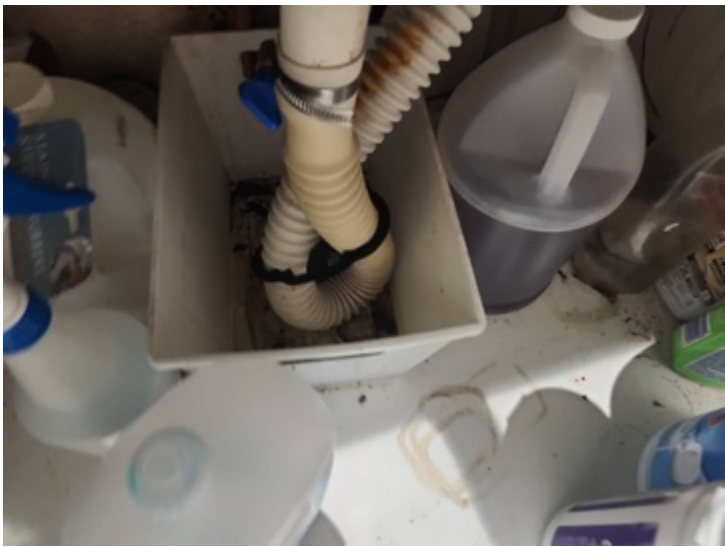
Leaking Drain Pipe

A drain / waste / vent pipe is leaking.

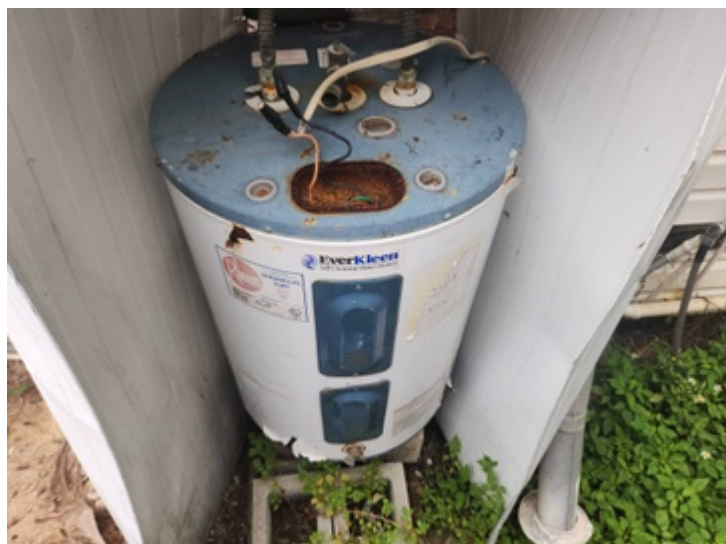
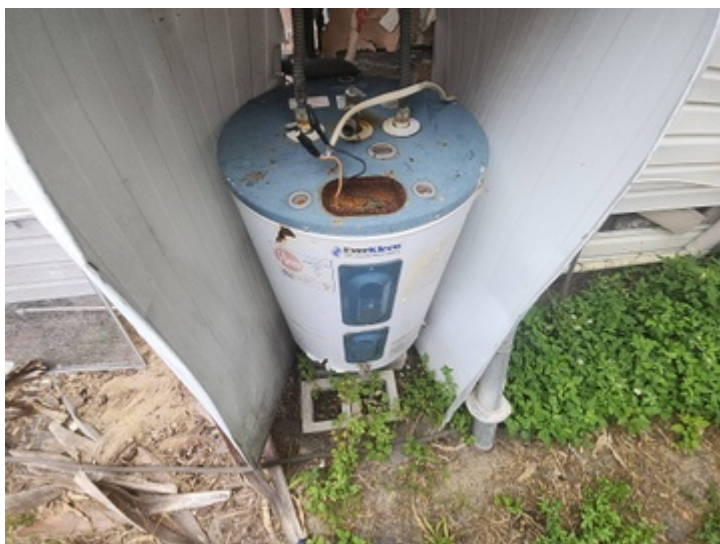
## Corroded Water Heater

The water heater fittings are corroded.

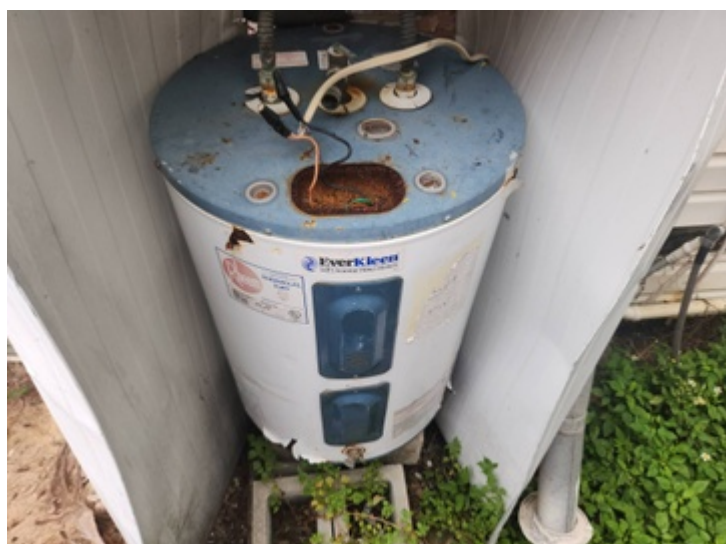
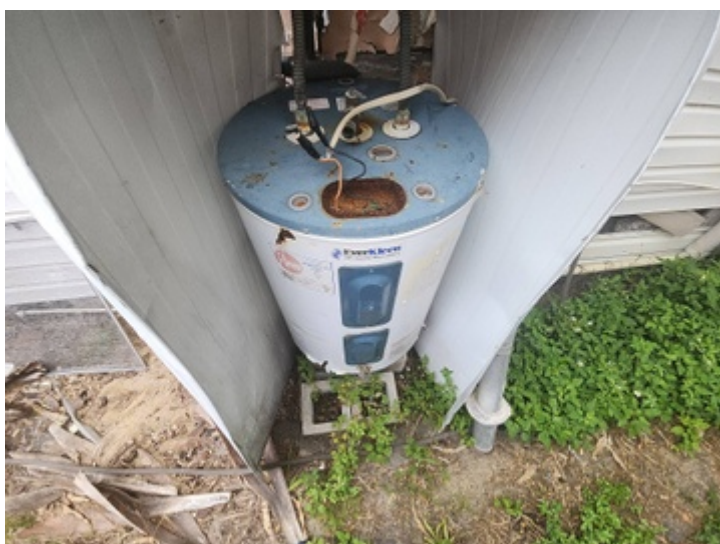
## Water Heater Nearing End of Useful Life

The water heater has normal signs of wear and tear and is near the end of its useful life.

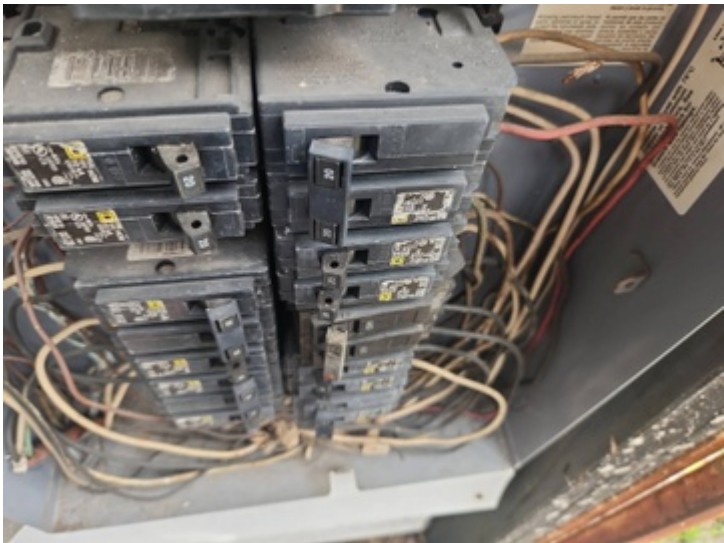
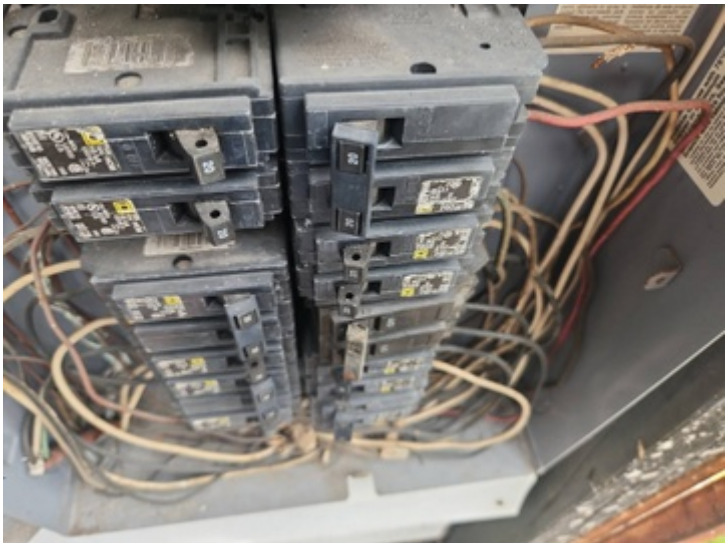
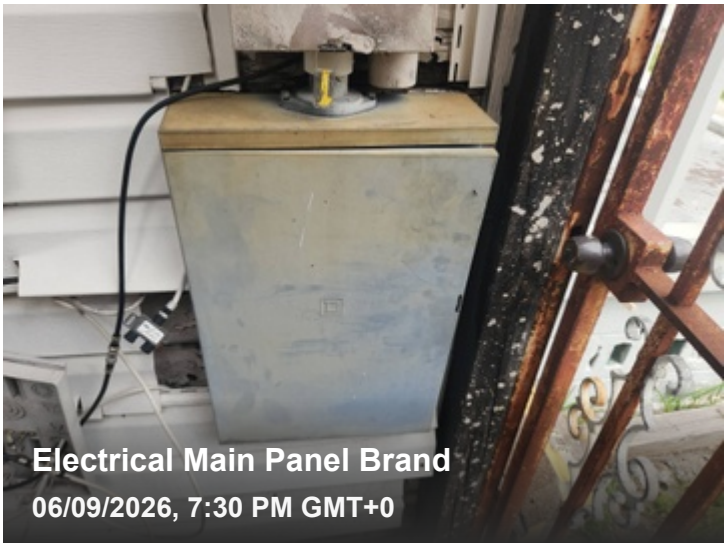
Poor (Significant Repairs)

Loose electrical breakers

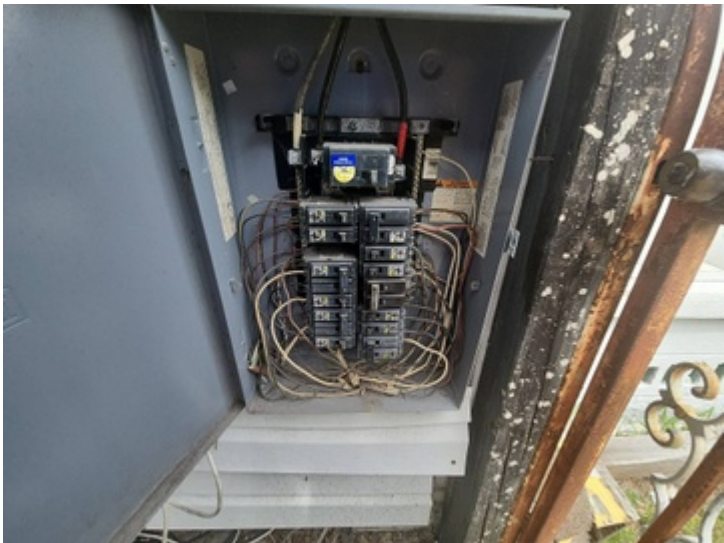
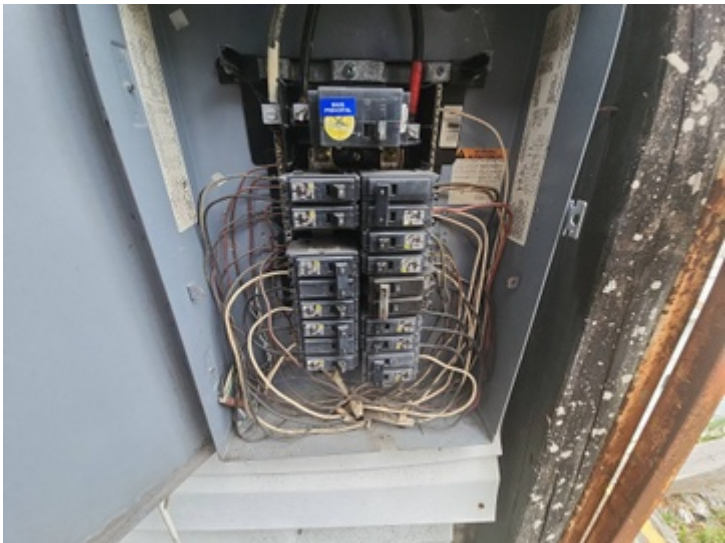
Missing Electrical Panel Cover

The electrical panel dead front is missing. Recommend further evaluation by a qualified professional.
