# 2414 E North Bay St

## Tampa, Florida 33610

**Major Systems Plus Report -  
2414 E North Bay St**

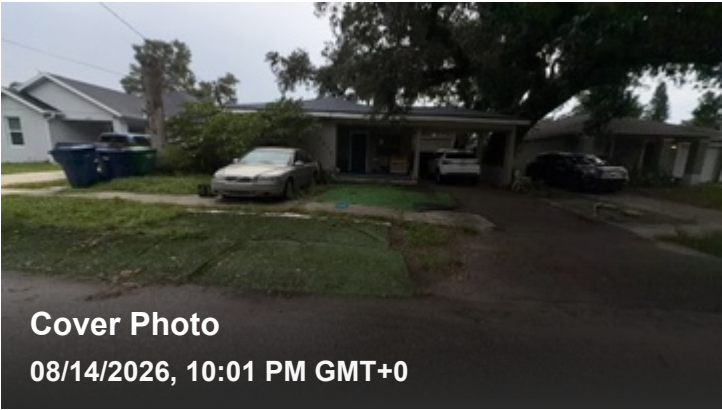
The tower of the house needs to be cleaned because full of garbage and user materials littered the floor of difficulties to pass on the side of the house due to a lot of debris and foliage.

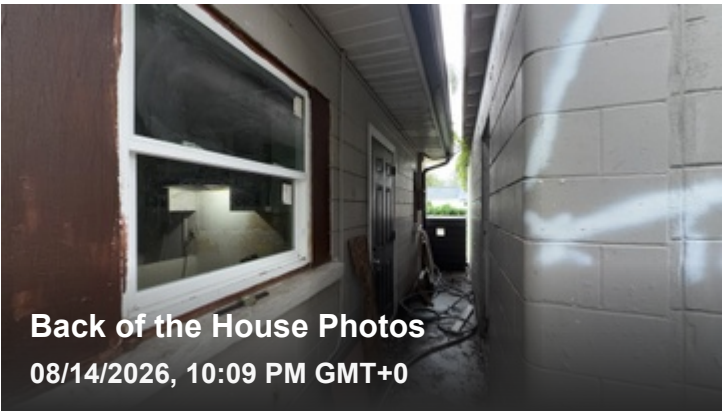
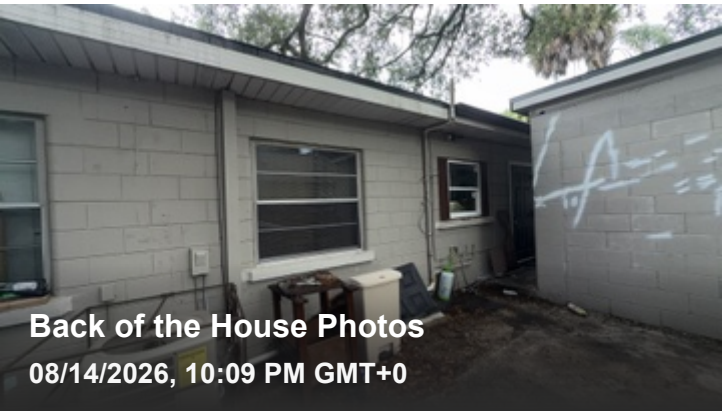
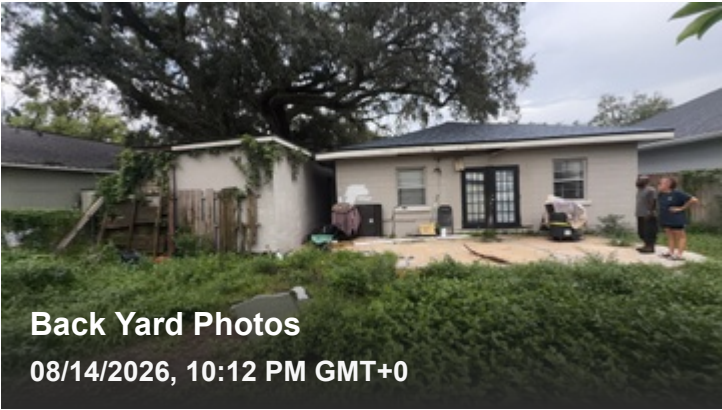
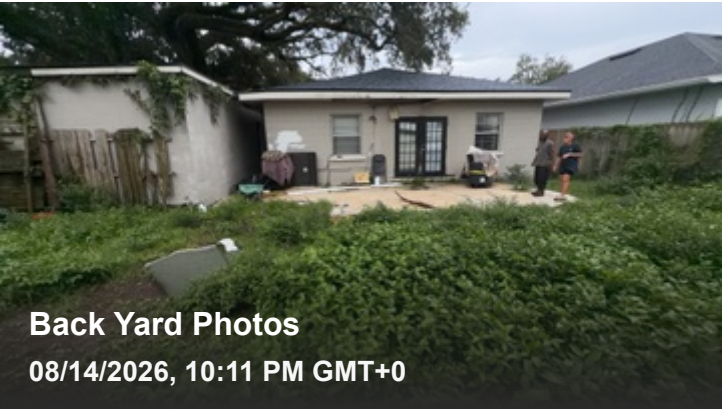
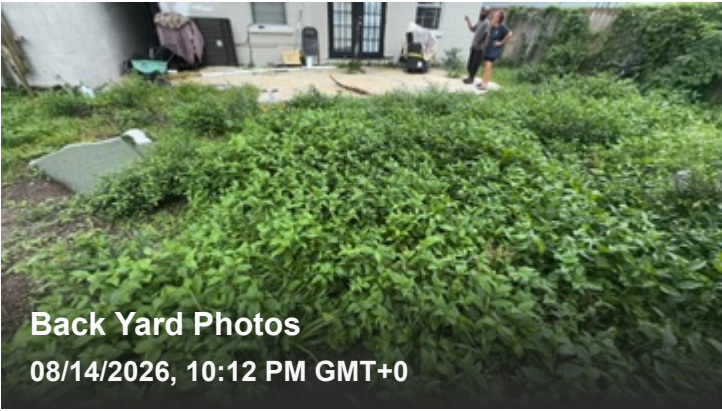
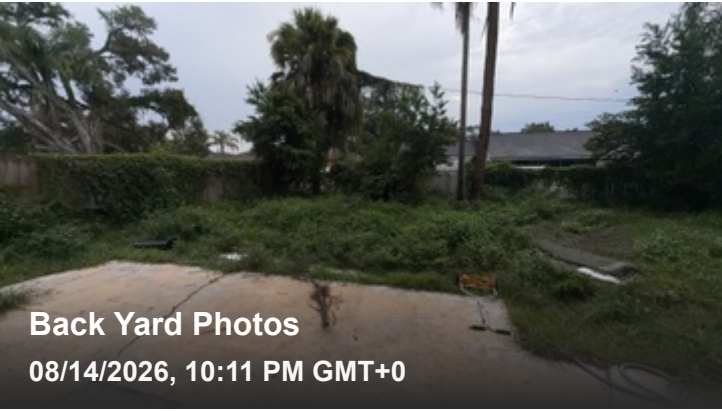
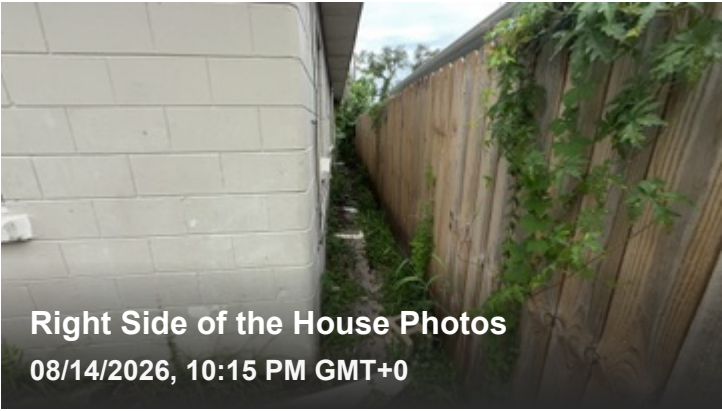
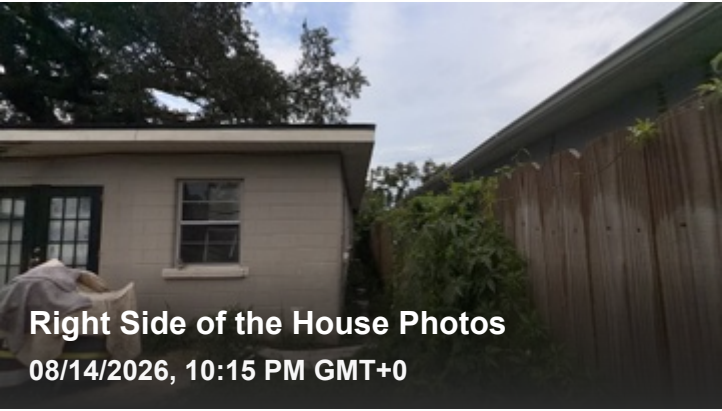
**Overgrown Vegetation**

There is overgrown vegetation / weeds on one or more areas of the property.

**The garden is not maintained and pieces of fake lawn splot the ground with a bad smell**

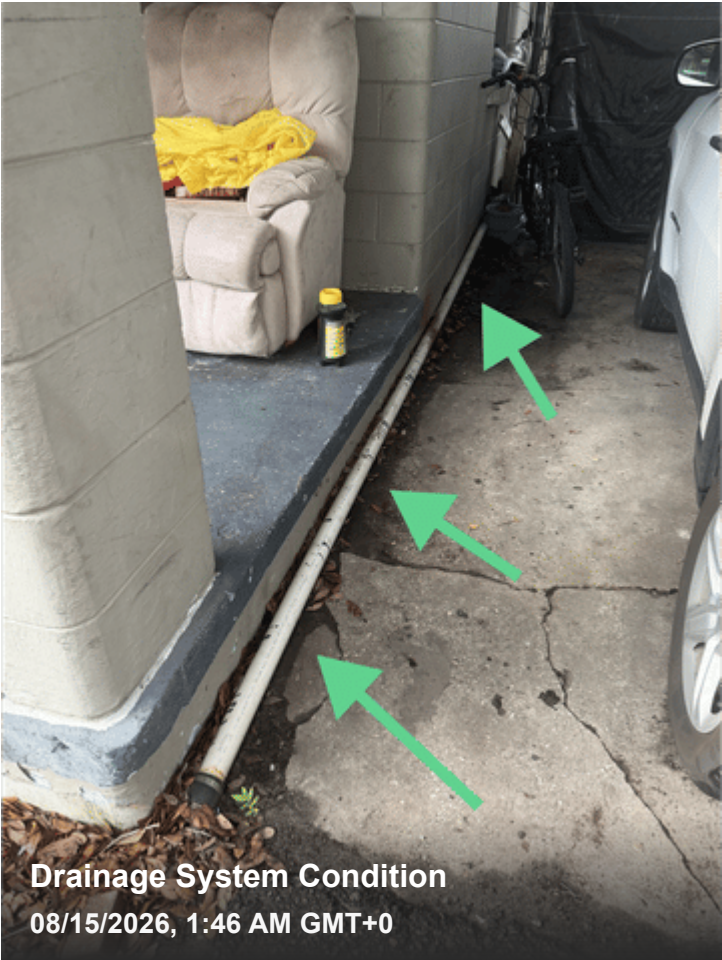
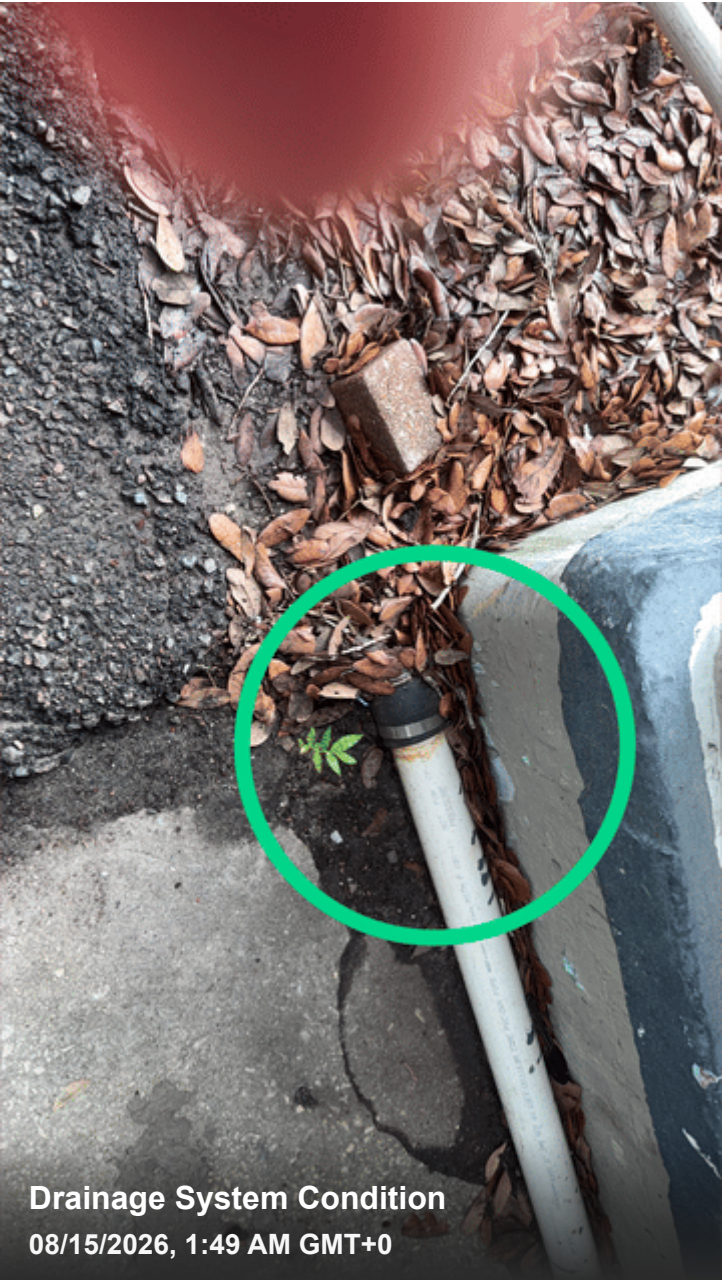
**The visible kitchen and shower wastewater drain lines show signs of deterioration and improper connections. Repairs by a qualified plumber are recommended to prevent leakage and ensure proper drainage.**

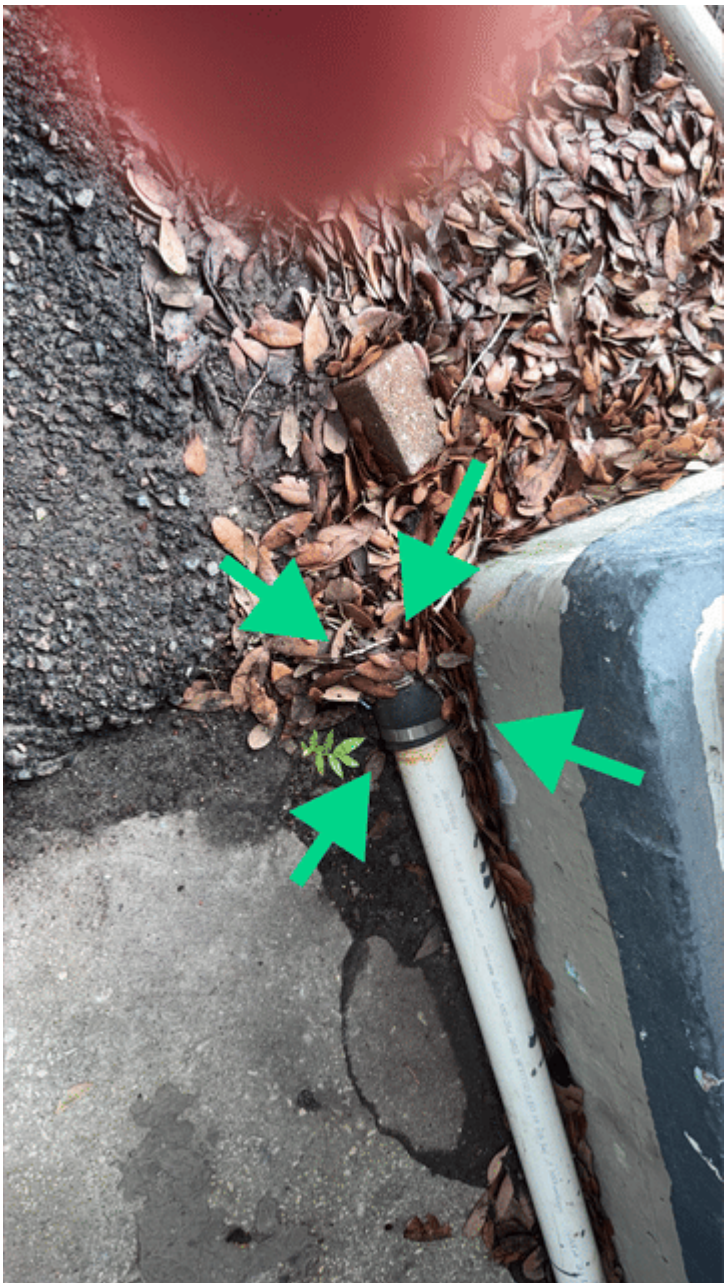
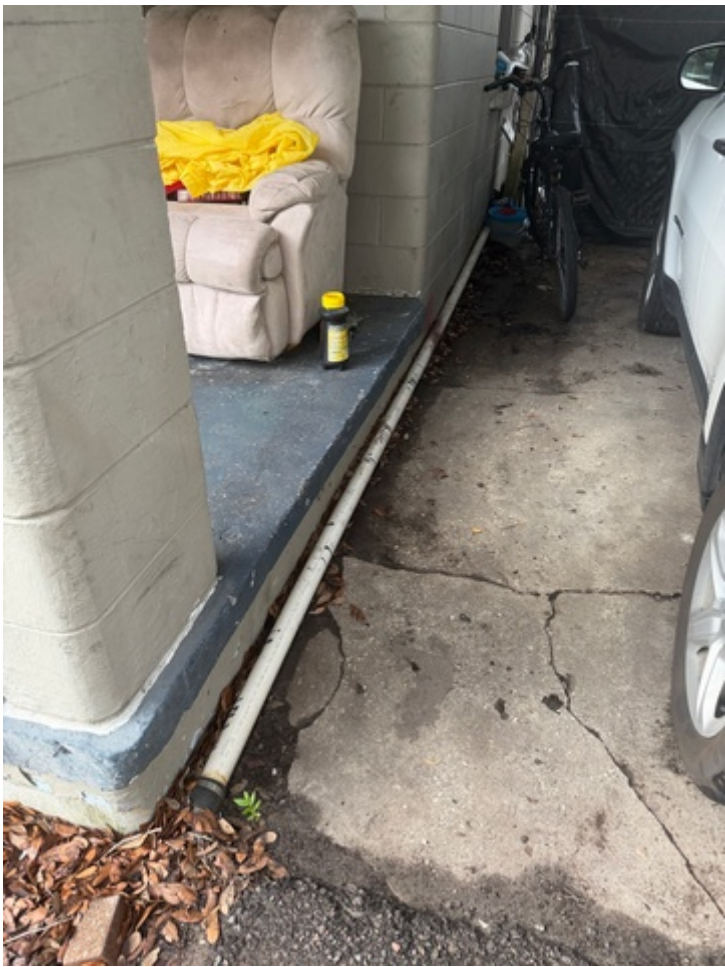
**Leaking Drain Pipe**

A drain / waste / vent pipe is leaking. Recommend further evaluation, and repairs or replacing by a qualified professional.

The visible kitchen and shower wastewater drain lines show signs of deterioration and improper connections. Repairs by a qualified plumber are recommended to prevent leakage and ensure proper drainage.

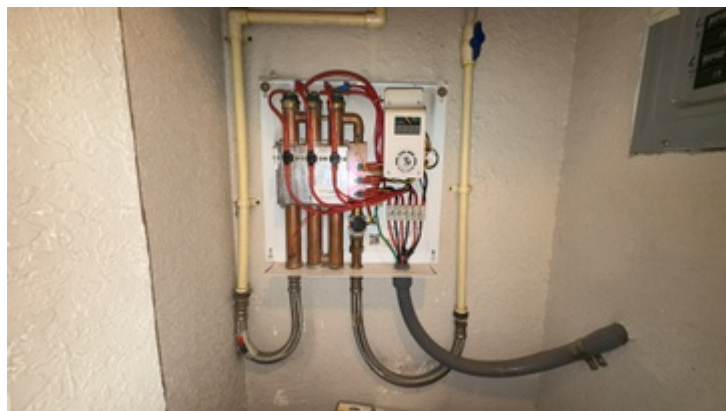
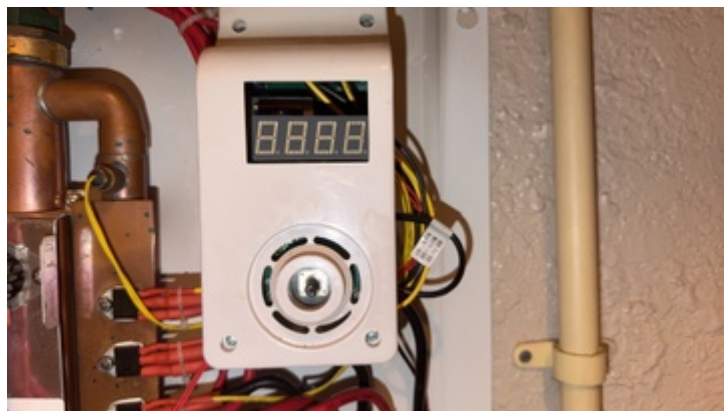
## Water Heater has Signs of a Leak

The water heater shows signs of a leak.

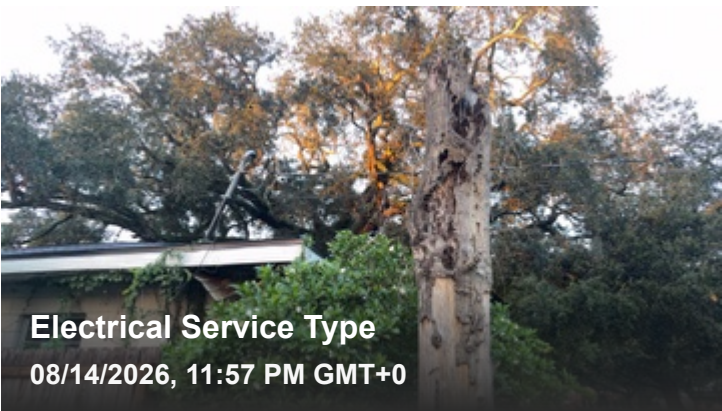
The overhead electrical service mast is visibly leaning and is not properly aligned. Evaluation and repair by a licensed electrician are recommended to ensure the service entrance is securely supported.

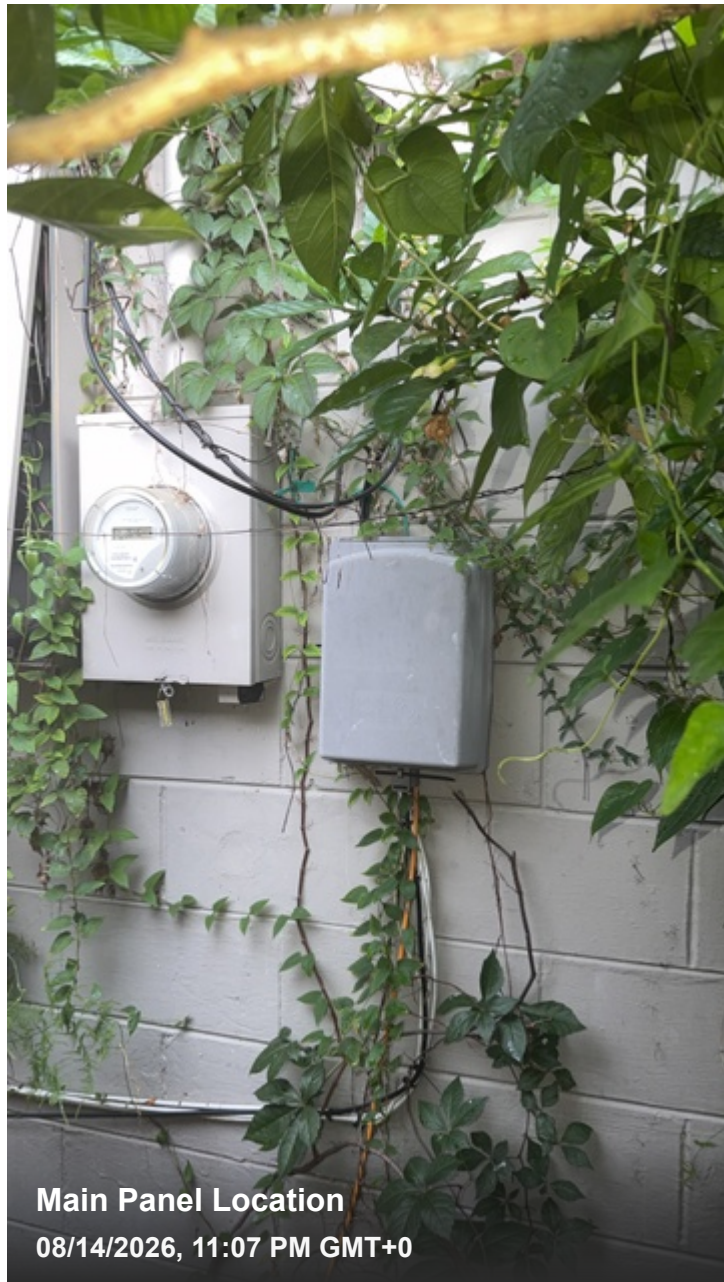
**Safety hazard: The exterior main electrical panel cover is detached and lying on the ground, leaving the electrical equipment improperly protected and potentially exposed to moisture, vegetation, and accidental contact. This condition presents a risk of electric shock, arcing, and fire. Do not touch the panel. Immediate evaluation and repair by a licensed electrician are strongly recommended**

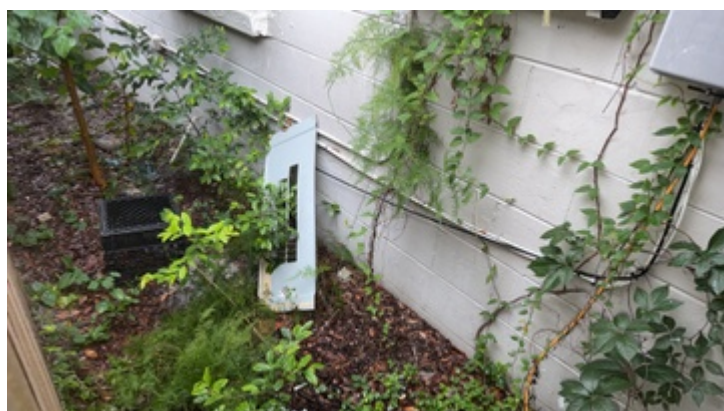
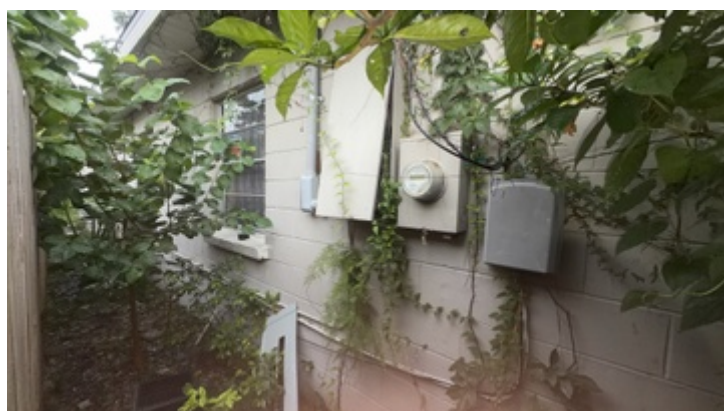
## Missing / Incorrect Screws for Electrical Panel

There are missing / incorrect screws.

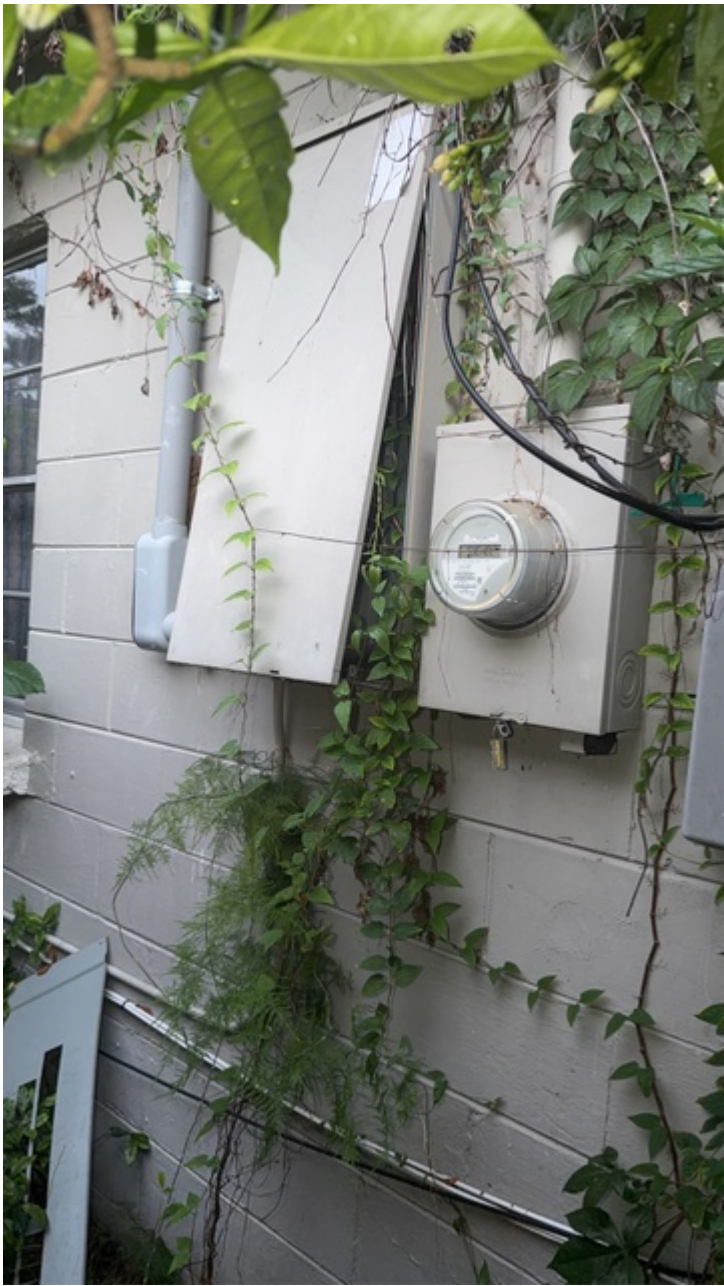
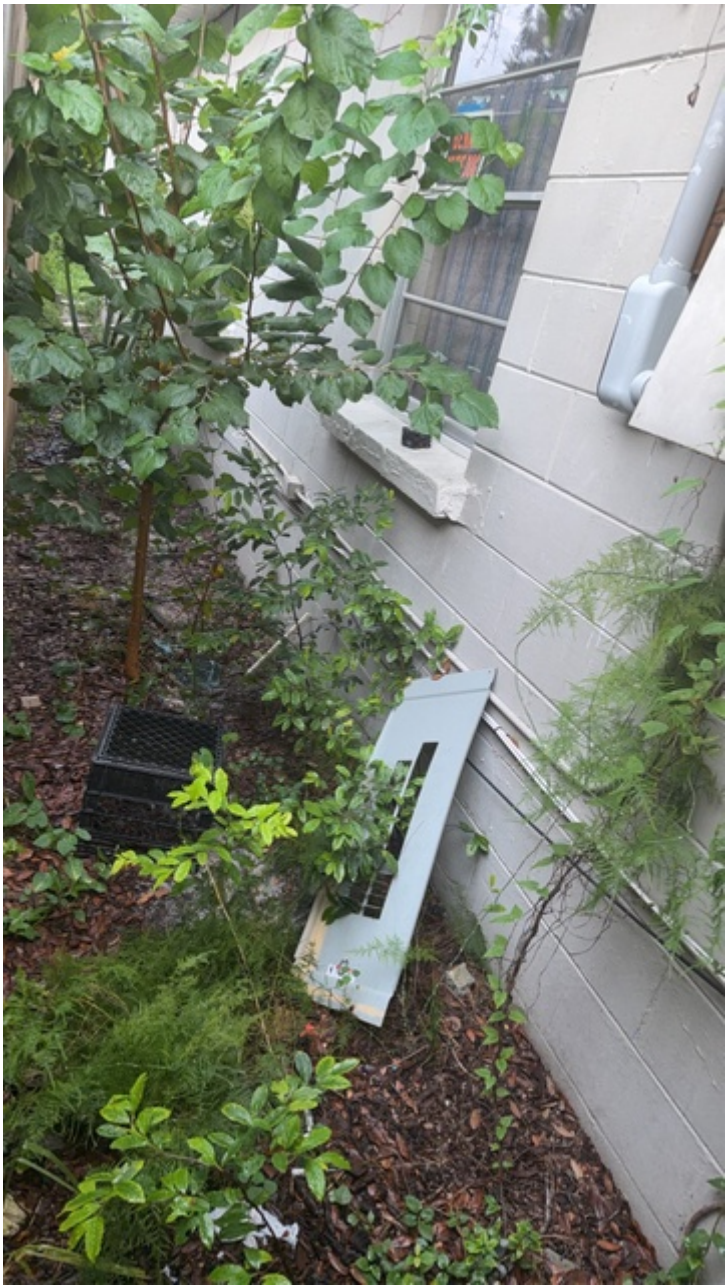
**Main Panel Wiring Type: No Access**

The wiring type could not be safely confirmed due to exposed energized components and the missing panel cover. Further evaluation by a licensed electrician is recommended

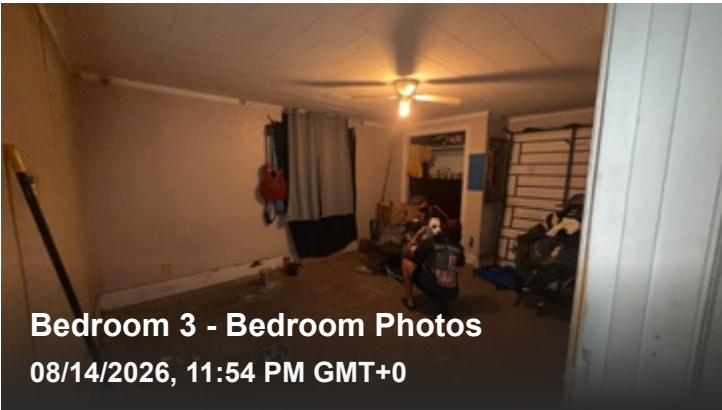
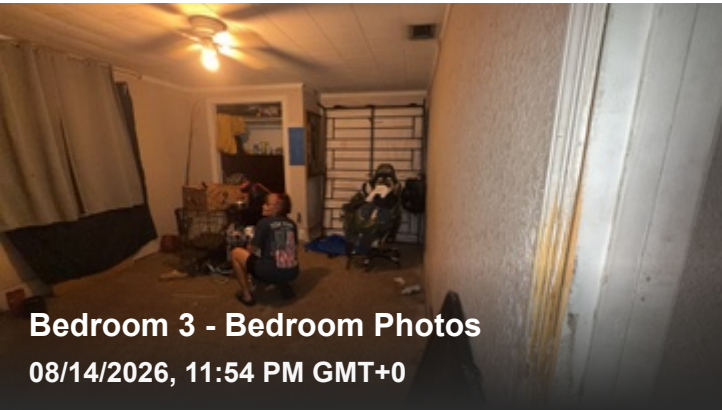
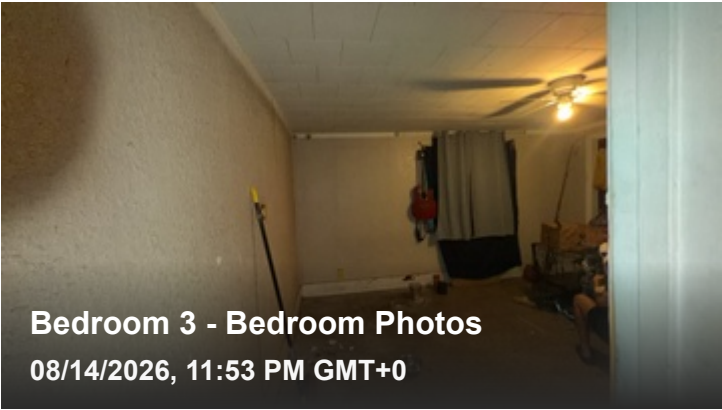
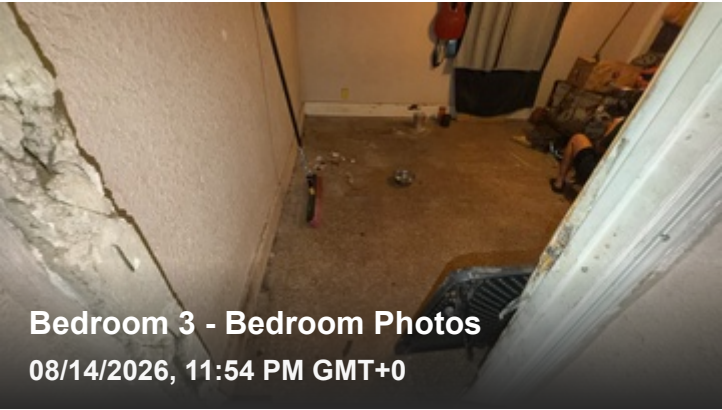
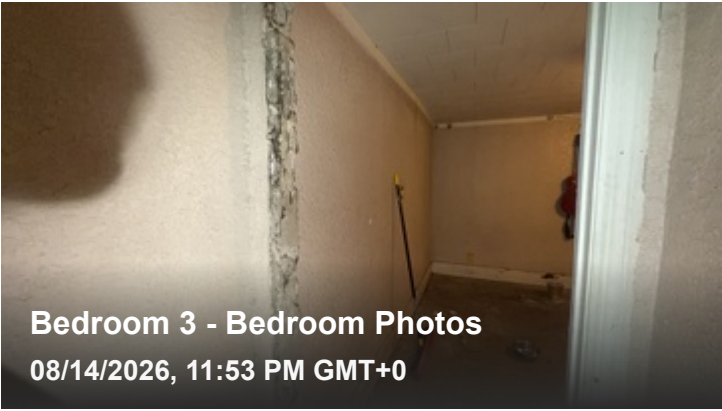
The room contains excessive stored items and personal belongings, significantly limiting access and visibility of the walls, flooring, windows, and electrical components. A complete inspection of this area could not be performed. The clutter also presents a potential trip and safety hazard. Removal and organization of the stored items are recommended.

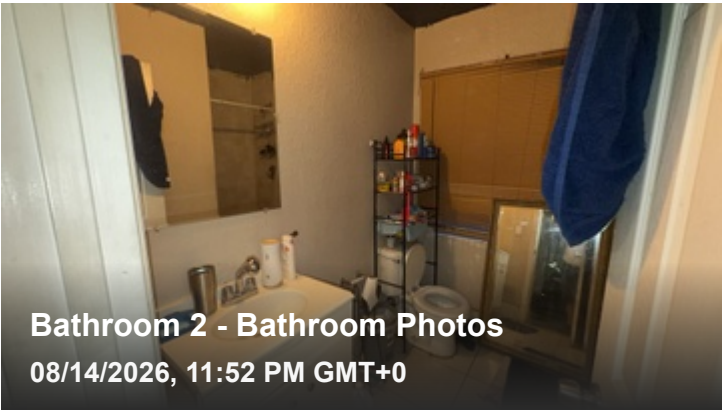
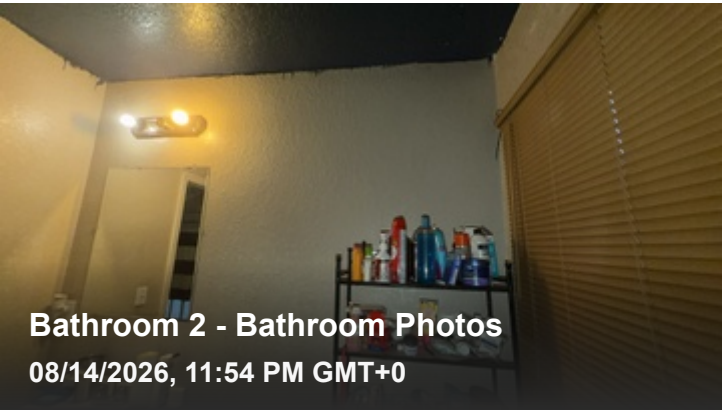
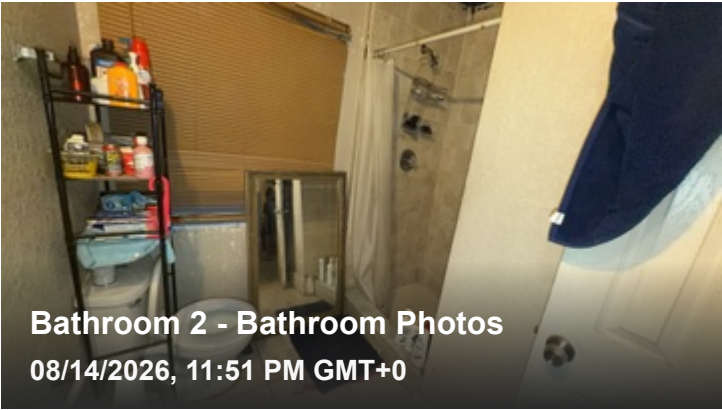
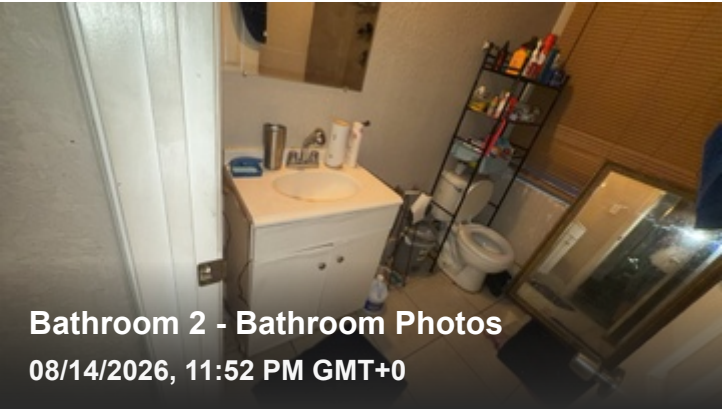
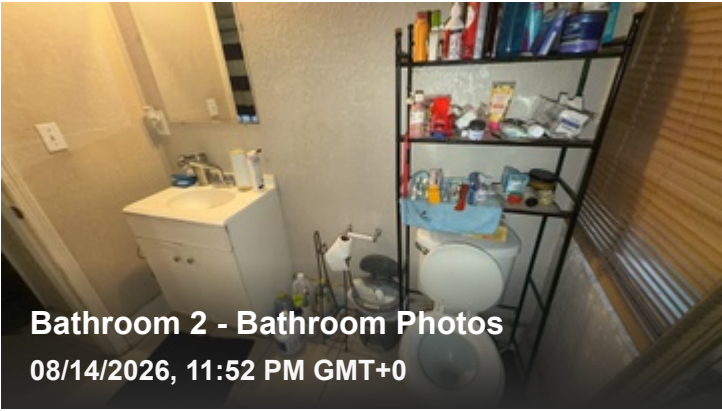
The bathroom was accessible and the main fixtures were present. Stored personal items limited visibility in some areas. Visible wear and unfinished or deteriorated finishes were observed around the shower area. Cleaning, repairs, and further evaluation of the plumbing and moisture-prone areas are recommended.

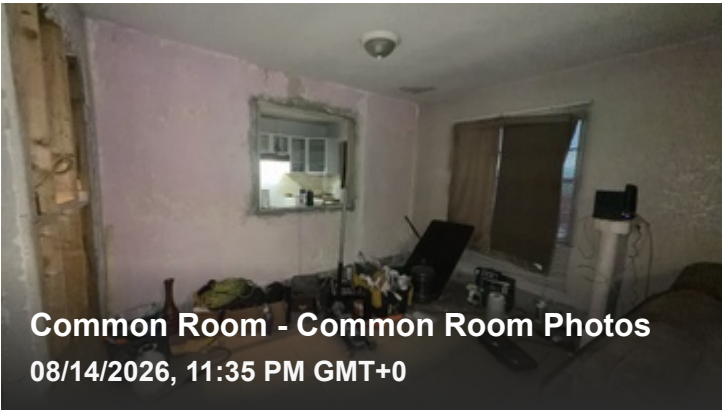
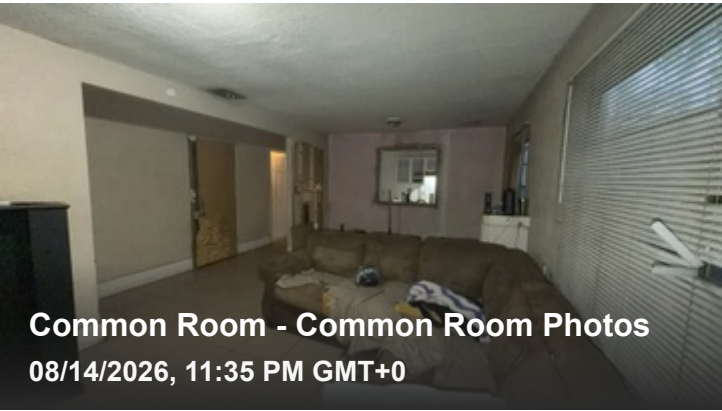
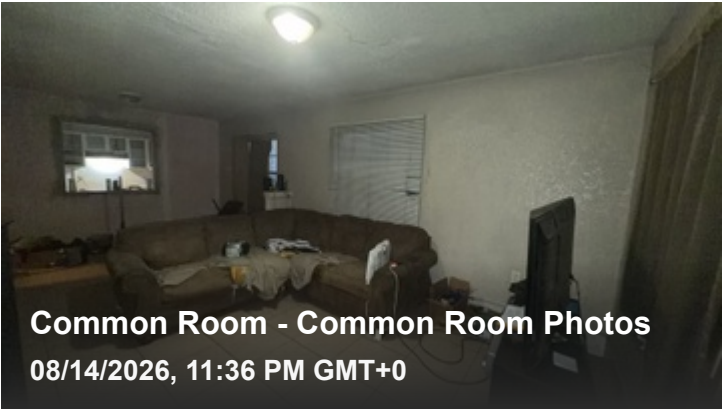
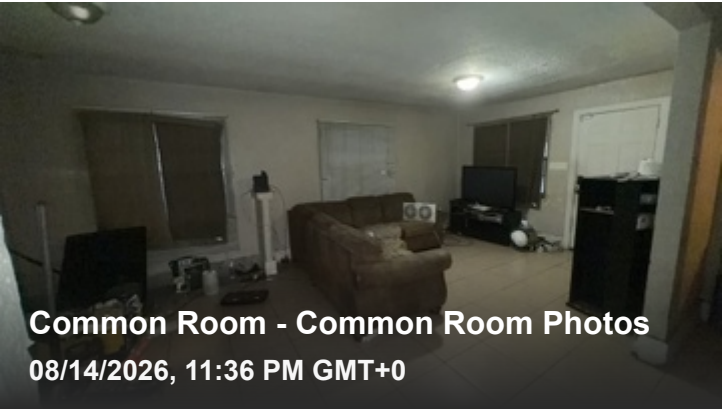
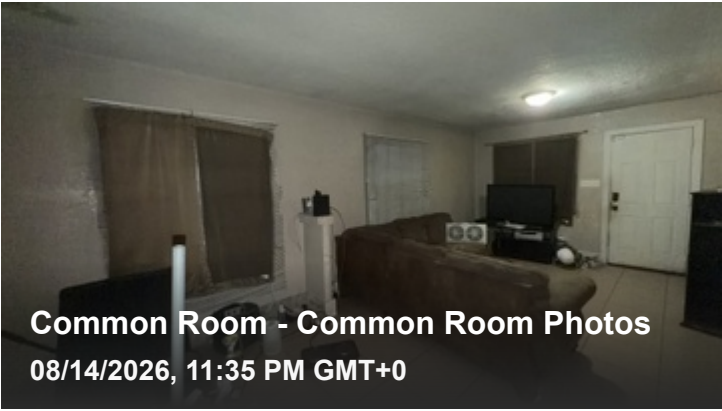
The common room was accessible and inspected. Personal belongings and furniture limited visibility in some areas. Unfinished wall repairs and missing or damaged interior finishes were observed. Completion of the renovation work and evaluation by qualified contractors are recommended.

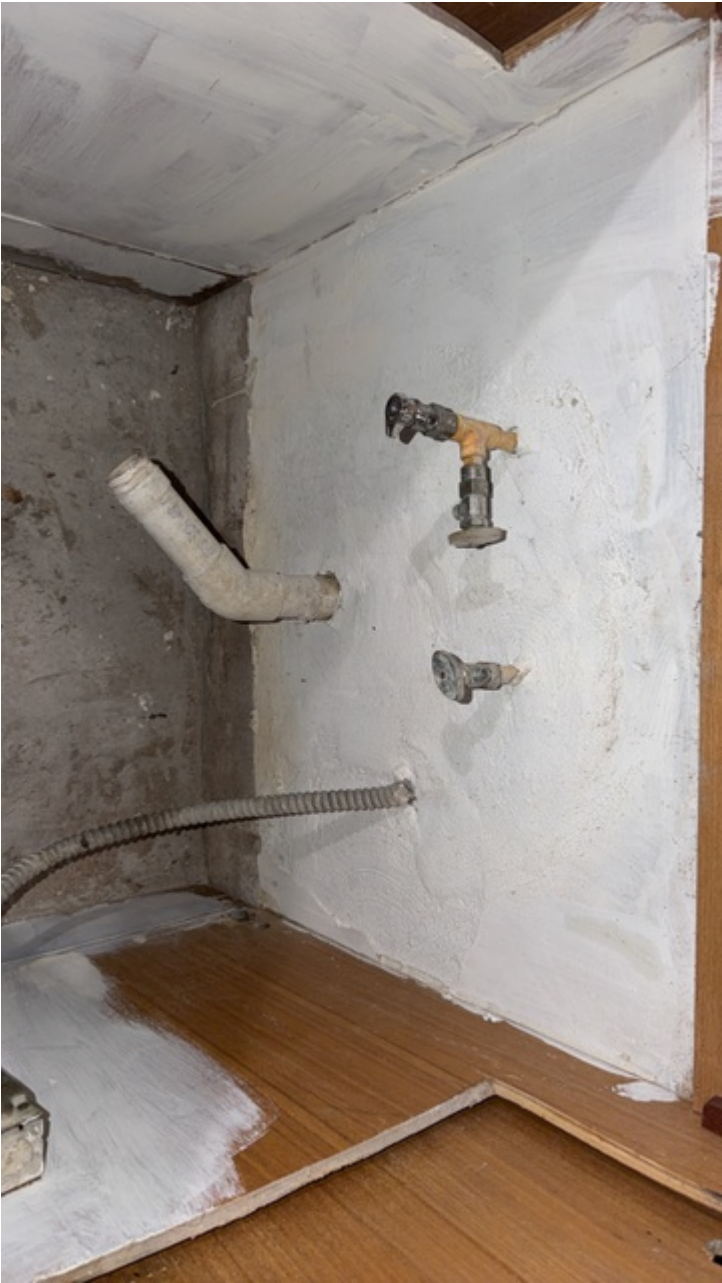
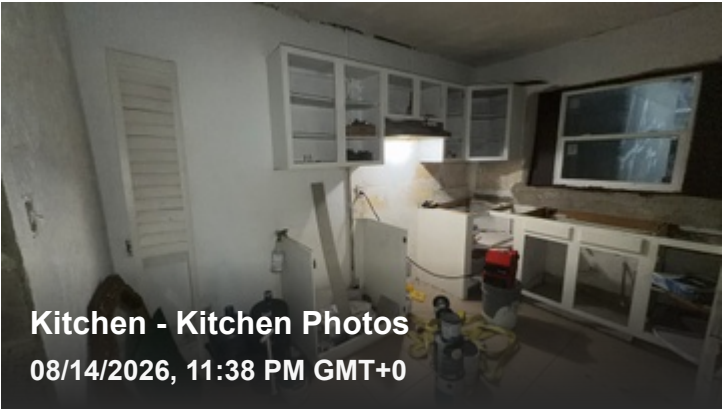
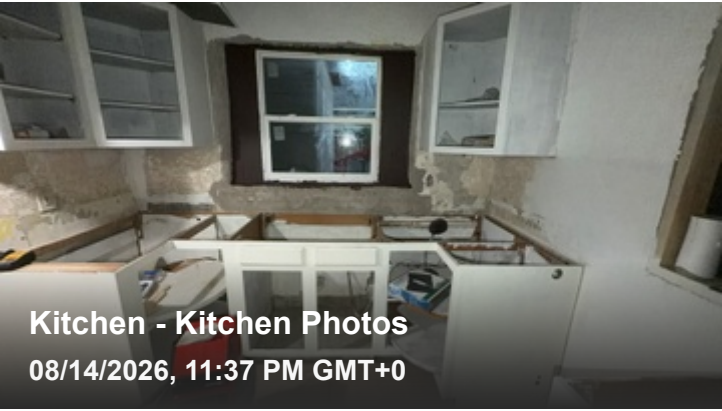
**The kitchen is undergoing renovation and remains incomplete. Countertops, cabinet doors, appliances, and portions of the wall finishes are missing or unfinished. Plumbing and electrical connections may be exposed or incomplete. Completion and evaluation by qualified contractors are recommended before use.**
