# 922 Peckham St

## Akron, Ohio 44320

| Type | Major Systems Plus Report - 922 Peckham St |
| Scheduled | October 15, 2026, 10:30 AM EDT |

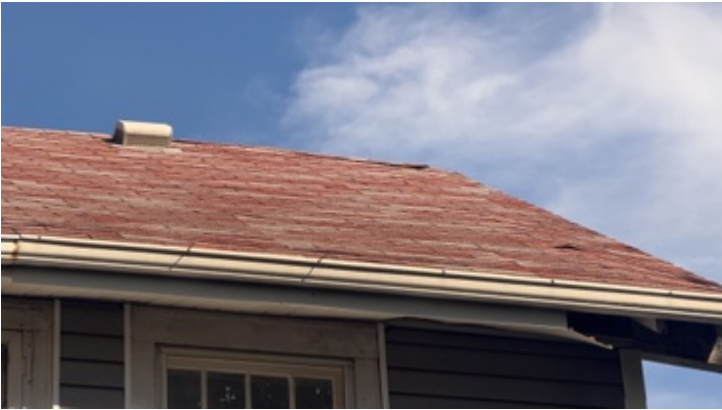
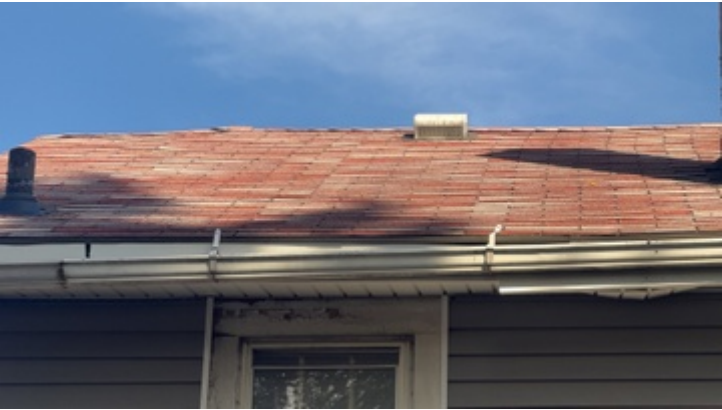
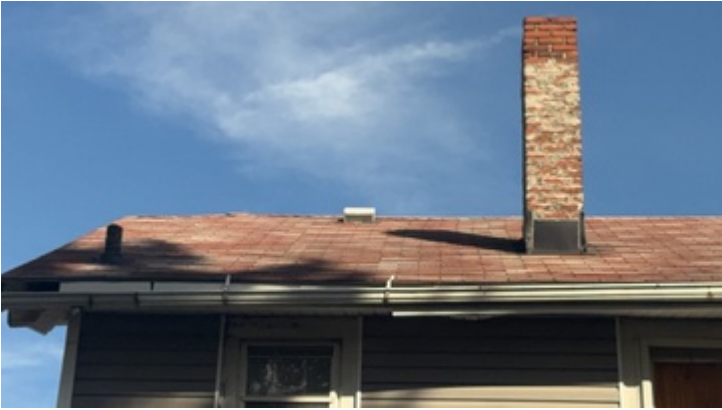
Fair (Some Repairs)

Roof Shingles Nearing End of Life

The roof shingles are nearing their end of life.

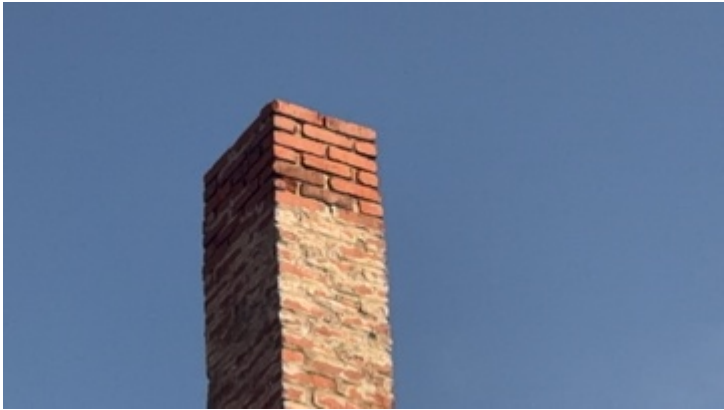
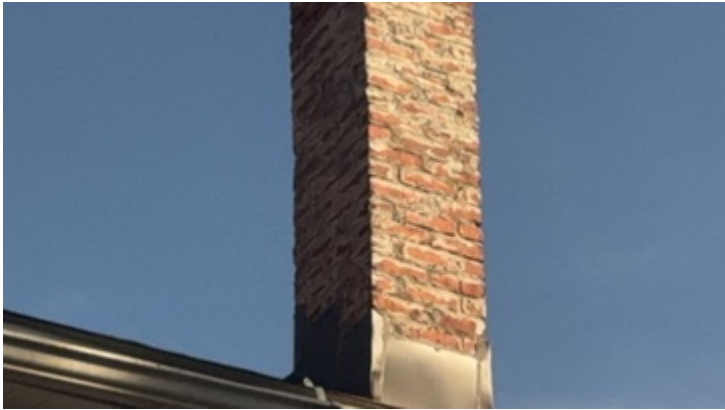
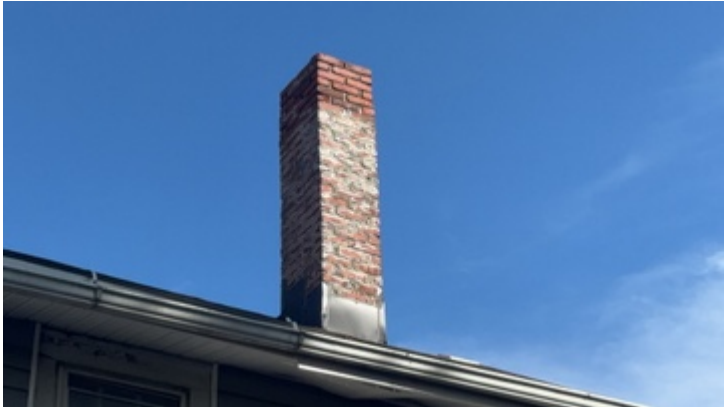
**Fair (Some Repairs)**

**Deteriorated Brick Mortar**

The mortar between the chimney bricks is deteriorated / damaged.

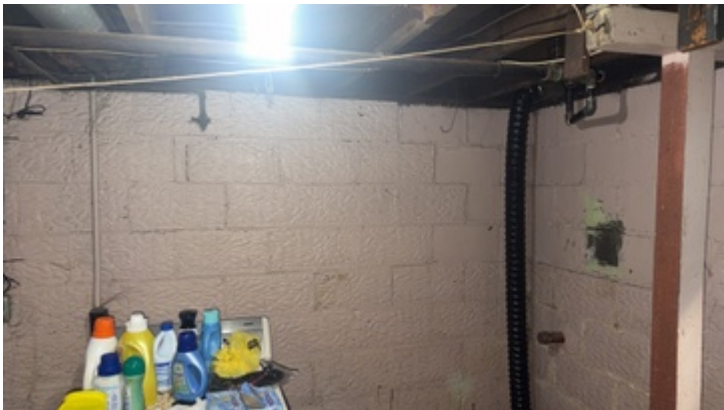
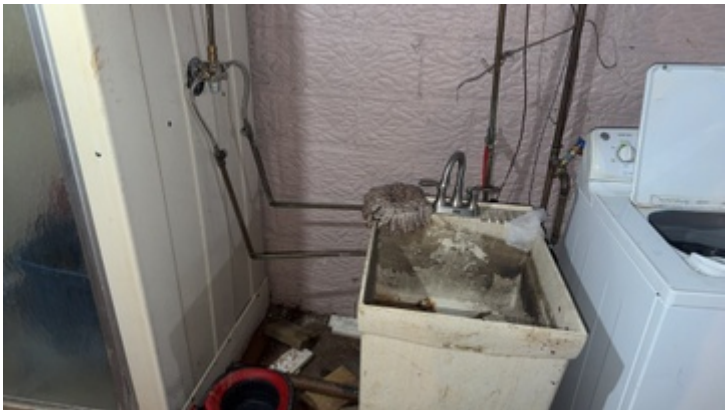
Missing Shut-off Valve

The main water shut-off valve is missing.
