## Home Inspection Report

1629 Marlin Street  
Saint Cloud, FL 34771

Inspected By: Hector Vargas, Lic. HI12079

Inspected On Wed, Aug 12, 2026 at 11:00 AM

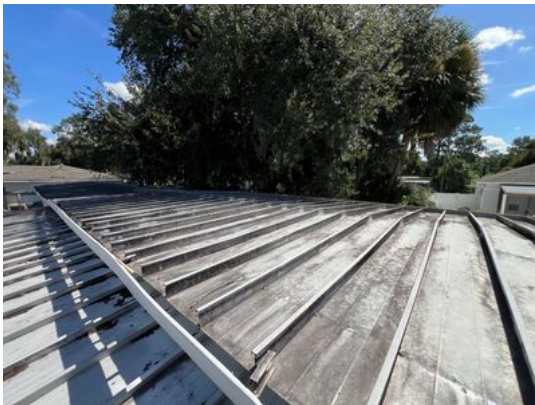
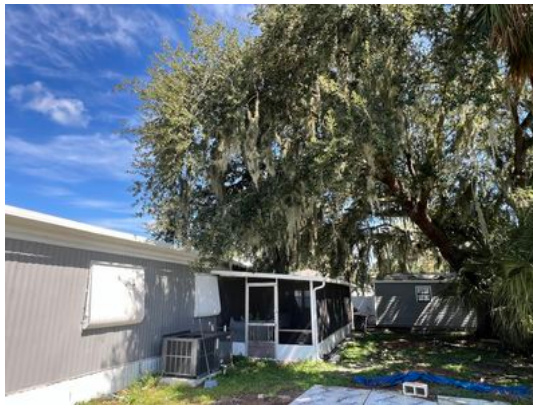
The home is situated on a property with large trees that overhang the roof and surrounding areas. While these trees add aesthetic value and shade, they also pose potential risks. Overhanging branches can cause damage to the roof, gutters, and siding, especially during storms or high winds. Additionally, falling branches may create safety hazards for residents and visitors. Regular tree maintenance, including trimming and monitoring for signs of decay or disease, is recommended to mitigate these risks and protect the home.

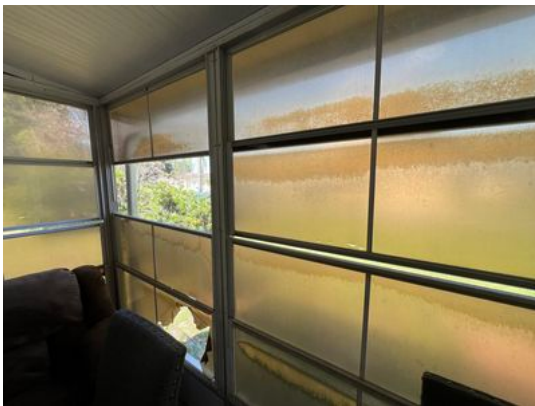
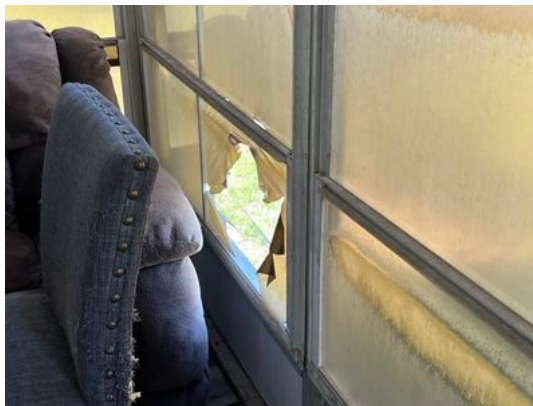
The front patio has been enclosed to create a screened room with vinyl window panels. The majority of the vinyl windows are missing, torn, or otherwise damaged, leaving the enclosure exposed to exterior weather conditions and reducing its intended protection from insects and moisture.

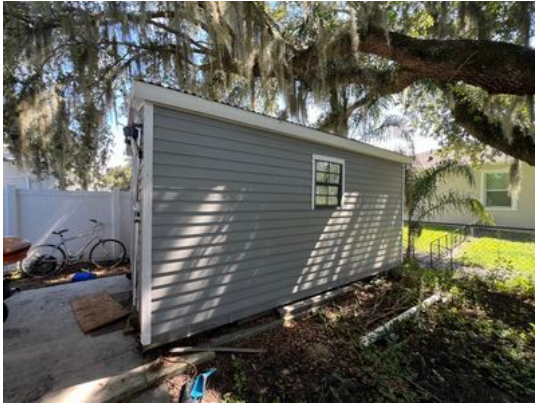
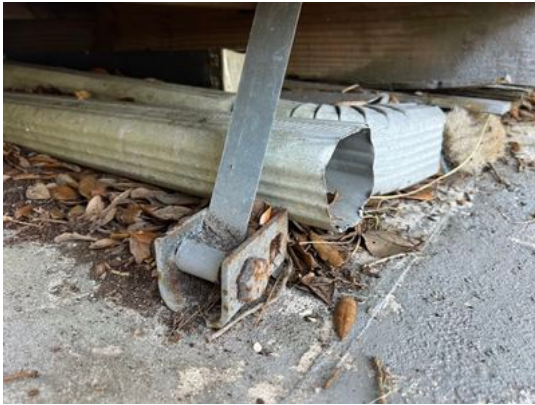
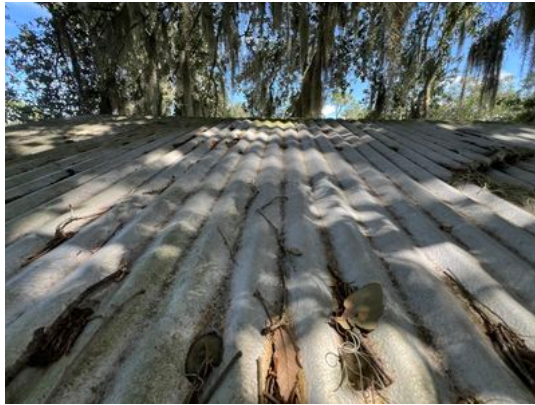
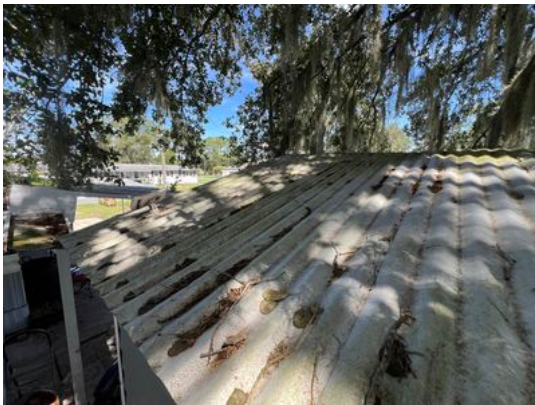
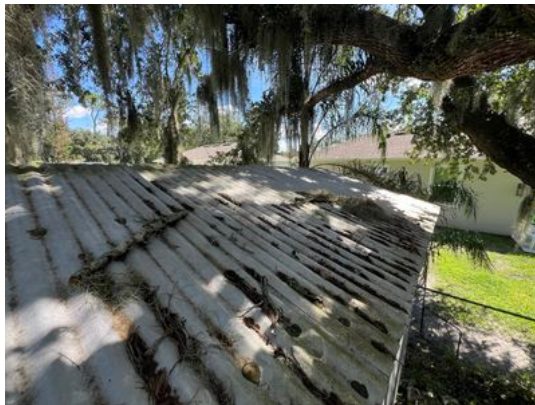
The property is equipped with a professionally installed storage shed constructed on a concrete slab. The shed appears to be properly secured and is equipped with the required hurricane anchoring/tie-down system.

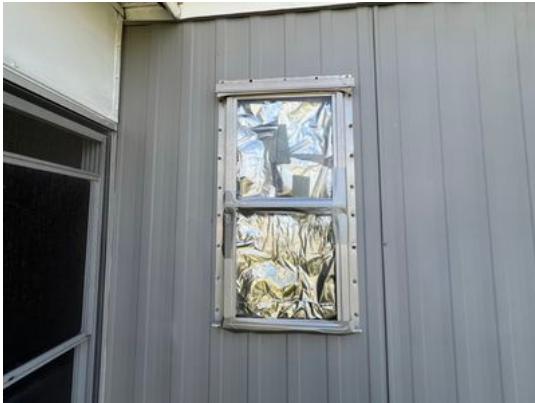
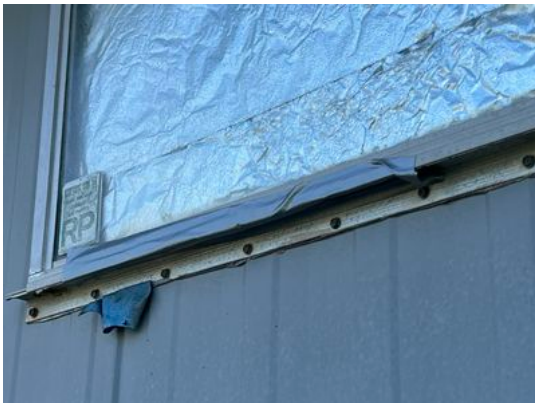
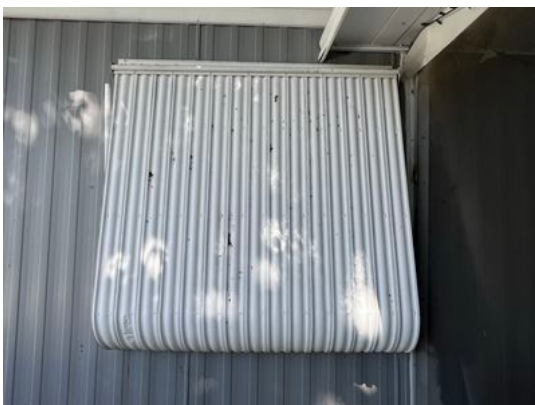
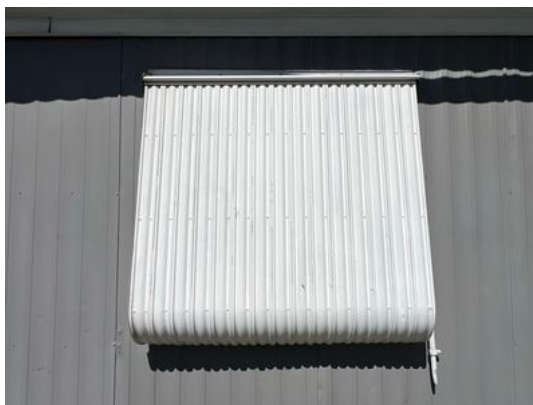
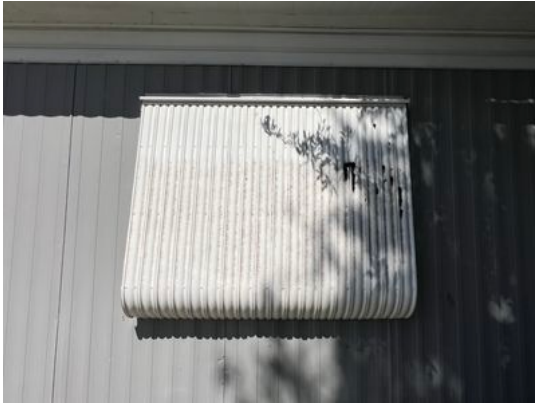
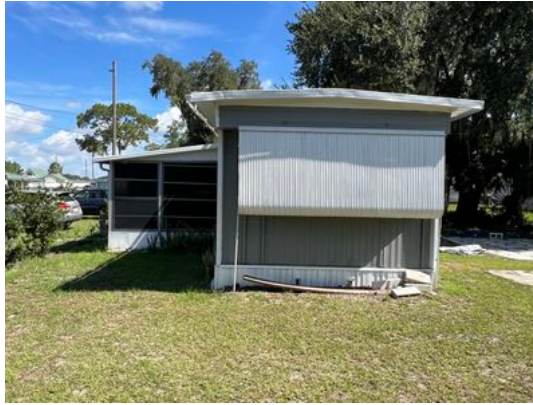
The exterior windows appear to be original to the home and are in aged condition. The majority of the windows are equipped with pull-down storm awnings. Windows without awnings have duct tape applied around portions of the frames and perimeters, apparently being used to maintain a seal. Overall, the windows exhibit age-related deterioration and evidence of makeshift sealing.

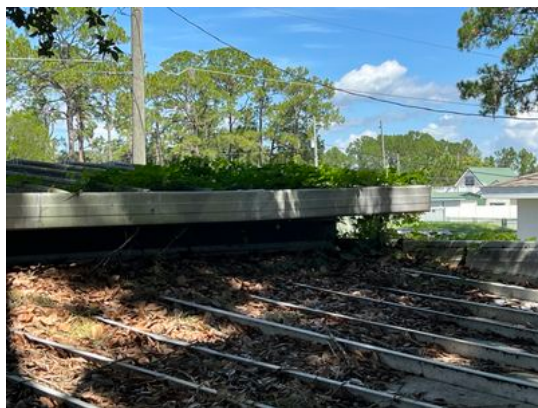
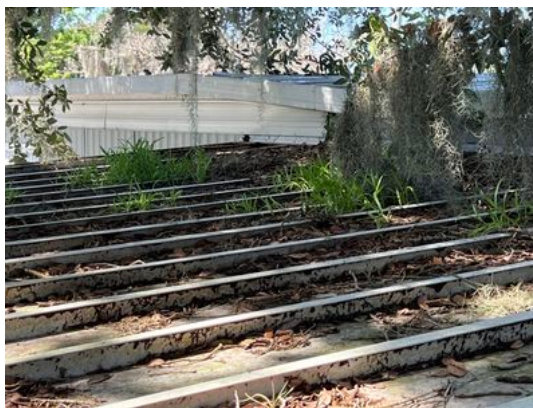
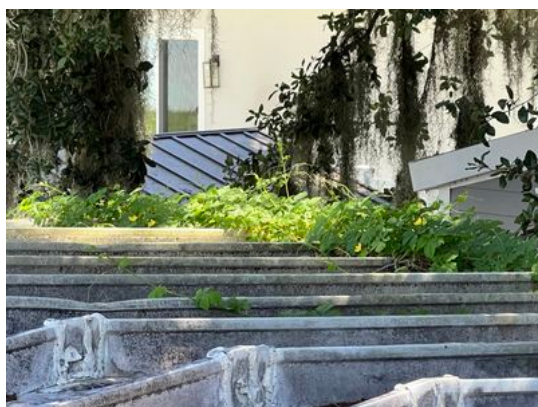
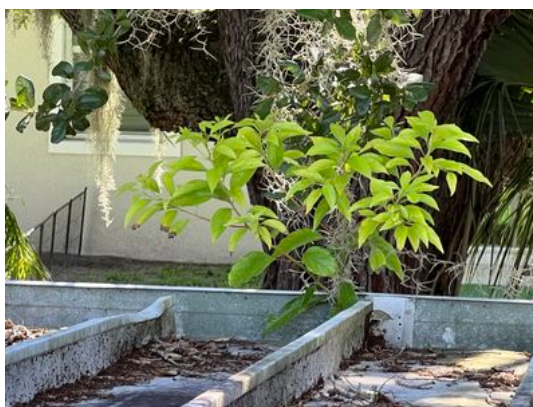
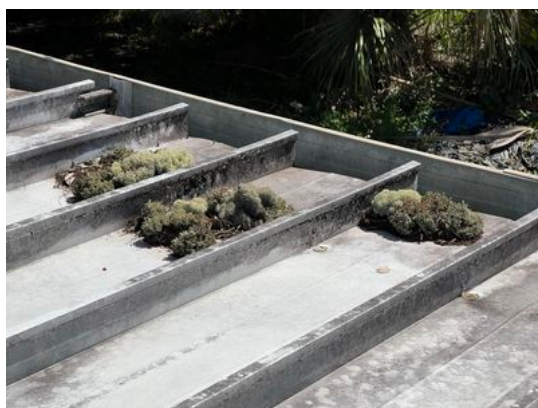
The home is equipped with a double-layer corrugated metal roofing system. The exterior roof covering appears to be original and shows significant age-related wear. Excessive organic growth is present throughout multiple areas of the roof surface, which may contribute to continued deterioration of the metal roofing material.

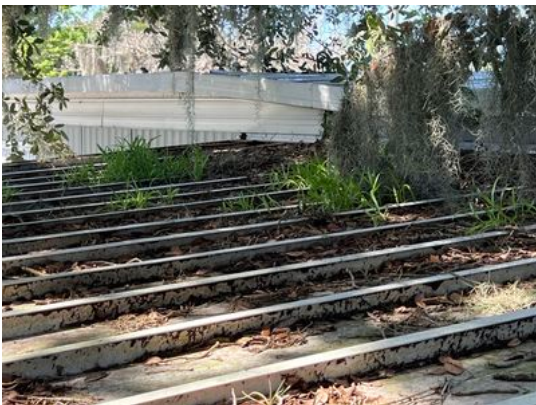
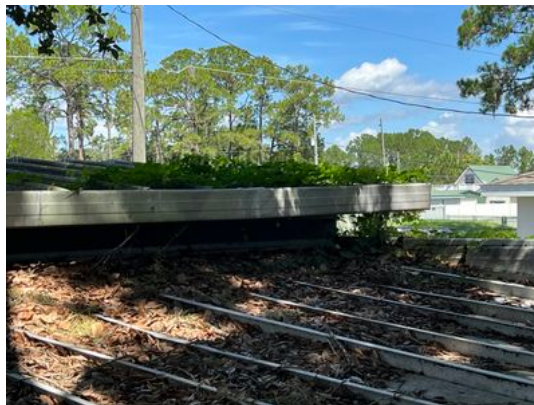
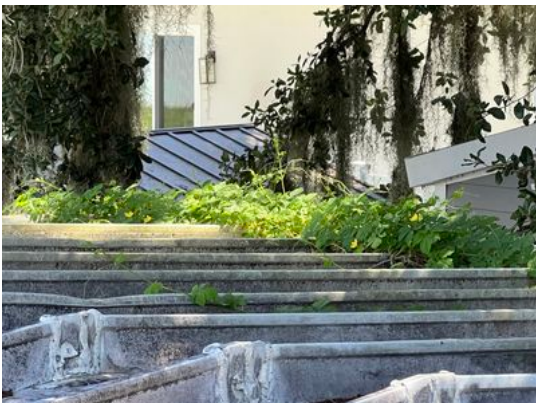
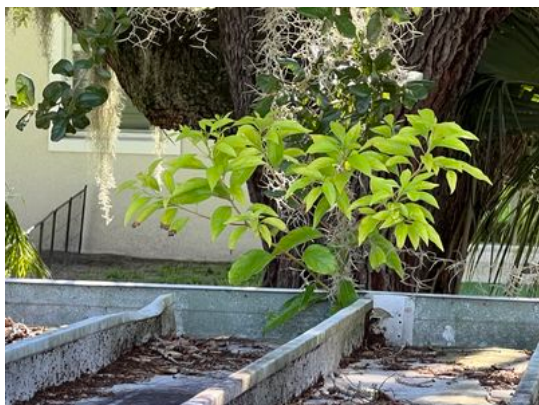
Organic growth

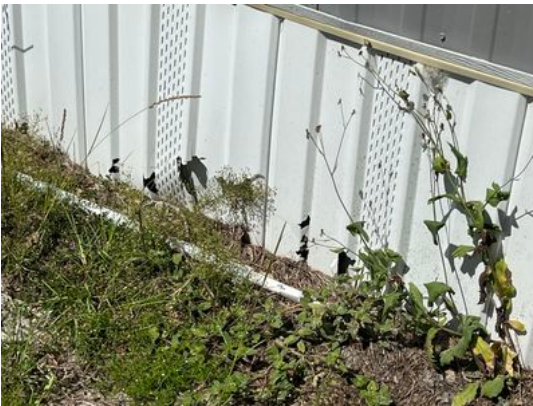
The manufactured home is equipped with perimeter skirting. Several sections of the skirting exhibit damage, including cracks, holes, and broken areas. The skirting remains in place around the perimeter of the home.

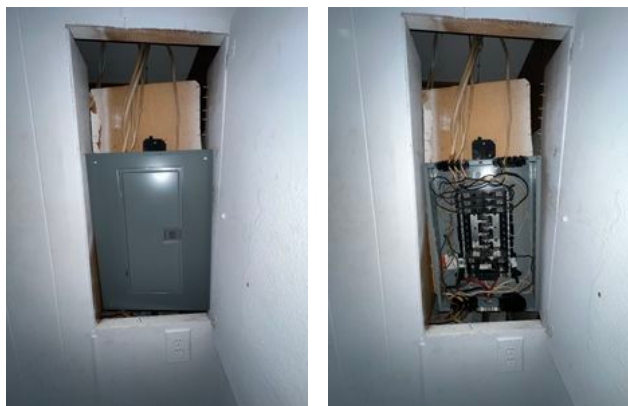
The interior electrical panel was reportedly upgraded in 2023 and is installed in the rear bedroom. The panel has been mounted to a section of particleboard that appears to have been secured to the structure with staples. The particleboard has become loose from the wall, causing the electrical panel to move and shift when touched. The panel is not securely mounted to the structure and should be properly reinstalled and secured by a qualified electrical contractor.

The electrical system is being rated unsatisfactory due to the interior electrical panel not being properly secured and installed. Once the panel is professionally reinstalled and securely mounted to the structure, the electrical system would otherwise be considered to be in satisfactory condition based on the components inspected.

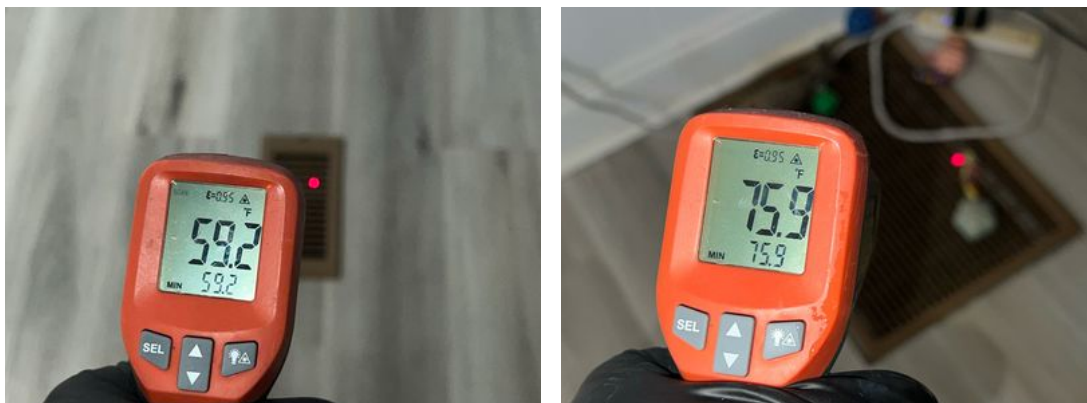
Ideally, there should be a temperature differential of around 14° to 20° Fahrenheit between the incoming air and the air being blown out by your air conditioner. This means that if the air entering the system is 75°F, the air coming out of the vent should be between 55°F and 61°F. The temp differential of this unit is 16°.

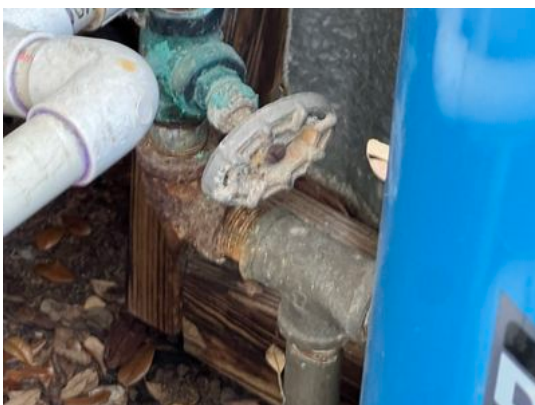
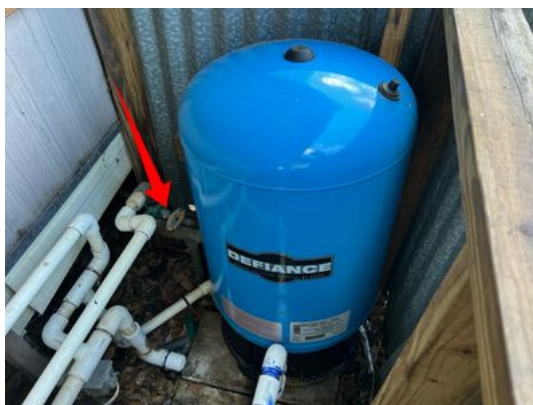
The well system plumbing and shutoff valve exhibit significant age-related corrosion and oxidation, including heavy buildup around the valve and associated fittings. The valve is substantially deteriorated and may be difficult to operate or prone to leakage. Service/replacement of the deteriorated valve and affected fittings is recommended by a qualified well/plumbing contractor.

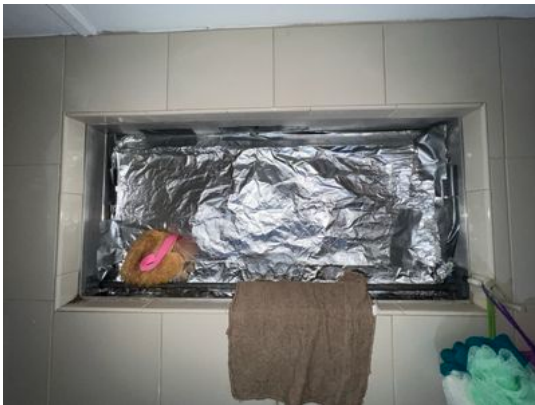
The bathroom window serves as the only means of ventilation for the bathroom. The window is currently sealed from the interior with duct tape and aluminum covering the glazing and was not operational. As a result, the bathroom does not currently have functional ventilation, which may contribute to excessive moisture and humidity within the space.

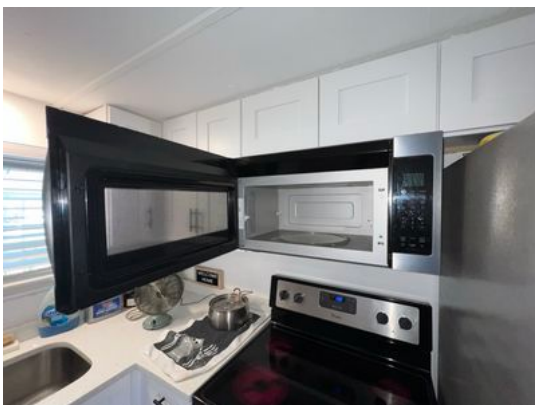
Microwave is not operational at time of inspection.

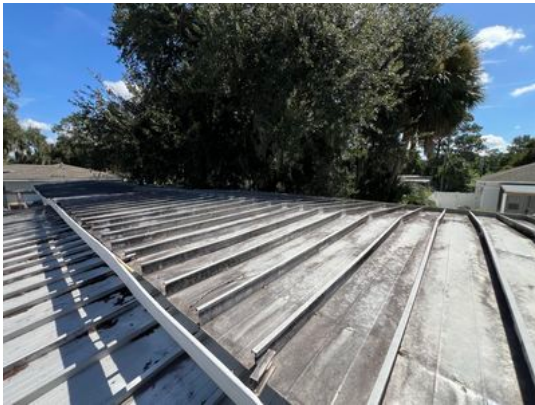
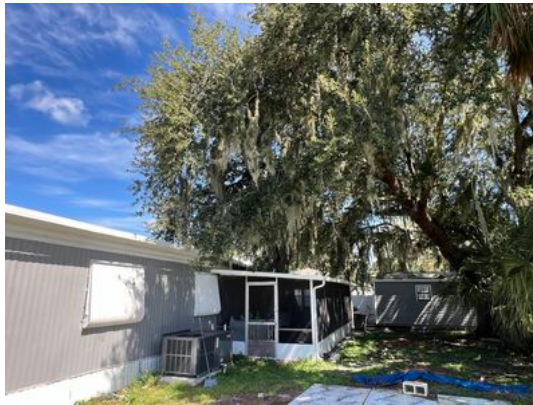
The home is situated on a property with large trees that overhang the roof and surrounding areas. While these trees add aesthetic value and shade, they also pose potential risks. Overhanging branches can cause damage to the roof, gutters, and siding, especially during storms or high winds. Additionally, falling branches may create safety hazards for residents and visitors. Regular tree maintenance, including trimming and monitoring for signs of decay or disease, is recommended to mitigate these risks and protect the home.

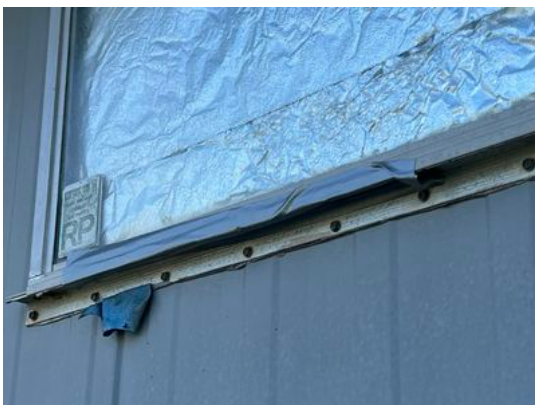
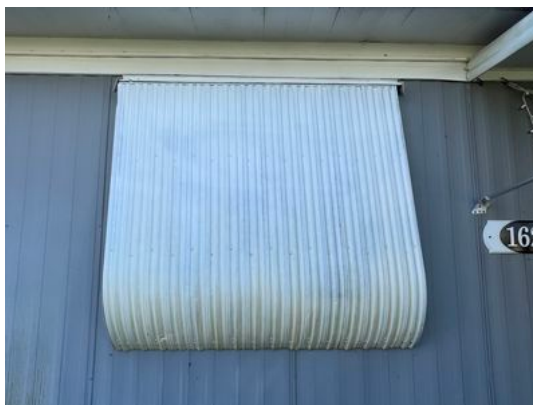
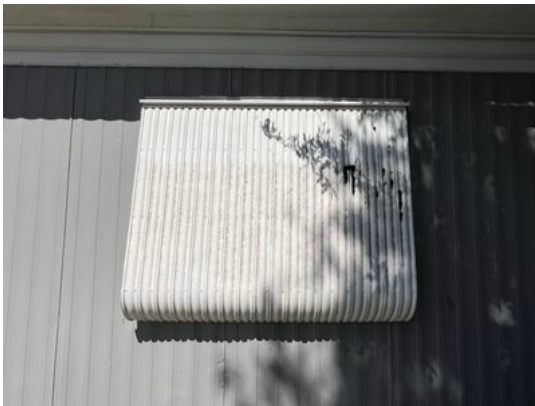
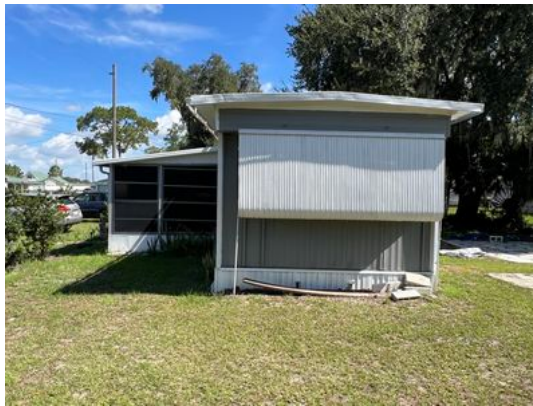
The exterior windows appear to be original to the home and are in aged condition. The majority of the windows are equipped with pull-down storm awnings. Windows without awnings have duct tape applied around portions of the frames and perimeters, apparently being used to maintain a seal. Overall, the windows exhibit age-related deterioration and evidence of makeshift sealing.

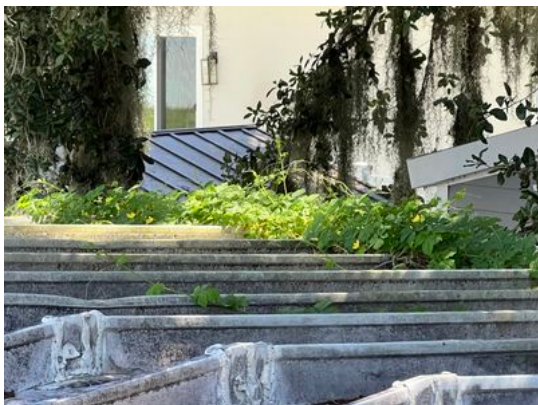
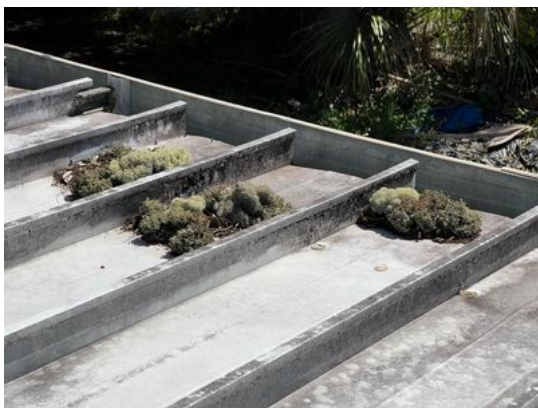
The home is equipped with a double-layer corrugated metal roofing system. The exterior roof covering appears to be original and shows significant age-related wear. Excessive organic growth is present throughout multiple areas of the roof surface, which may contribute to continued deterioration of the metal roofing material.

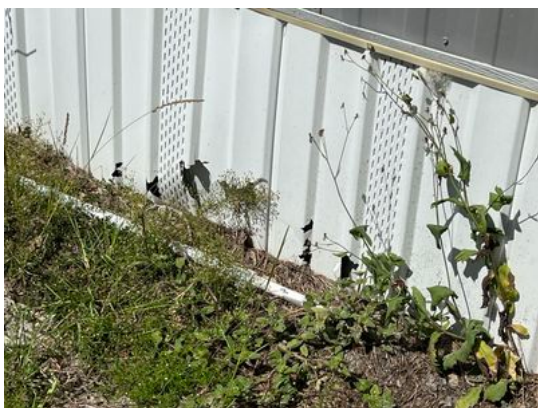
The manufactured home is equipped with perimeter skirting. Several sections of the skirting exhibit damage, including cracks, holes, and broken areas. The skirting remains in place around the perimeter of the home.

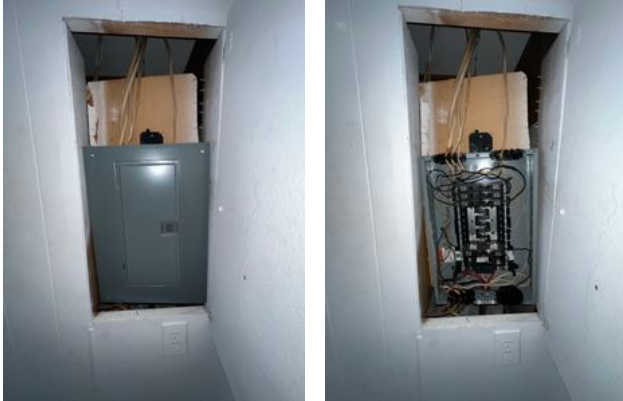
The interior electrical panel was reportedly upgraded in 2023 and is installed in the rear bedroom. The panel has been mounted to a section of particleboard that appears to have been secured to the structure with staples. The particleboard has become loose from the wall, causing the electrical panel to move and shift when touched. The panel is not securely mounted to the structure and should be properly reinstalled and secured by a qualified electrical contractor.

The electrical system is being rated unsatisfactory due to the interior electrical panel not being properly secured and installed. Once the panel is professionally reinstalled and securely mounted to the structure, the electrical system would otherwise be considered to be in satisfactory condition based on the components inspected.

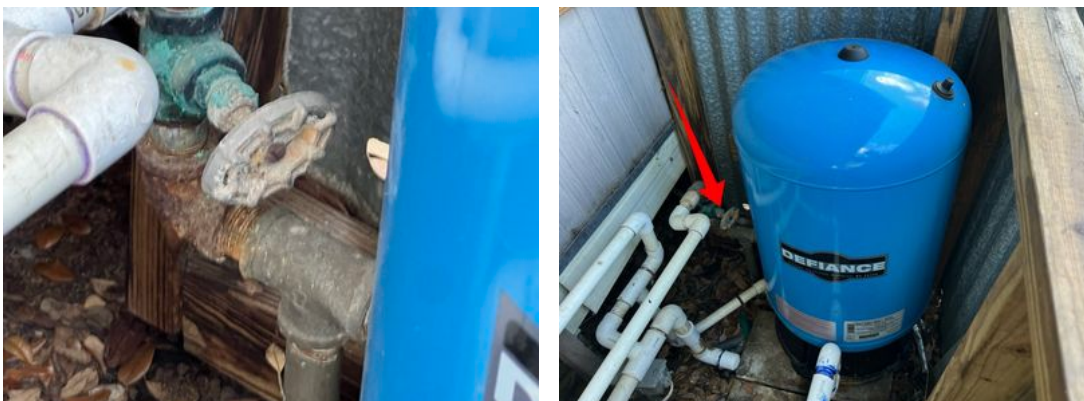
The well system plumbing and shutoff valve exhibit significant age-related corrosion and oxidation, including heavy buildup around the valve and associated fittings. The valve is substantially deteriorated and may be difficult to operate or prone to leakage. Service/replacement of the deteriorated valve and affected fittings is recommended by a qualified well/plumbing contractor.
