## Home Inspection Report

4863 Foxwood Boulevard  
Lakeland, FL 33810

Inspected By: Hector Vargas, Lic. HI12079

Prepared For: Easy Sell FL TC  
Inspected On Tue, Aug 18, 2026 at 1:00 PM

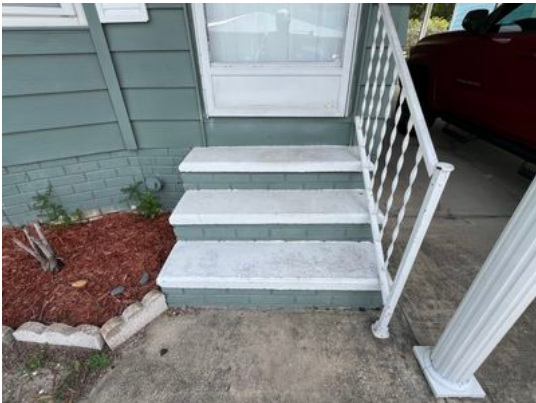
The exterior entry steps are covered with outdoor carpet/artificial turf, which shows visible wear and deterioration, particularly along the leading edges of the steps. The edge trim is worn and deteriorated in areas, creating an uneven walking surface and a potential trip hazard. Repair or replacement of the deteriorated covering and trim is recommended.

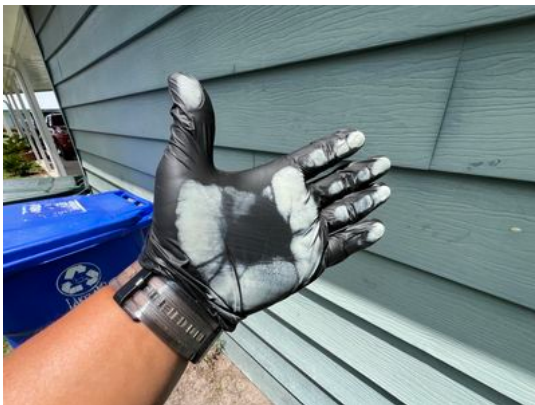
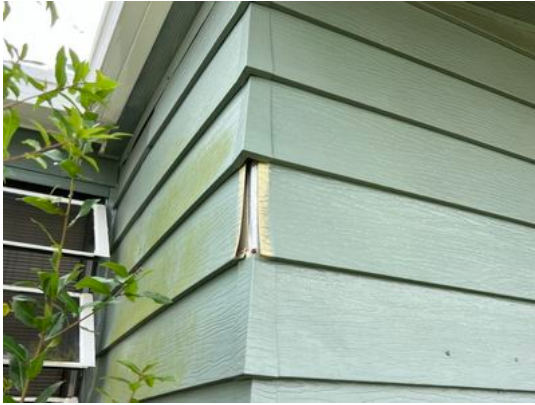
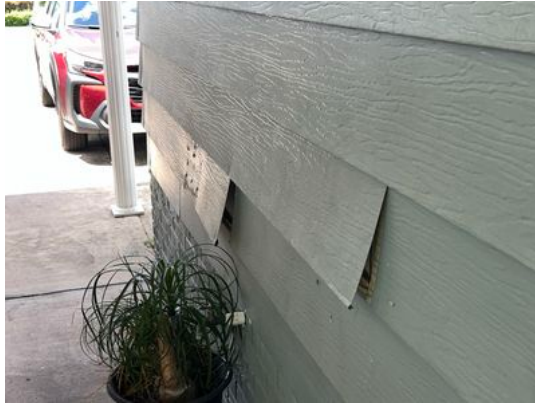
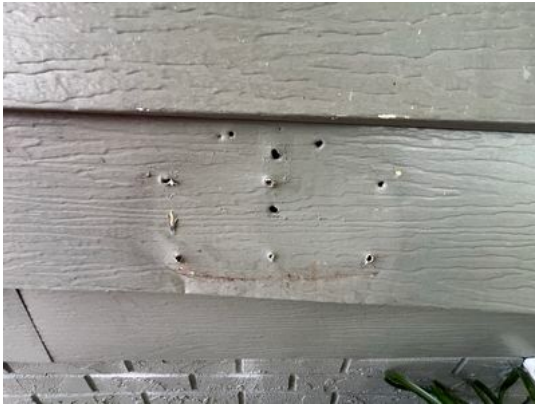
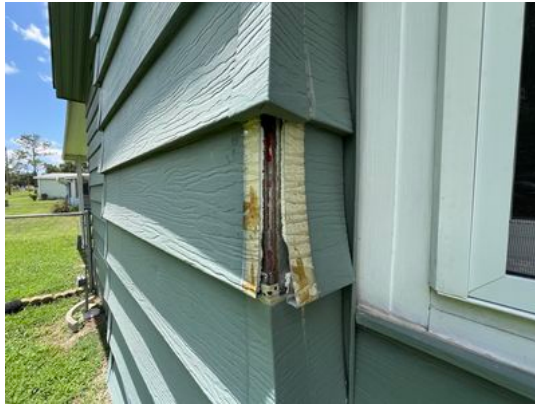
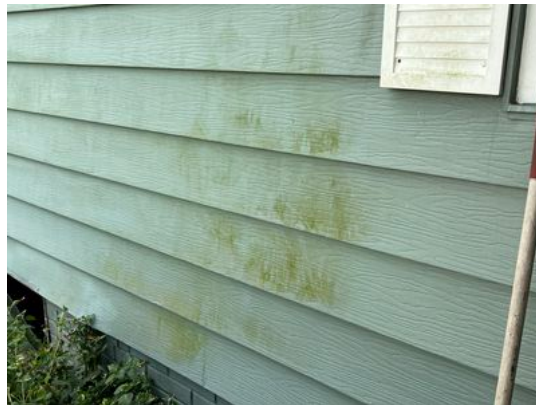
The exterior is clad with lap siding, and multiple deficiencies are present throughout. Areas of the siding show organic growth/staining, peeling and damaged paint, numerous holes from previous attachments, loose or displaced siding sections, and damaged/missing corner trim pieces with exposed underlying materials. Several locations have open gaps that can allow moisture intrusion behind the siding. The siding also shows chalking/paint transfer when touched, indicating deterioration of the exterior coating. Repair of damaged and loose siding, replacement of missing or deteriorated trim, sealing of openings, cleaning of organic growth, and preparation/repainting of affected areas is recommended.

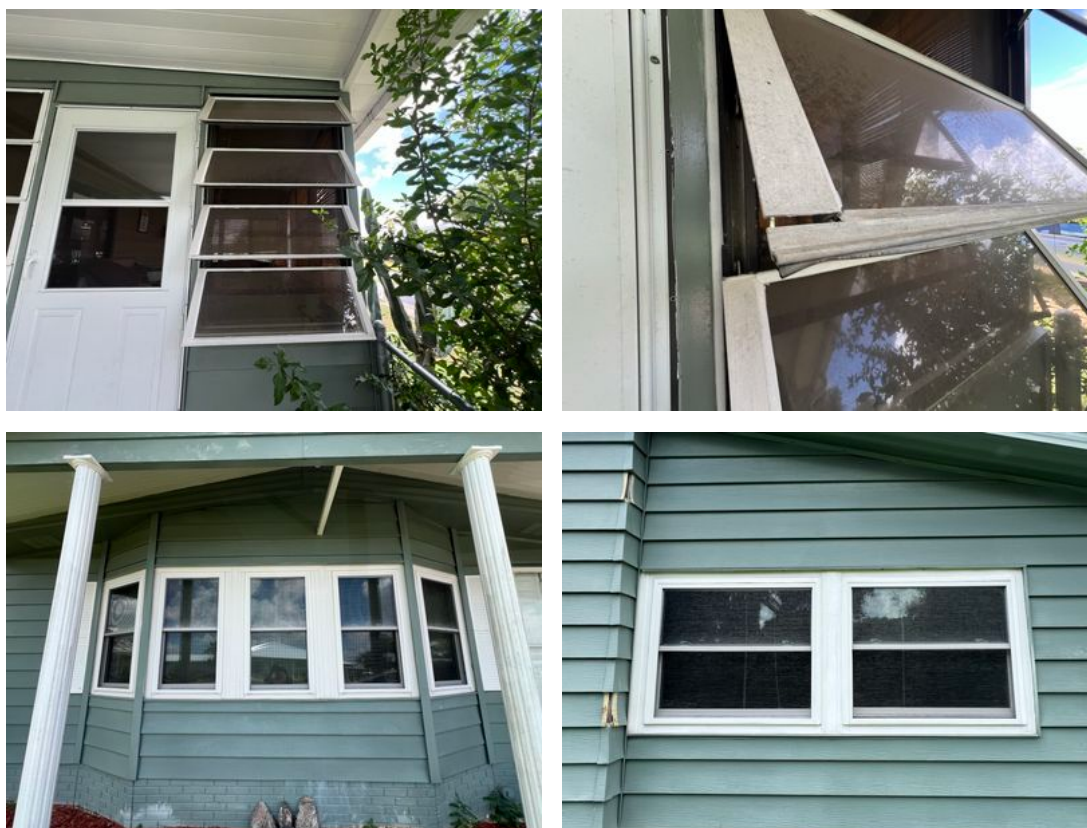
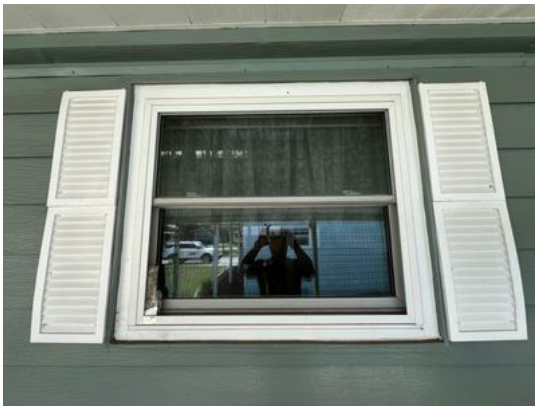
The majority of the exterior windows have been upgraded to newer double-pane, double-hung windows. However, jalousie-style windows original to the 1985 home remain in the patio area and bathroom. These original windows are approximately 41 years old and show greater age and wear compared with the upgraded windows.

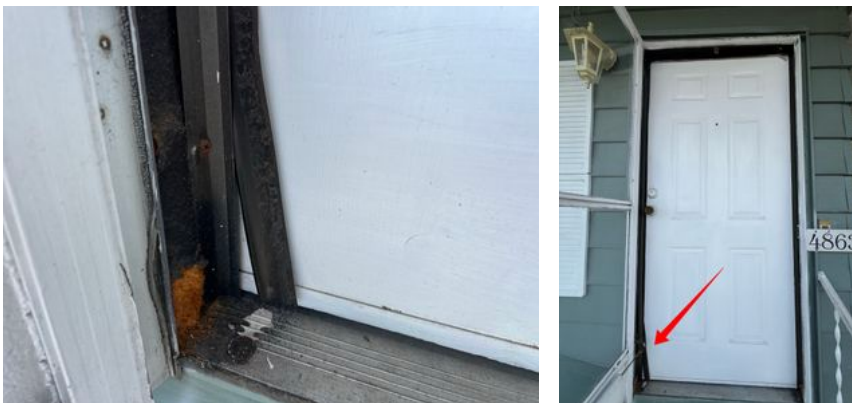
The front entry door has damaged and deteriorated weatherstripping/insulation at the lower corner of the door frame. The material is torn and partially detached, which may allow air, moisture, and pest intrusion. Repair or replacement is recommended.

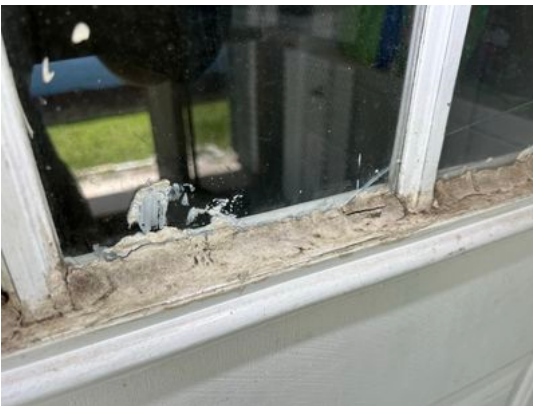
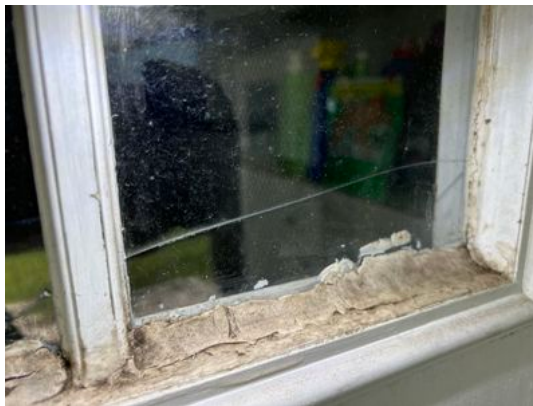
The side entrance door to the laundry room has multiple cracked glass panes, and the glazing compound/sealant around the lower panes is severely deteriorated, cracked, and separating. Repair or replacement of the damaged glass and deteriorated glazing is recommended.

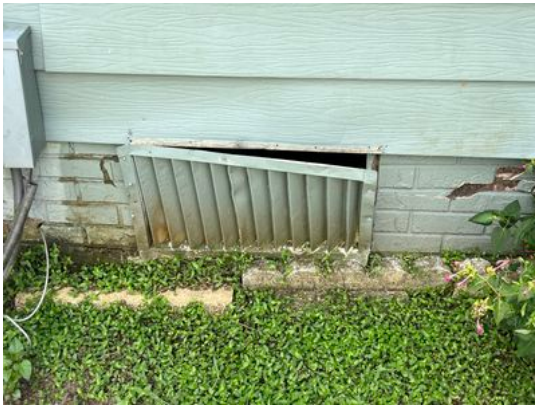
The crawlspace/foundation vent is damaged and partially detached from the wall opening, leaving an exposed gap. Repair or replacement is recommended to properly secure the opening and help prevent pest and moisture intrusion.

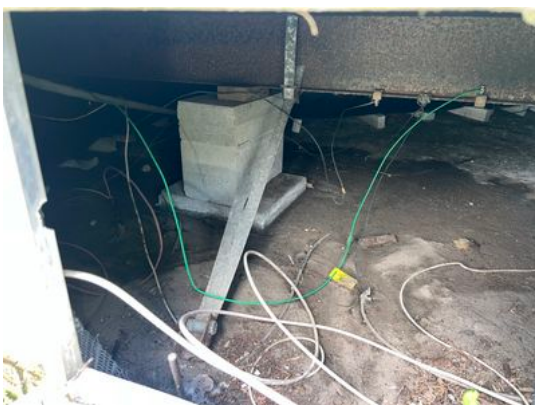
One of the manufactured home metal tie-down/hurricane straps is visibly loose and not properly tensioned, with the strap leaning away from its intended position. The anchoring/tie-down system should be evaluated and corrected as needed to ensure the home is properly secured.

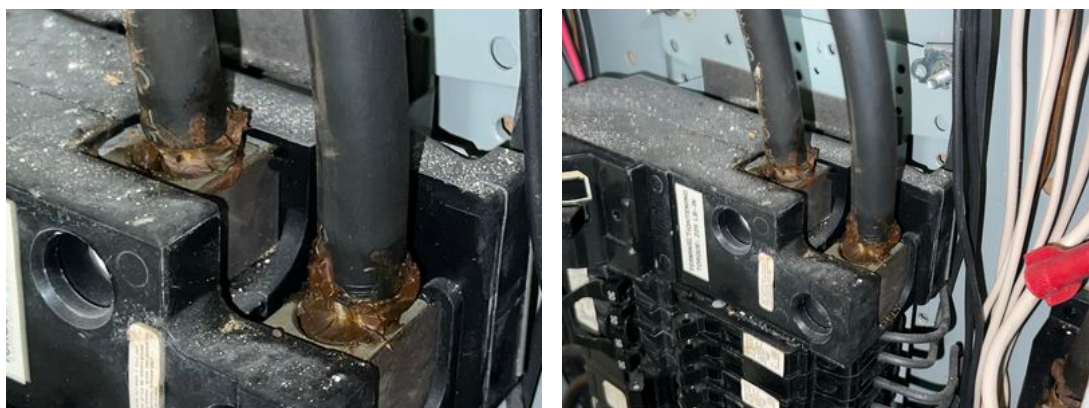
The service-entrance conductors at the main breaker exhibit deteriorated and heat-damaged insulation at the terminal connections, with significant discoloration and deformation visible around the conductor ends. This condition may be associated with overheating or a compromised electrical connection. Evaluation and repair by a licensed electrician is recommended.

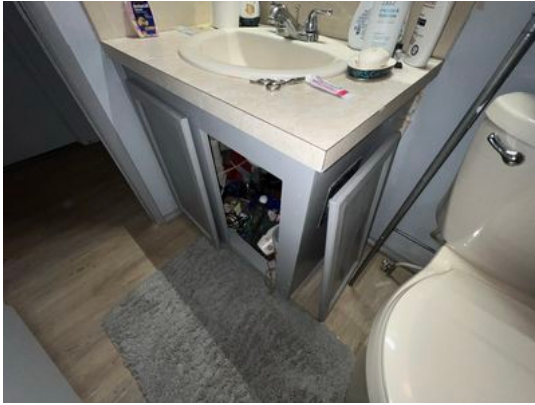
The bathroom vanity cabinet is damaged and deteriorated, with the cabinet doors loose.

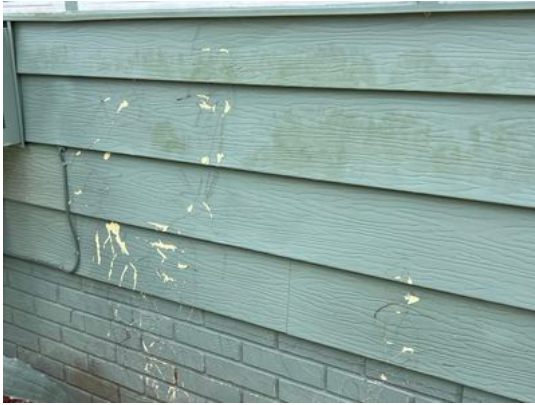
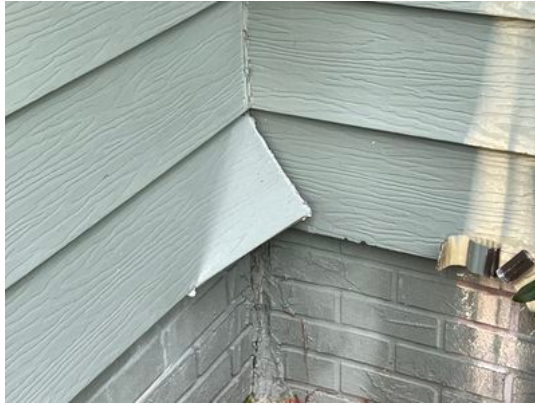
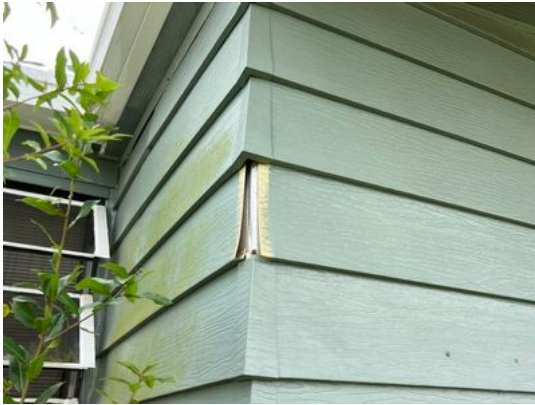
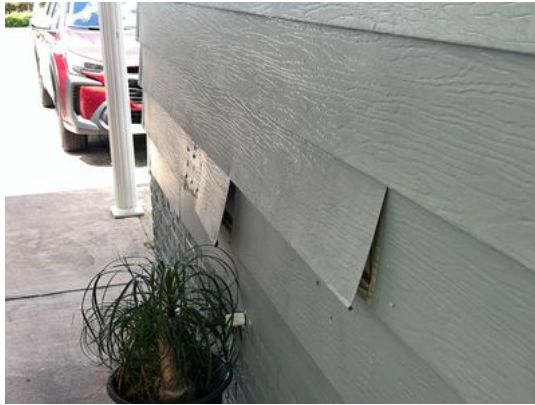
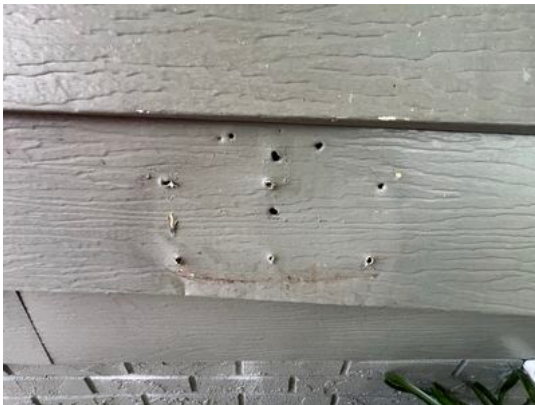
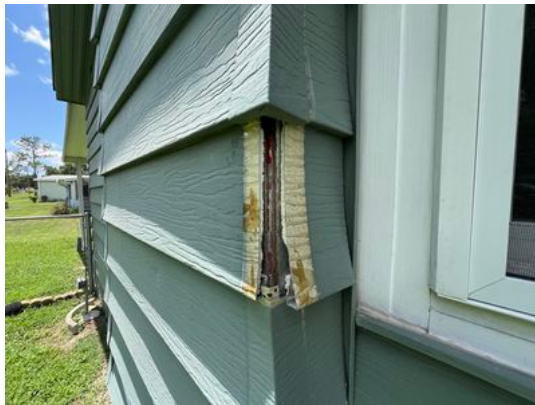
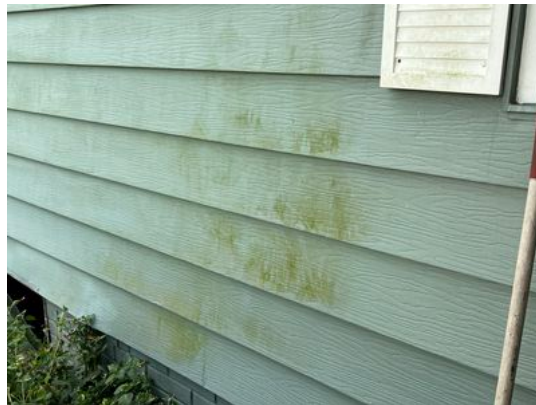
The exterior is clad with lap siding, and multiple deficiencies are present throughout. Areas of the siding show organic growth/staining, peeling and damaged paint, numerous holes from previous attachments, loose or displaced siding sections, and damaged/missing corner trim pieces with exposed underlying materials. Several locations have open gaps that can allow moisture intrusion behind the siding. The siding also shows chalking/paint transfer when touched, indicating deterioration of the exterior coating. Repair of damaged and loose siding, replacement of missing or deteriorated trim, sealing of openings, cleaning of organic growth, and preparation/repainting of affected areas is recommended.

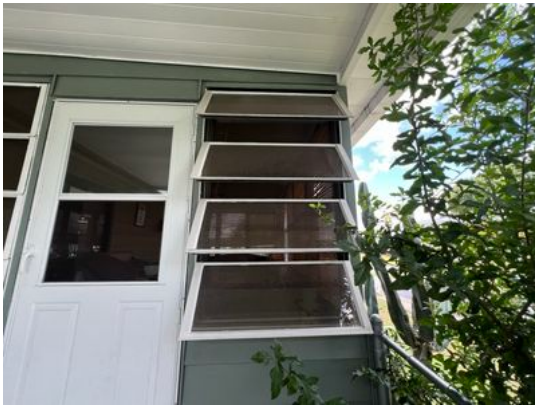
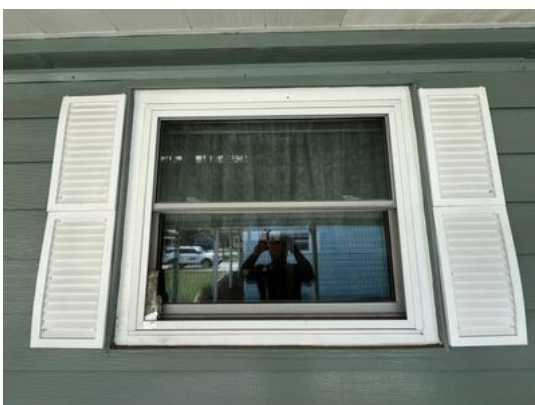
The majority of the exterior windows have been upgraded to newer double-pane, double-hung windows. However, jalousie-style windows original to the 1985 home remain in the patio area and bathroom. These original windows are approximately 41 years old and show greater age and wear compared with the upgraded windows.

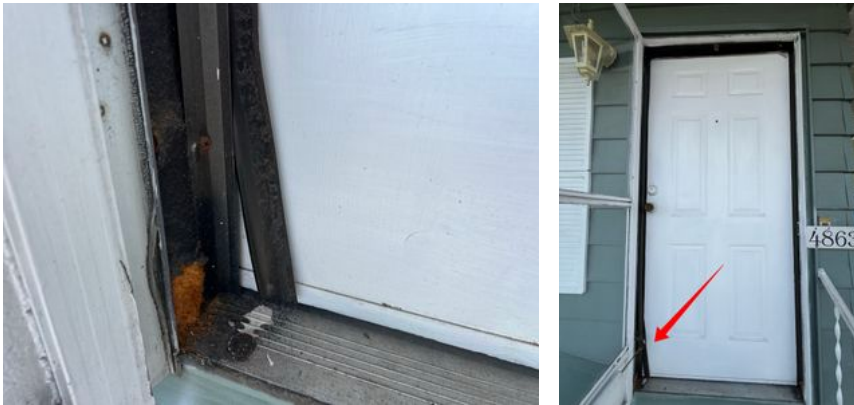
The front entry door has damaged and deteriorated weatherstripping/insulation at the lower corner of the door frame. The material is torn and partially detached, which may allow air, moisture, and pest intrusion. Repair or replacement is recommended.

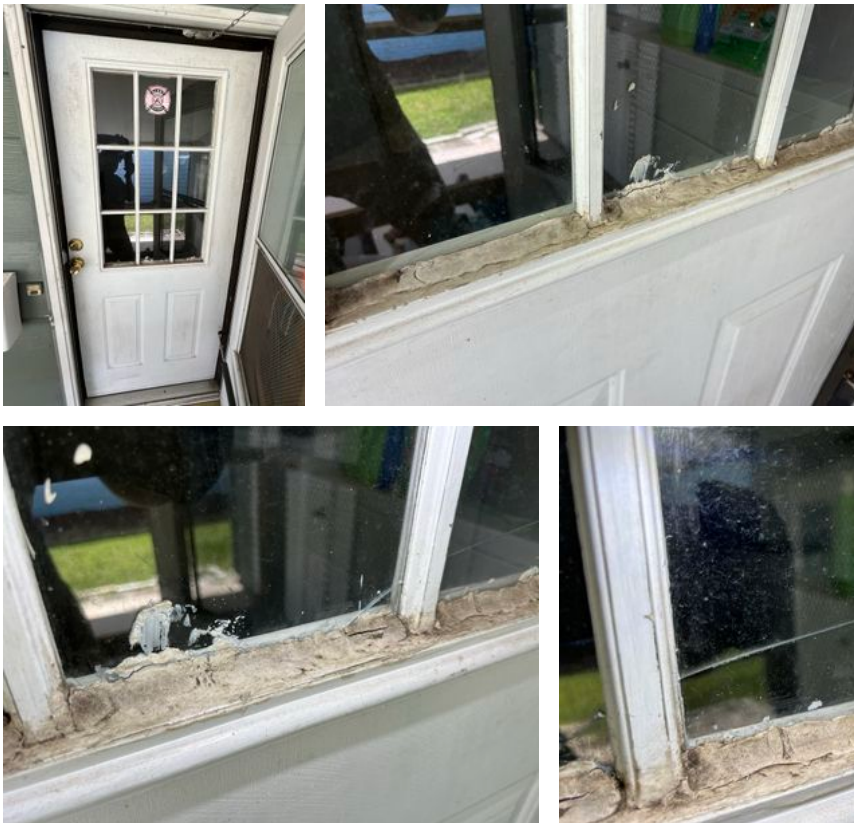
The side entrance door to the laundry room has multiple cracked glass panes, and the glazing compound/sealant around the lower panes is severely deteriorated, cracked, and separating. Repair or replacement of the damaged glass and deteriorated glazing is recommended.

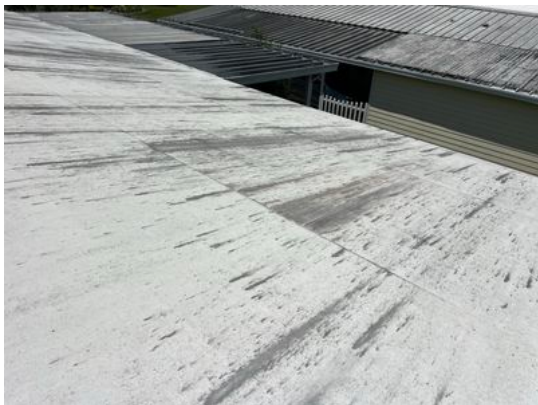
The roof is covered with a TPO membrane roofing system. The membrane shows widespread surface discoloration, staining, and visible wear/scuffing in multiple areas. No significant open seams or large tears were visible in the areas inspected.

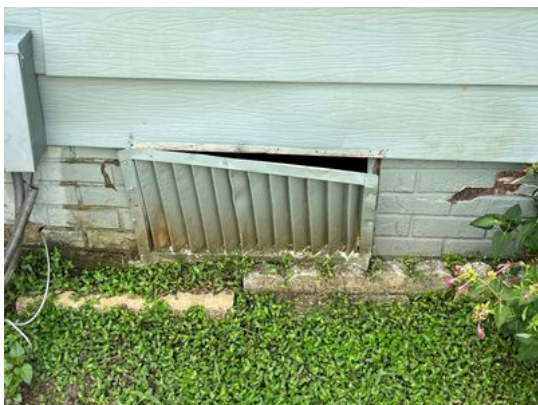
The crawlspace/foundation vent is damaged and partially detached from the wall opening, leaving an exposed gap. Repair or replacement is recommended to properly secure the opening and help prevent pest and moisture intrusion.

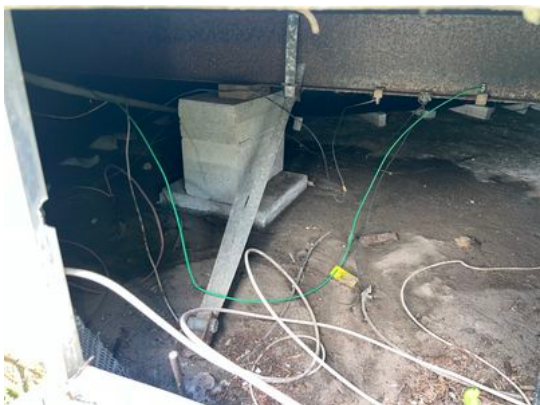
One of the manufactured home metal tie-down/hurricane straps is visibly loose and not properly tensioned, with the strap leaning away from its intended position. The anchoring/tie-down system should be evaluated and corrected as needed to ensure the home is properly secured.

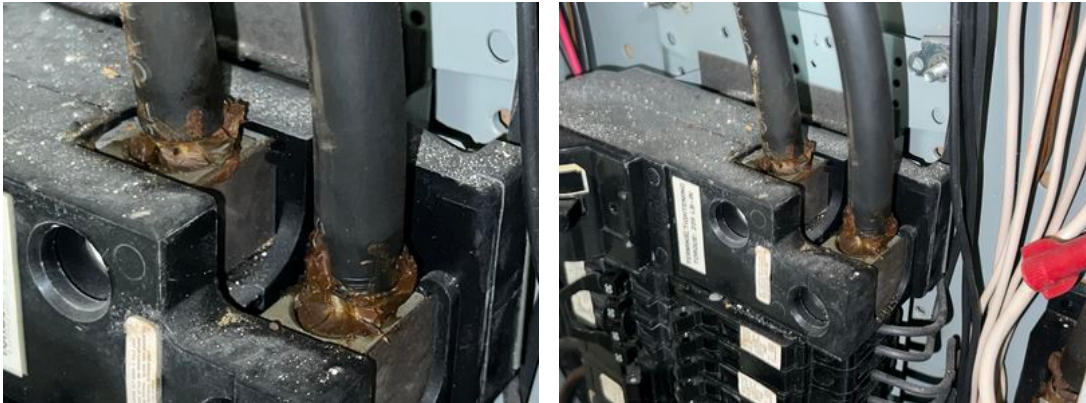
The service-entrance conductors at the main breaker exhibit deteriorated and heat-damaged insulation at the terminal connections, with significant discoloration and deformation visible around the conductor ends. This condition may be associated with overheating or a compromised electrical connection. Evaluation and repair by a licensed electrician is recommended.

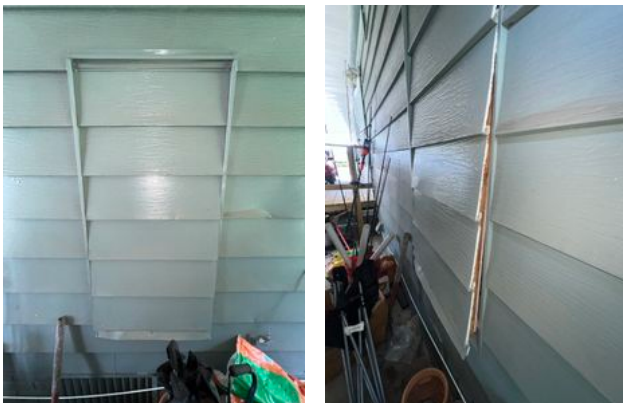
The exterior access panel for the water heater is loose and partially detached from the wall, leaving the opening exposed along the side. The panel should be properly secured and repaired to protect the water heater compartment from moisture and pest intrusion.

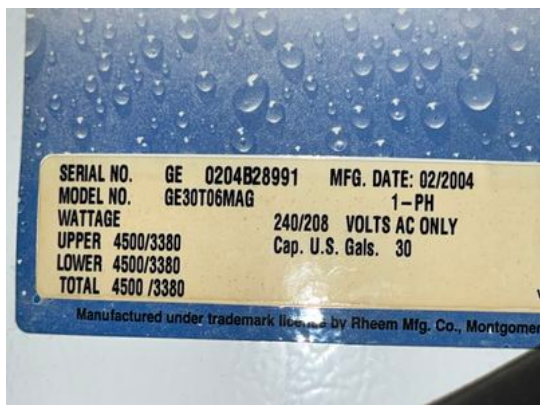
The home is equipped with a 22-year-old water heater, which has reached the upper limit of its typical life expectancy of 10 to 15 years. While it was functional at the time of inspection, water heaters of this age are more prone to failure, including

leaks or inefficiency. Additionally, many insurance companies are reluctant to provide coverage for homes with water heaters older than 15 years due to the increased risk of water damage. We recommend replacing the unit to reduce the risk of failure and to comply with potential insurance requirements.

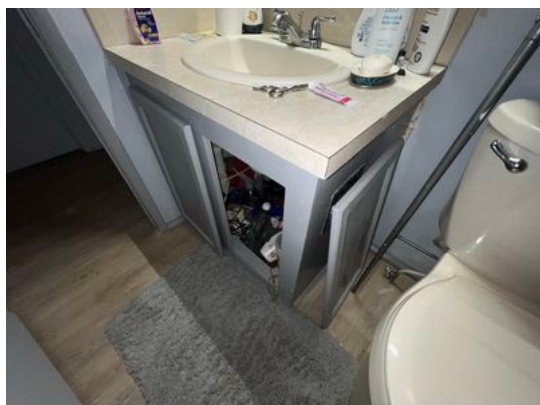
The bathroom vanity cabinet is damaged and deteriorated, with the cabinet doors loose.
