## Home Inspection Report

10081 SW 100th Avenue  
Ocala, FL 34481

Inspected By: Hector Vargas, Lic. HI12079

Inspected On Fri, Jul 17, 2026 at 11:30 AM

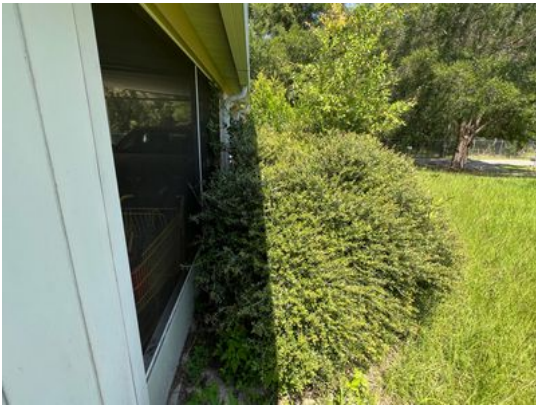
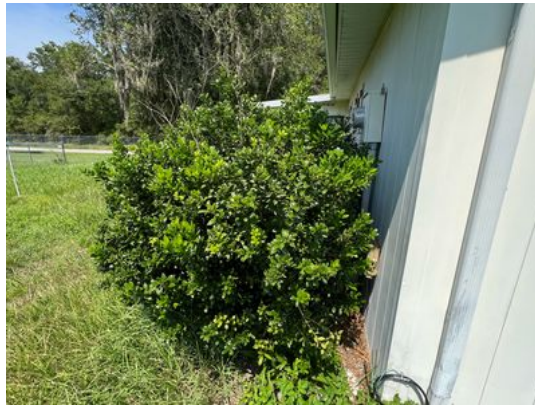
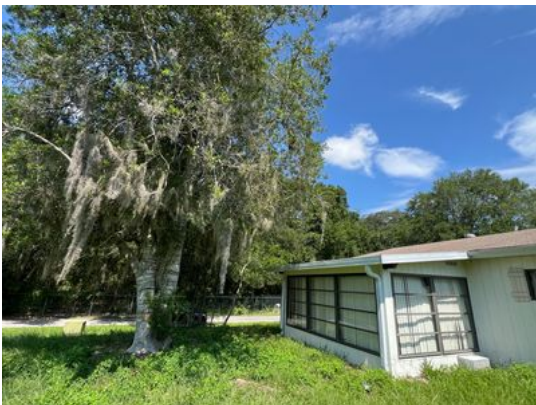
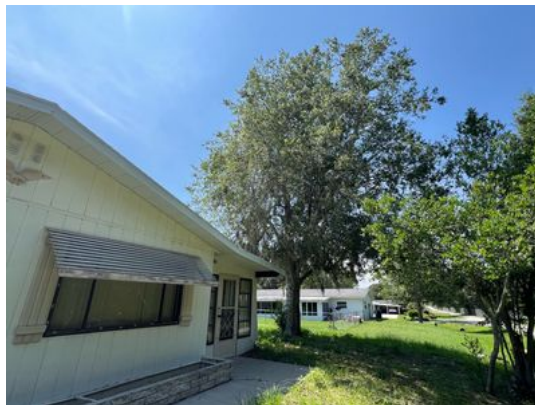
The home is situated on a property with large trees that overhang the roof and surrounding areas. While these trees add aesthetic value and shade, they also pose potential risks. Overhanging branches can cause damage to the roof, gutters, and siding, especially during storms or high winds. Additionally, falling branches may create safety hazards for residents and visitors. Regular tree maintenance, including trimming and monitoring for signs of decay or disease, is recommended to mitigate these risks and protect the home.

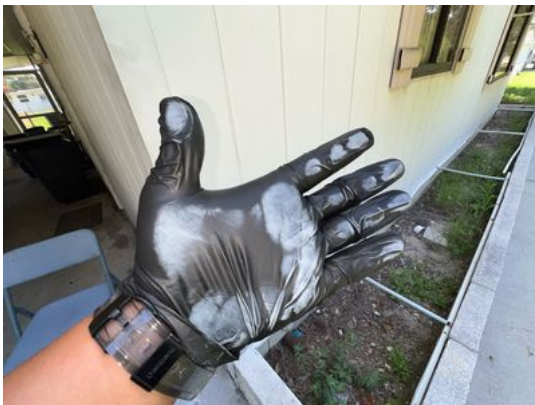
Exterior paint has a chalky look and feel. Recommend exterior be sealed and painted.

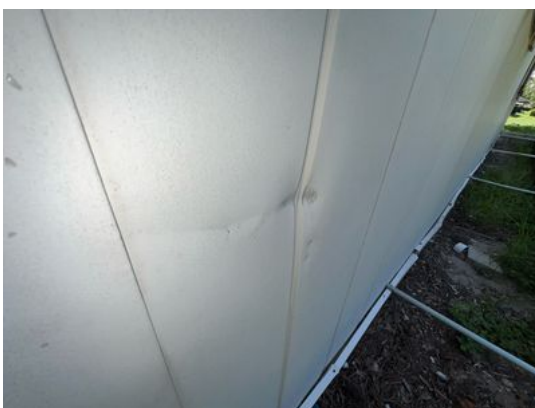
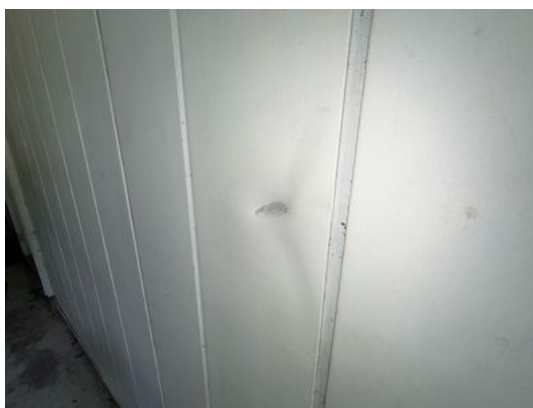
The vinyl siding exhibits multiple dings and areas of impact damage at various locations around the exterior of the home. The damage is cosmetic in nature and was observed throughout the siding. Repair or replacement of the affected siding sections may be needed as desired to restore the exterior finish.

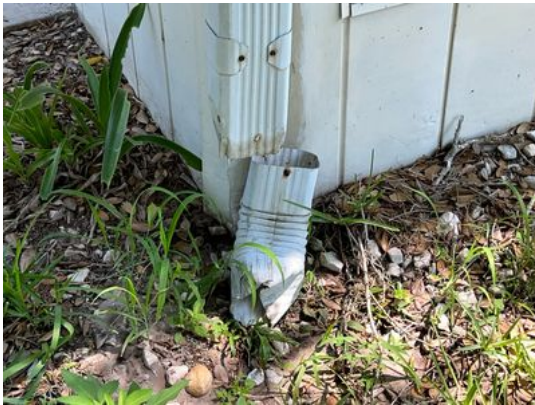
The metal gutter downspouts exhibit damage at multiple locations. Repair or replacement of the damaged downspouts is recommended to help ensure proper drainage.

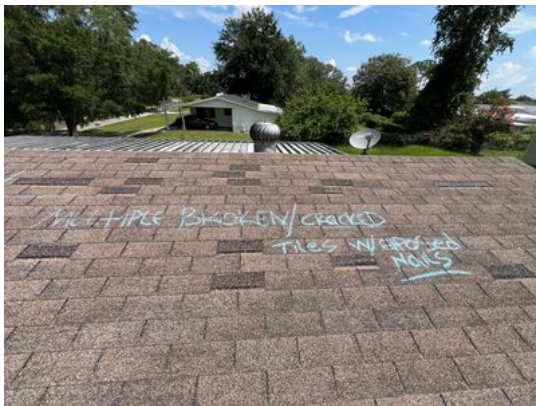
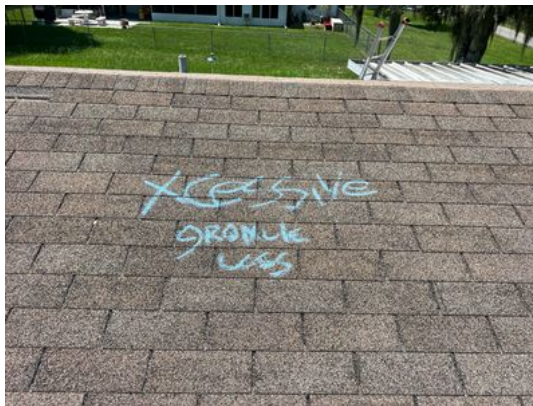
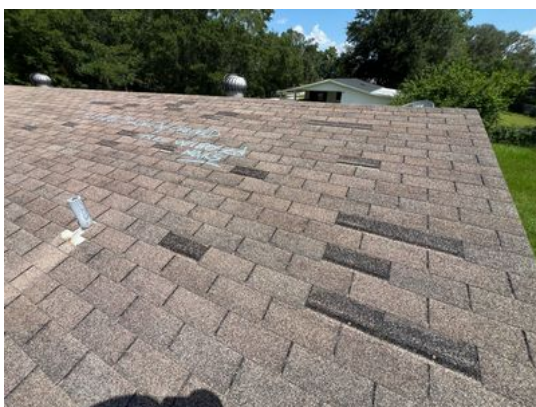
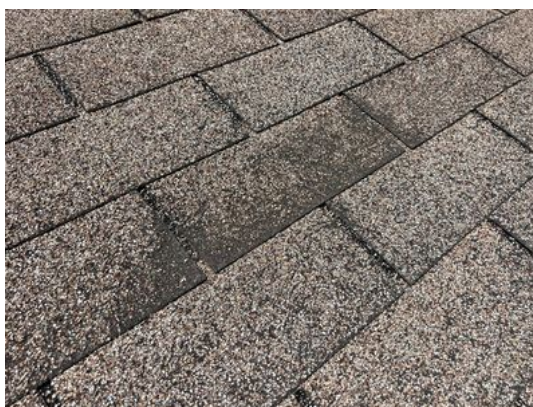
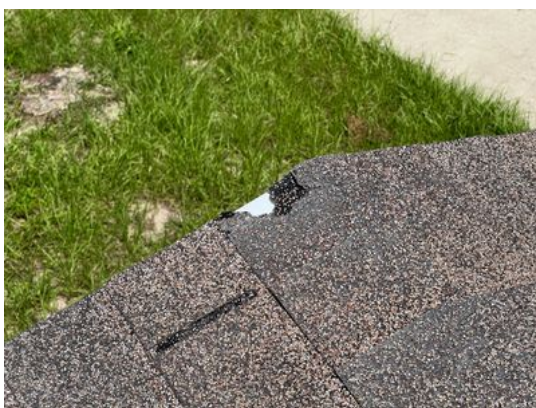
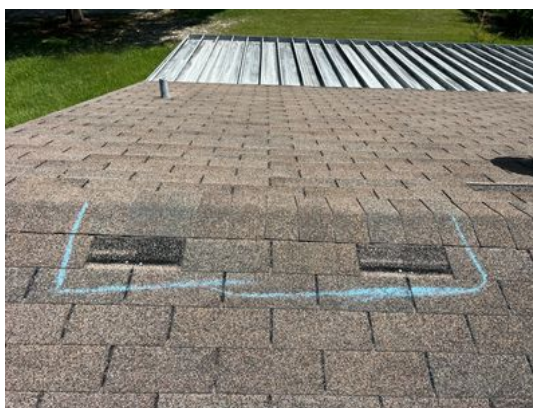
The roof covering exhibits excessive granule loss throughout, along with more than 20 cracked, broken, or missing roof tiles. Numerous exposed fasteners were also observed. These conditions increase the potential for water intrusion and indicate the roof covering is at or near the end of its serviceable life. Replacement of the roof covering is recommended.

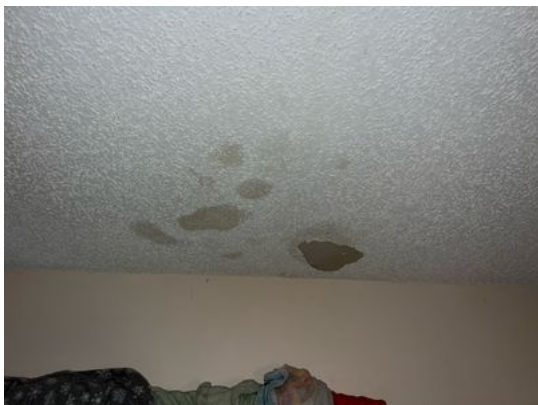
The primary bedroom ceiling exhibits multiple moisture stains and an area of peeling and missing textured ceiling finish, consistent with moisture-related damage. The source of the moisture should be identified and corrected, and the damaged ceiling materials repaired as needed.

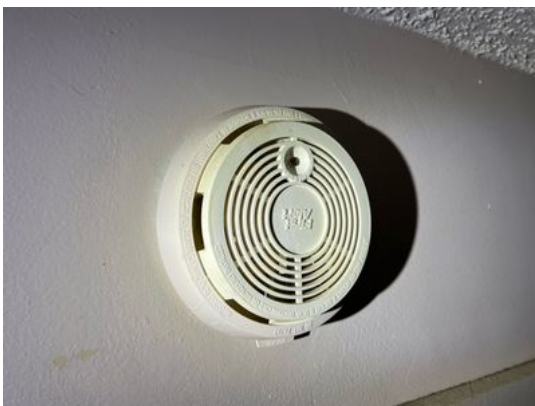
Smoke detectors And alarms should be replaced every 10 years. Recommend replacement prior to occupancy.

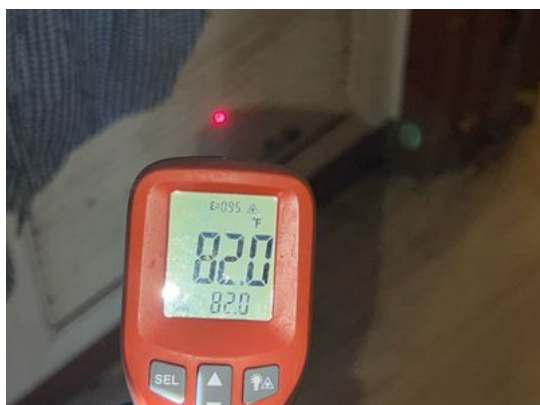
Ideally, there should be a temperature differential of around 14° to 20° Fahrenheit between the incoming air and the air being blown out by your air conditioner. This means that if the air entering the system is 75°F, the air coming out of the vent should be between 55°F and 61°F. The temp differential of this unit is 13°.

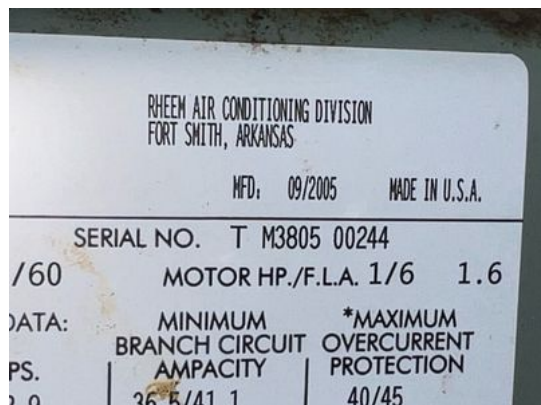
The HVAC system is original to the home and was manufactured in 2005, making it approximately 21 years old at the time of inspection. Typical service life for residential HVAC systems in Florida is approximately 12–15 years, depending on

usage, maintenance history, and environmental conditions. While the system was operating at the time of inspection, it is past its expected service life. As with any aging mechanical system, the likelihood of repair or replacement increases as the unit continues to age.

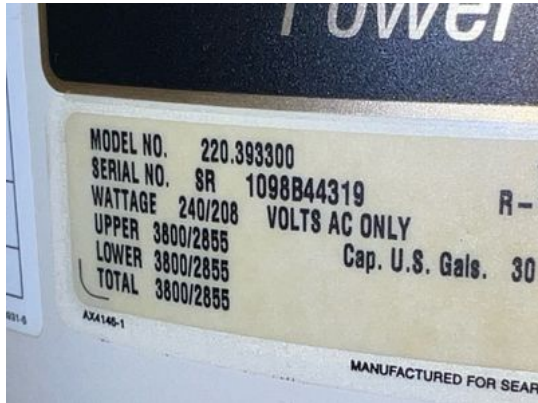
The home is equipped with a 28-year-old water heater, which is passed the upper limit of its typical life expectancy of 10 to 15 years. While it was functional at the time of inspection, water heaters of this age are more prone to failure, including

leaks or inefficiency. Additionally, many insurance companies are reluctant to provide coverage for homes with water heaters older than 15 years due to the increased risk of water damage. We recommend replacing the unit to reduce the risk of failure and to comply with potential insurance requirements.

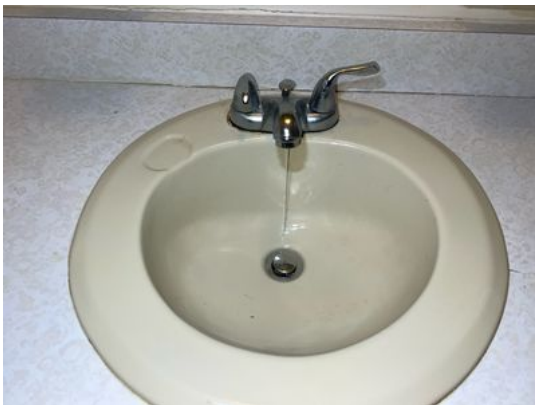
The hot water at the hallway half bathroom sink is inoperative. Only cold water was available from the sink faucet at the time of the inspection.

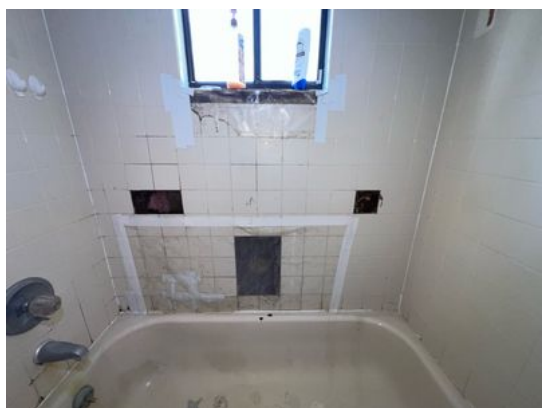
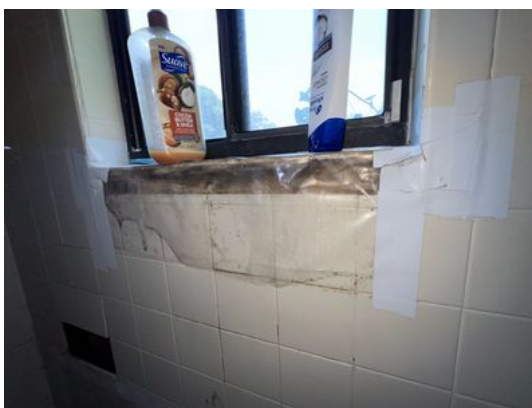
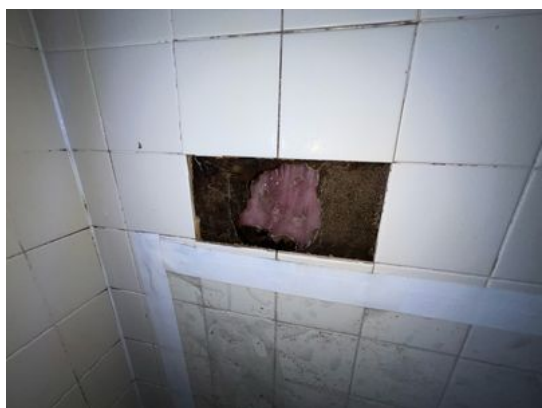
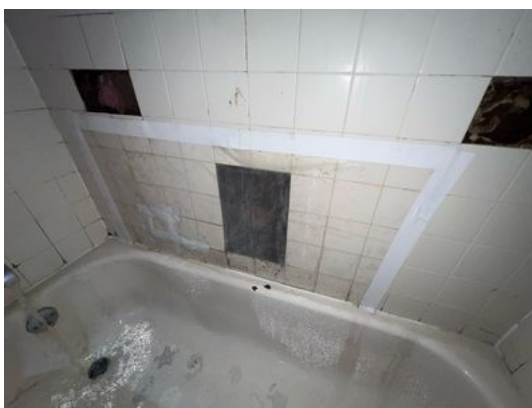
The tub/shower surround exhibits numerous deficiencies, including missing and damaged ceramic tiles, unprofessional patch repairs using tape and plastic sheeting, deteriorated grout and sealant, and exposed wall cavity materials. These conditions are indicative of previous moisture intrusion and allow water to penetrate behind the wall covering, increasing the potential for concealed damage. The tub/shower surround is in need of significant repair or replacement.

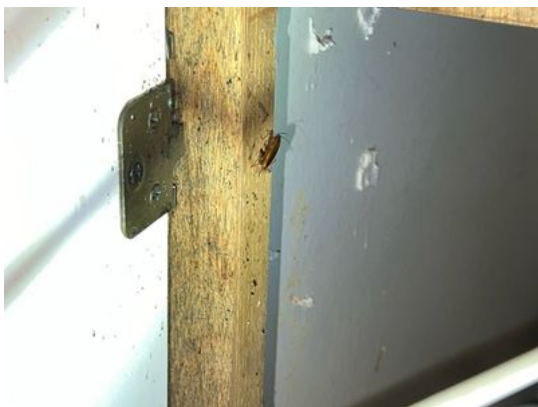
An extensive German cockroach infestation was observed in the kitchen area. Numerous live cockroaches were present throughout the kitchen, indicating a significant active infestation. Evaluation and treatment by a licensed pest control contractor is recommended.

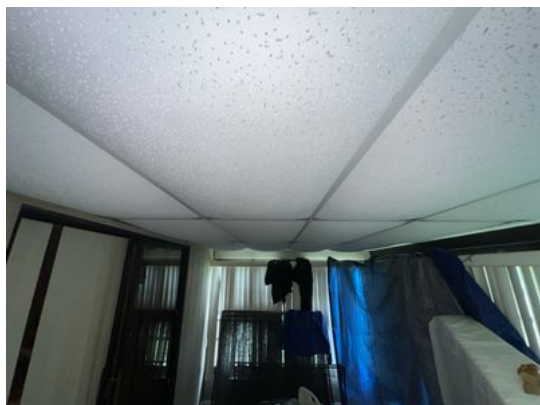
The enclosed rear patio exhibited elevated humidity levels at the time of the inspection. The suspended (drop) ceiling tiles are warped and show evidence of moisture exposure, consistent with prolonged high humidity within the space.

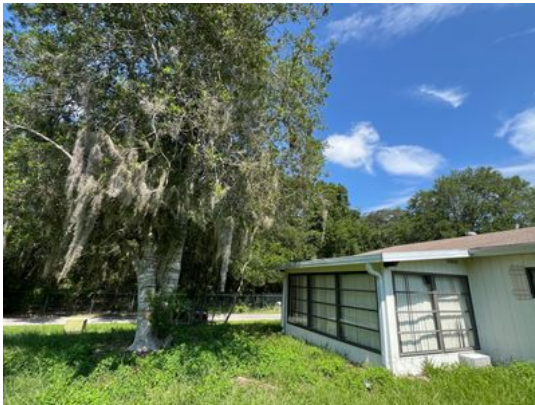
The home is situated on a property with large trees that overhang the roof and surrounding areas. While these trees add aesthetic value and shade, they also pose potential risks. Overhanging branches can cause damage to the roof, gutters, and siding, especially during storms or high winds. Additionally, falling branches may create safety hazards for residents and visitors. Regular tree maintenance, including trimming and monitoring for signs of decay or disease, is recommended to mitigate these risks and protect the home.

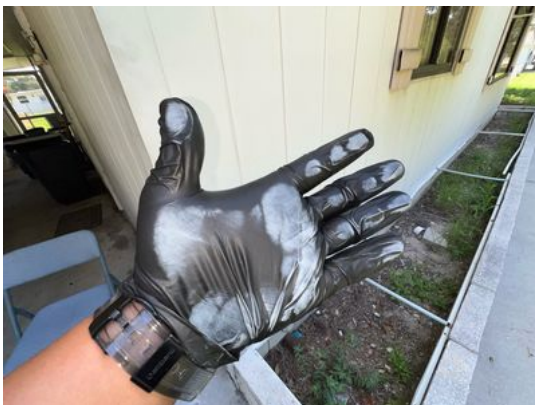
Exterior paint has a chalky look and feel. Recommend exterior be sealed and painted.

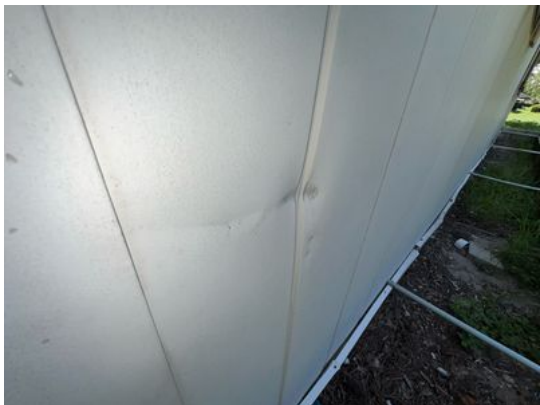
The vinyl siding exhibits multiple dings and areas of impact damage at various locations around the exterior of the home. The damage is cosmetic in nature and was observed throughout the siding. Repair or replacement of the affected siding sections may be needed as desired to restore the exterior finish.

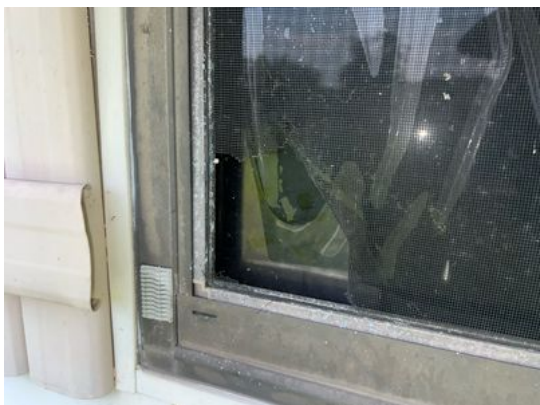
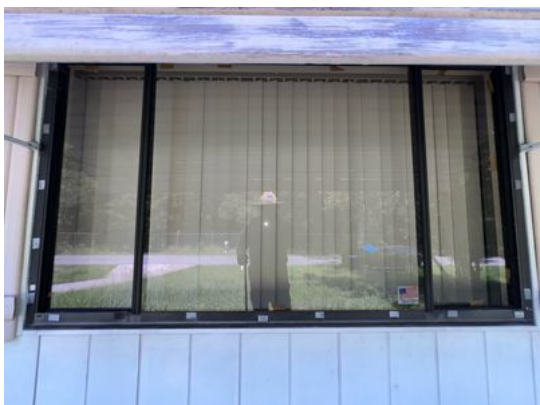
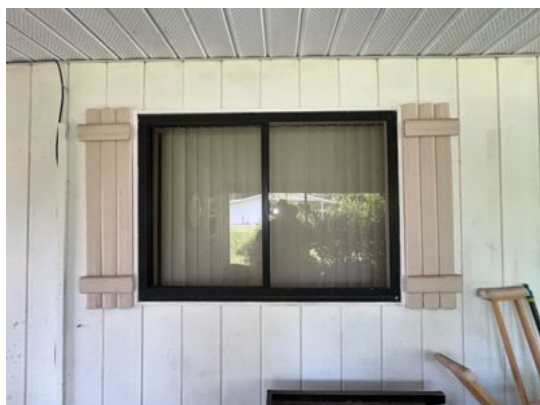
Exterior screens are missing or broken. Recommend repair or replacement

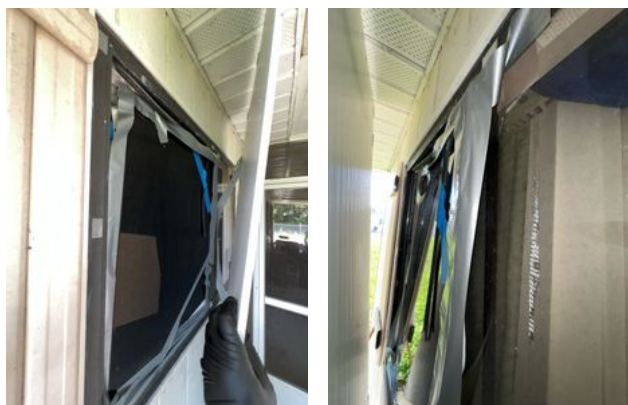
A rear window is covered with plastic board and was found to be severely damaged and displaced from its frame. The window is no longer providing a proper weather-resistant seal and should be replaced.

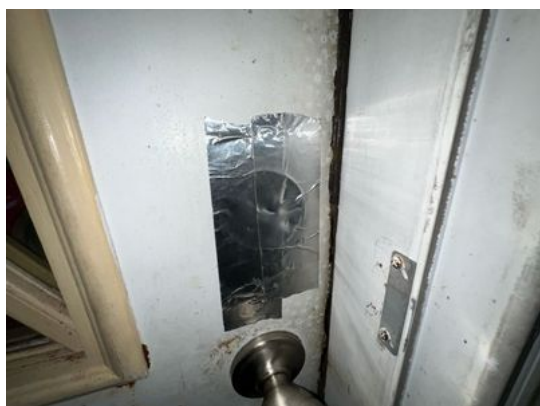
The exterior door exhibits evidence of a prior forced entry or repair at the latch area. The door jamb is damaged and has been patched with metal tape, preventing the door from latching and securing properly. Repair or replacement of the damaged door and/or frame is recommended to restore proper operation and security.

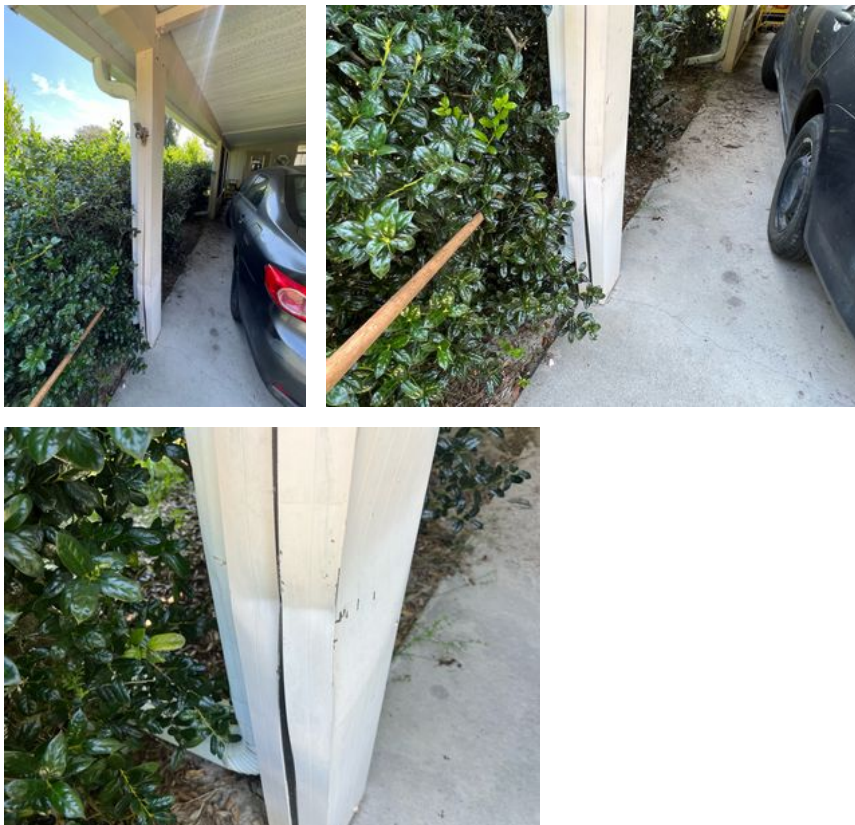
The front left carport support post, which is wrapped in aluminum siding, exhibits evidence of impact damage. Repair or replacement of the damaged post covering is recommended as needed.

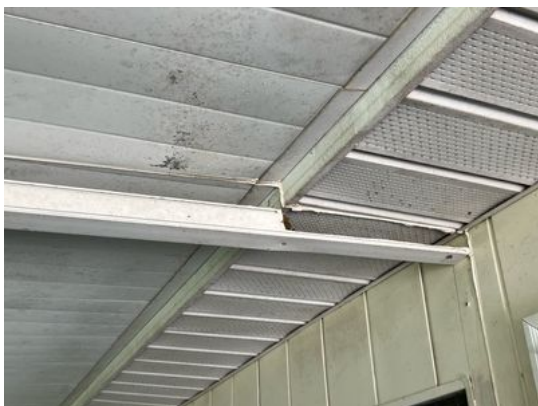
One of the carport support beams exhibits localized deterioration at the lower edge, with evidence of moisture-related damage and material loss. Repair or replacement of the affected beam is recommended to maintain the integrity of the carport structure.

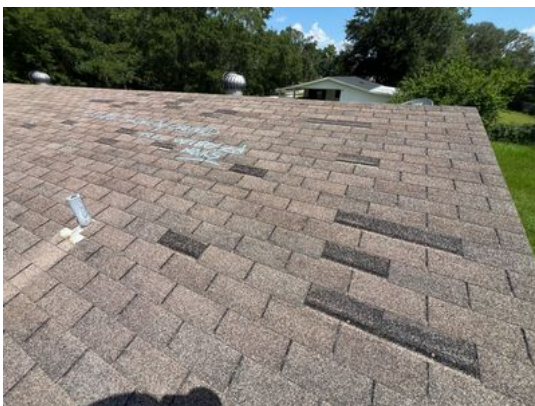
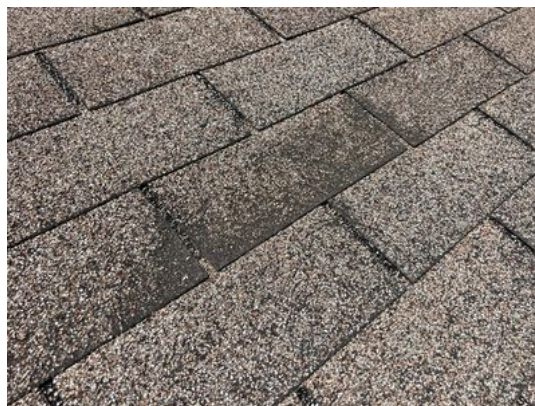
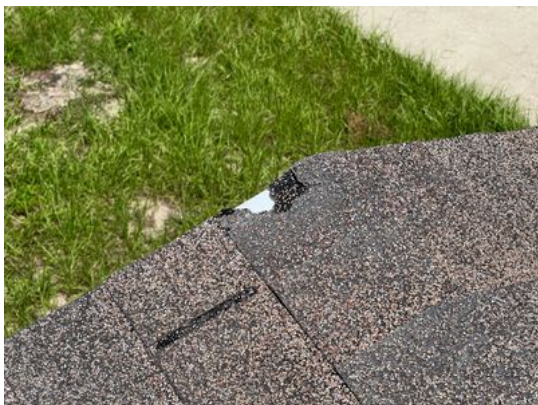
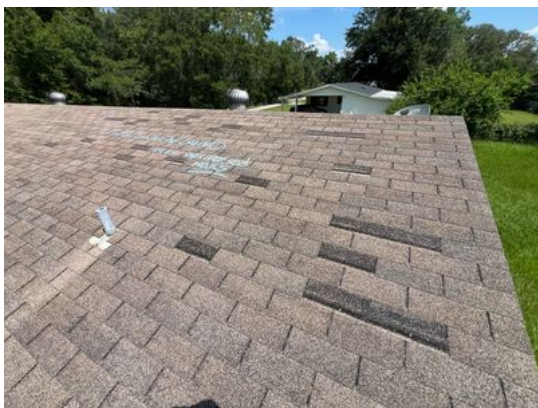
The roof covering exhibits excessive granule loss throughout, along with more than 20 cracked, broken, or missing roof tiles. Numerous exposed fasteners were also observed. These conditions increase the potential for water intrusion and indicate the roof covering is at or near the end of its serviceable life. Replacement of the roof covering is recommended.

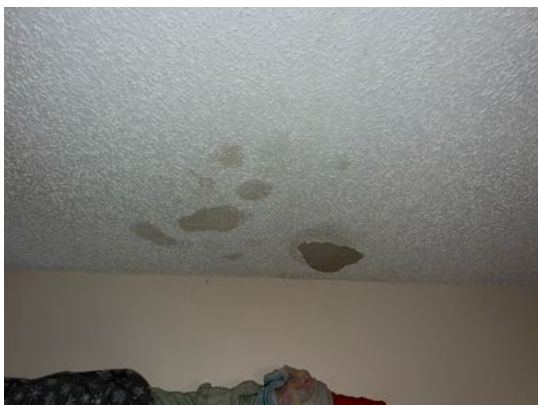
The primary bedroom ceiling exhibits multiple moisture stains and an area of peeling and missing textured ceiling finish, consistent with moisture-related damage. The source of the moisture should be identified and corrected, and the damaged ceiling materials repaired as needed.

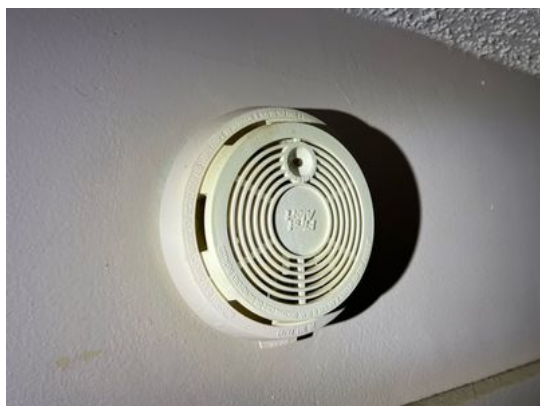
Smoke detectors And alarms should be replaced every 10 years. Recommend replacement prior to occupancy.

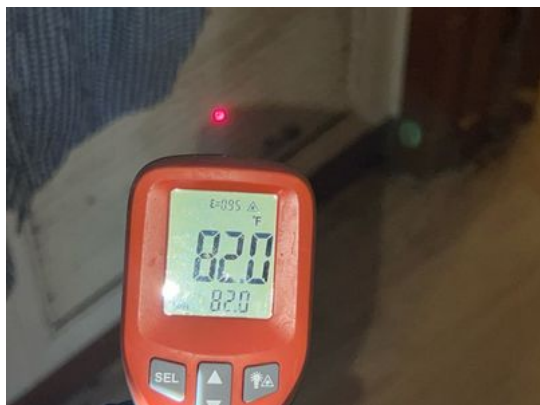
Ideally, there should be a temperature differential of around 14° to 20° Fahrenheit between the incoming air and the air being blown out by your air conditioner. This means that if the air entering the system is 75°F, the air coming out of the vent should be between 55°F and 61°F. The temp differential of this unit is 13°.

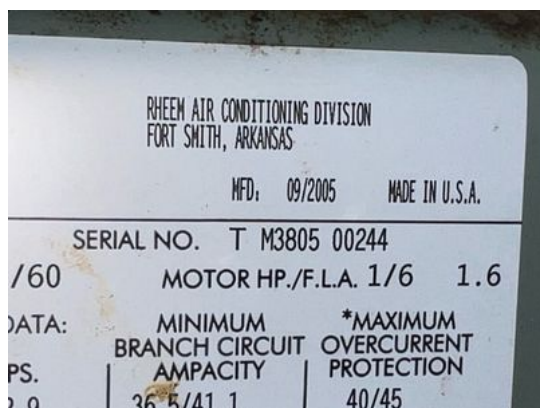
The HVAC system is original to the home and was manufactured in 2005, making it approximately 21 years old at the time of inspection. Typical service life for residential HVAC systems in Florida is approximately 12–15 years, depending on usage, maintenance history, and environmental conditions. While the system was operating at the time of inspection, it is past its expected service life. As with any aging mechanical system, the likelihood of repair or replacement increases as the unit continues to age.

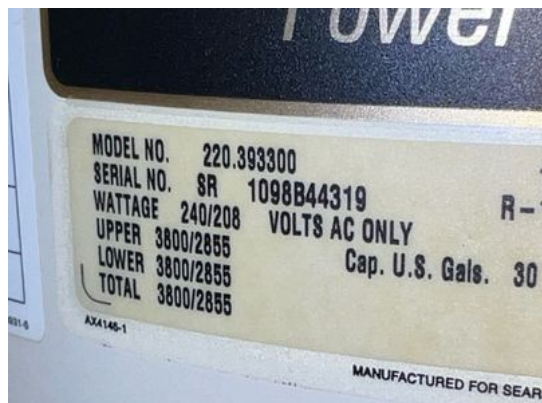
The home is equipped with a 28-year-old water heater, which is passed the upper limit of its typical life expectancy of 10 to 15 years. While it was functional at the time of inspection, water heaters of this age are more prone to failure, including

leaks or inefficiency. Additionally, many insurance companies are reluctant to provide coverage for homes with water heaters older than 15 years due to the increased risk of water damage. We recommend replacing the unit to reduce the risk of failure and to comply with potential insurance requirements.

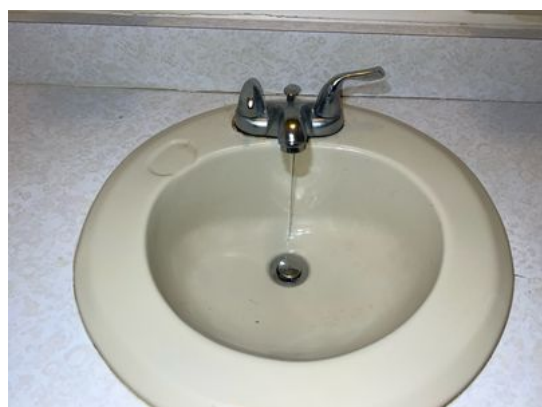
The hot water at the hallway half bathroom sink is inoperative. Only cold water was available from the sink faucet at the time of the inspection.

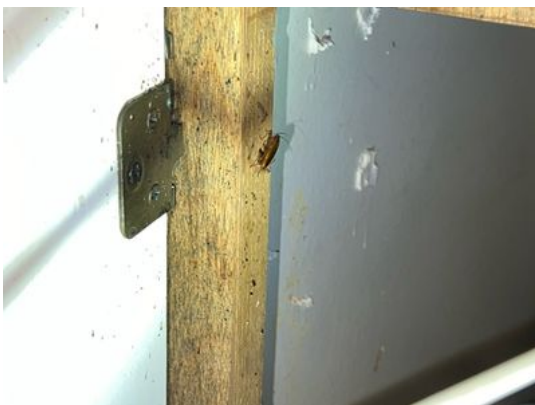
An extensive German cockroach infestation was observed in the kitchen area. Numerous live cockroaches were present throughout the kitchen, indicating a significant active infestation. Evaluation and treatment by a licensed pest control contractor is recommended.

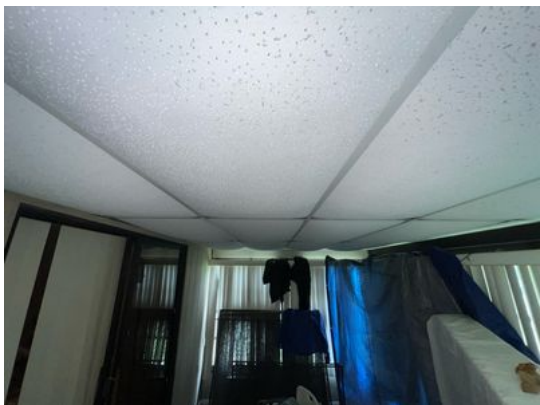
The enclosed rear patio exhibited elevated humidity levels at the time of the inspection. The suspended (drop) ceiling tiles are warped and show evidence of moisture exposure, consistent with prolonged high humidity within the space.
