## Home Inspection Report

619 E Seventh Street  
Sanford, FL 32771

Inspected By: Hector Vargas, Lic. HI12079

Inspected On Fri, Aug 14, 2026 at 12:00 PM

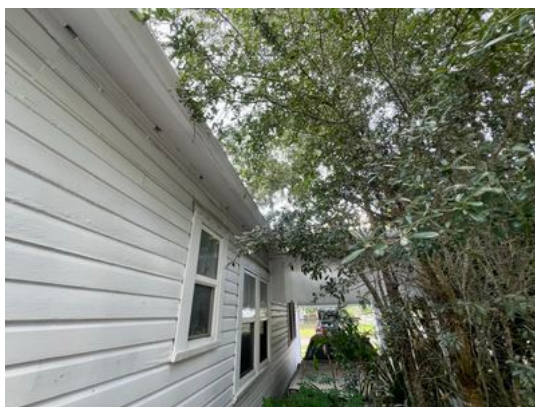
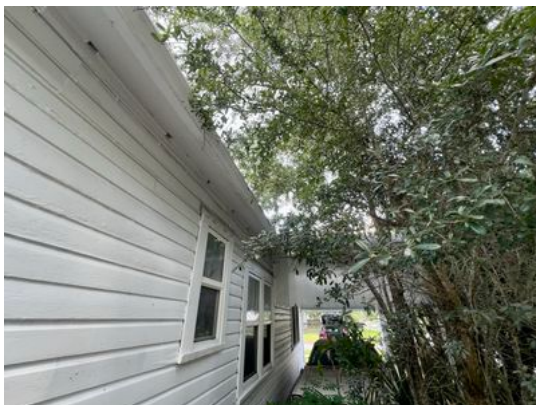
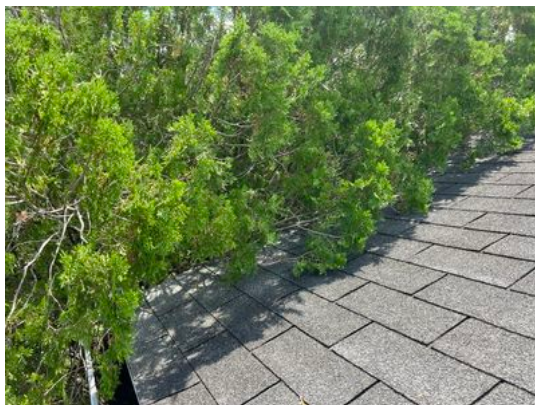
The home is situated on a property with large trees that overhang the roof and surrounding areas. While these trees add aesthetic value and shade, they also pose potential risks. Overhanging branches can cause damage to the roof, gutters, and siding, especially during storms or high winds. Additionally, falling branches may create safety hazards for residents and visitors. Regular tree maintenance, including trimming and monitoring for signs of decay or disease, is recommended to mitigate these risks and protect the home.

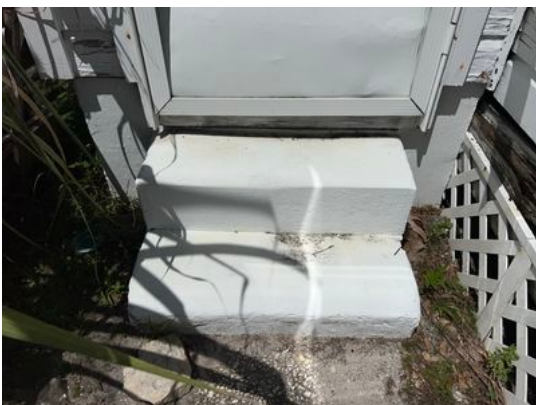
The tiled front entry steps are in poor condition. Multiple stair-nosing/edge trim pieces are loose, separated, or missing, creating exposed edges and a potential trip hazard. Repair and secure the damaged stair edging and any loose tile components as needed.

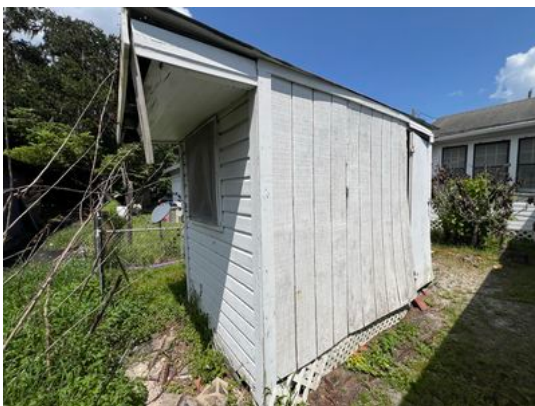
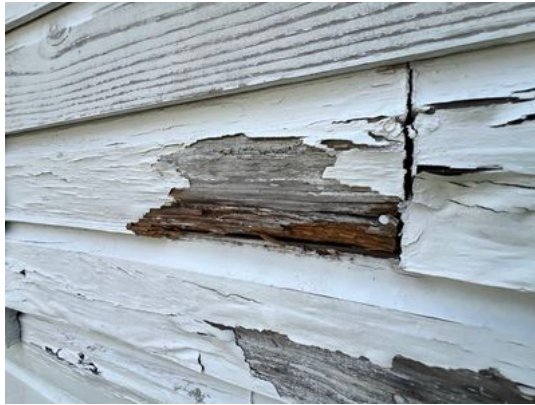
The exterior wood siding and trim on the detached structure are in poor condition, with widespread peeling paint, moisture deterioration, wood rot, open holes, damaged/missing sections, and deterioration along the lower wall areas and roof overhang. Portions of the siding are soft and deteriorated enough that the underlying material is exposed. The structure will require substantial repair, including replacement of deteriorated siding and trim and correction of the damaged roof-edge/overhang components.

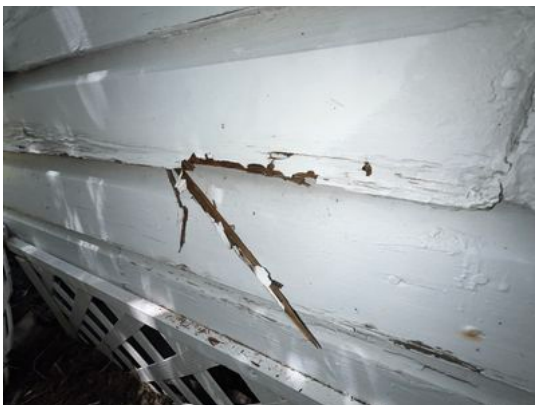
The exterior wood siding on the home is in poor condition, with widespread deterioration including wood rot, splitting, cracking, delamination, loose and broken sections, open holes, and areas where the siding has deteriorated completely through. Several lower wall sections are severely decayed with exposed underlying materials. Extensive repair and replacement of the deteriorated wood siding is needed.

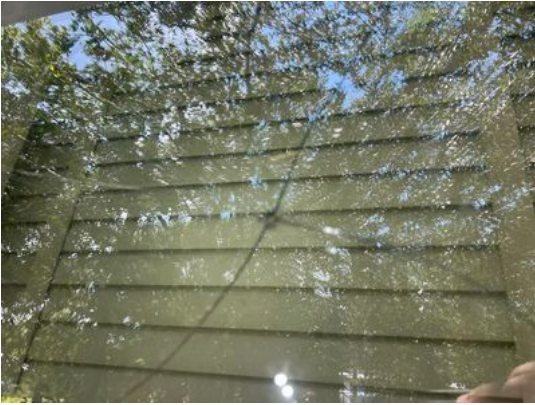
The home is fitted with a mixture of newer double-pane windows and older wood-framed windows that appear to be original to the 1940 construction. The original wood-framed windows are significantly aged and deteriorated, with cracked glazing, deteriorated frames, and damaged or loose exterior storm/screen panels noted. Due to their age and condition, the original windows have exceeded their typical service life and should be repaired or replaced as needed.

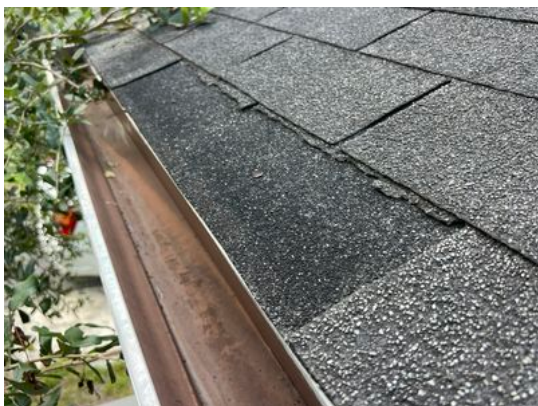
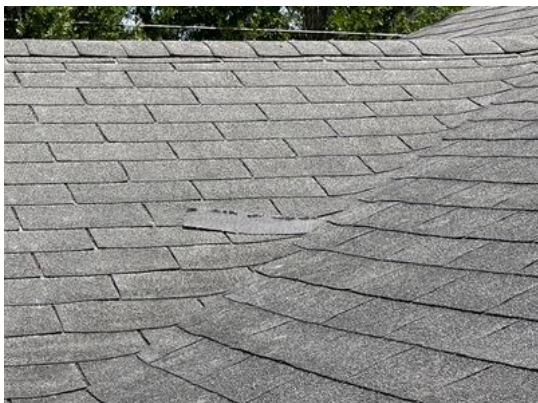
The asphalt shingle roof is in poor condition. Multiple shingles are lifted, curled, loose, damaged, and missing, with areas of exposed underlayment and previous patching visible. Significant deterioration is also present along portions of the roof edge/eaves, including open sections with exposed and deteriorated wood components. Due to the extent of deterioration, the roof covering should be considered near or at the end of its serviceable life and replacement is recommended.

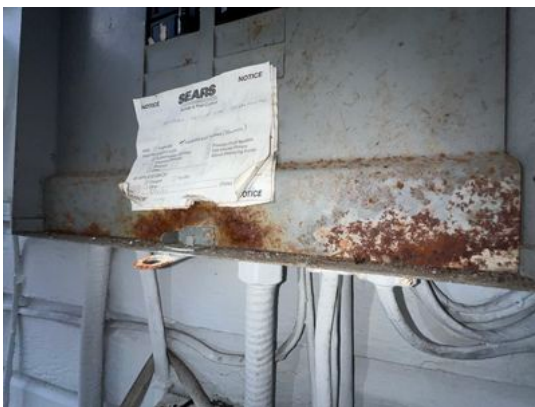
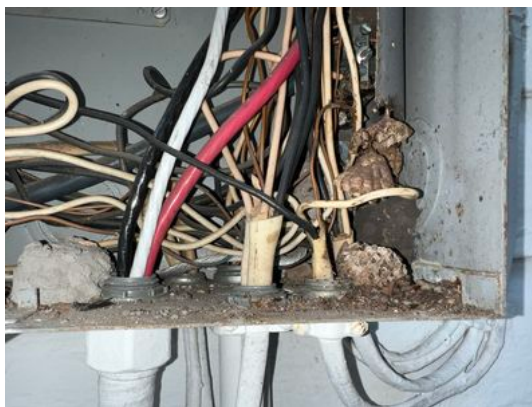
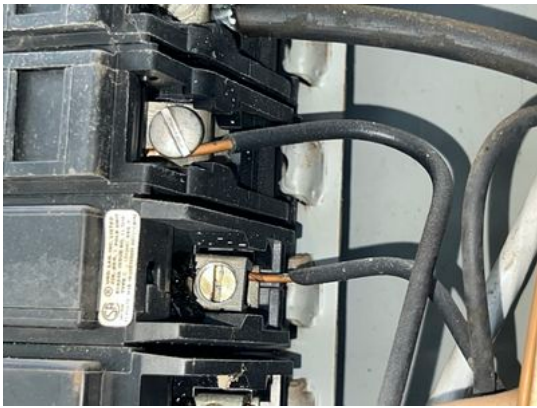
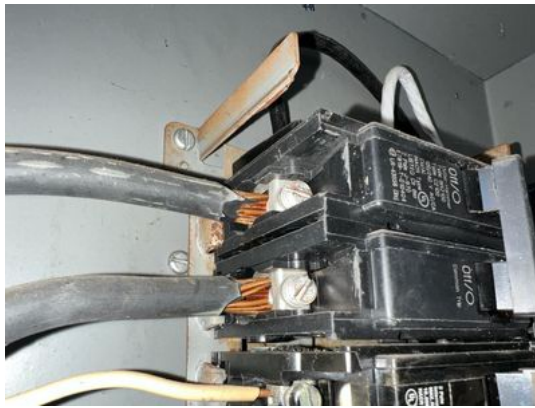
The electrical panel is in poor condition and exhibits multiple installation and safety concerns. Significant rust/corrosion and accumulated debris are present inside the cabinet, along with evidence of insect nesting. Multiple conductors/cables enter the panel without proper fittings or protection, and several cable jackets have been stripped back excessively, leaving individual conductors exposed within the cabinet. The wiring is generally disorganized and appears to include improper or questionable terminations. Due to the overall condition of the panel and the electrical power being unavailable for functional testing, evaluation and necessary repairs by a licensed electrician are recommended prior to restoring power to the property.

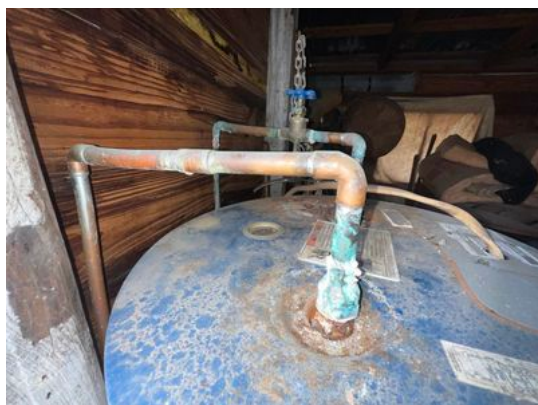
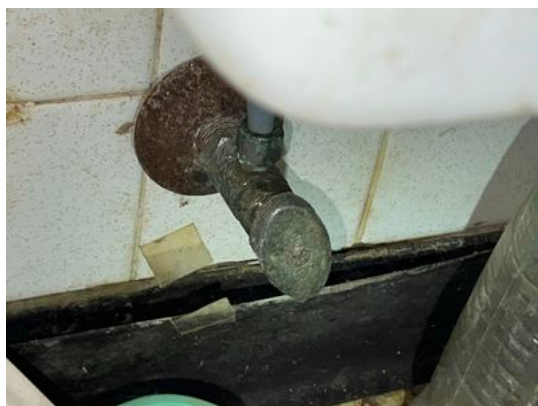
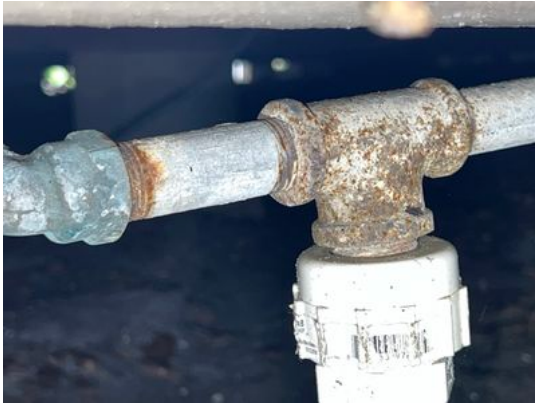
The plumbing appears to be a mixture of copper and galvanized steel piping, with some newer blue plastic piping/repair sections visible in the crawlspace.

There is significant corrosion/oxidation at multiple copper fittings and connections, especially around the water heater and fixture supply piping. The galvanized piping also shows surface rust and age-related deterioration. Given the mixed materials and visible corrosion, I would document it as an older, partially modified plumbing system and recommend further evaluation for leakage and serviceability once the water is restored.

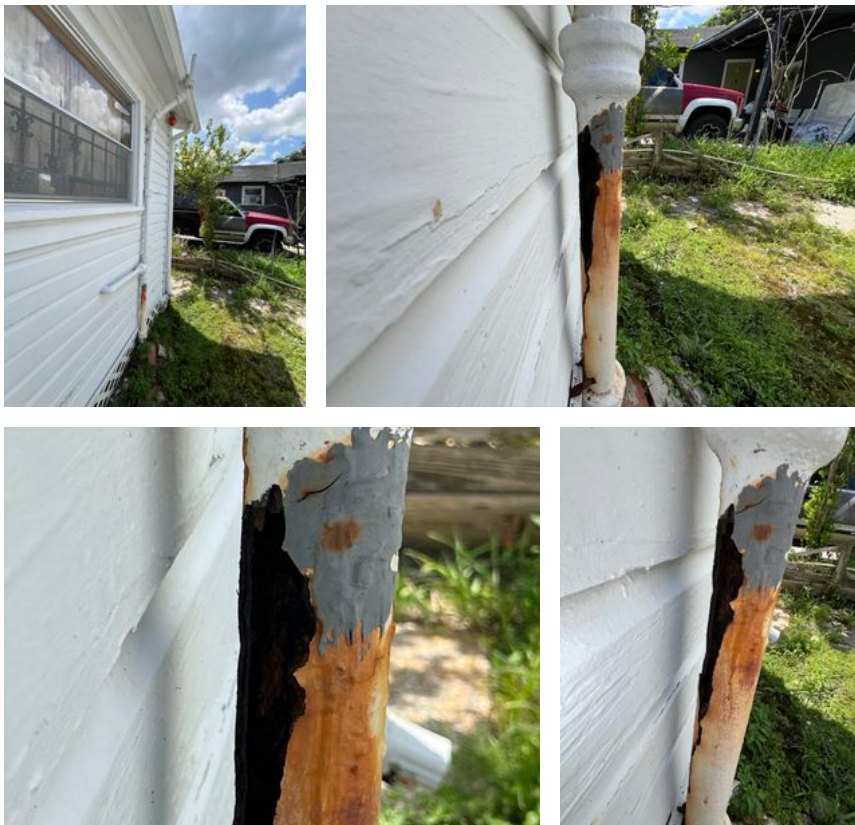
The exterior plumbing vent pipe is severely corroded and deteriorated, with a large section of the pipe wall rusted through and missing. This condition can allow sewer gases to escape and may affect proper venting of the plumbing drainage system. Repair or replacement of the damaged vent piping by a licensed plumber is recommended.

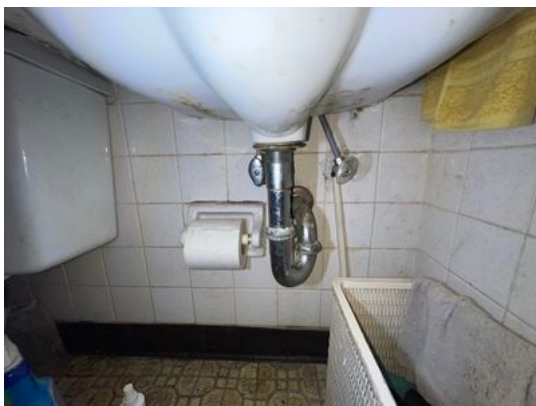
The bathroom sink drain piping exhibits significant corrosion and mineral buildup at the connection below the sink. This condition may indicate leakage or deterioration of the fitting. Due to the water service being unavailable, the drain could not be functionally tested. Further evaluation and repair by a licensed plumber is recommended once water service is restored.

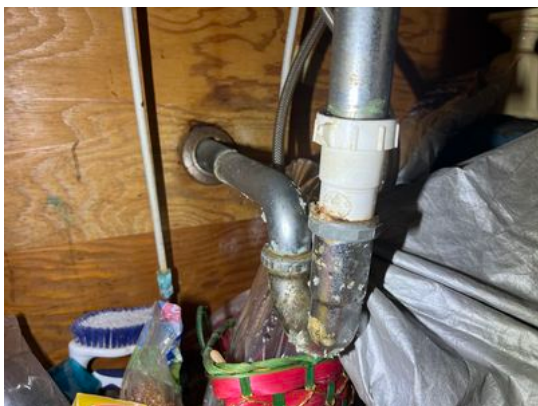
The kitchen sink drain piping shows significant corrosion, mineral buildup, and deterioration at multiple connections, including the trap assembly and transition fitting. The mixed piping and visible buildup are consistent with aging and possible past leakage. Due to the water service being unavailable, the drain could not be functionally tested. Further evaluation and repair by a licensed plumber is recommended once water service is restored.

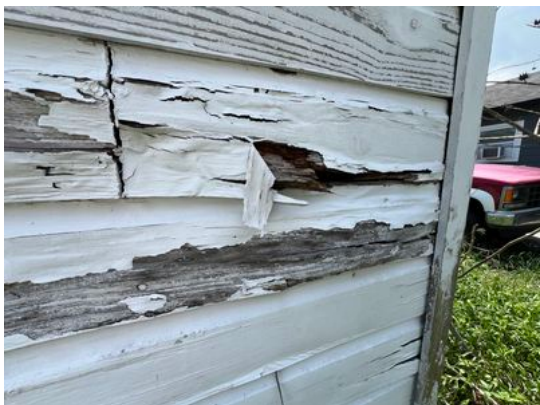
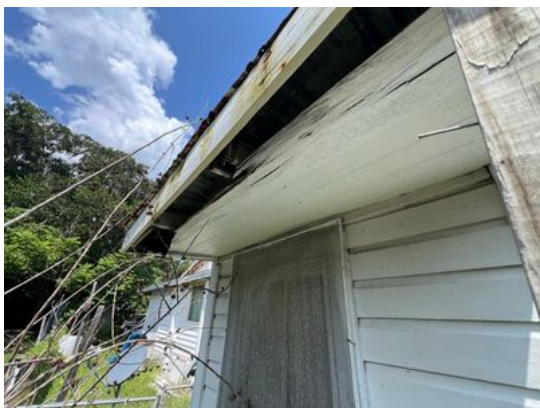
The exterior wood siding and trim on the detached structure are in poor condition, with widespread peeling paint, moisture deterioration, wood rot, open holes, damaged/missing sections, and deterioration along the lower wall areas and roof overhang. Portions of the siding are soft and deteriorated enough that the underlying material is exposed. The structure will require substantial repair, including replacement of deteriorated siding and trim and correction of the damaged roof-edge/overhang components.

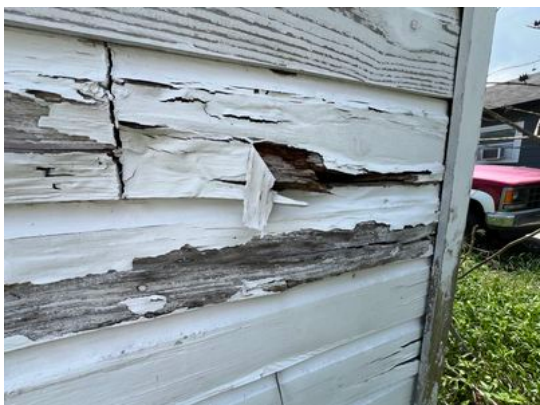
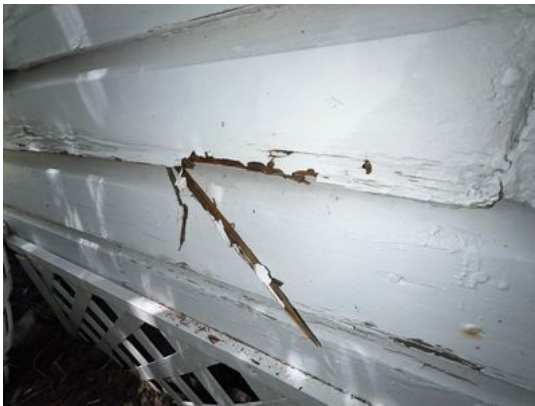
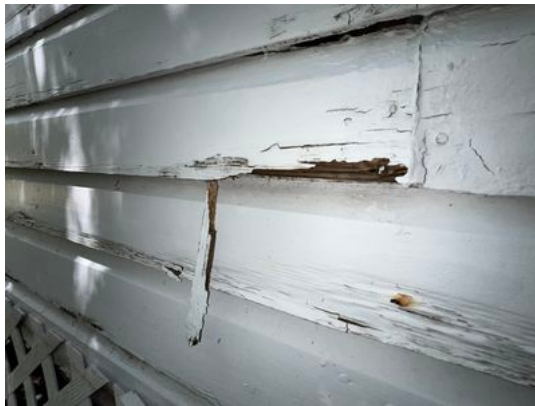
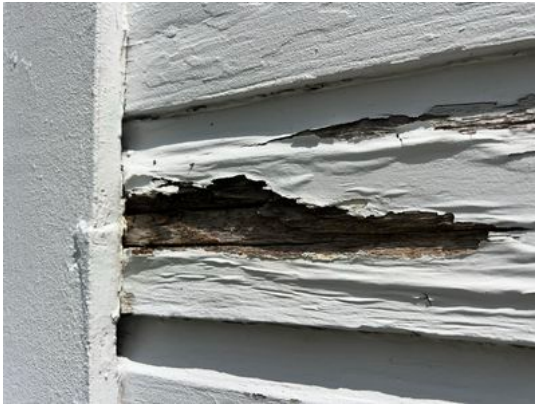
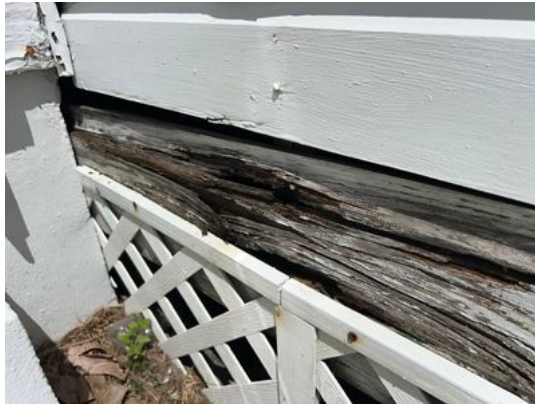
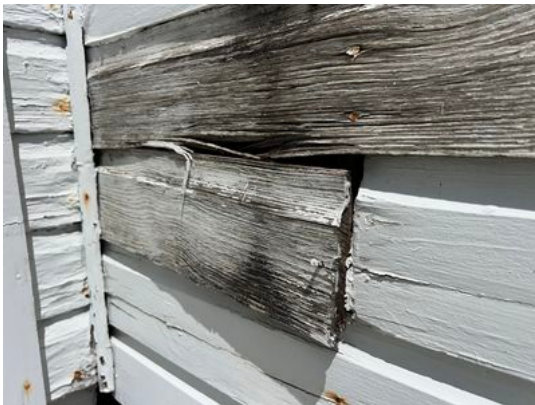
#### **Exterior: Exterior Covering**

The exterior wood siding on the home is in poor condition, with widespread deterioration including wood rot, splitting, cracking, delamination, loose and broken sections, open holes, and areas where the siding has deteriorated completely through. Several lower wall sections are severely decayed with exposed underlying materials. Extensive repair and replacement of the deteriorated wood siding is needed.

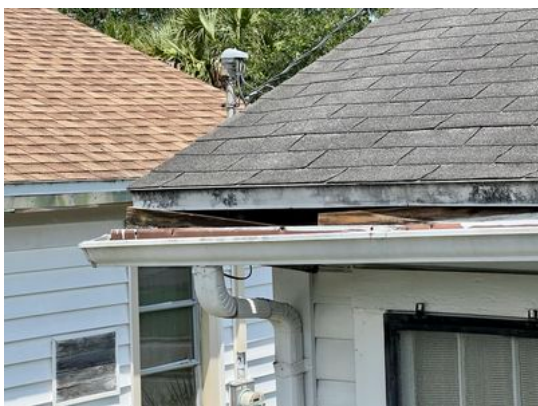
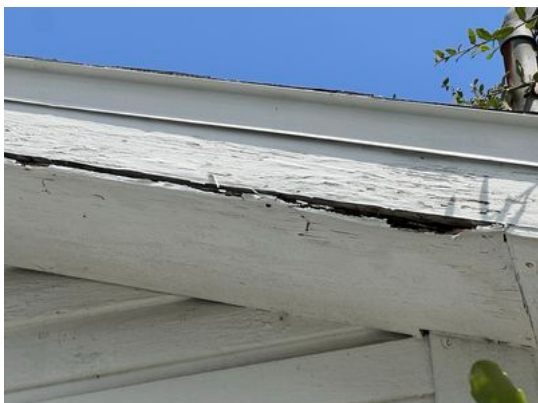
#### Exterior: Exterior Trim Material

The exterior wood trim, fascia, and soffit components are in poor condition, with multiple areas of severe wood rot, splitting, separation, and missing/deteriorated sections. Several locations have open gaps exposing the underlying roof-edge framing. Extensive repair and replacement of the deteriorated trim, fascia, and soffit materials is needed.

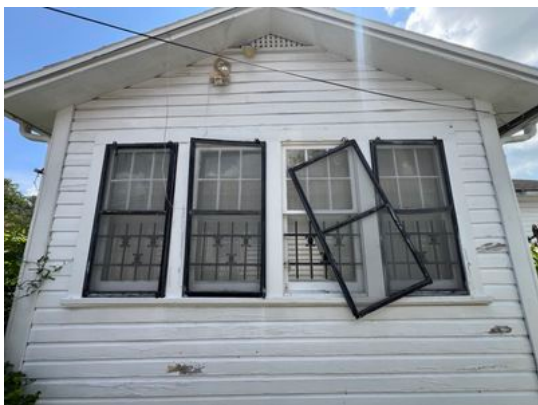
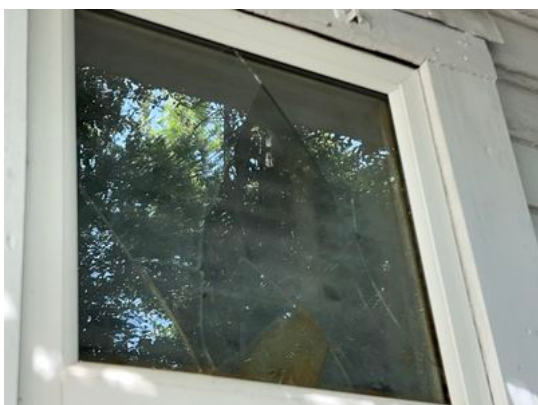
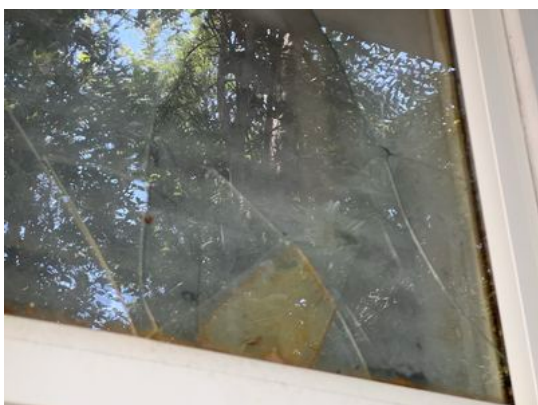
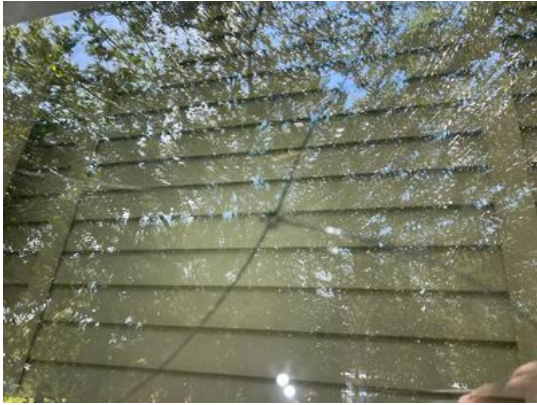
### Exterior: Windows

The home is fitted with a mixture of newer double-pane windows and older wood-framed windows that appear to be original to the 1940 construction. The original wood-framed windows are significantly aged and deteriorated, with cracked glazing, deteriorated frames, and damaged or loose exterior storm/screen panels noted. Due to their age and condition, the original windows have exceeded their typical service life and should be repaired or replaced as needed.

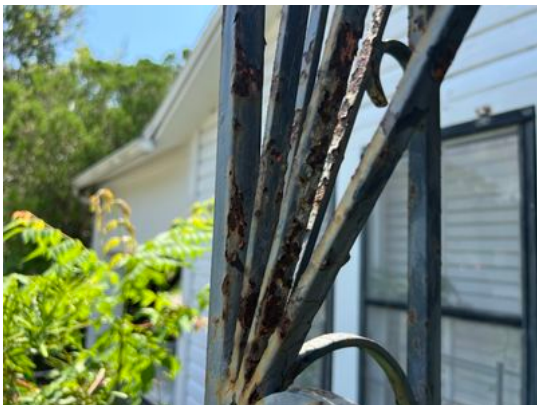
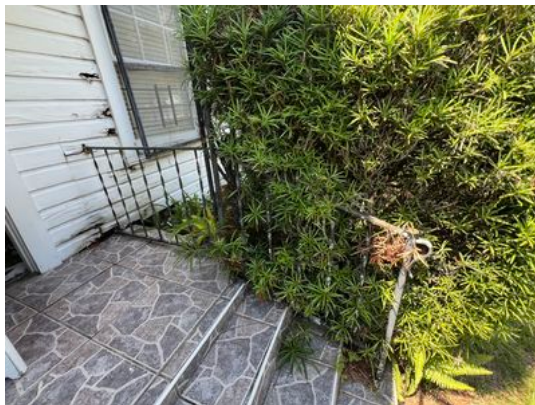
### Exterior: Railings

The metal railings at the front entry are in poor condition, with widespread surface rust, corrosion, peeling paint, and deterioration of multiple railing components. Vegetation is also heavily overgrown around and through portions of the railing. Repairs are needed to address the corrosion and restore the railings to a secure and serviceable condition.

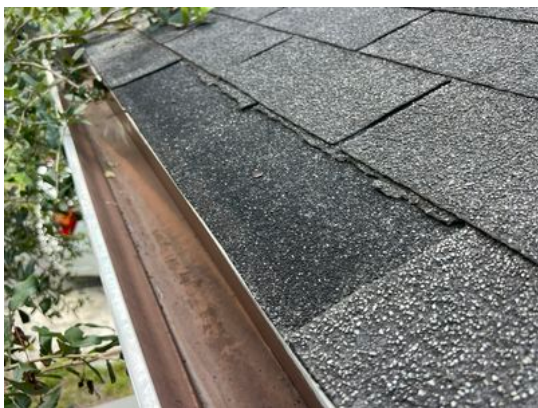
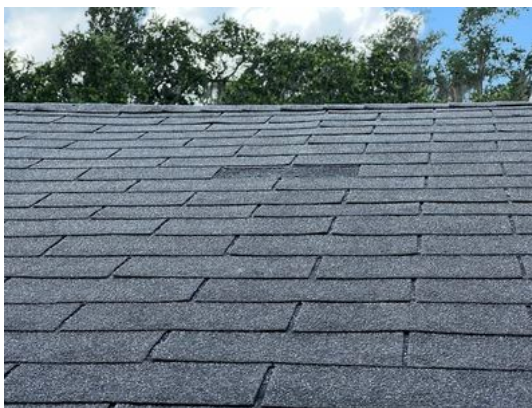
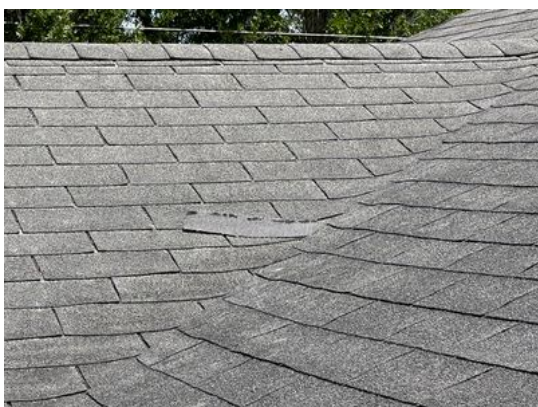
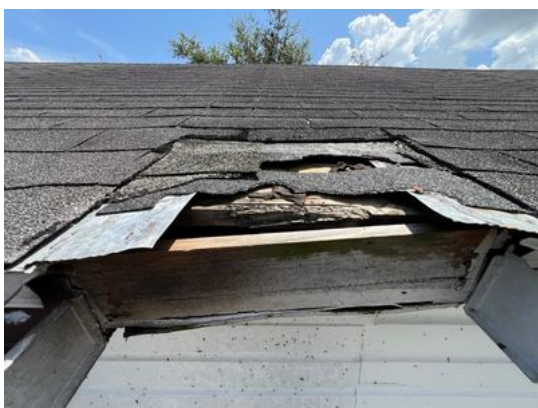
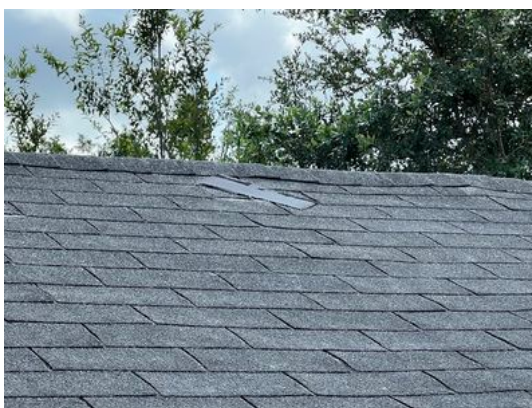
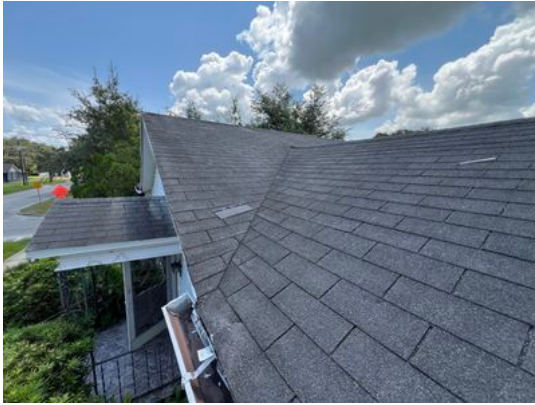
### Roofing: Visible Damage

The asphalt shingle roof is in poor condition. Multiple shingles are lifted, curled, loose, damaged, and missing, with areas of exposed underlayment and previous patching visible. Significant deterioration is also present along portions of the roof edge/eaves, including open sections with exposed and deteriorated wood components. Due to the extent of deterioration, the roof covering should be considered near or at the end of its serviceable life and replacement is recommended.

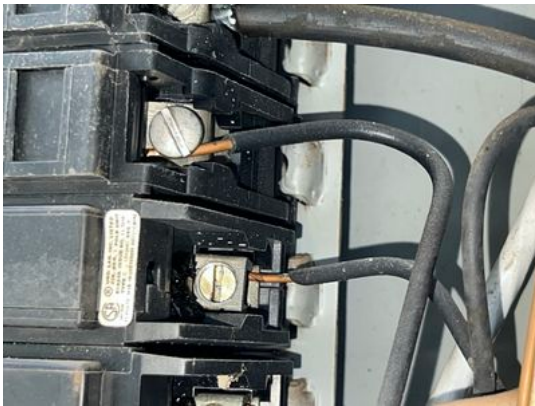
The electrical panel is in poor condition and exhibits multiple installation and safety concerns. Significant rust/corrosion and accumulated debris are present inside the cabinet, along with evidence of insect nesting. Multiple conductors/cables enter the panel without proper fittings or protection, and several cable jackets have been stripped back excessively, leaving individual conductors exposed within the cabinet. The wiring is generally disorganized and appears to include improper or questionable terminations. Due to the overall condition of the panel and the electrical power being unavailable for functional testing, evaluation and necessary repairs by a licensed electrician are recommended prior to restoring power to the property.

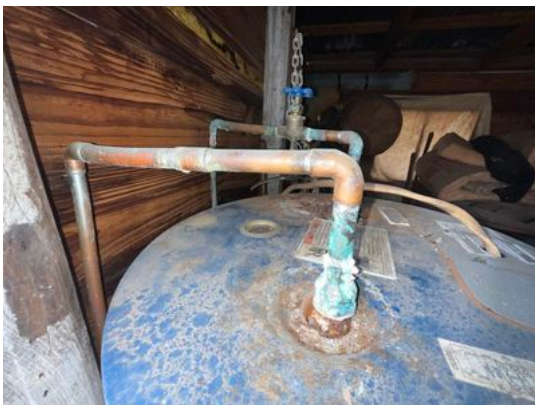
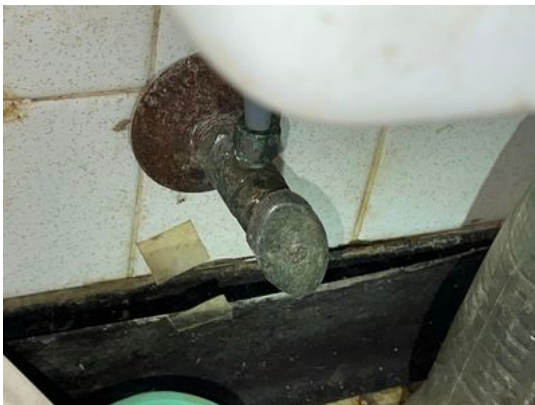
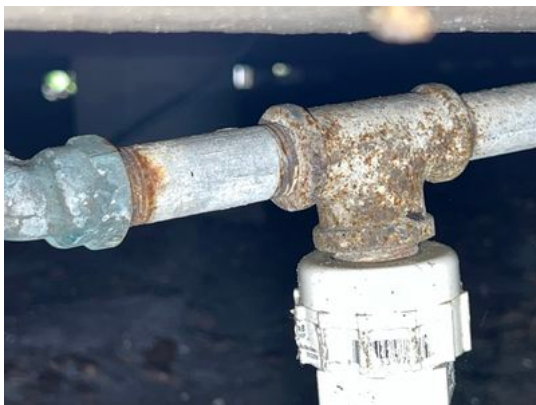
### Plumbing: Supply Pipe Material

The plumbing appears to be a mixture of copper and galvanized steel piping, with some newer blue plastic piping/repair sections visible in the crawlspace.

There is significant corrosion/oxidation at multiple copper fittings and connections, especially around the water heater and fixture supply piping. The galvanized piping also shows surface rust and age-related deterioration. Given the mixed materials and visible corrosion, I would document it as an older, partially modified plumbing system and recommend further evaluation for leakage and serviceability once the water is restored.

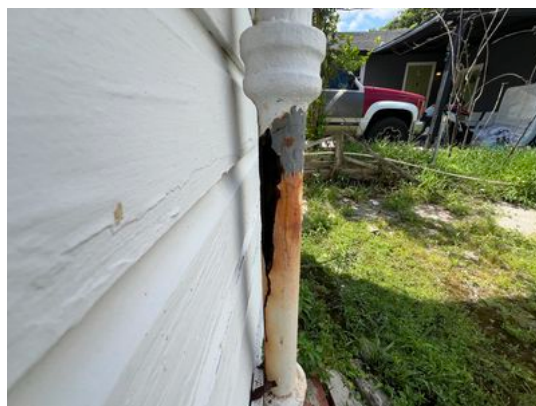
### Plumbing: Waste Pipe Material

The exterior plumbing vent pipe is severely corroded and deteriorated, with a large section of the pipe wall rusted through and missing. This condition can allow sewer gases to escape and may affect proper venting of the plumbing drainage system. Repair or replacement of the damaged vent piping by a licensed plumber is recommended.

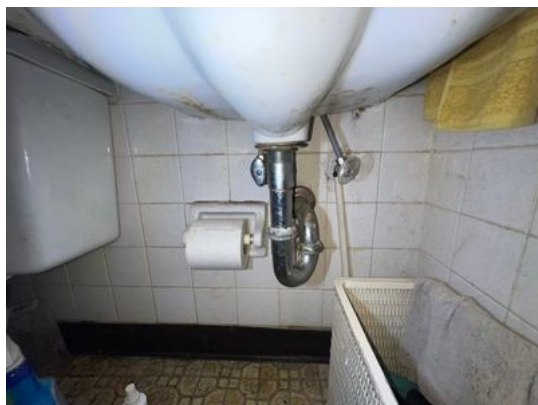
### **Bathrooms: Bathroom #1: Sink(s)**

The bathroom sink drain piping exhibits significant corrosion and mineral buildup at the connection below the sink. This condition may indicate leakage or deterioration of the fitting. Due to the water service being unavailable, the drain could not be functionally tested. Further evaluation and repair by a licensed plumber is recommended once water service is restored.

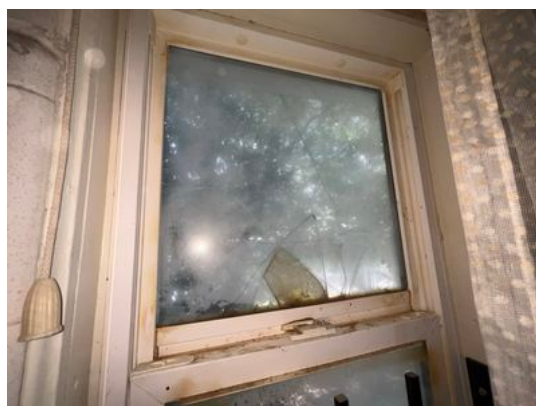
### **Bathrooms: Bathroom #1: Ventilation Type**

The bathroom window, which serves as the bathroom's only source of ventilation, has a broken window pane. The damaged glazing should be repaired or replaced to restore the window to a safe and serviceable condition.

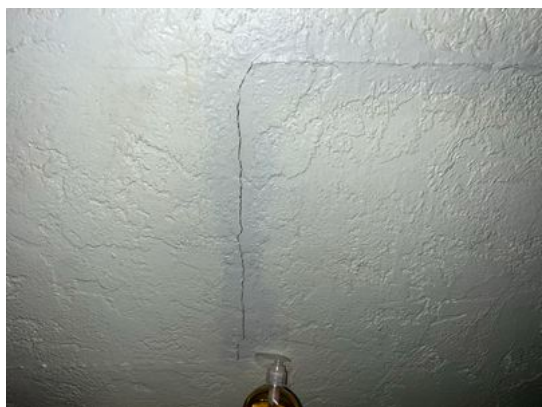
The ceiling popcorn texture is peeling and separating in multiple areas, exposing the underlying ceiling surface. Additionally, the blue wall shows evidence of a previous repair where the repaired seam has reopened and is cracking. Repair and refinishing of the affected wall and ceiling surfaces are recommended.
