INSPECTION REPORT

402 Crawford Road,  
Opelika, Alabama 36804

Prepared for  
Uncommon  
Date Inspected  
Aug 26, 2024

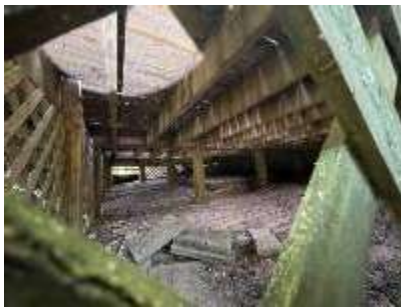
Foot rail is showing wear

If not addressed, the post may dry or rot

Paint, stain and/or seal with a weatherproof product

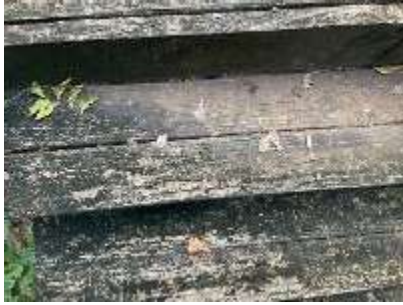
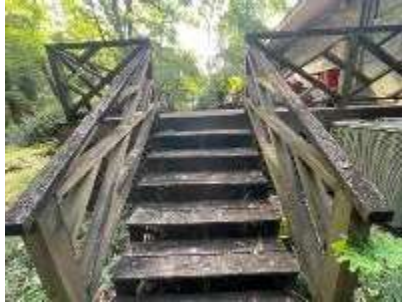
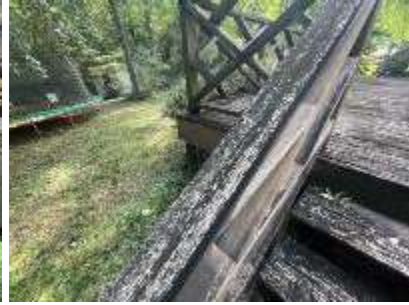
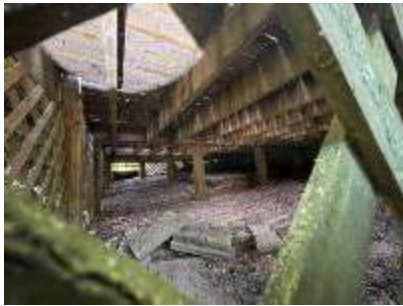
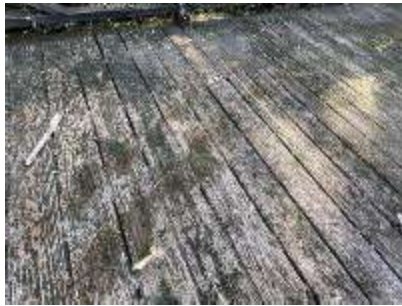
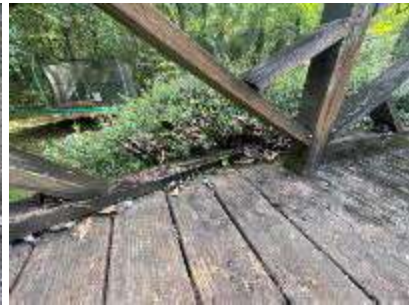
Decking is deteriorated or damaged

The sub-standard decking material diminishes structural integrity of the planking

Replace deteriorating decking

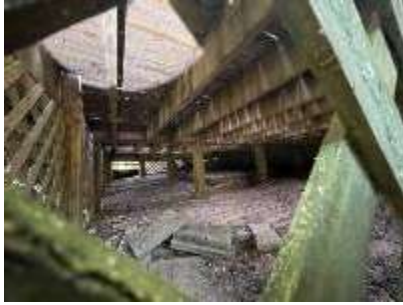
Decking is showing wear

If not protected from the elements, the decking may prematurely wear

Paint, stain and/or seal with a weatherproof product

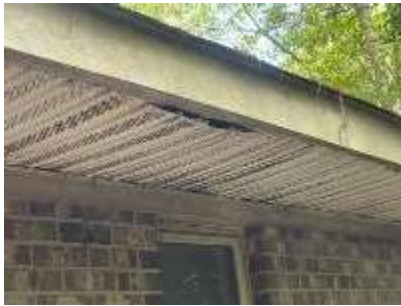
### Aluminum soffit is damaged

The damaged aluminum exposes the wood to the elements

Replace the run of soffit that is damaged

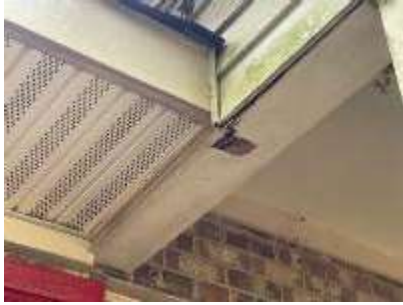
### Wood soffit is damaged

With damaged fascia, the home lacks protection from animals entering

Replace the damaged area

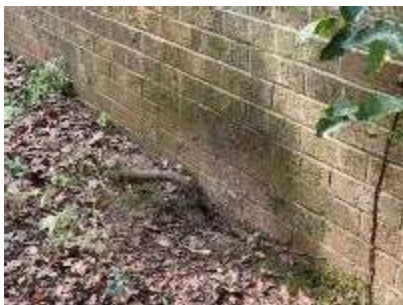
Has moss growth on the brick

It may lead to deterioration of the brick or mortar

Have a qualified mason assess for the source of moisture intrusion and recommend repairs

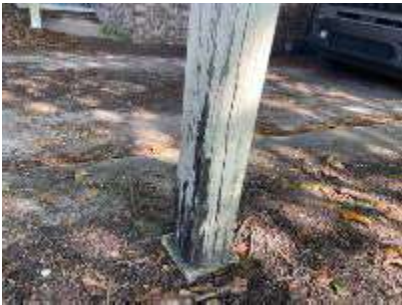
COLUMN / PIER

Slightly rotted

| IMPACT | The rotting may worsen risking movement in other parts of the home |

| SUGGESTED ACTION | Dry it, apply paint sealer and monitor for further deterioration |

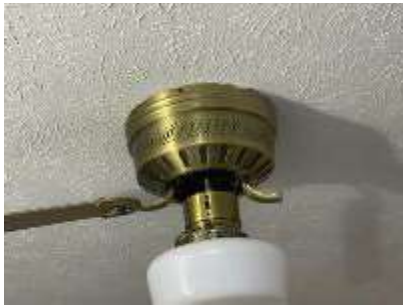
### ! CEILING FAN

Damaged

Replace the damaged component or entire unit

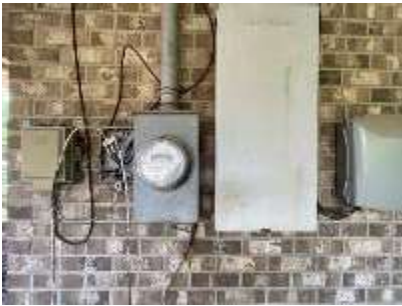
# JUNCTION BOX

Cover plate is missing

Without a cover plate, electrical shock may result if touched

Install a cover

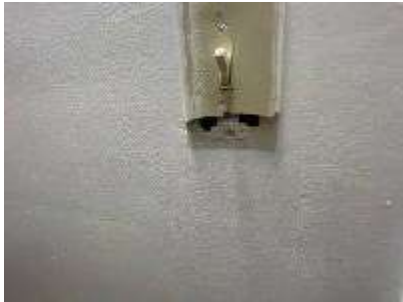
Cover is cracked

Replace the cover

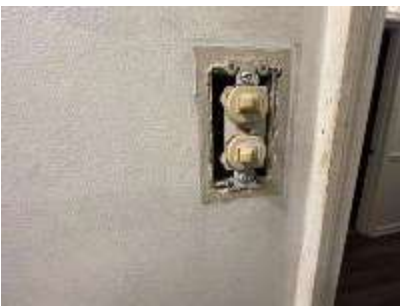
Cover plate is missing

Without a cover plate, can cause electrical shock if touched

Install a cover

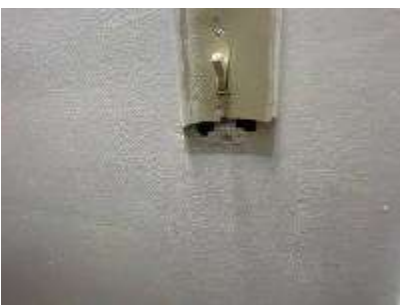
Cover plate is damaged and missing in parts

With missing parts of the cover plate, electrical shock may result if touched

## Replace the cover

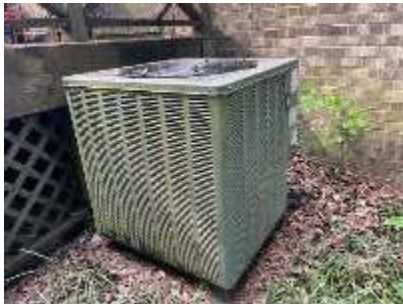
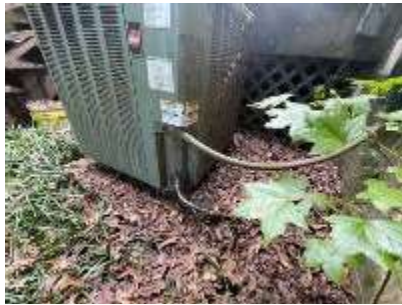
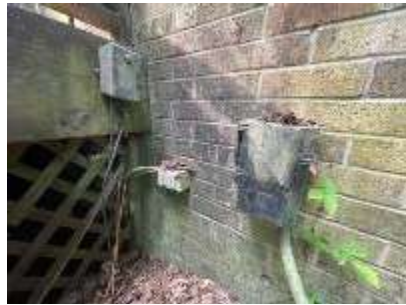
### AIR CONDITIONER

Unit is in good condition

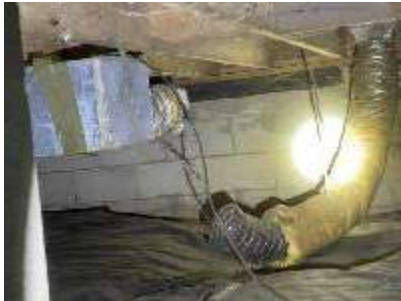
### Disconnected at one or more connection points

The deficient ductwork is preventing the heating and/or cooling from operating at optimal efficiency potentially increasing heating and cooling costs

Resecure or add additional supports to ensure each duct section is firmly supported and connected

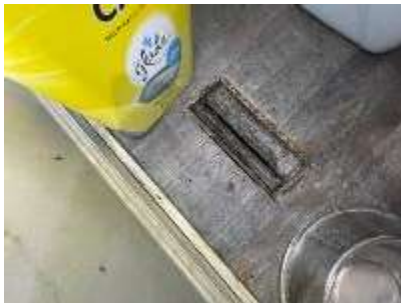
Damaged

With a damaged cover, the air flow can not be properly controlled

Replace the register cover

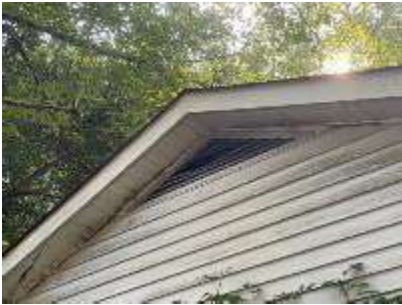
Screen is damaged or missing

Without an appropriate screen, the home lacks protection from animals entering

Replace the vent

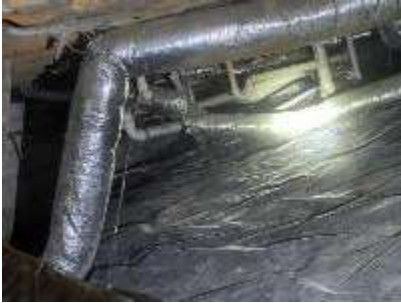
Insulation is slightly damaged and not properly secure in a few spots.

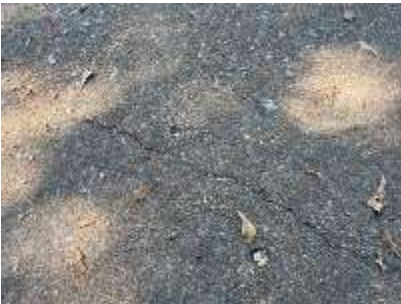
Asphalt is cracking

The crack allows water intrusion, which may cause the surrounding surfaces to also deteriorate possibly requiring a complete driveway replacement

Sealcoat the driveway with an oil-based asphalt sealer and consult with a seal coating contractor for a regular maintenance program based on the traffic and weather conditions

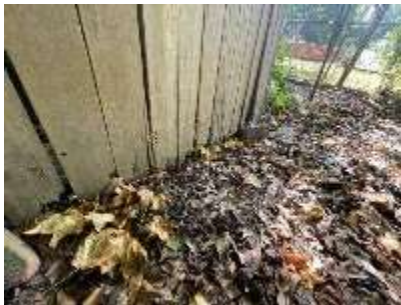
#### Boards are damaged

The damaged boards decrease the aesthetic value and function of the fence

Repair the damaged areas

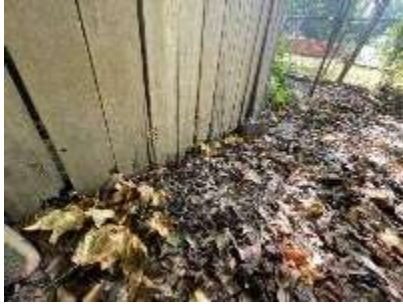
#### Leaning

If not addressed, over time, portions of the fence may fall

Have the fence repaired by a fence contractor

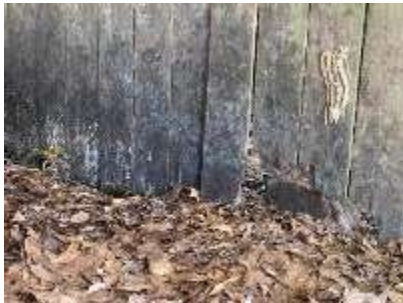
Damaged

Repair the damaged areas of the fence

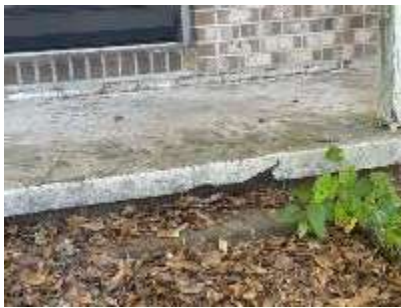
Damaged

The damage may worsen and become a trip hazard

Repair or replace the damaged steps

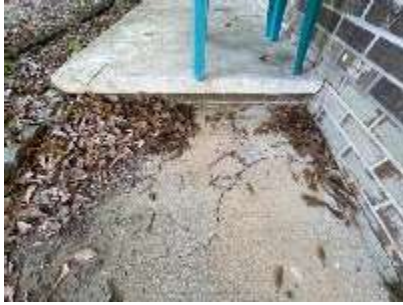
Settling with minor cracks

The cracks allow for water intrusion, which may cause the surrounding surfaces to also deteriorate possibly requiring a complete replacement

Seal the crack(s) with weather-resistant pliable concrete sealer

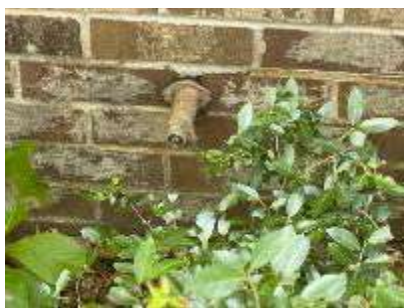
Faucet handles do not operate

Repair the handle valve or replace the entire faucet assembly

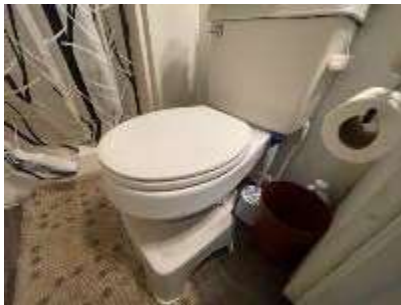
Water is running continuously

This may cause excessive water usage

Adjust the connection between the handle and the flapper valve

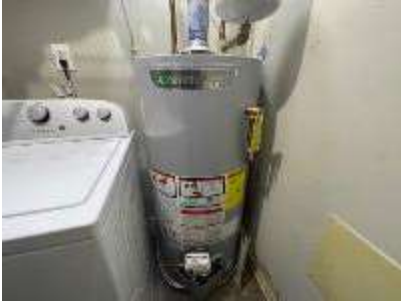
## WATER HEATER

Unit is in good condition

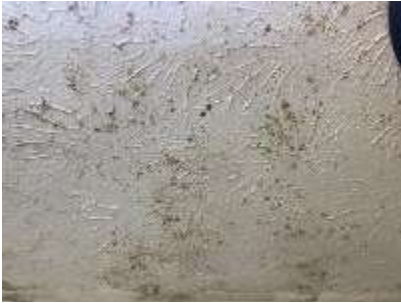
Signs of previous leak.

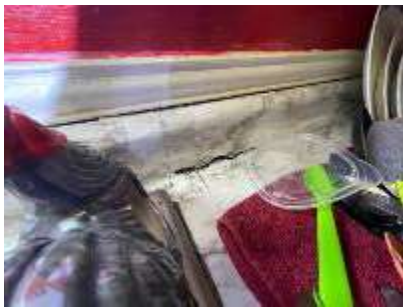
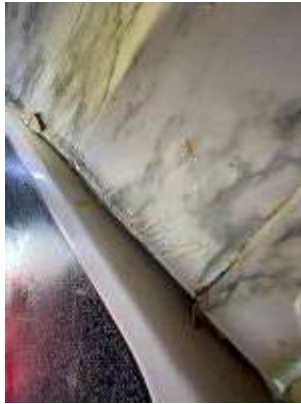
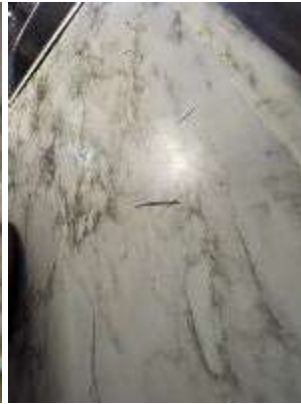
Damaged

While still functional, it lacks aesthetics

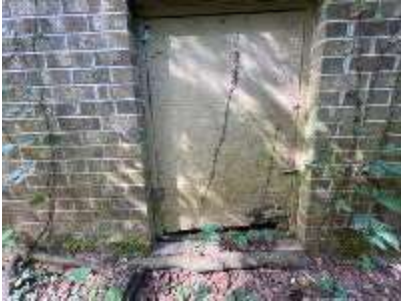
Crawl Space door is damaged

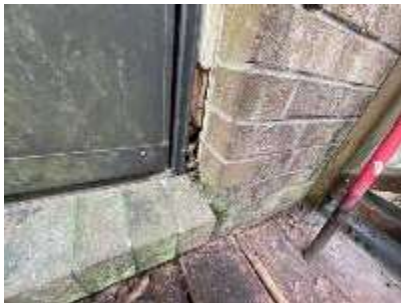
**Flashing is damaged**

Damaged flashing is a conducive condition for moisture penetration and could possibly cause damage

Repairing the flashing

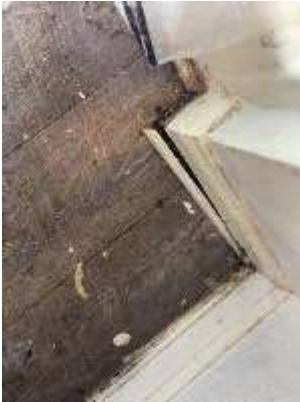
#### Floor boards are loose

Loose floor boards may squeak and in an extreme case may create a trip hazard

Have repaired by a qualified wood floor professional

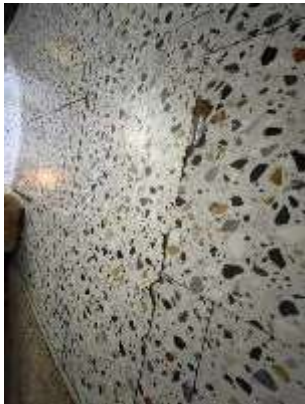
#### Tile is damaged

If not repaired, the tile may become loose

Damaged tiles may be an indication of impact from the surface or air pockets between the tile and the sub floor

Replace the damaged tile. Be careful not to damage the surrounding tile during the process.

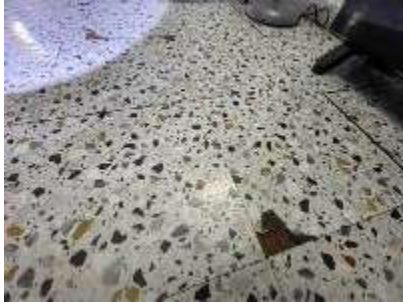
Tile is cracked

The tiles could come loose and cause either a trip or a sharp edge cutting hazard

Replace the broken tiles

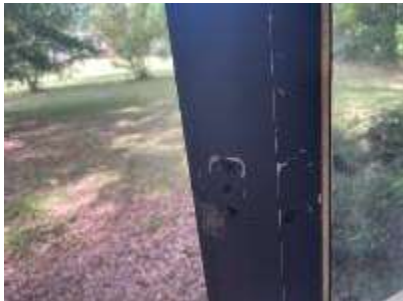
Handle is missing or broken

Replace the door handle assembly

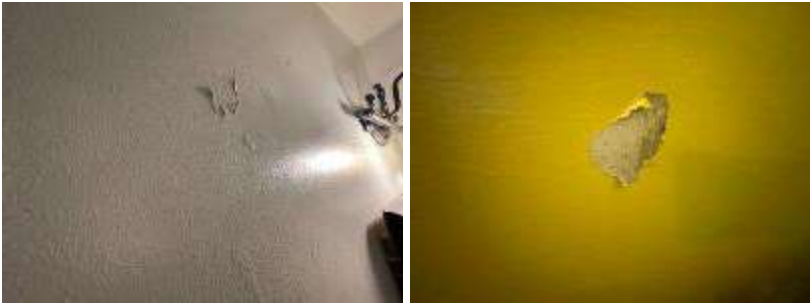
Paint damage

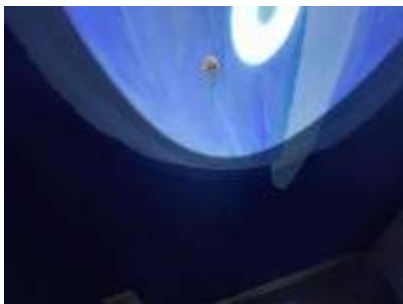
Drywall has damage

| IMPACT | Beyond being an aesthetic issue, the lack of the gaps in the wall affect the thermal boundary of the home |

| SUGGESTED ACTION | Replace the damaged areas of the wall |
