## INSPECTION REPORT

301 Satellite Circle,  
Fortson, Georgia 31808

Prepared for  
Uncommon  
Date Inspected  
Oct 4, 2024

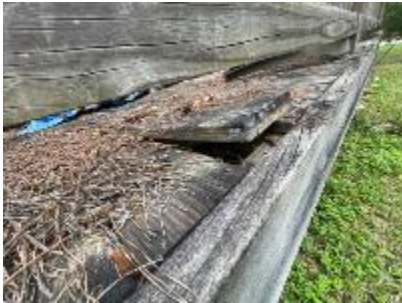
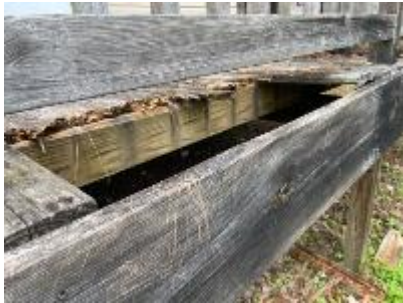
Exterior: Ground View

SAFETY CONCERN

Deck board damaged

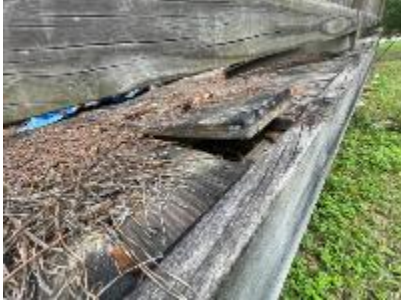
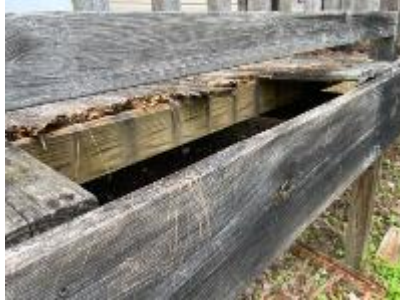
MODERATE CONCERN

Boards are deteriorated

The splintering diminishes the structural integrity of the planking

Replace the deteriorating boards

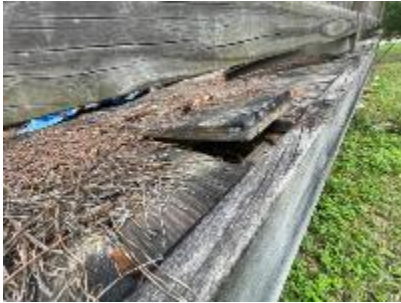
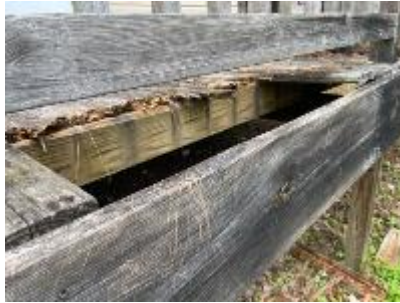
**MINOR CONCERN**

**Decking is showing wear**

If not protected from the elements, the decking may prematurely wear

Paint, stain and/or seal with a weatherproof product

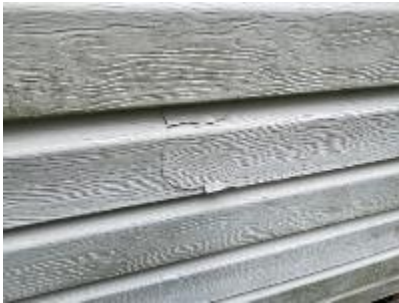
### MODERATE CONCERN

#### Material is damaged

With damaged siding, the home lacks protection from insects, animals and the elements and it may negatively affect the thermal boundary of the home

Replace the damaged area

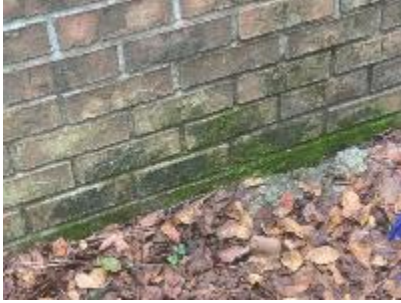
### MODERATE CONCERN

#### Has moss growth on the brick

It may lead to deterioration of the brick or mortar

Have a qualified mason assess for the source of moisture intrusion and recommend repairs

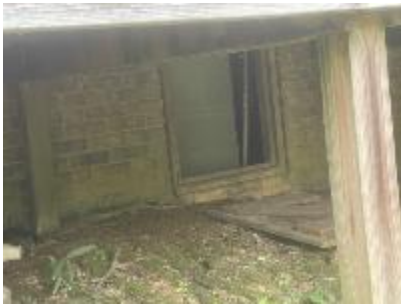
#### FOUNDATION WALL

**SAFETY CONCERN**

**Foundation is not properly covered**

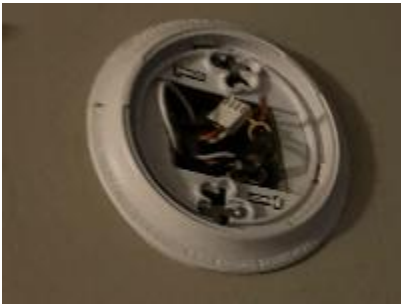
SMOKE ALARM

SAFETY CONCERN

Missing

Without one, smoke that may be an indicator of a fire can not be detected

Install a smoke detector

Smoke detectors should be located inside every sleep room, outside each sleeping area, and on every level of the home

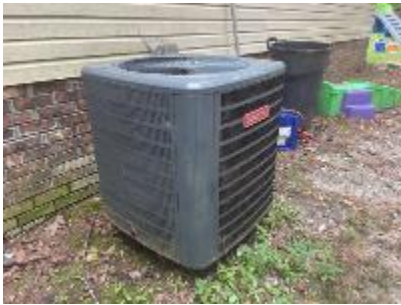
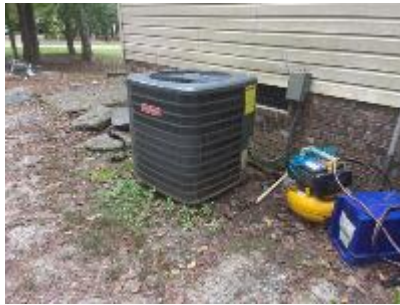
### AIR CONDITIONER

COMPLIMENT

Unit is in good condition

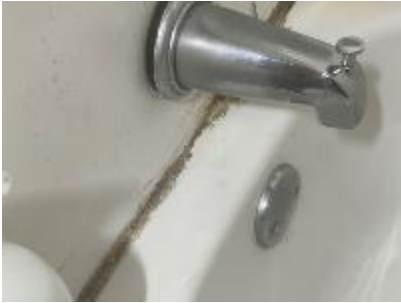
SHOWER / TUB

MINOR CONCERN

Caulking is deteriorated

Without the seal that caulk provides, moisture may leak into surrounding areas causing damage to floors and walls

Clean out the existing caulk and re-caulk the seams

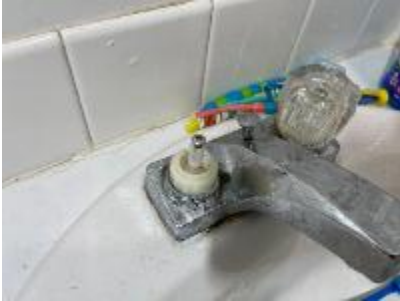
## ⚡ SINK

NOT WORKING

Faucet handle is missing

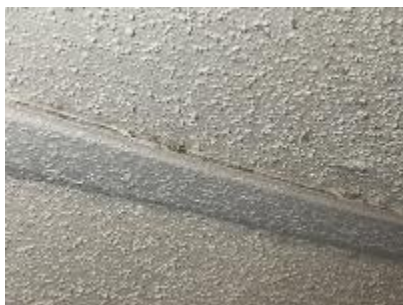
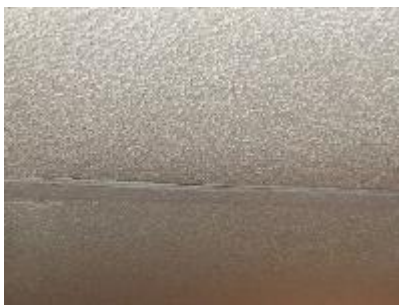
### ! CEILING

POSSIBLE CONCERN

Damaged

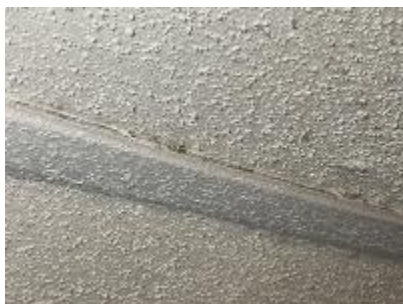
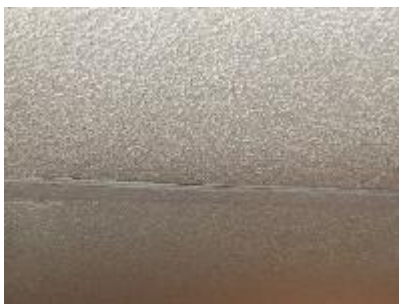
OBSERVATION TO MONITOR

Crack from possible previous water leak.

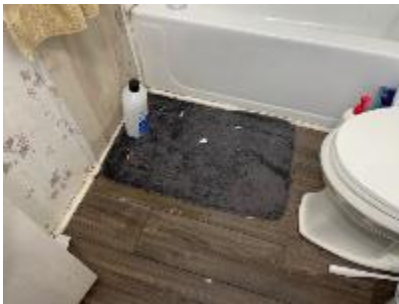
## FLOOR

#### Squeaking

Squeaky floors may be caused by a number of different situations including gaps between the subfloor and the joist, warped joists, noisy joists, and the floor rubbing against the sub-floor.

Depending on the cause and the access to the joists or subfloor from the floor below, a number of solutions are available, including inserting shims into gaps, filling gaps with construction adhesive, sistering a joist for additional support, and securing the subfloor with screws or nails to eliminate squeaks or flexing.

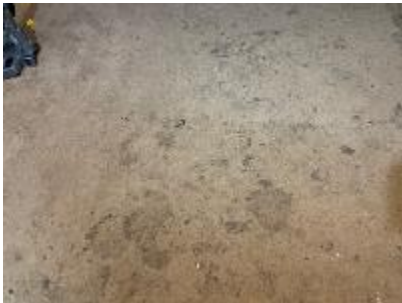
### COSMETIC

#### Showing signs of wear

Consider repairing or replacing the flooring

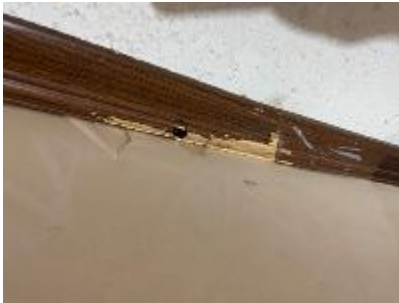
## ! INTERIOR TRIM

MODERATE CONCERN

Damaged

The damage may allow for moisture or insect intrusion which if not corrected provides an environment for mold growth or structural damage

Replace the damaged trim

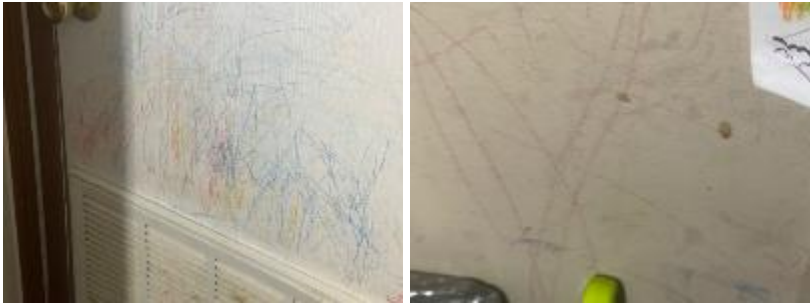
# ! WALL

COSMETIC

Paint damage

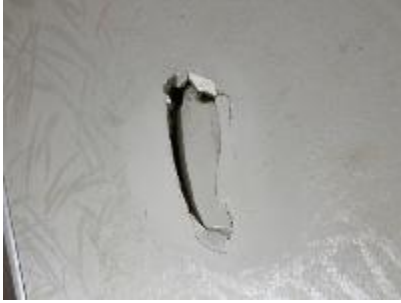
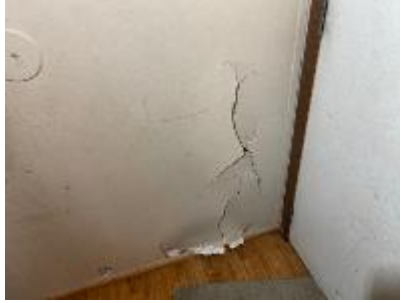
MODERATE CONCERN

Drywall has damage

| IMPACT | Beyond being an aesthetic issue, the lack of the gaps in the wall affect the thermal boundary of the home |
| INFORMATION | The finished aspect of the wall is a component in creating a thermal boundary of a home which controls the transfer of energy (heat) between the interior and the exterior |

| SUGGESTED ACTION | Replace the damaged areas of the wall |
