**Property Analysis Packet**

# 7031 Magnolia Valley Dr, New Port Richey, FL 34653

VACANT, EASY COSMETIC/QUICK  
CLEAN-UP FLIP -\$40K-60K+ GROSS  
PROFIT. 3BR/1.5BA.

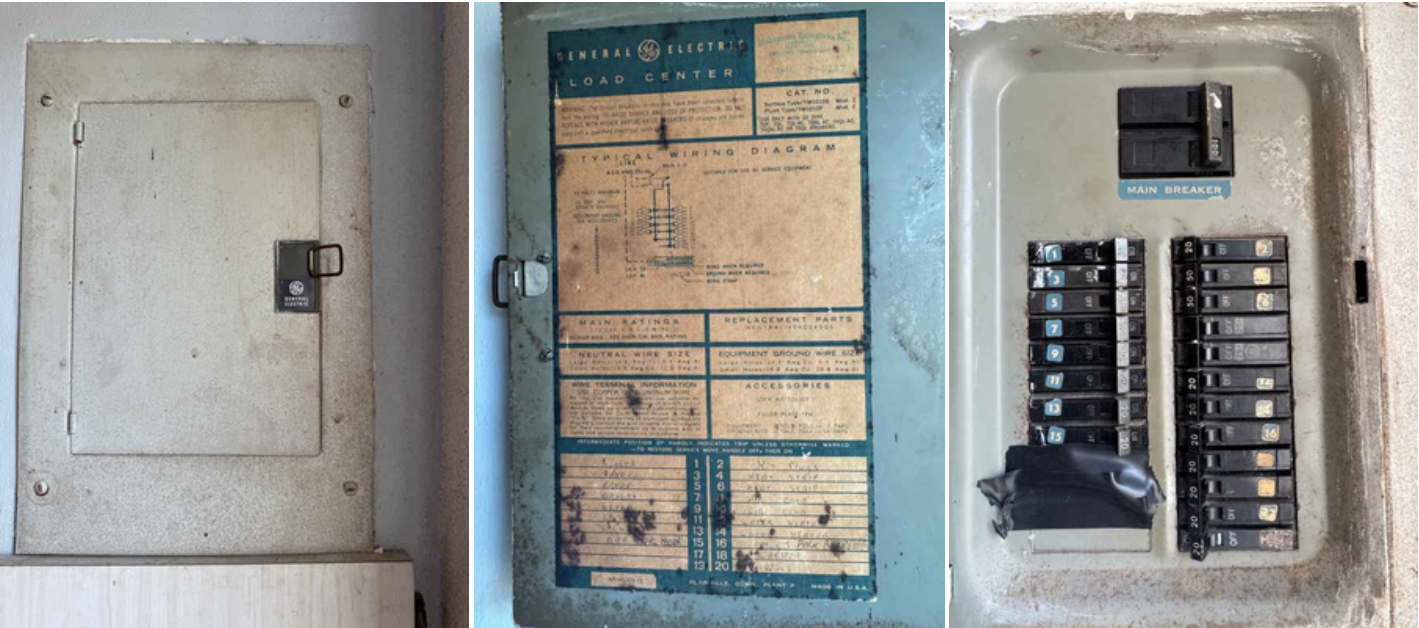
Panel Photos

General condition of the electrical system: ☐ Satisfactory ☒ Unsatisfactory (explain)

Knock-out covers missing.

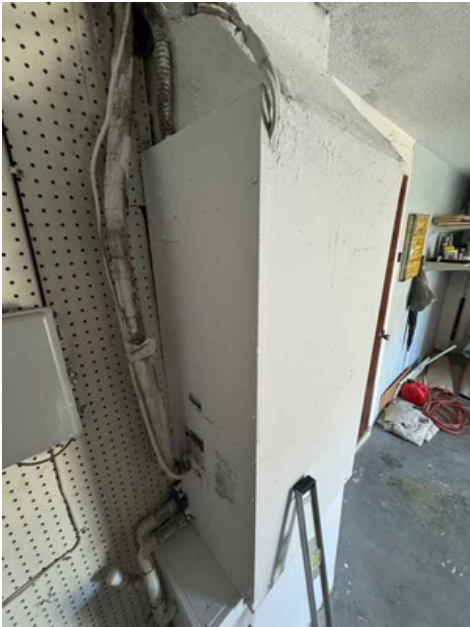
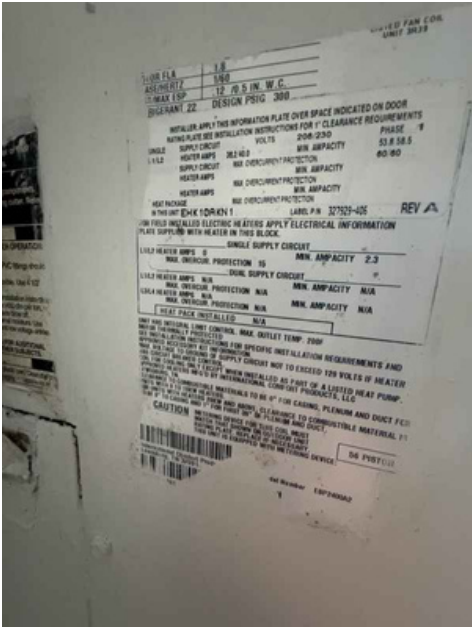
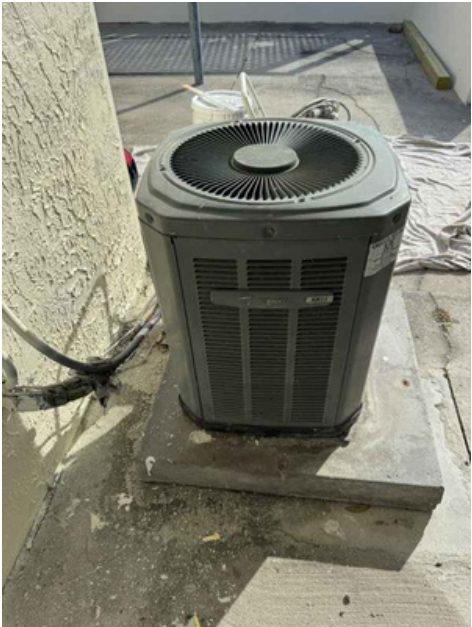
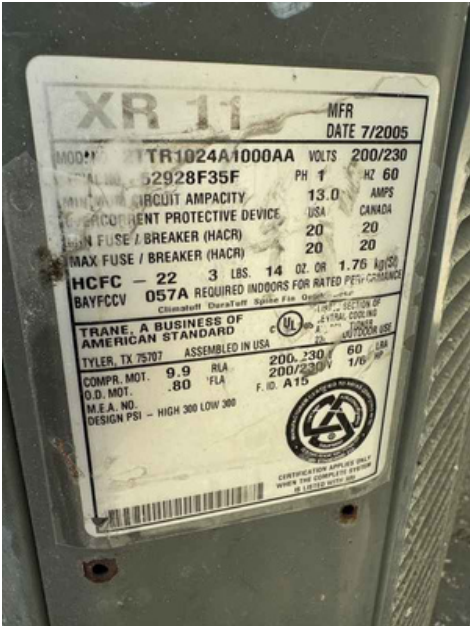
### HVAC Equipment

Central AC: ☒ Yes ☐ NoCentral heat: ☒ Yes ☐ NoIf not central heat, indicate **primary** heat source and fuel type: \_\_\_\_\_Are the heating, ventilation and air conditioning systems in good working order? ☒ Yes ☐ No (explain)

Wood burning stove or central gas fireplace *not professionally installed*? ☐ Yes ☒ NoSpace heater used as primary heat source? ☐ Yes ☒ NoIs the source portable? ☐ Yes ☒ NoDoes the air handler/condensate line or drain pan show any signs of blockage or leakage, including water damage to the surrounding area?  
☐ Yes ☒ No

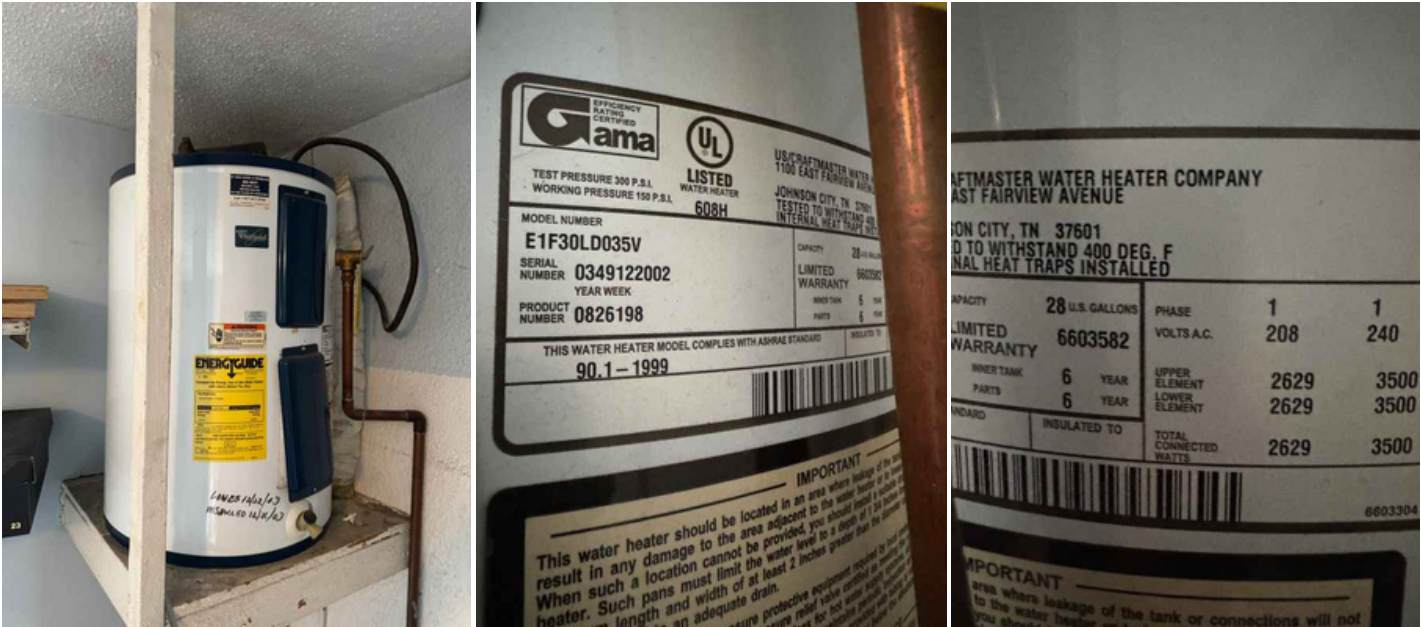
Plumbing System  
Water Heater

Is there a temperature pressure relief valve on the water heater? ☒ Yes ☐ NoIs there any indication of an active leak? ☐ Yes ☒ NoIs there any indication of a prior leak? ☐ Yes ☒ NoWater heater location: Garage

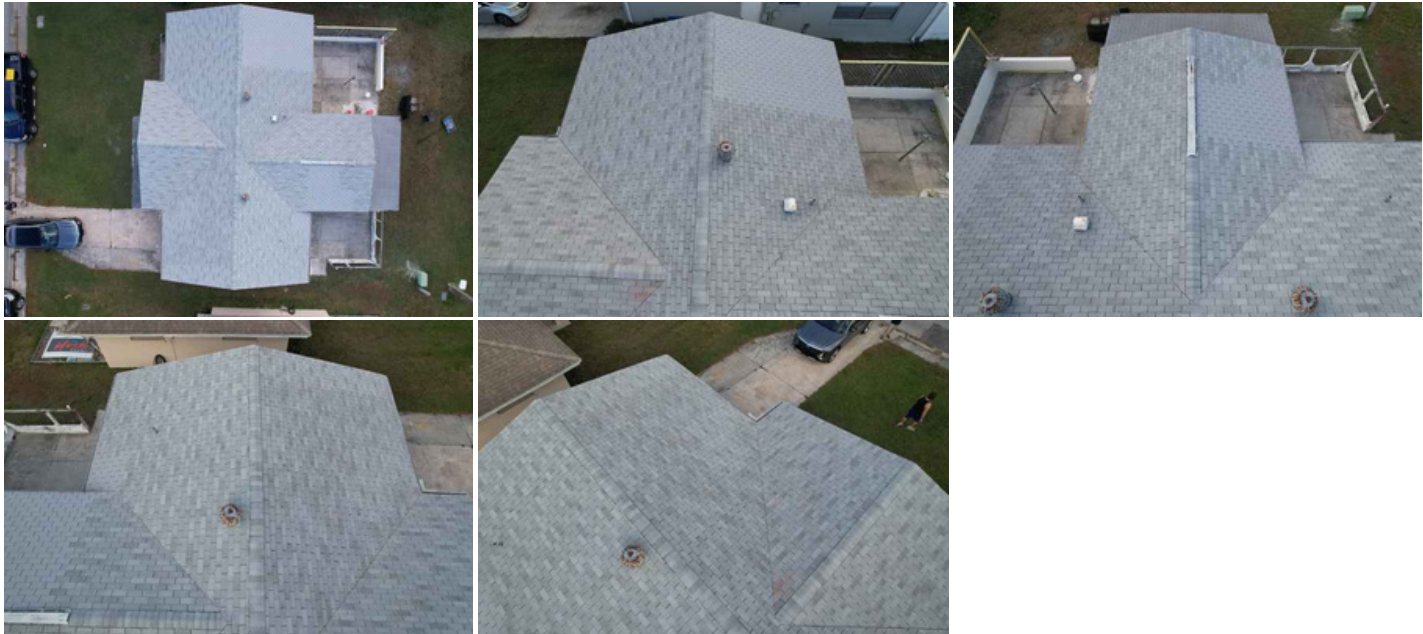
Roof  
Photos of Each Slope

☐ Cracking☐ Cupping/Curling☐ Excessive granule loss☐ Exposed asphalt☐ Exposed felt☐ Missing/loose/cracked tabs or tiles☐ Soft spots in decking☐ Visible hail damageAny visible signs of leaks ☐ Yes ☒ NoAttic/underside of decking ☐ Yes ☒ NoInterior ceilings ☐ Yes ☒ No
