# 2323 W Chestnut St

## Tampa, Florida 33607

**Major Systems Plus Report -  
2323 W Chestnut St**

**June 9, 2026, 3:00 PM EDT**

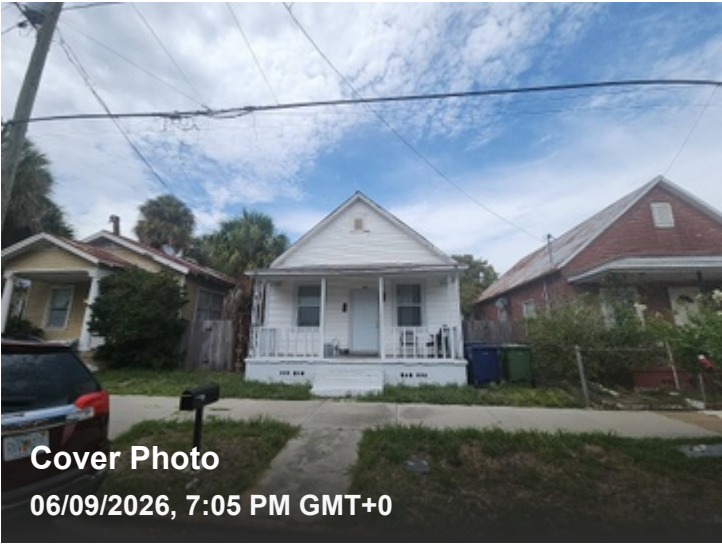
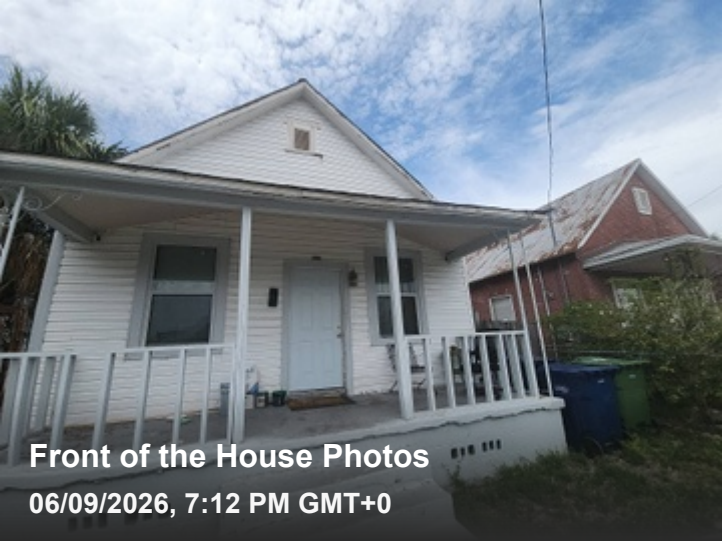
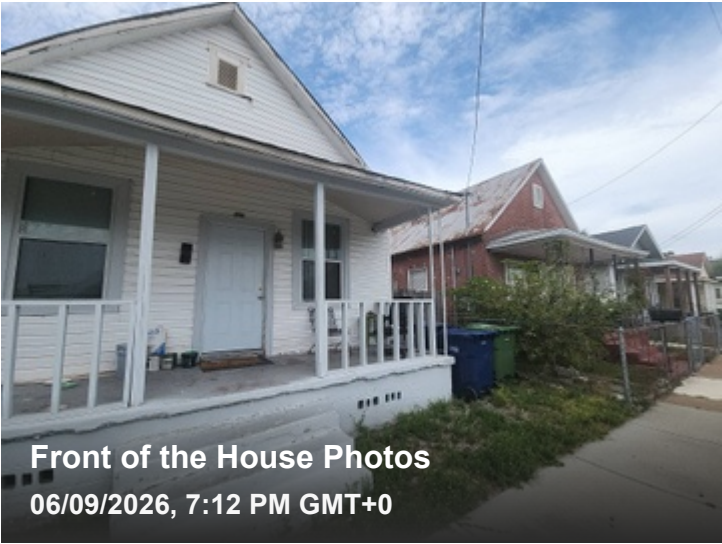
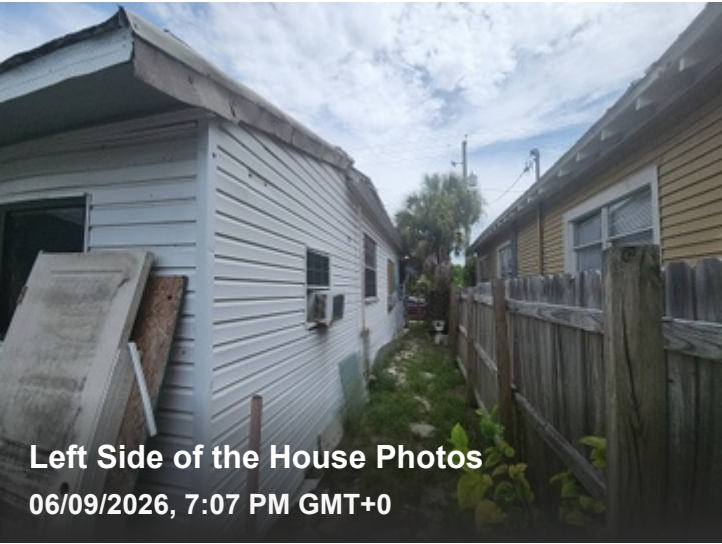
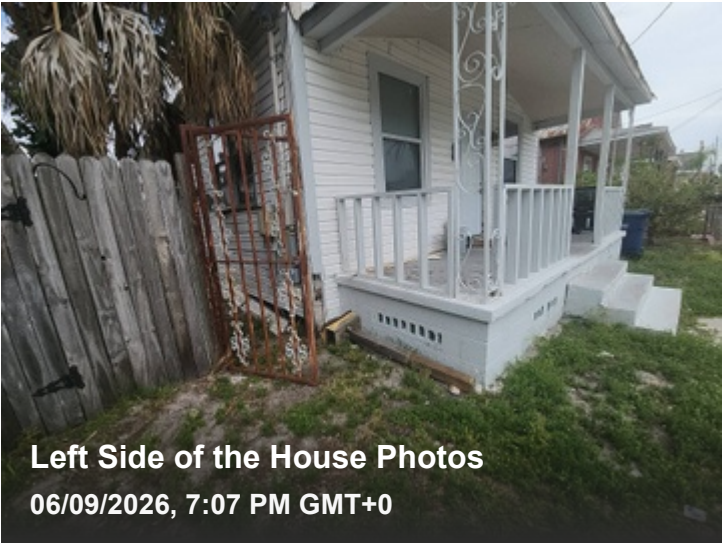
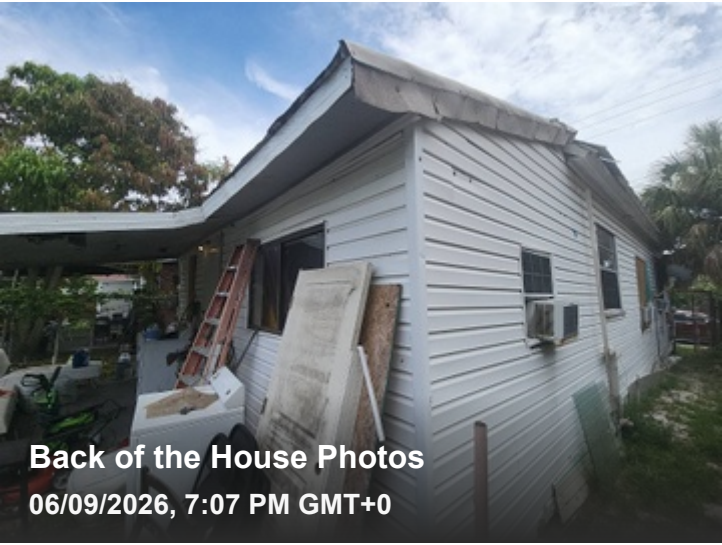
**Flooring was uneven at numerous areas throughout the interior, ceilings were damaged at various areas. Roof was damaged at various areas, exterior siding/ trim was damaged at various areas. Crawlspace was limited visual, due to height to get under/ debris underneath made it difficult to get under.**

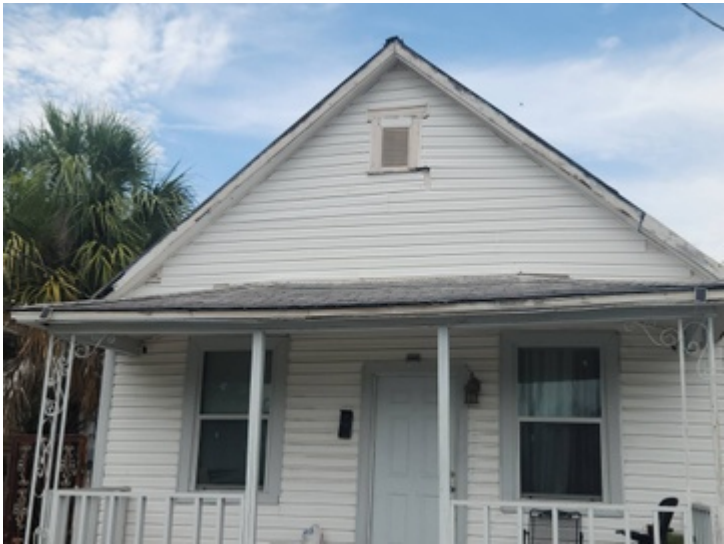
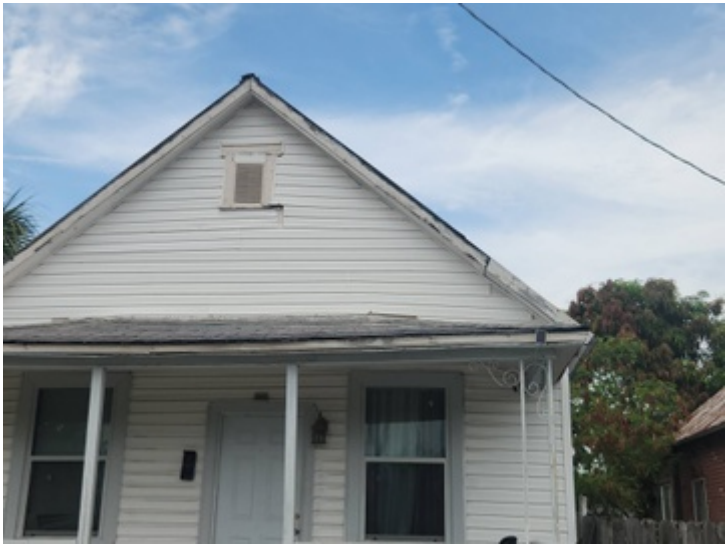
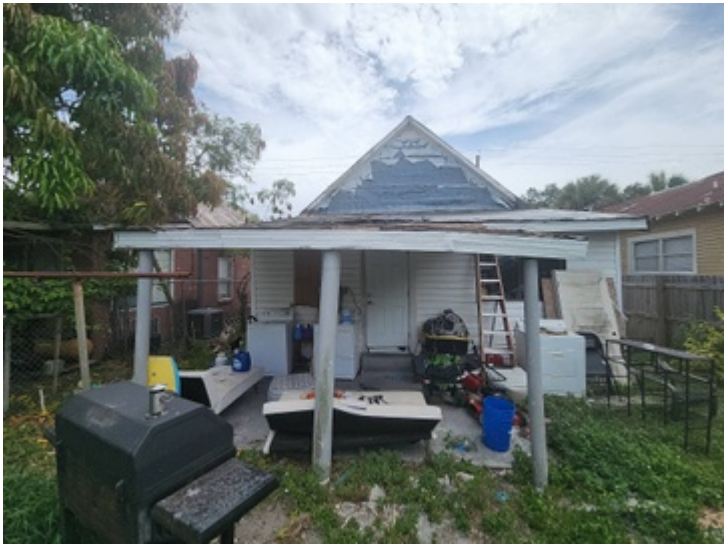
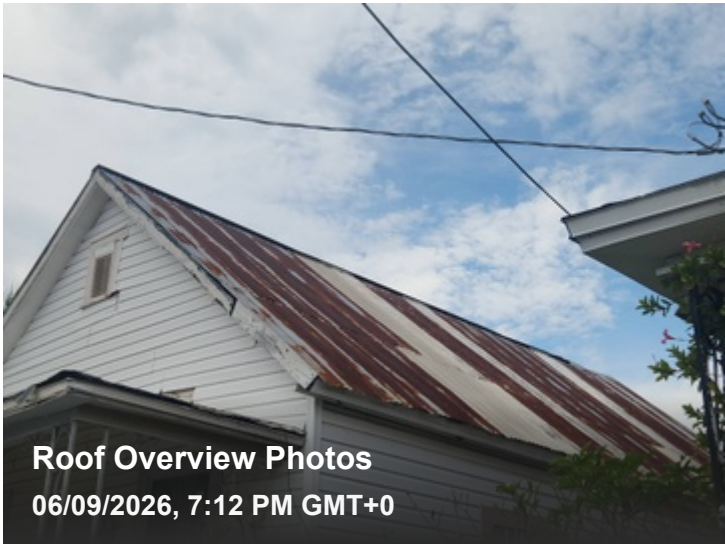
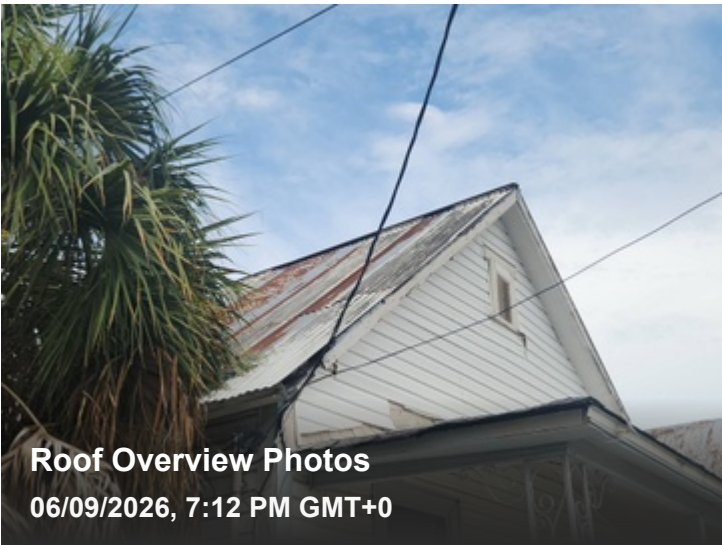
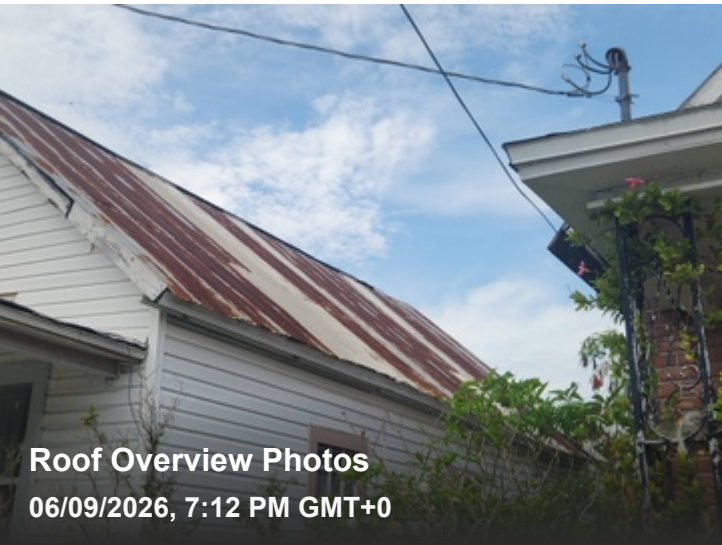
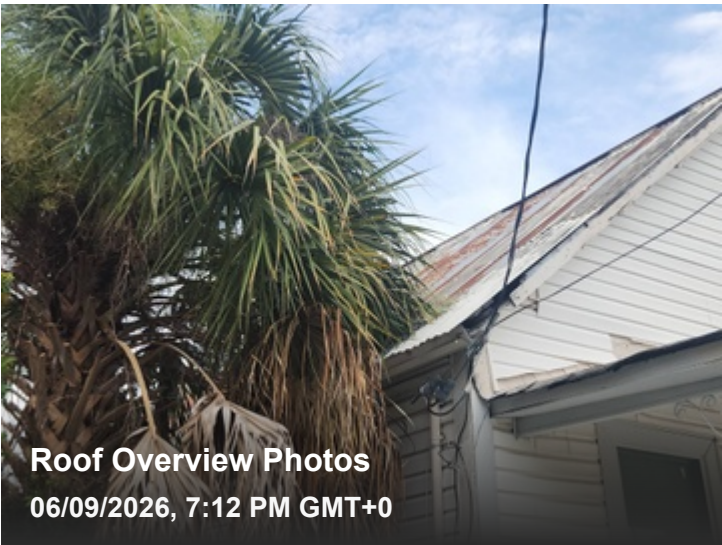
Roof Inspection Method  
Viewed from Ground Level

There are components of the roof that are not visible or accessible, including the underlayment, decking, fastening, flashing, age, shingle quality, manufacturer installation recommendations, etc.

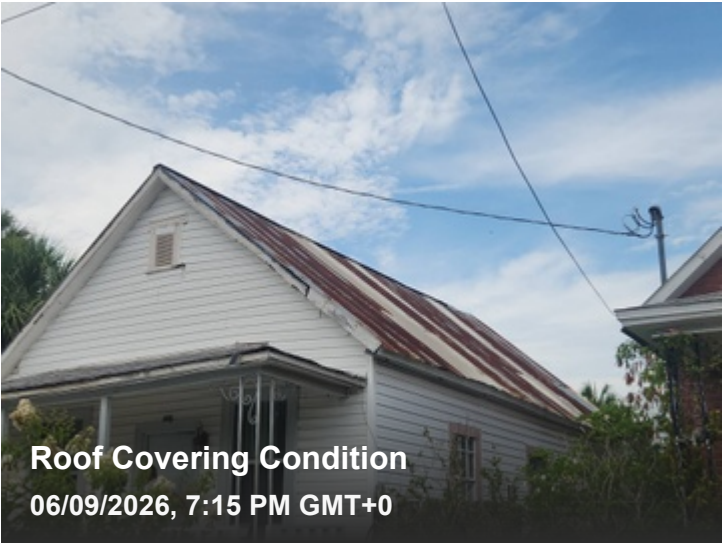
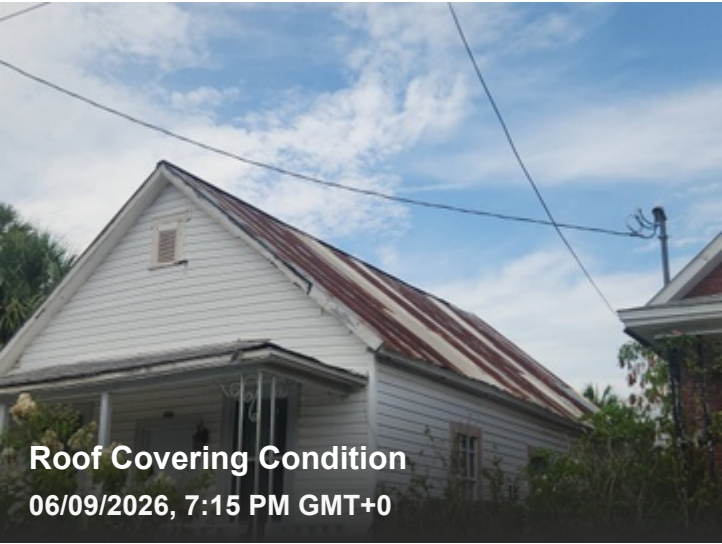
**Poor (Significant Repairs)**

The roof shingles are nearing their end of life. Recommend further evaluation by a qualified professional.

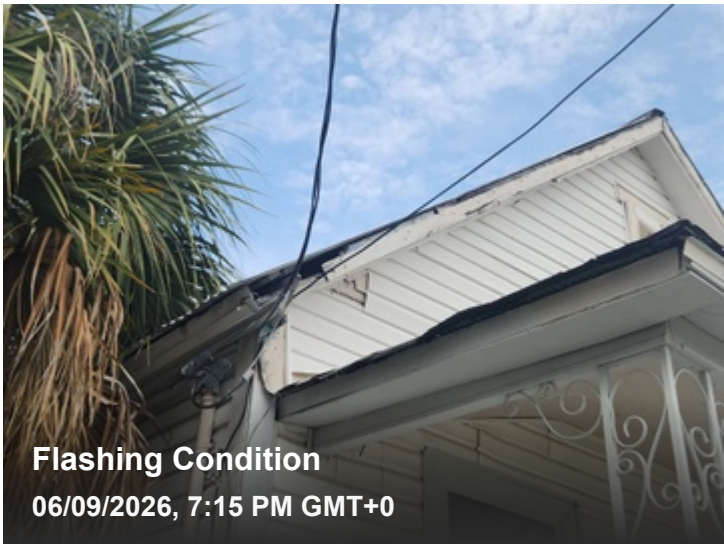
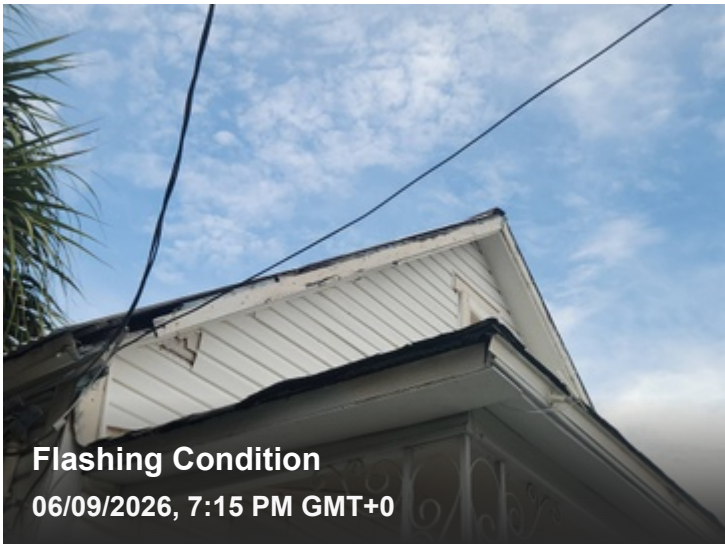
Flashing Condition  
**Poor (Significant Repairs)**

The flashing is damaged.

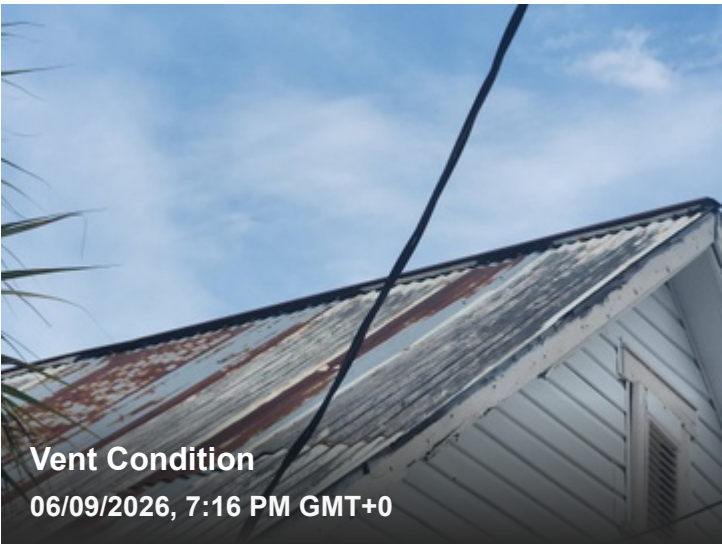
**Poor (Significant Repairs)**

One or more roof vents are damaged. Recommend further evaluation by a qualified professional.

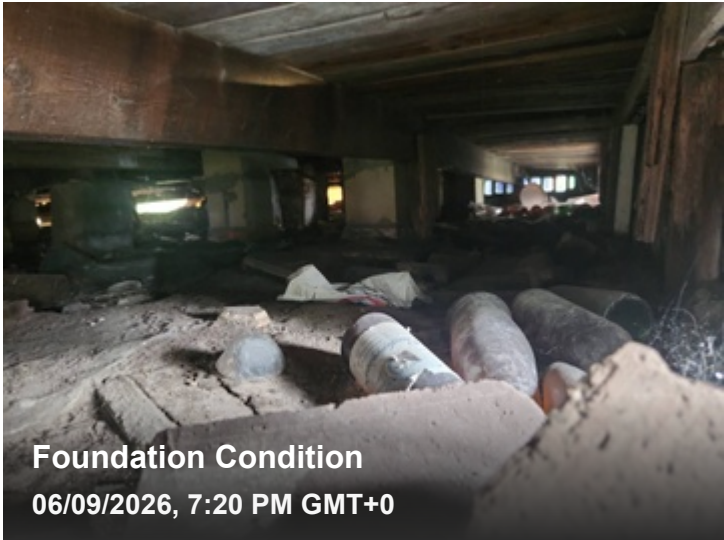
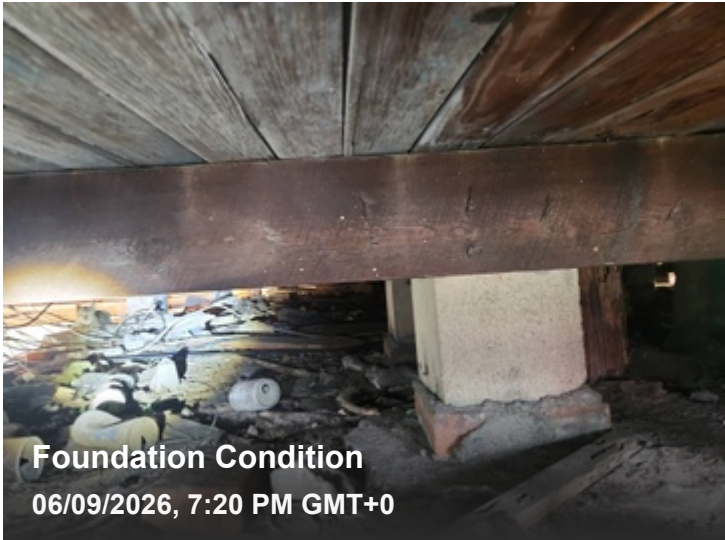
Fair (Some Repairs)

A wooden support is touching the ground, which is conducive to wood-destroying organisms. Recommend further evaluation by a qualified professional.

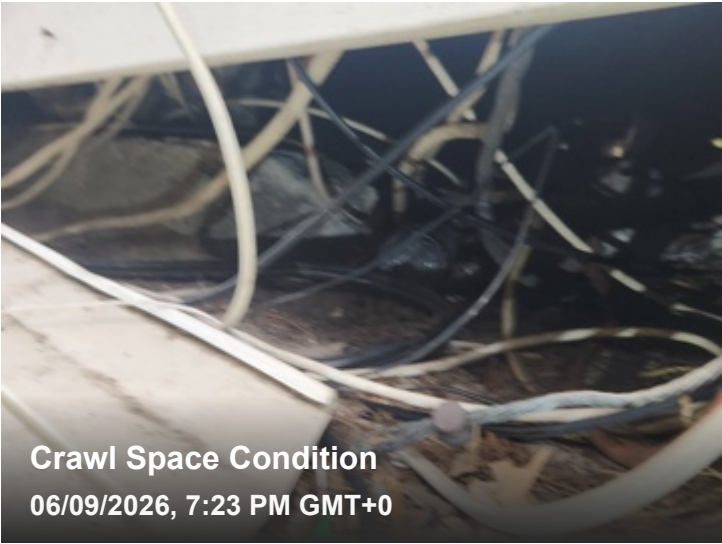
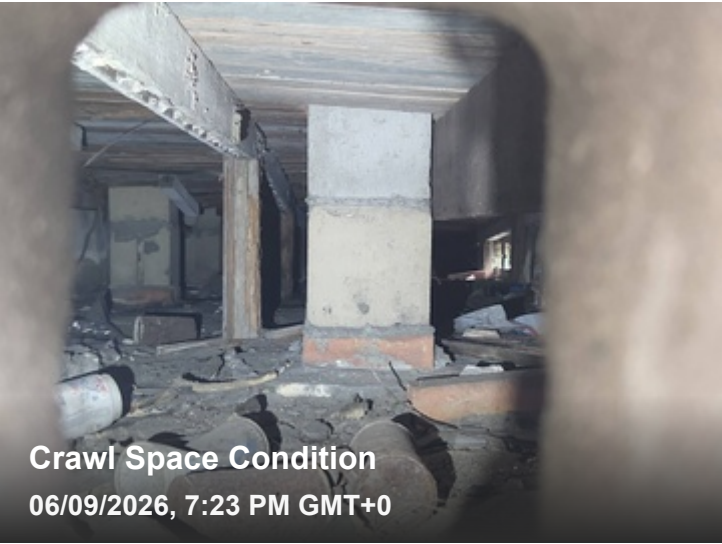
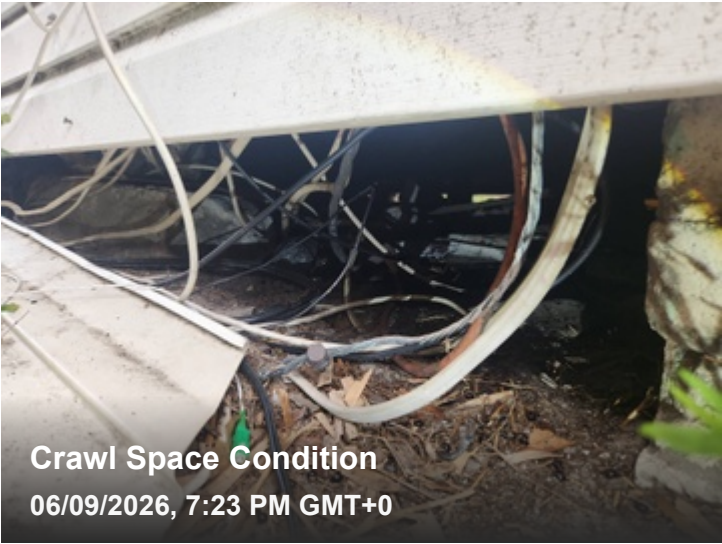
Crawl Space Condition  
06/09/2026, 7:23 PM GMT+0

Wood rot is observed on / in the property. Recommend further evaluation by a qualified professional.

The vapor barrier is missing.

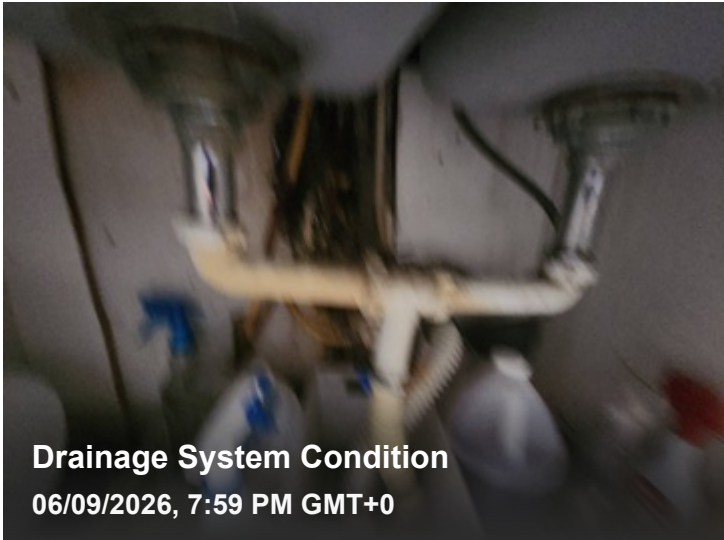
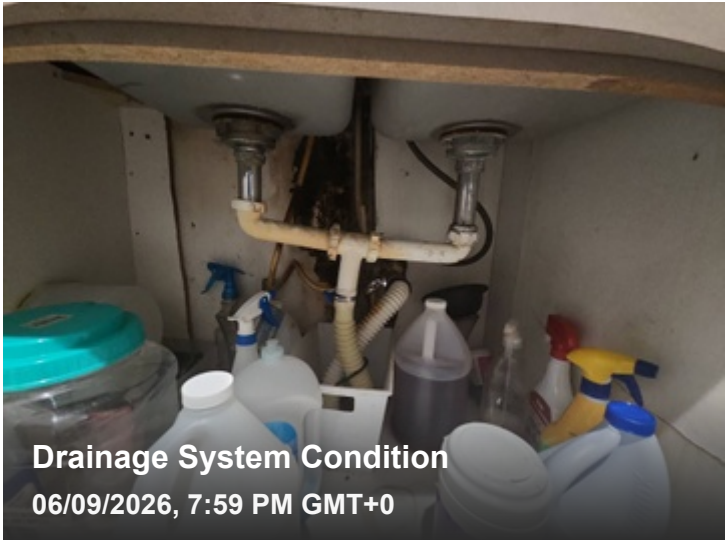
Poor (Significant Repairs)

A drain / waste / vent pipe is leaking.

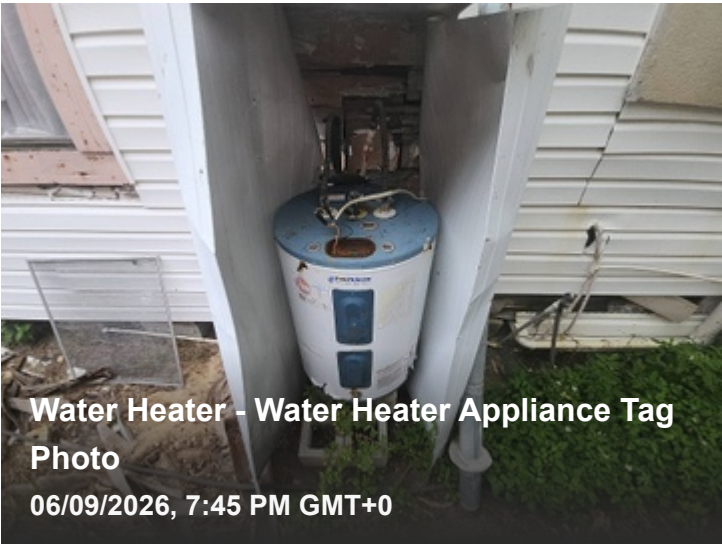
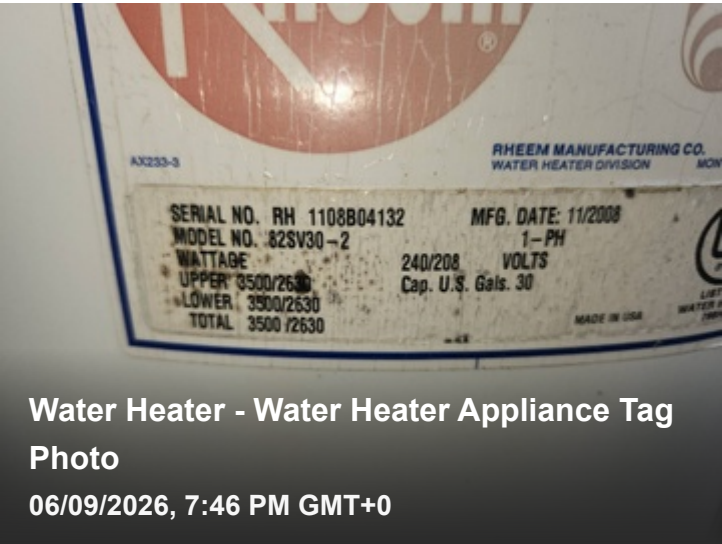
Water Heater photos / videos

Water Heater Condition

Poor (Significant Repairs)

## Corroded Water Heater

The water heater fittings are corroded.
