# 2414 E North Bay St

## Tampa, Florida 33610

**Major Systems Plus Report -  
2414 E North Bay St**

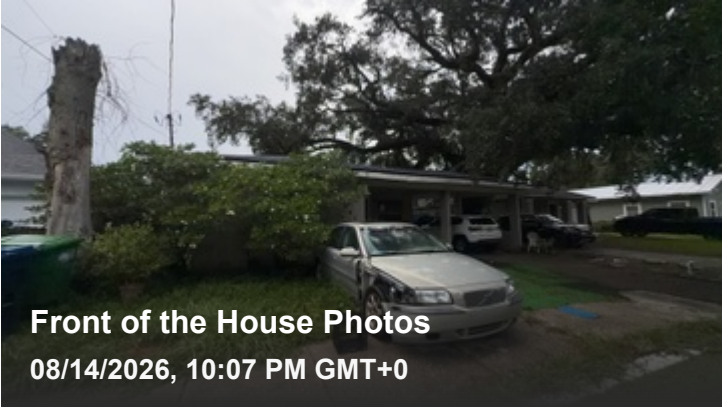
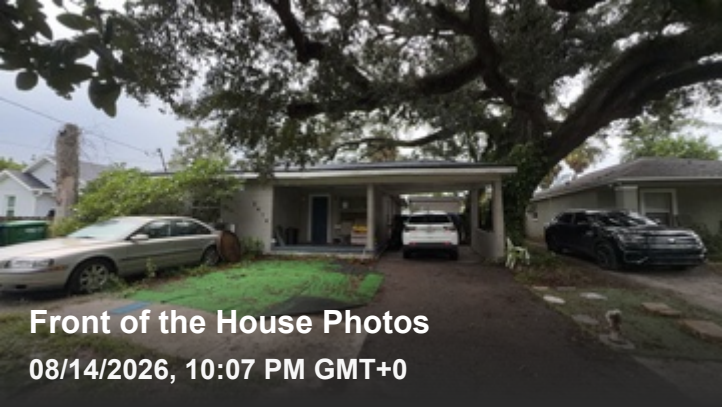
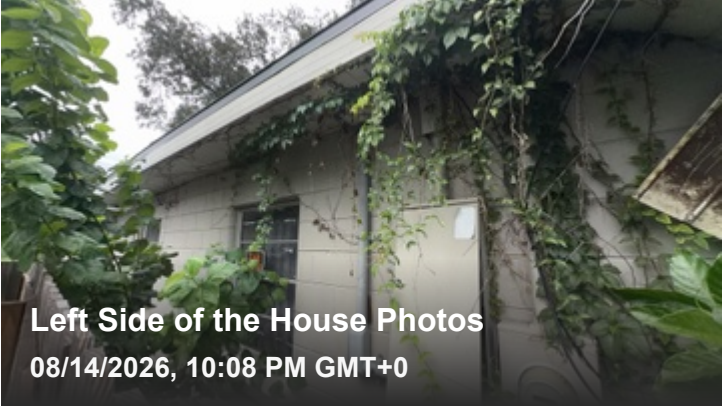
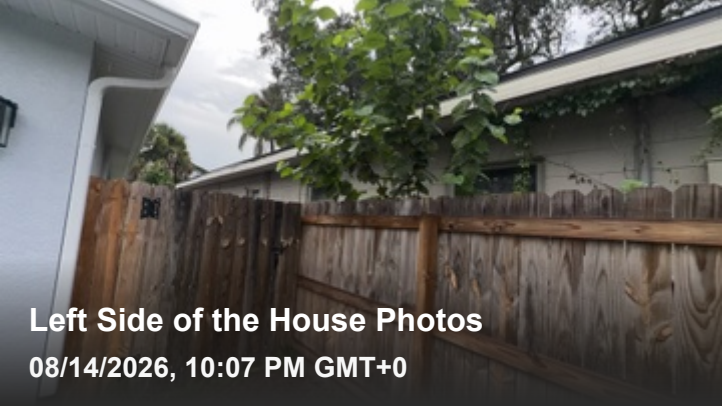
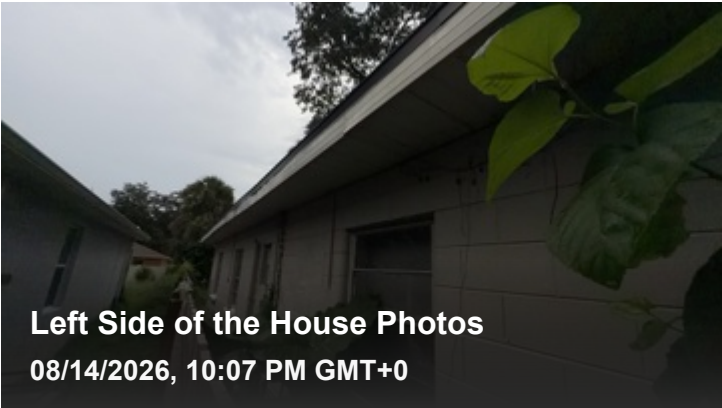
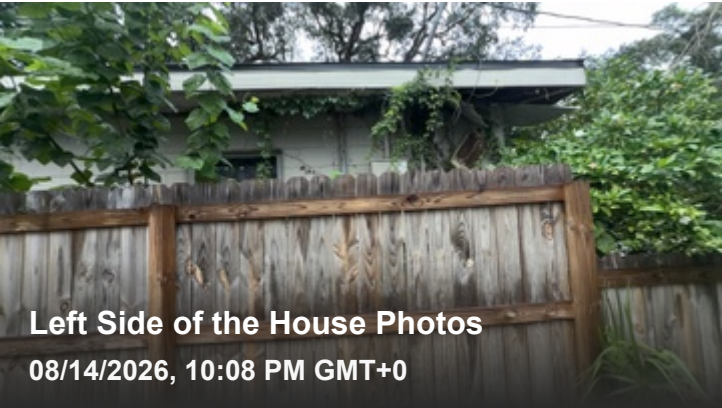
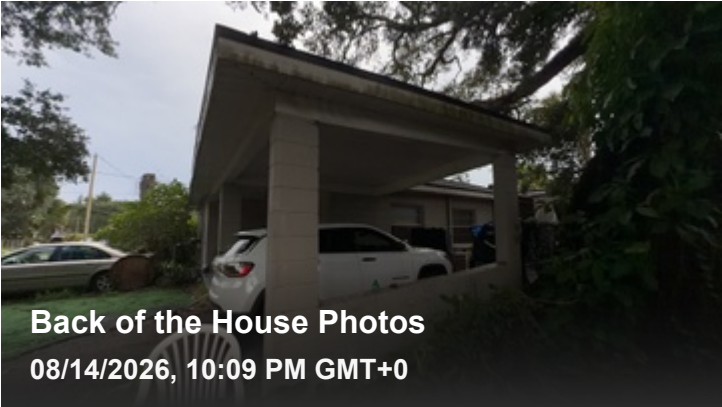
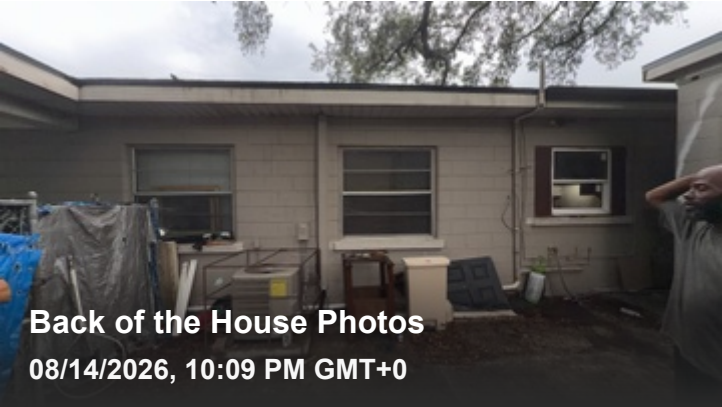
The tower of the house needs to be cleaned because full of garbage and user materials littered the floor of difficulties to pass on the side of the house due to a lot of debris and foliage.

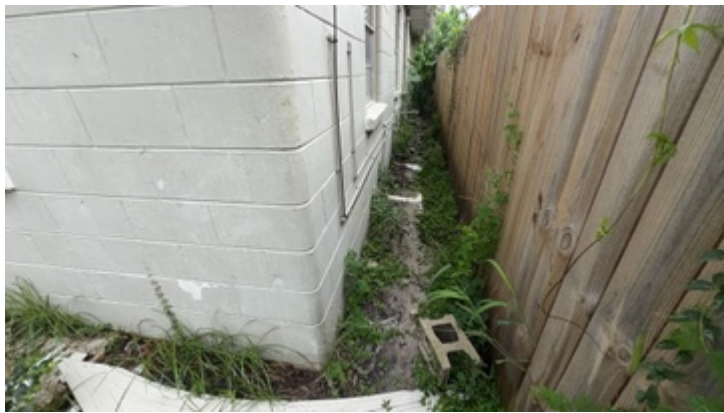
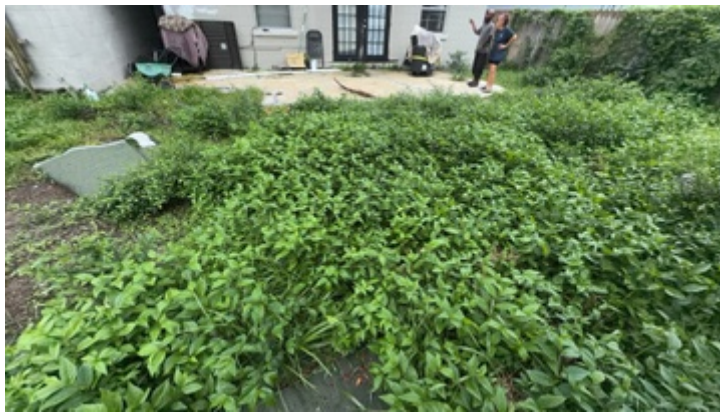
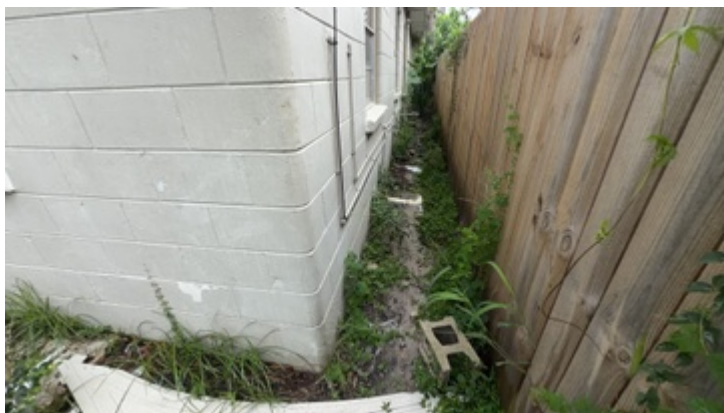
There is overgrown vegetation / weeds on one or more areas of the property.

**The garden is not maintained and pieces of fake lawn splot the ground with a bad smell**

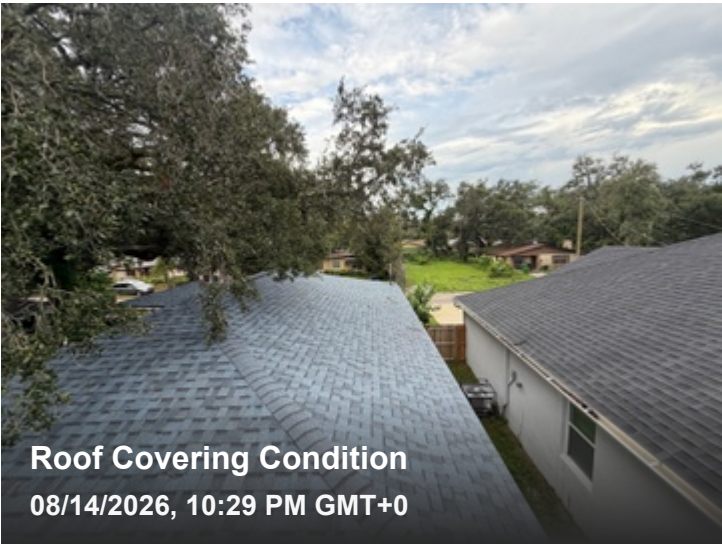
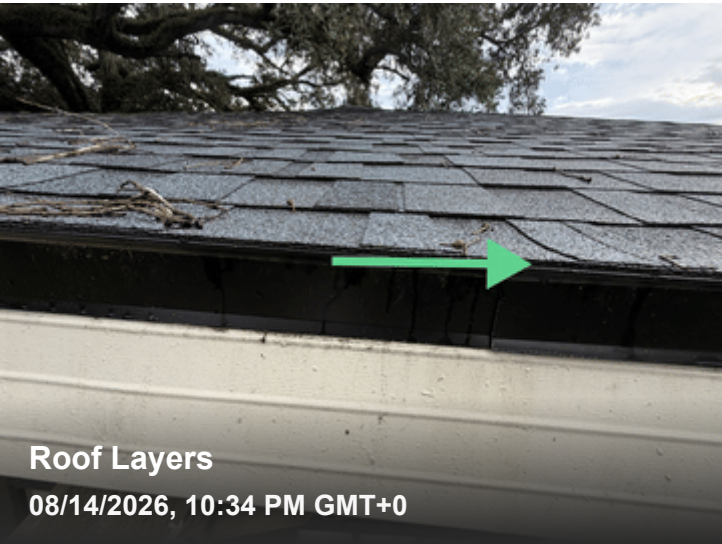
Great (No Repairs)

The roof was redone a year ago

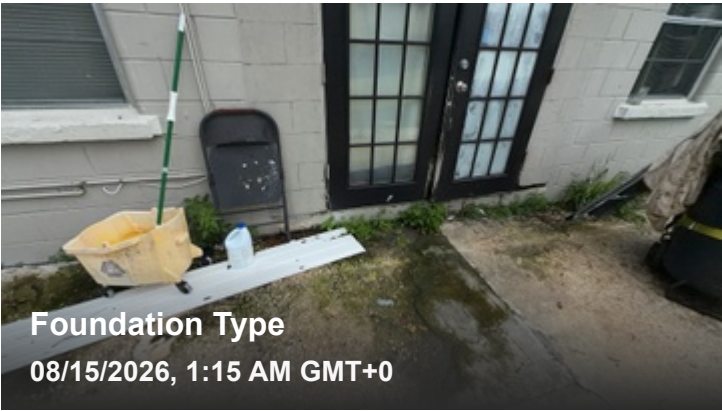
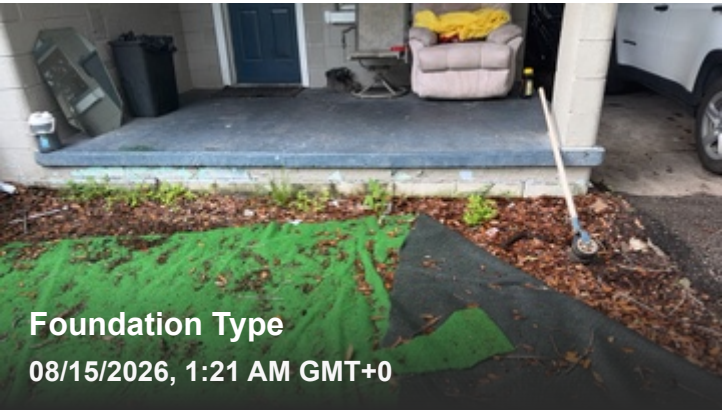
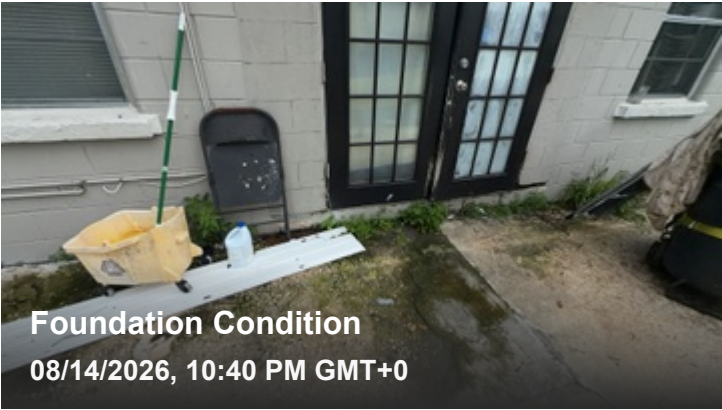
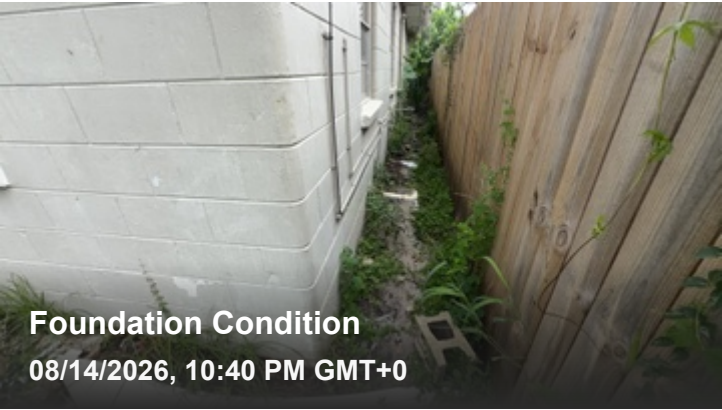
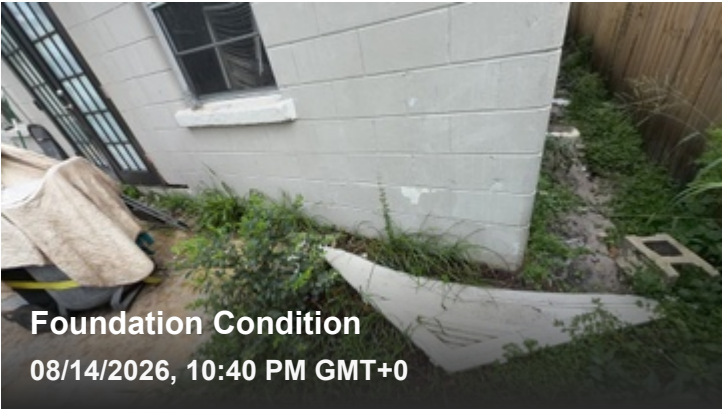
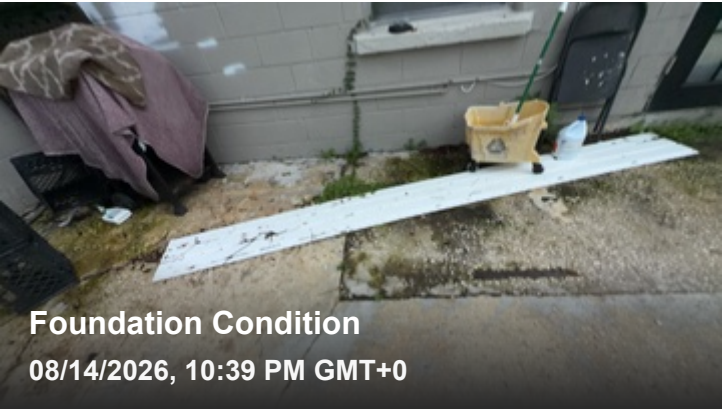
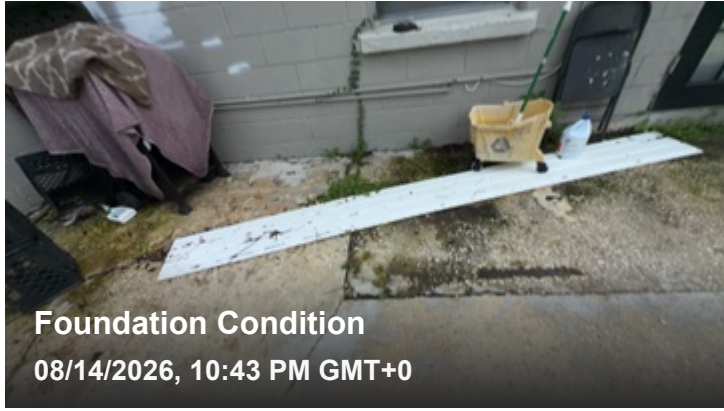
The property appears to be constructed on a concrete slab-on-grade foundation. No crawlspace or basement was observed

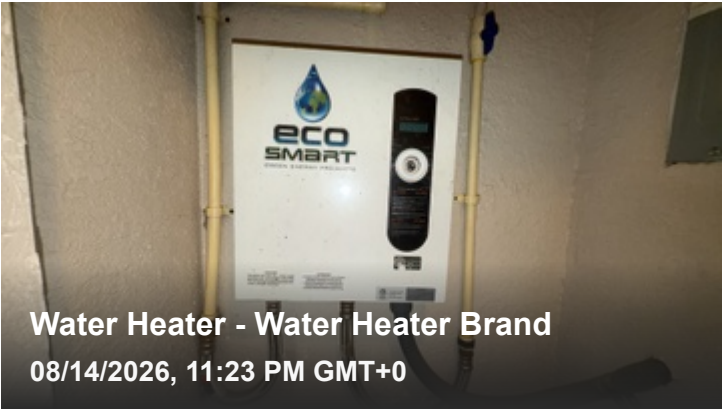
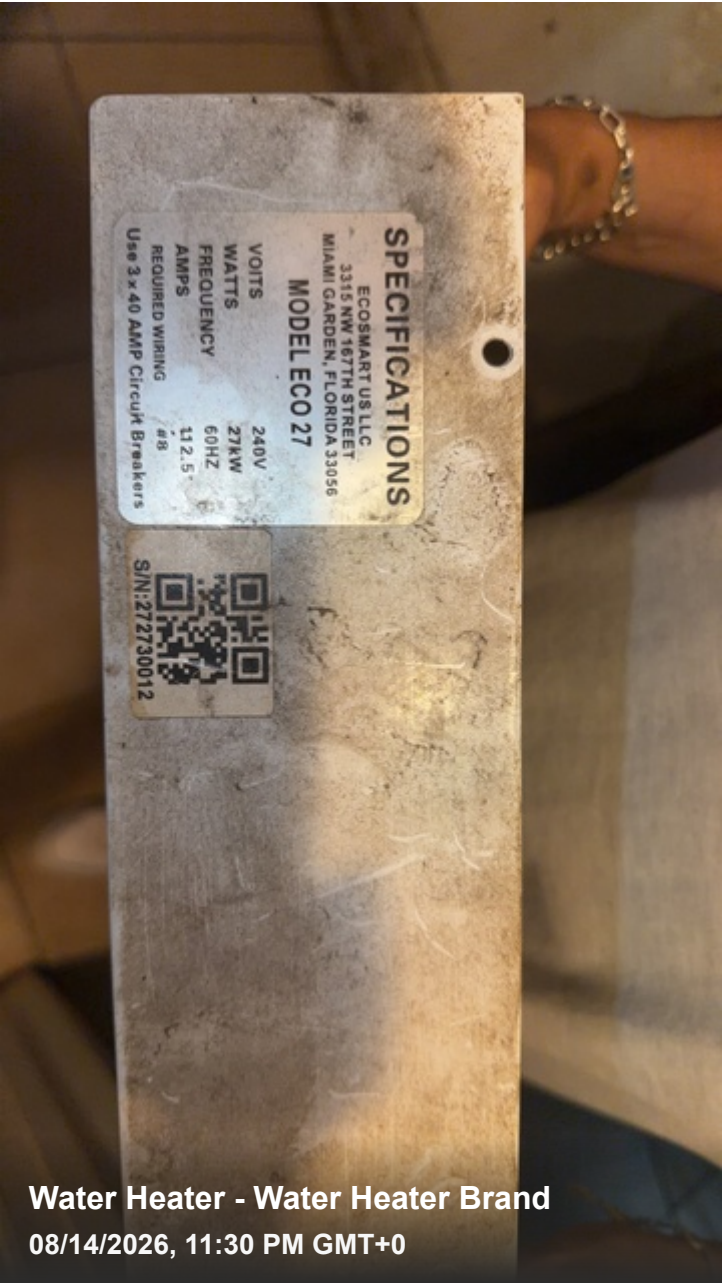
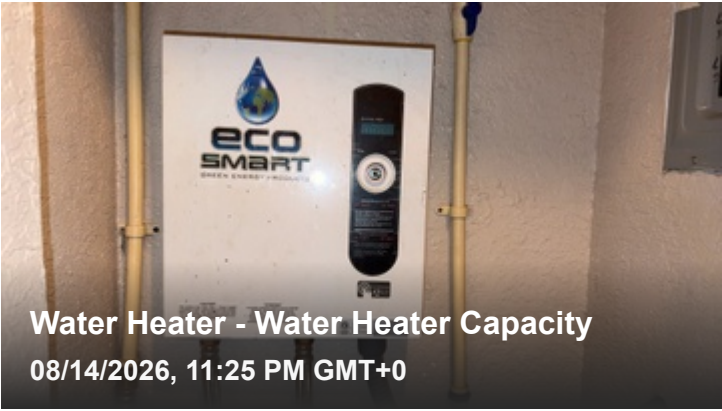
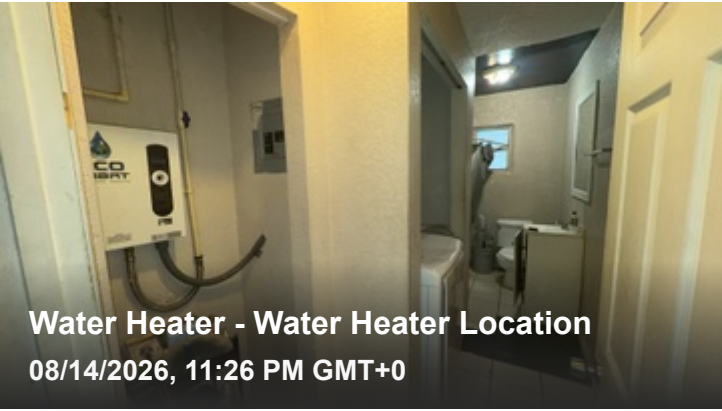
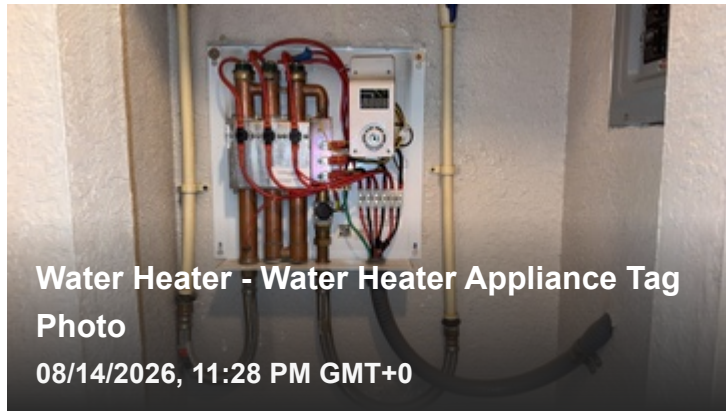
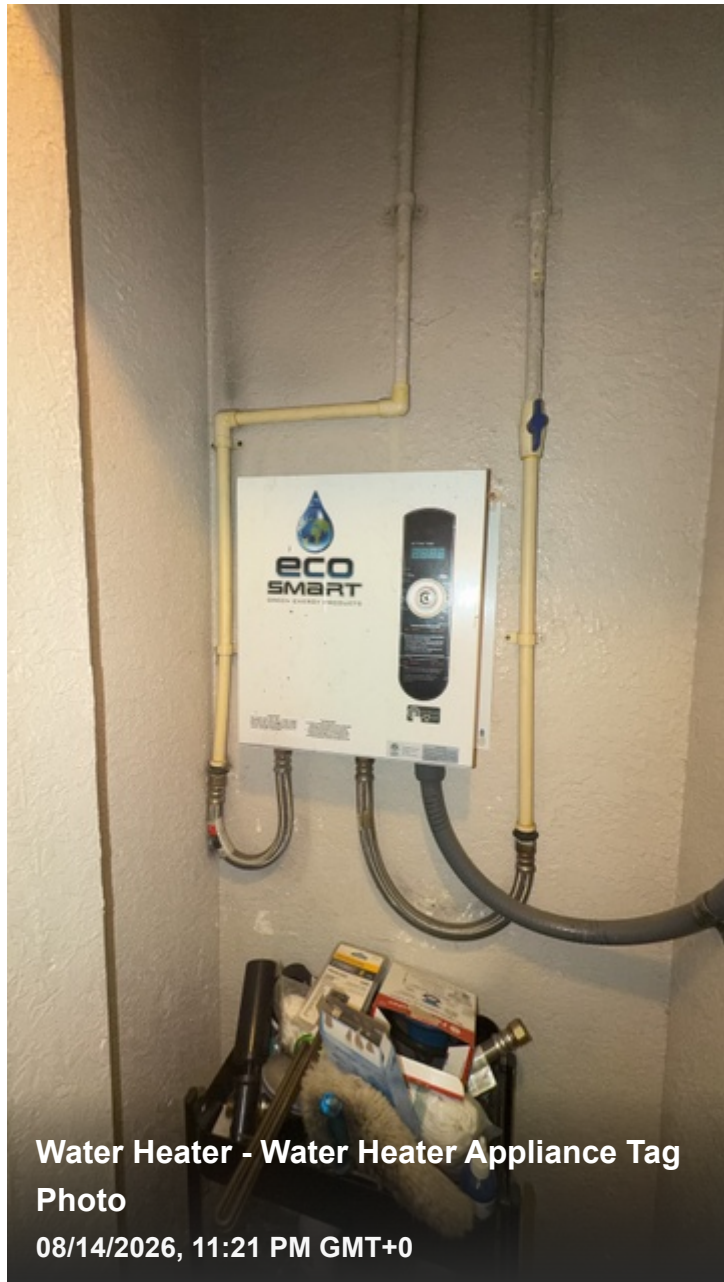
Water Heater photos / videos

Poor (Significant Repairs)

## Water Heater has Signs of a Leak

The water heater shows signs of a leak.

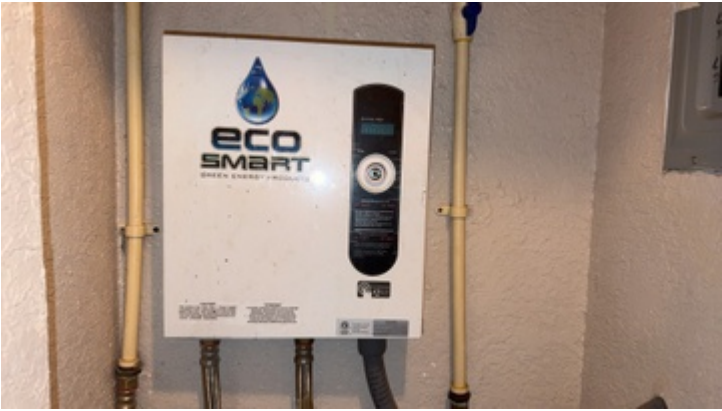
Water Heater photos / videos

There is no buffer tank it is an instant heating

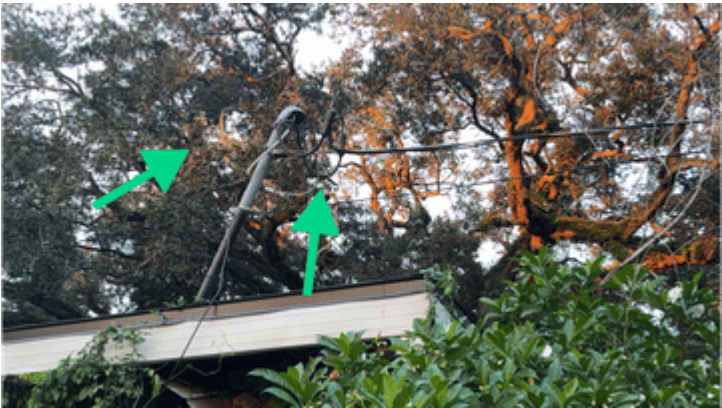
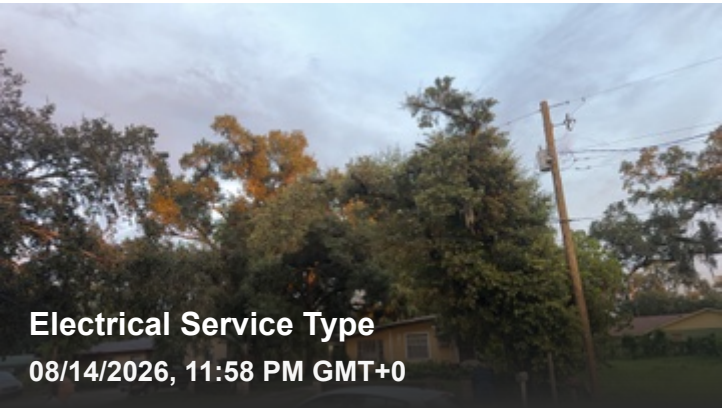
Service Entrance Conductors photos / videos

The overhead electrical service mast is visibly leaning and is not properly aligned. Evaluation and repair by a licensed electrician are recommended to ensure the service entrance is securely supported.

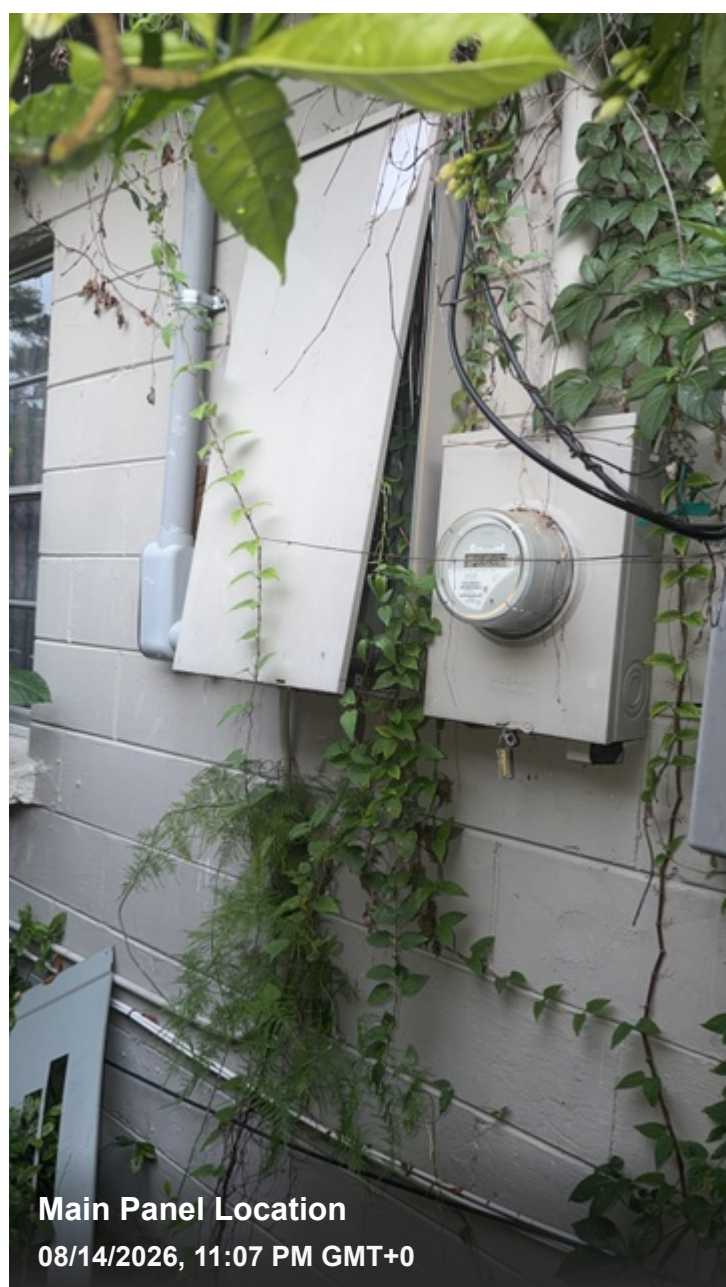
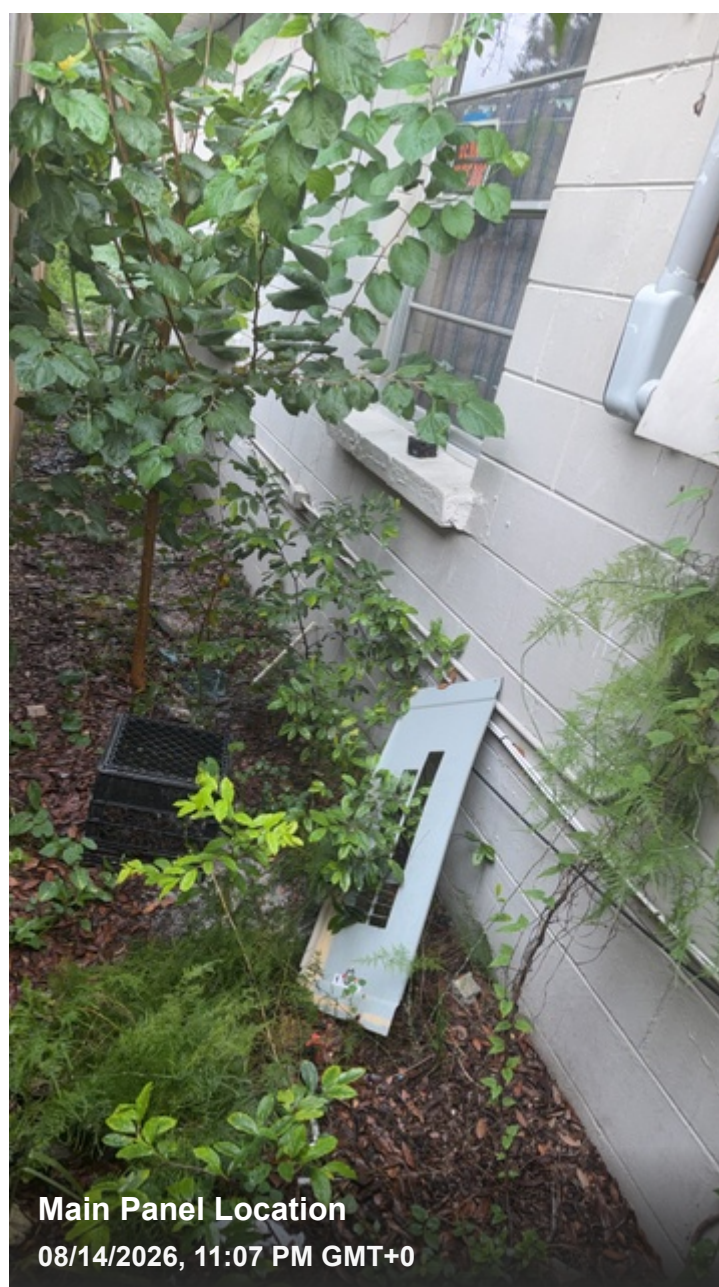
Electrical Panels, Grounding, Main Overcurrent Device

Poor (Significant Repairs)

**Safety hazard: The exterior main electrical panel cover is detached and lying on the ground, leaving the electrical equipment improperly protected and potentially exposed to moisture, vegetation, and accidental contact. This condition presents a risk of electric shock, arcing, and fire. Do not touch the panel. Immediate evaluation and repair by a licensed electrician are strongly recommended**

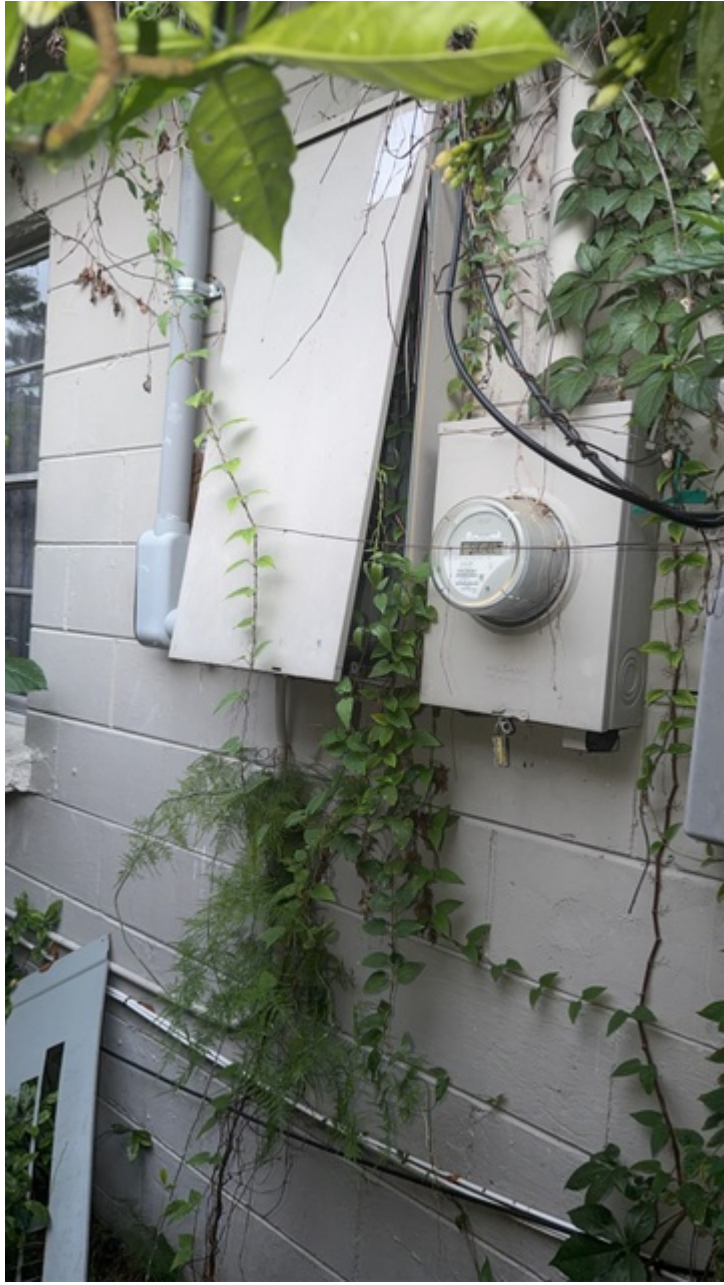
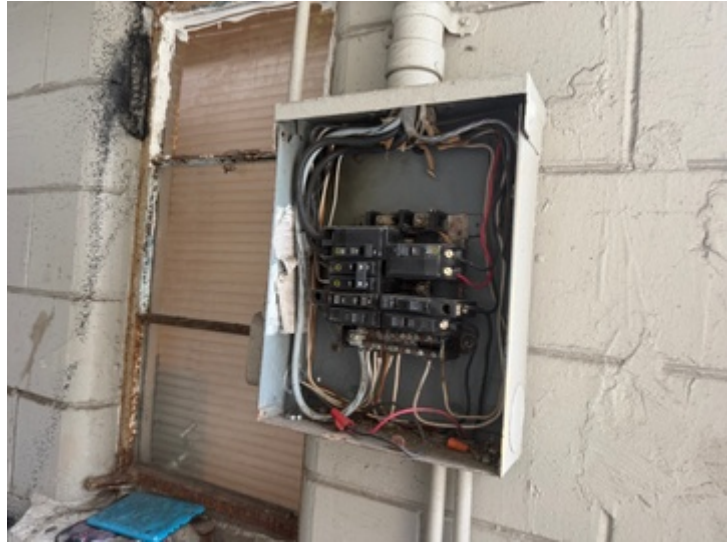
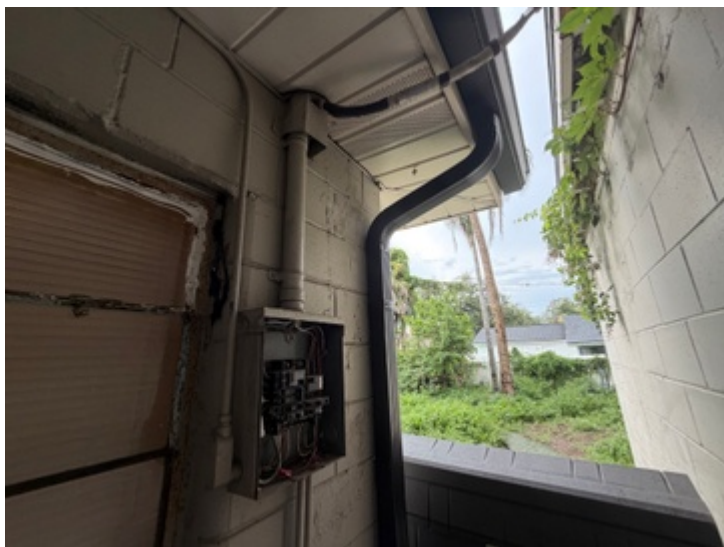
Electrical Panels, Grounding, Main Overcurrent Device  
photos / videos

## Missing / Incorrect Screws for Electrical Panel

There are missing / incorrect screws.

The wiring type could not be safely confirmed due to exposed energized components and the missing panel cover. Further evaluation by a licensed electrician is recommended

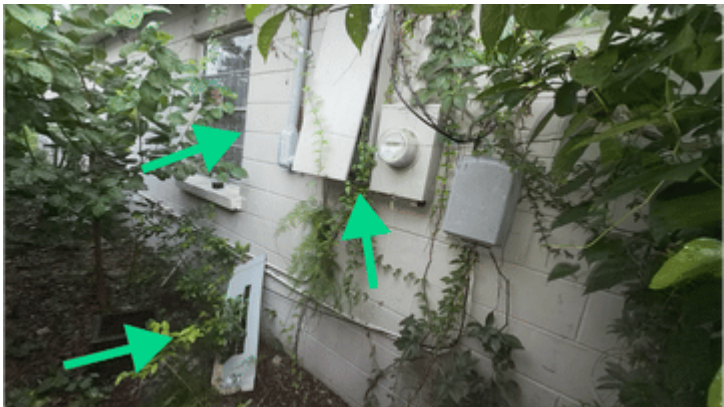
Electrical Panels, Grounding, Main Overcurrent Device  
photos / videos

**Electrical Main Panel Brand: No Access**

The panel brand could not be safely determined because the exterior electrical panel cover was detached and the electrical components were potentially exposed

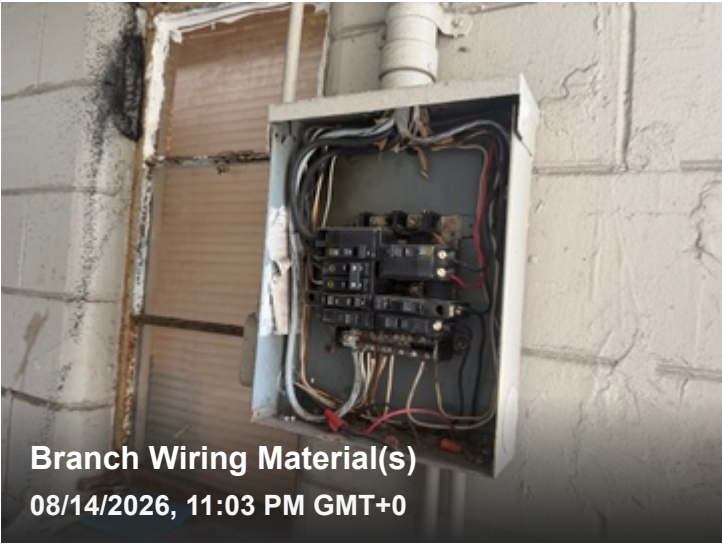
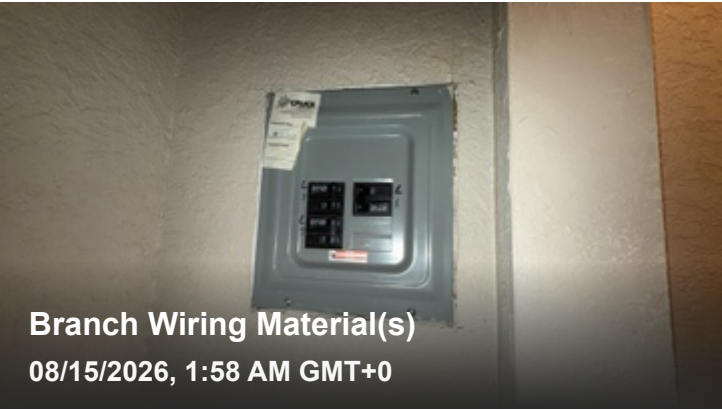
Branch Wiring photos / videos

Note  
**An electrical panel is located next to the electric water heater and has no unidentifiable marking**

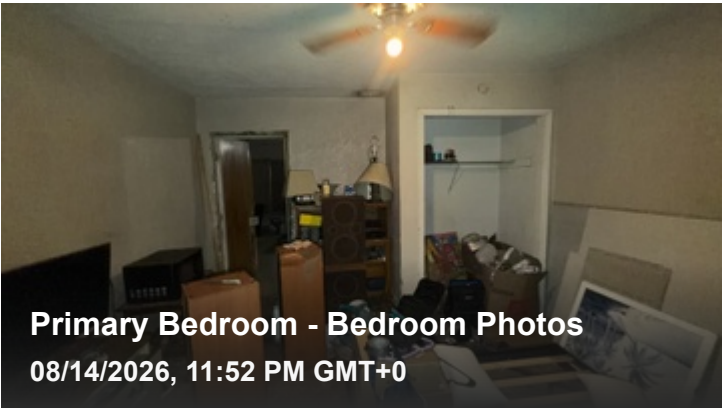
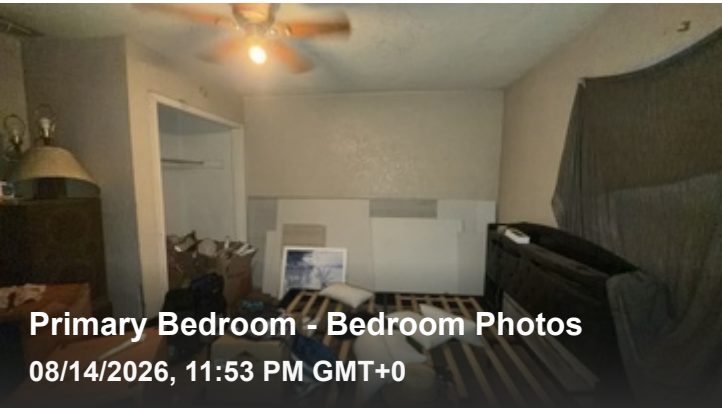
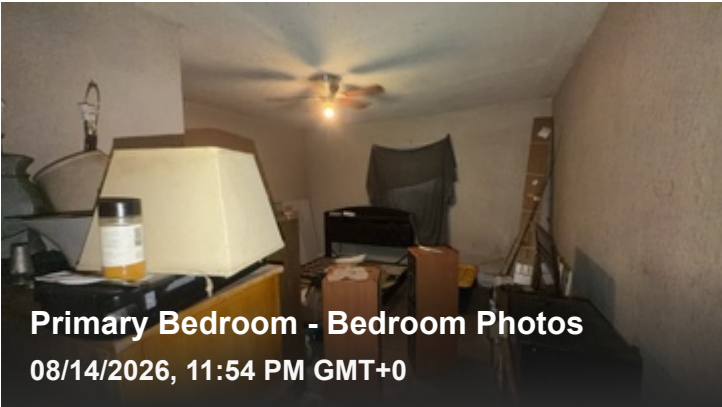
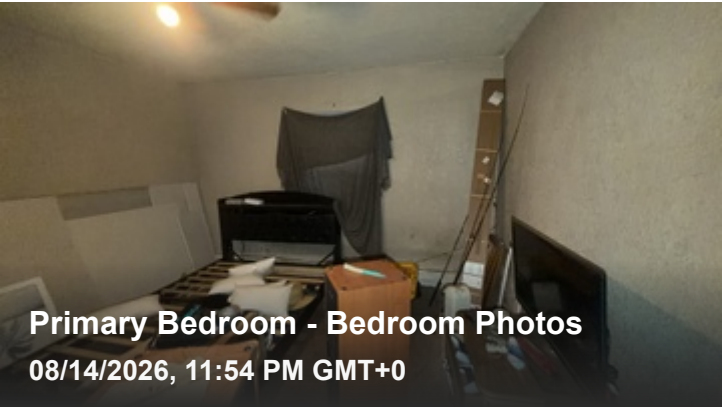
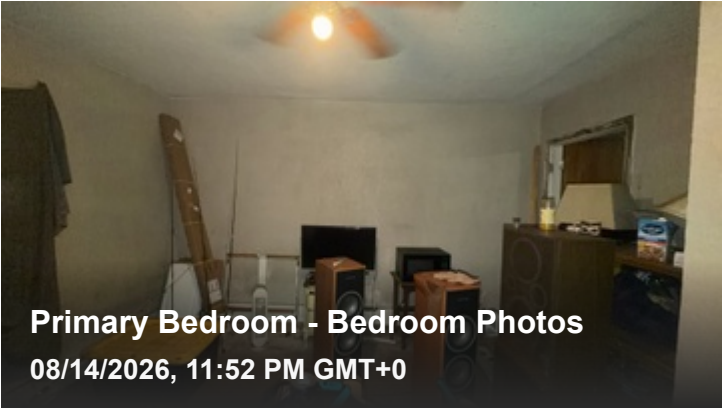
### Primary Bedroom photos / videos

The room contains excessive stored items and personal belongings, significantly limiting access and visibility of the walls, flooring, windows, and electrical components. A complete inspection of this area could not be performed. The clutter also presents a potential trip and safety hazard. Removal and organization of the stored items are recommended.

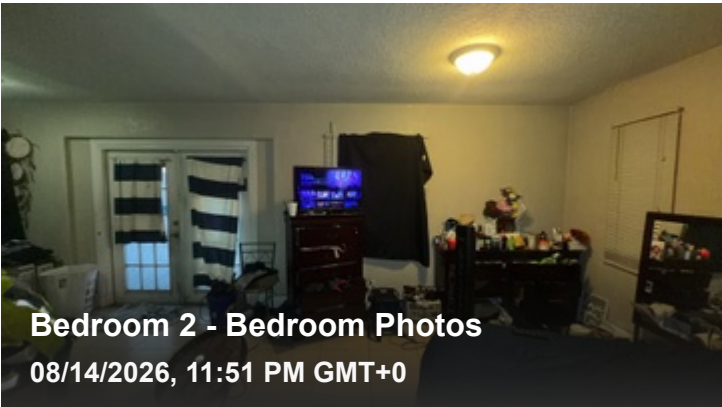
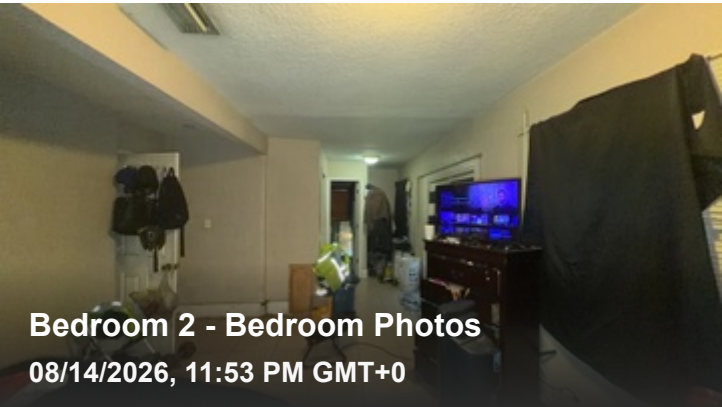
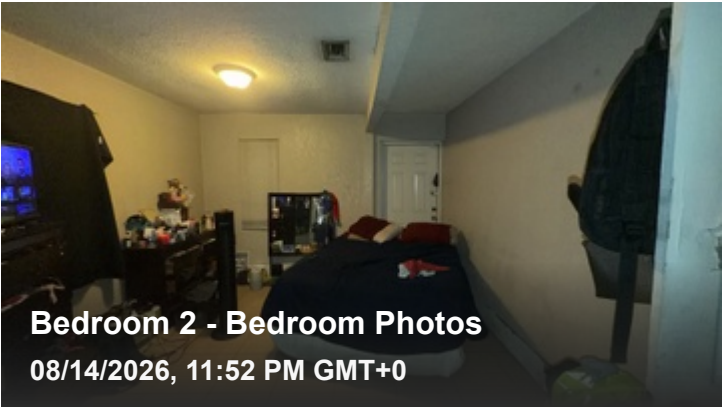
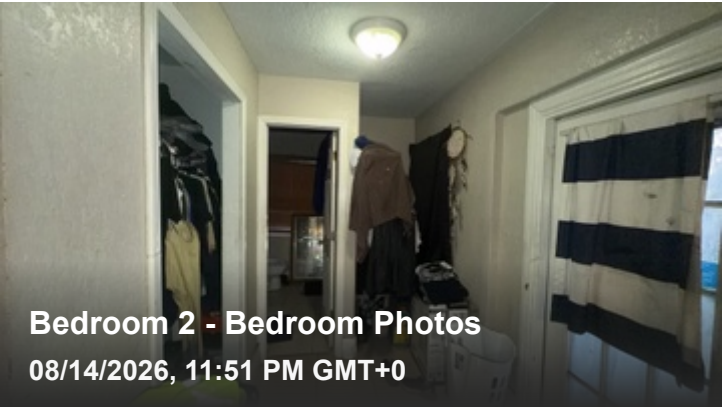
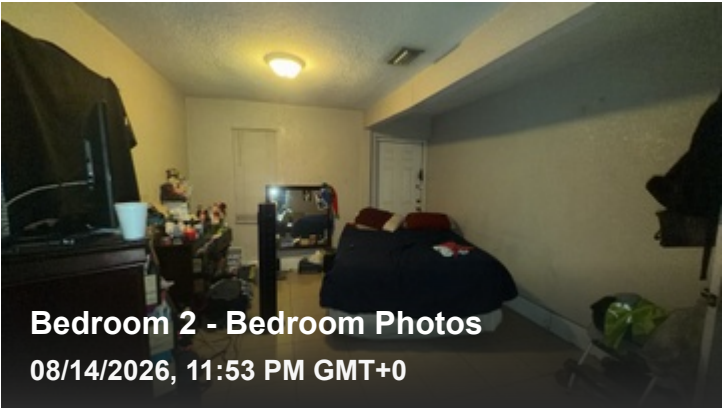
Bedroom 2 photos / videos

The room contains excessive stored items and personal belongings, significantly limiting access and visibility of the walls, flooring, windows, and electrical components. A complete inspection of this area could not be performed. The clutter also presents a potential trip and safety hazard. Removal and organization of the stored items are recommended.

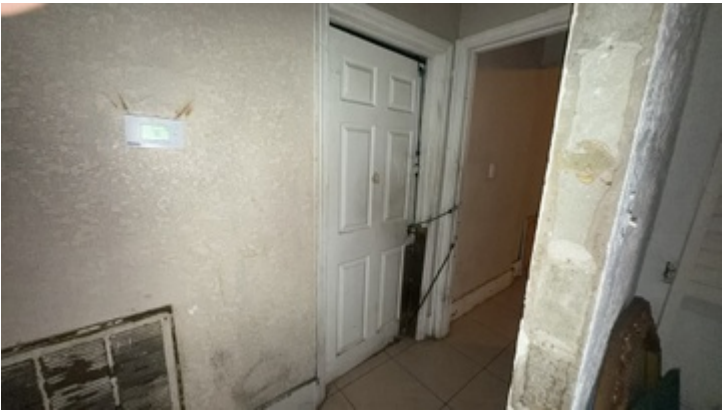
Bedroom 4 photos / videos

I cannot access the object / room.

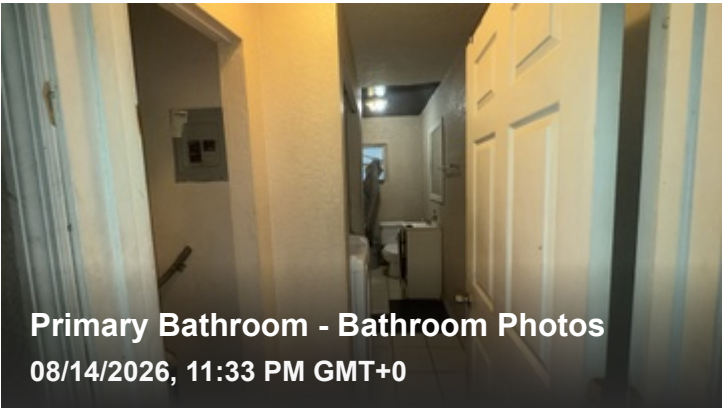
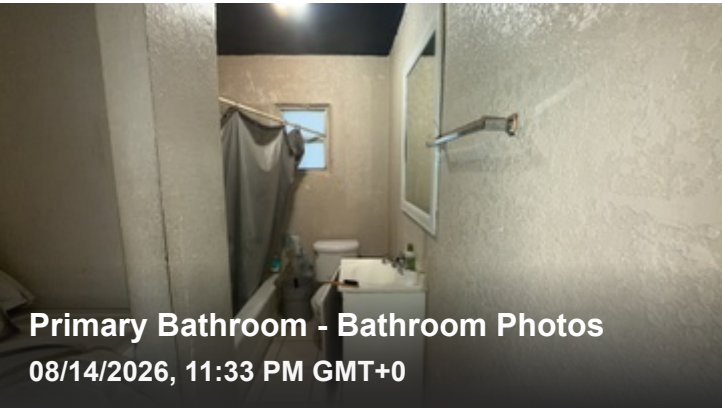
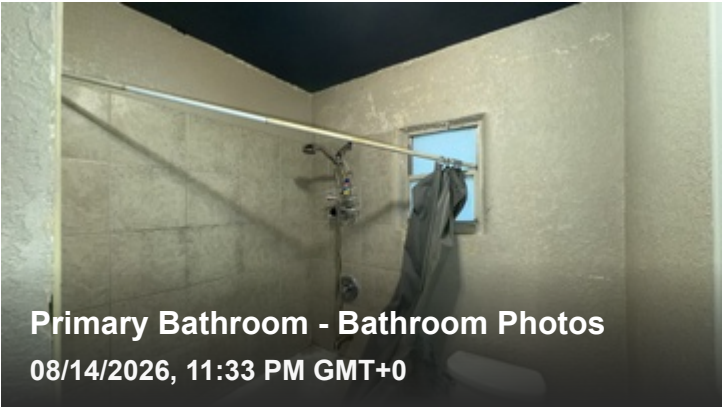
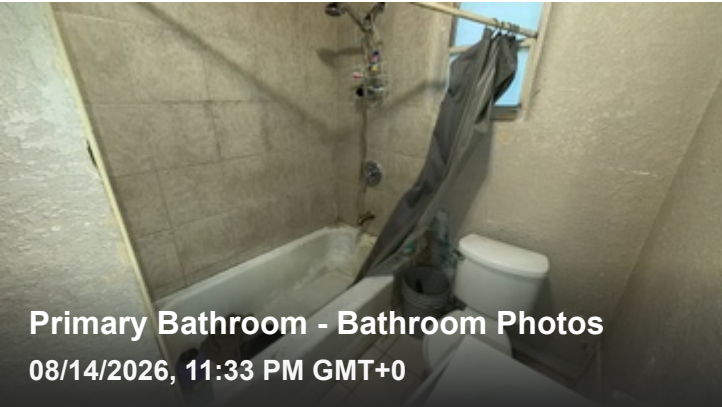
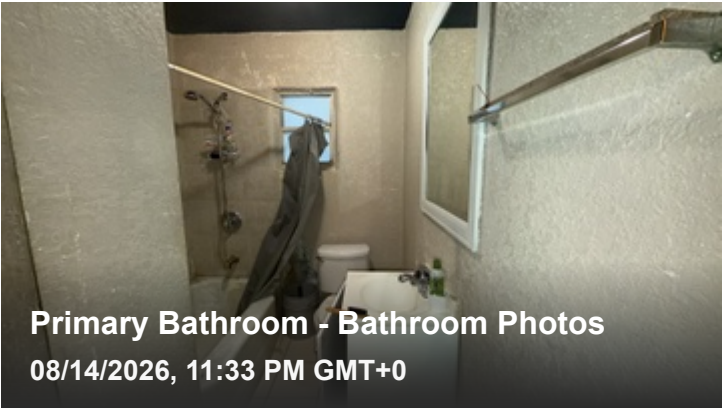
### Primary Bathroom photos / videos

The bathroom was accessible and inspected. The tub/shower area and surrounding finishes show visible wear, staining, and deterioration. Cleaning, repairs, and replacement of deteriorated caulking or sealant are recommended to help prevent moisture intrusion.

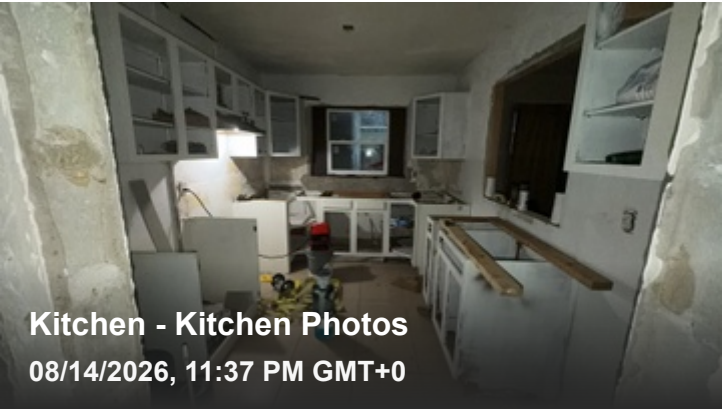
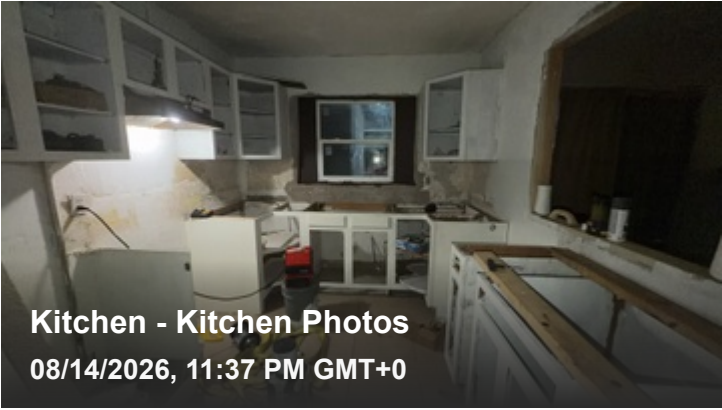
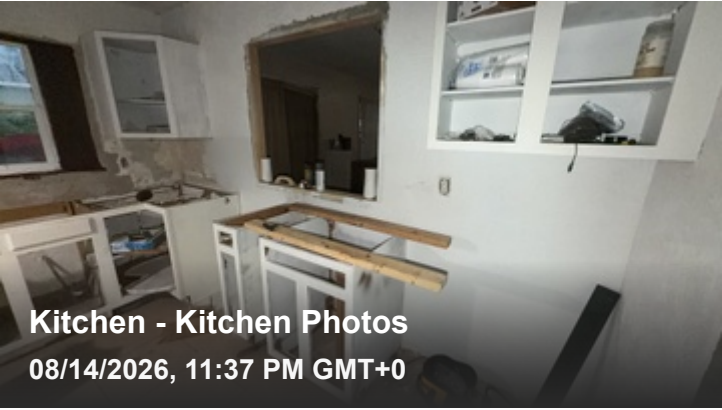
Kitchen photos / videos

**The kitchen is undergoing renovation and remains incomplete. Countertops, cabinet doors, appliances, and portions of the wall finishes are missing or unfinished. Plumbing and electrical connections may be exposed or incomplete. Completion and evaluation by qualified contractors are recommended before use.**
