## Home Inspection Report

1629 Marlin Street  
Saint Cloud, FL 34771

Inspected By: Hector Vargas, Lic. HI12079

Inspected On Wed, Aug 12, 2026 at 11:00 AM

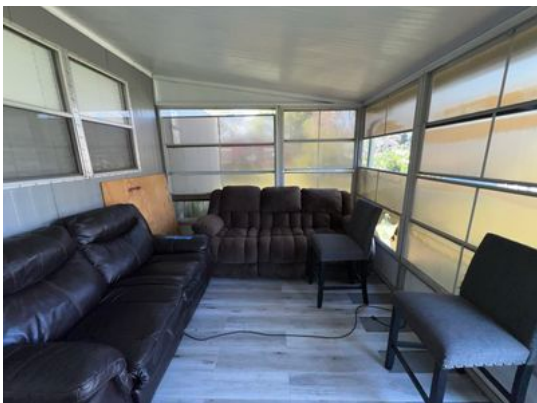
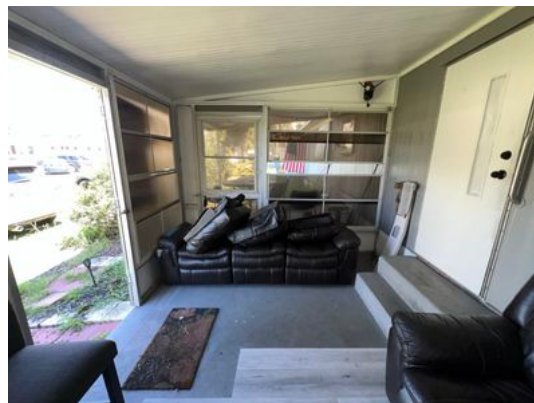
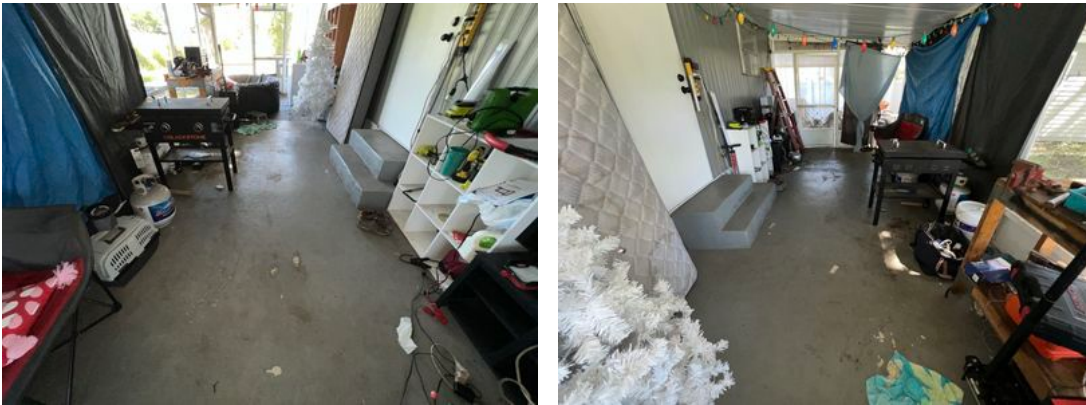
Condition: Repair or Replace

**Comment 4**  
**Deficiency**

The front patio has been enclosed to create a screened room with vinyl window panels. The majority of the vinyl windows are missing, torn, or otherwise damaged, leaving the enclosure exposed to exterior weather conditions and reducing its intended protection from insects and moisture.

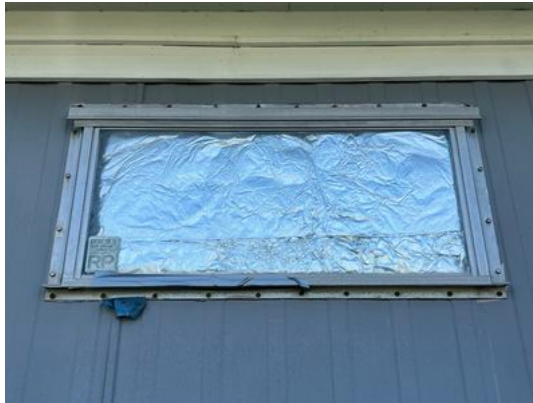
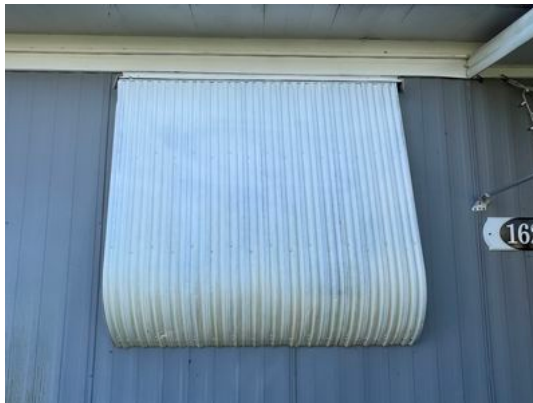
Condition: Repair or Replace

The exterior windows appear to be original to the home and are in aged condition. The majority of the windows are equipped with pull-down storm awnings. Windows without awnings have duct tape applied around portions of the frames and perimeters, apparently being used to maintain a seal. Overall, the windows exhibit age-related deterioration and evidence of makeshift sealing.

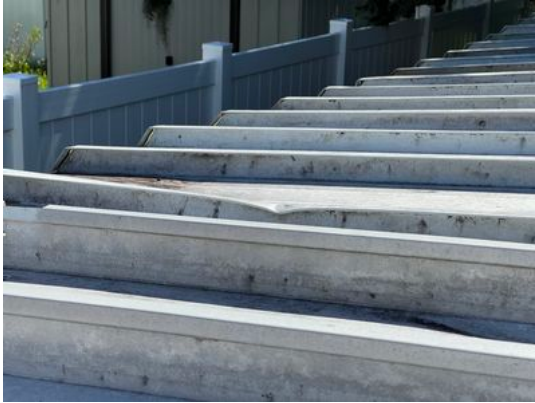
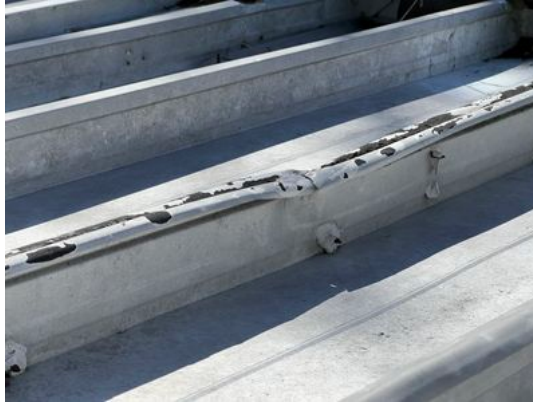
Condition: Marginal

The carport roof shows evidence of impact damage. The damage appears cosmetic in nature and does not currently affect the functionality or overall use of the carport.

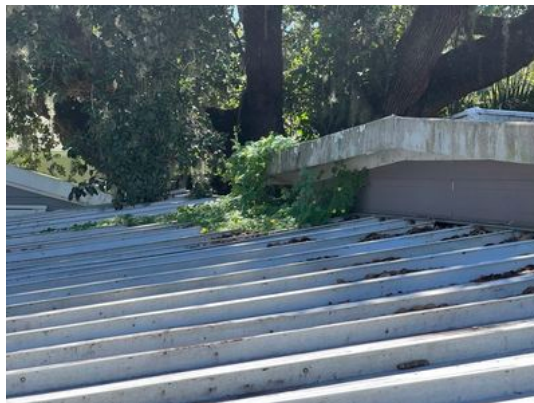
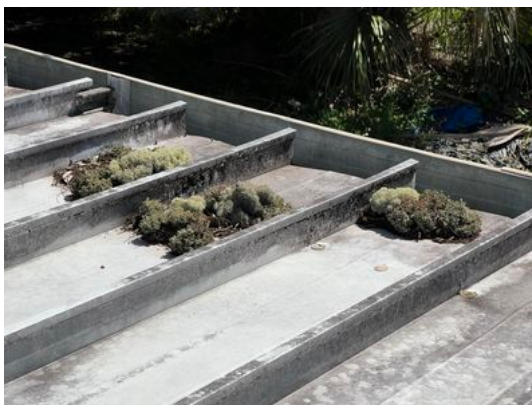
### Visible Damage

The home is equipped with a double-layer corrugated metal roofing system. The exterior roof covering appears to be original and shows significant age-related wear. Excessive organic growth is present throughout multiple areas of the roof surface, which may contribute to continued deterioration of the metal roofing material.

Organic growth

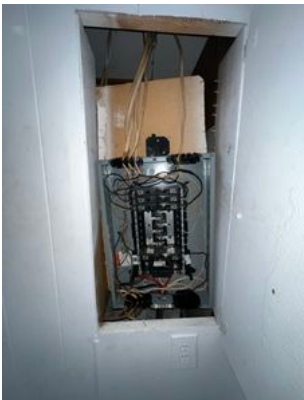
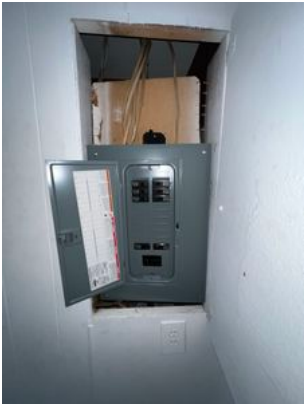
The interior electrical panel was reportedly upgraded in 2023 and is installed in the rear bedroom. The panel has been mounted to a section of particleboard that appears to have been secured to the structure with staples. The particleboard has become loose from the wall, causing the electrical panel to move and shift when touched. The panel is not securely mounted to the structure and should be properly reinstalled and secured by a qualified electrical contractor.

The electrical system is being rated unsatisfactory due to the interior electrical panel not being properly secured and installed. Once the panel is professionally reinstalled and securely mounted to the structure, the electrical system would otherwise be considered to be in satisfactory condition based on the components inspected.

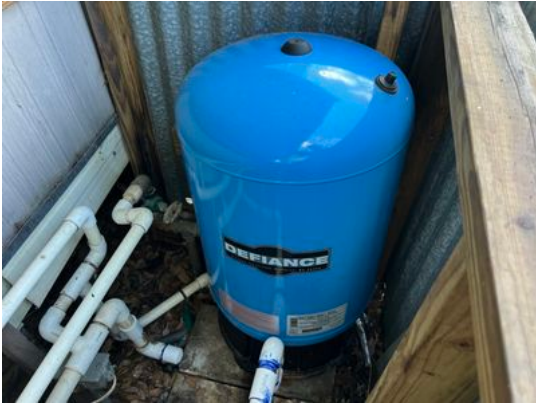
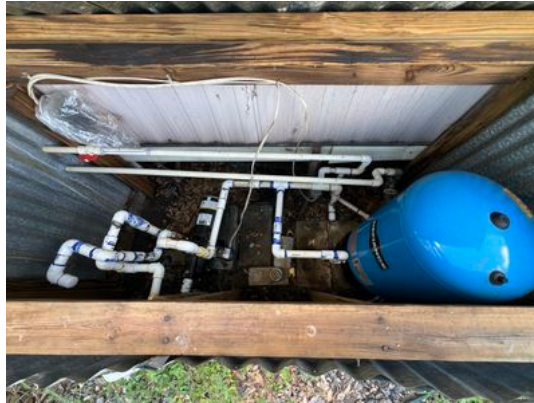
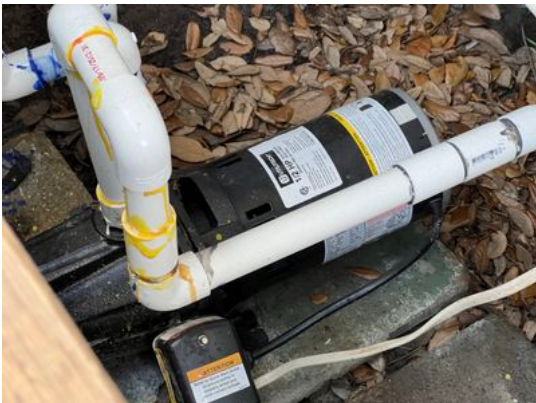
#### Well System

The well system plumbing and shutoff valve exhibit significant age-related corrosion and oxidation, including heavy buildup around the valve and associated fittings. The valve is substantially deteriorated and may be difficult to operate or prone to leakage. Service/replacement of the deteriorated valve and affected fittings is recommended by a qualified well/plumbing contractor.

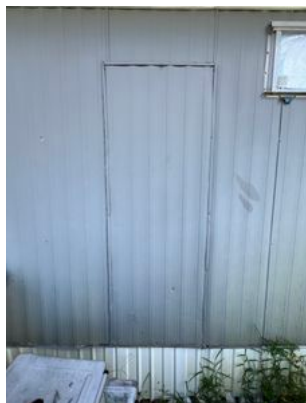
The water heater is located within an exterior compartment of the manufactured home. The access panel has been sealed to the exterior covering and could not be opened without causing damage to the panel or surrounding exterior materials. Therefore, the water heater and its associated components were inaccessible and could not be visually inspected or evaluated.

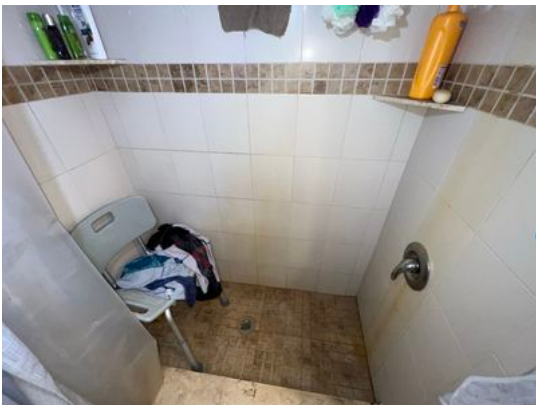
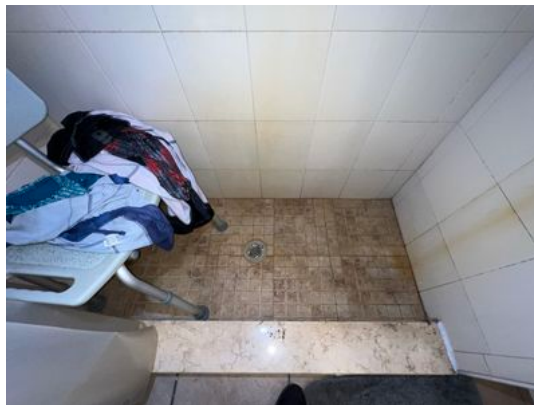
### Shower Walls

Condition: Marginal

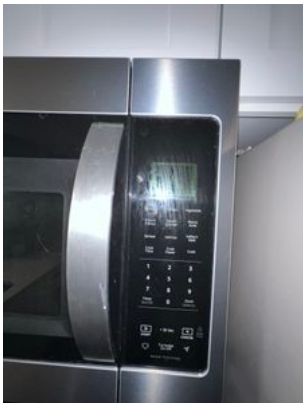
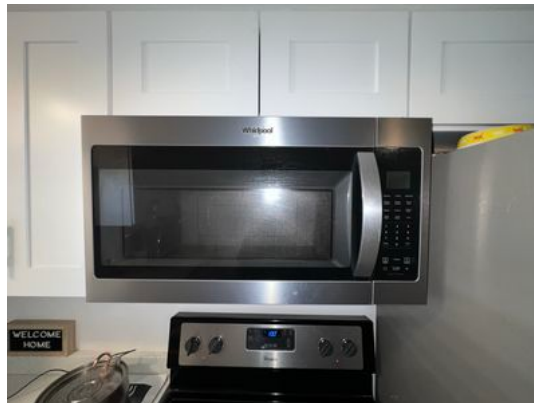
### Microwave

Microwave is not operational at time of inspection.

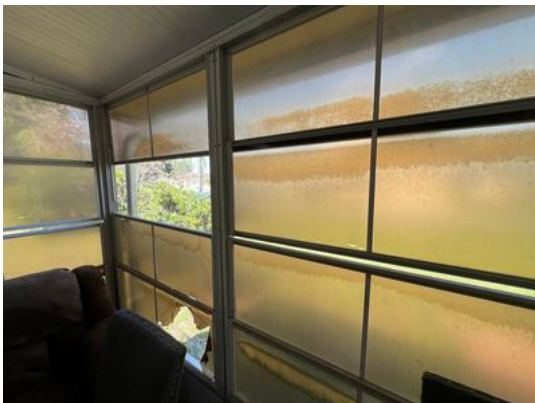
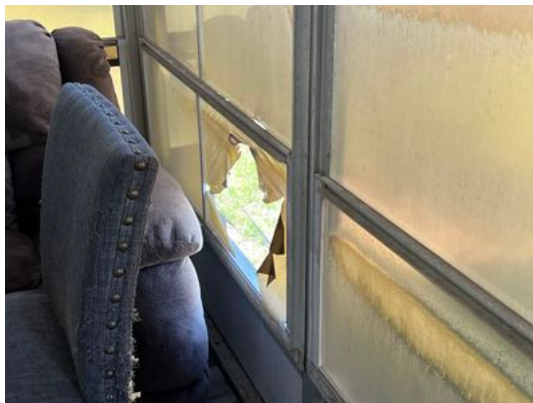
#### Site: Patios/Decks

The front patio has been enclosed to create a screened room with vinyl window panels. The majority of the vinyl windows are missing, torn, or otherwise damaged, leaving the enclosure exposed to exterior weather conditions and reducing its intended protection from insects and moisture.

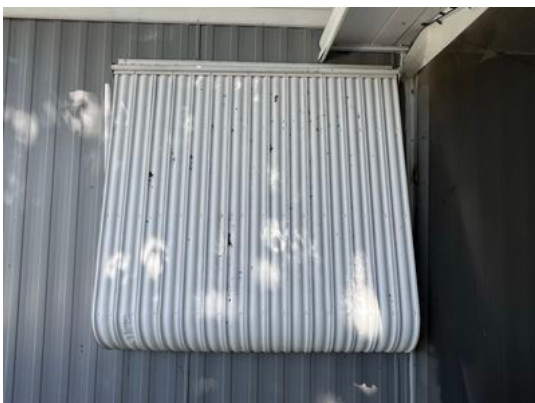
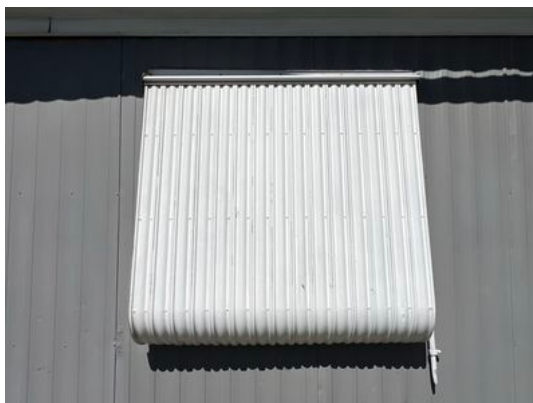
### Exterior: Windows

The exterior windows appear to be original to the home and are in aged condition. The majority of the windows are equipped with pull-down storm awnings. Windows without awnings have duct tape applied around portions of the frames and perimeters, apparently being used to maintain a seal. Overall, the windows exhibit age-related deterioration and evidence of makeshift sealing.

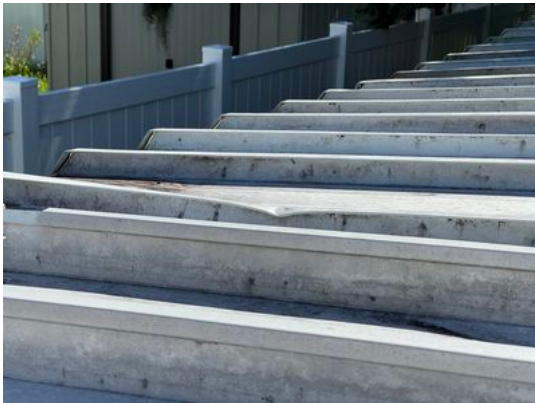
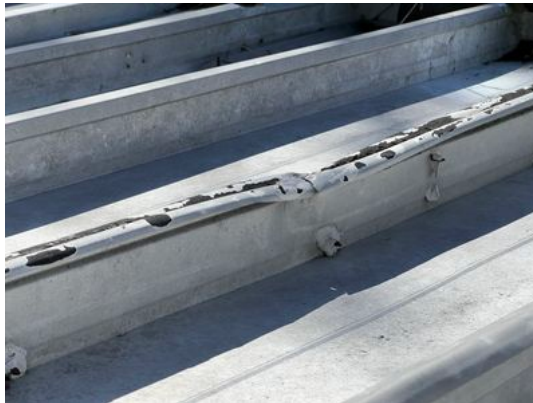
### Garage: Garage Type

The carport roof shows evidence of impact damage. The damage appears cosmetic in nature and does not currently affect the functionality or overall use of the carport.

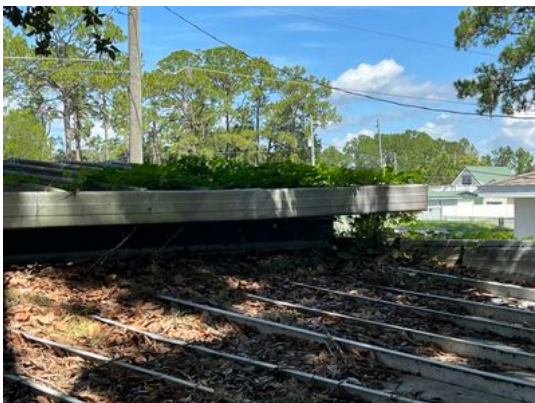
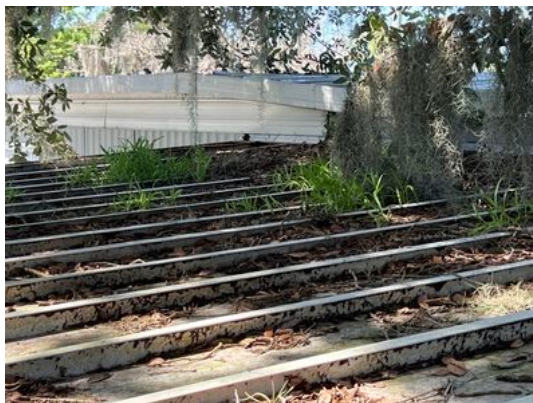
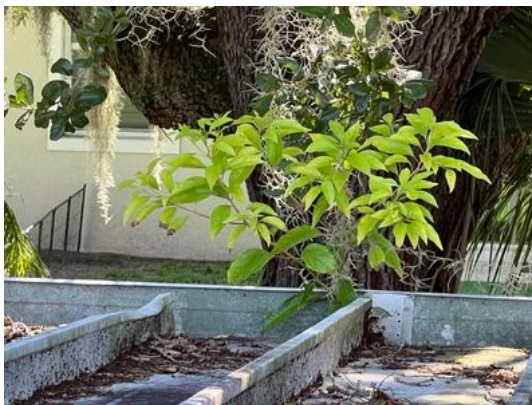
### Roofing: Roof Covering

The home is equipped with a double-layer corrugated metal roofing system. The exterior roof covering appears to be original and shows significant age-related wear. Excessive organic growth is present throughout multiple areas of the roof surface, which may contribute to continued deterioration of the metal roofing material.

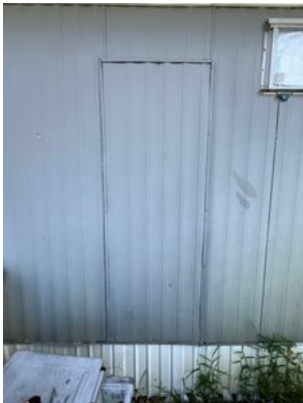
### Plumbing: Water Heater: Water Heater Location

The water heater is located within an exterior compartment of the manufactured home. The access panel has been sealed to the exterior covering and could not be opened without causing damage to the panel or surrounding exterior materials. Therefore, the water heater and its associated components were inaccessible and could not be visually inspected or evaluated.

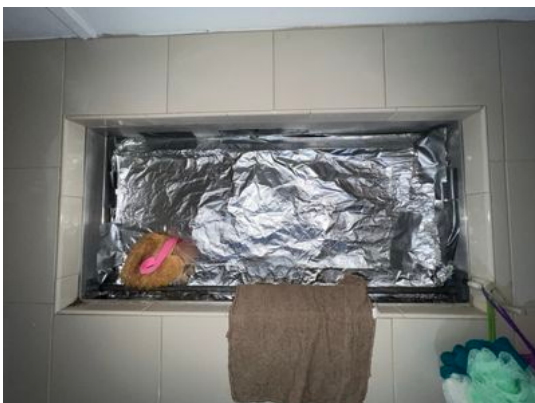
### Bathrooms: Bathroom #1: Ventilation Type

The bathroom window serves as the only means of ventilation for the bathroom. The window is currently sealed from the interior with duct tape and aluminum covering the glazing and was not operational. As a result, the bathroom does not currently have functional ventilation, which may contribute to excessive moisture and humidity within the space.

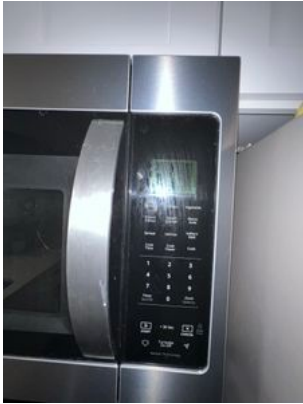
**Kitchen: Appliances: Microwave**

Microwave is not operational at time of inspection.
