## Home Inspection Report

4863 Foxwood Boulevard  
Lakeland, FL 33810

Inspected By: Hector Vargas, Lic. HI12079

Prepared For: Easy Sell FL TC  
Inspected On Tue, Aug 18, 2026 at 1:00 PM

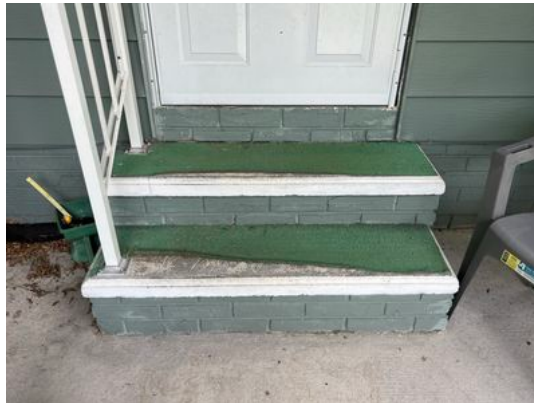
The exterior entry steps are covered with outdoor carpet/artificial turf, which shows visible wear and deterioration, particularly along the leading edges of the steps. The edge trim is worn and deteriorated in areas, creating an uneven walking surface and a potential trip hazard. Repair or replacement of the deteriorated covering and trim is recommended.

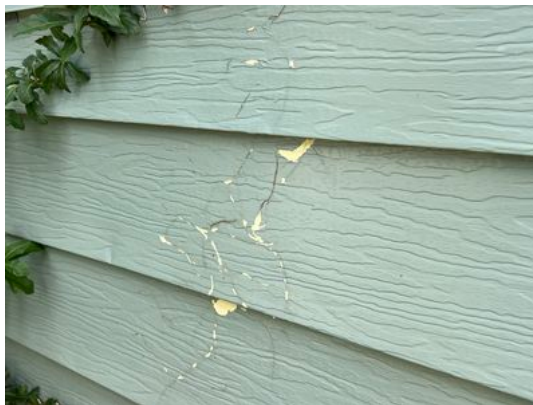
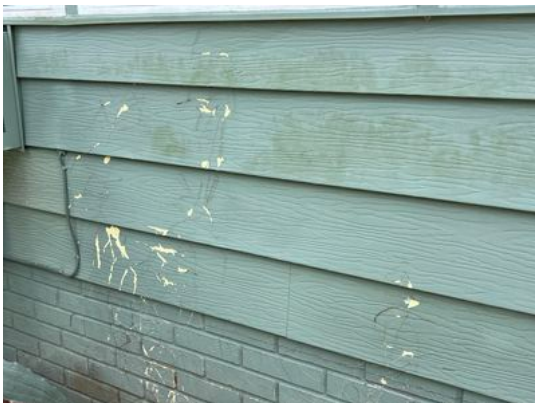
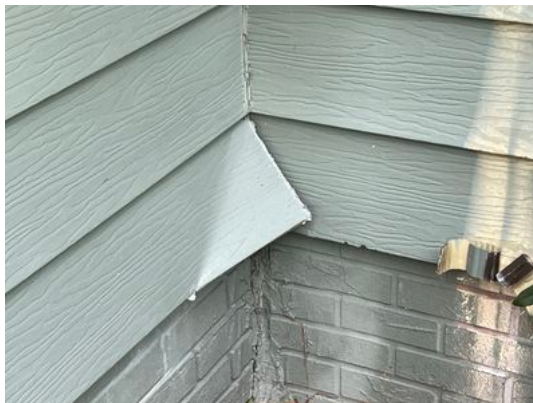
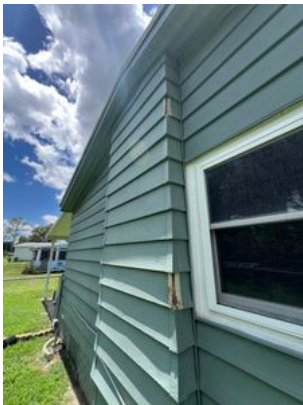
The exterior is clad with lap siding, and multiple deficiencies are present throughout. Areas of the siding show organic growth/staining, peeling and damaged paint, numerous holes from previous attachments, loose or displaced siding sections, and damaged/missing corner trim pieces with exposed underlying materials. Several locations have open gaps that can allow moisture intrusion behind the siding. The siding also shows chalking/paint transfer when touched, indicating deterioration of the exterior coating. Repair of damaged and loose siding, replacement of missing or deteriorated trim, sealing of openings, cleaning of organic growth, and preparation/repainting of affected areas is recommended.

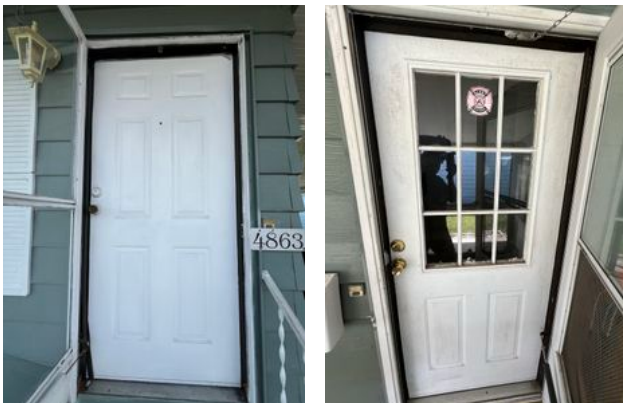
The front entry door has damaged and deteriorated weatherstripping/insulation at the lower corner of the door frame. The material is torn and partially detached, which may allow air, moisture, and pest intrusion. Repair or replacement is recommended.

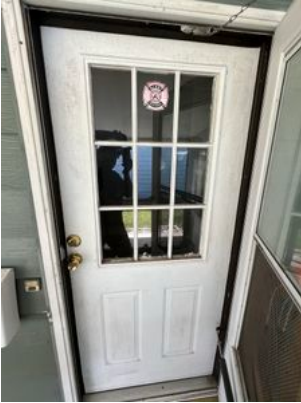
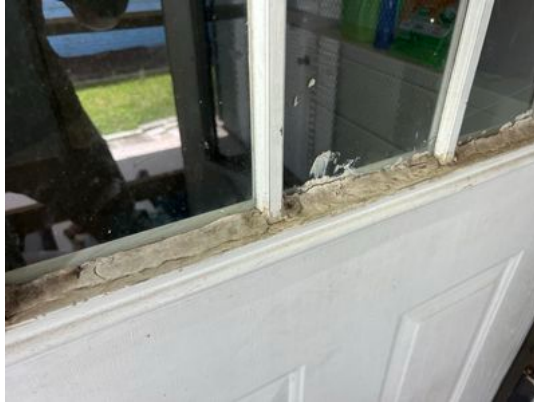
The side entrance door to the laundry room has multiple cracked glass panes, and the glazing compound/sealant around the lower panes is severely deteriorated, cracked, and separating. Repair or replacement of the damaged glass and deteriorated glazing is recommended.

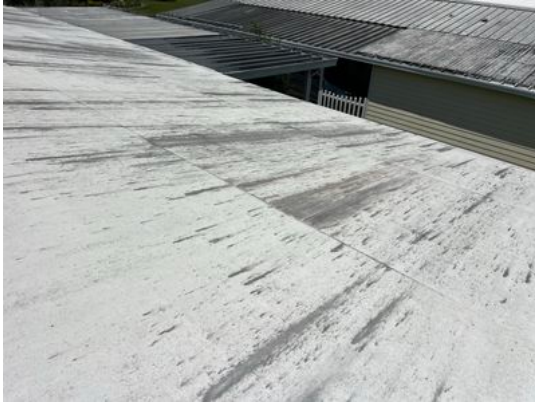
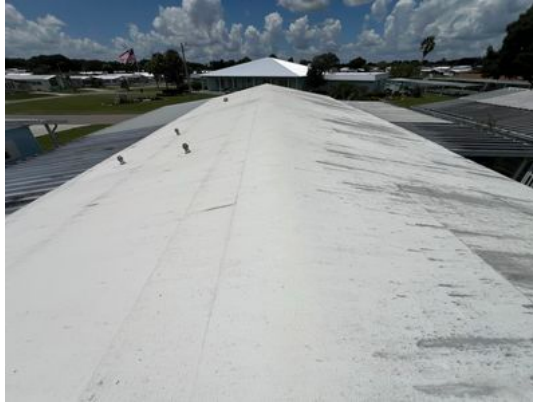
The roof is covered with a TPO membrane roofing system. The membrane shows widespread surface discoloration, staining, and visible wear/scuffing in multiple areas. No significant open seams or large tears were visible in the areas inspected.

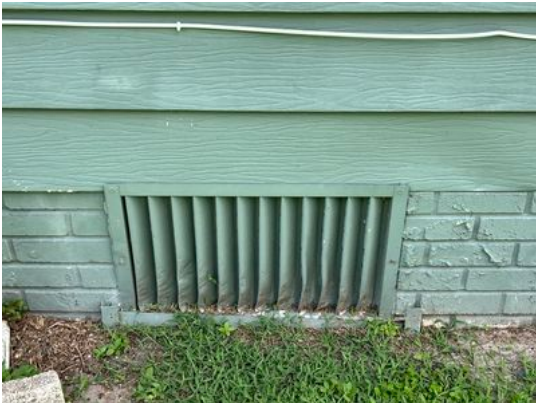
**Comment 9**

**Deficiency**

The crawlspace/foundation vent is damaged and partially detached from the wall opening, leaving an exposed gap. Repair or replacement is recommended to properly secure the opening and help prevent pest and moisture intrusion.

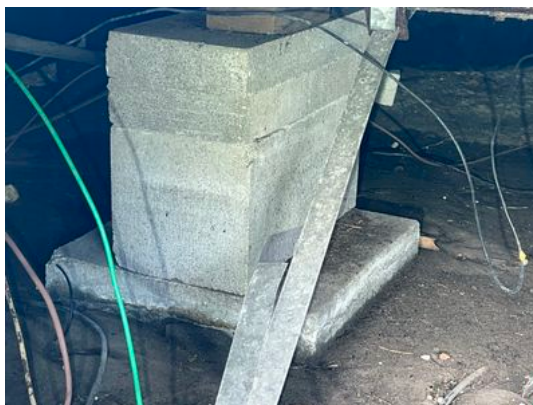
One of the manufactured home metal tie-down/hurricane straps is visibly loose and not properly tensioned, with the strap leaning away from its intended position. The anchoring/tie-down system should be evaluated and corrected as needed to ensure the home is properly secured.

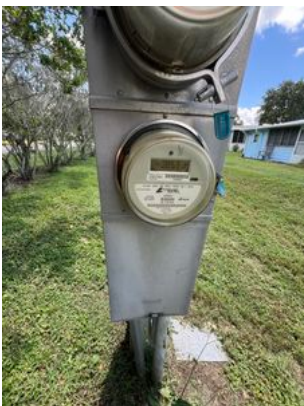
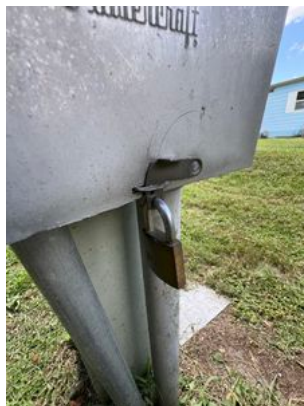
### Comment 11

Panel door has a lock that we don't have a key for.

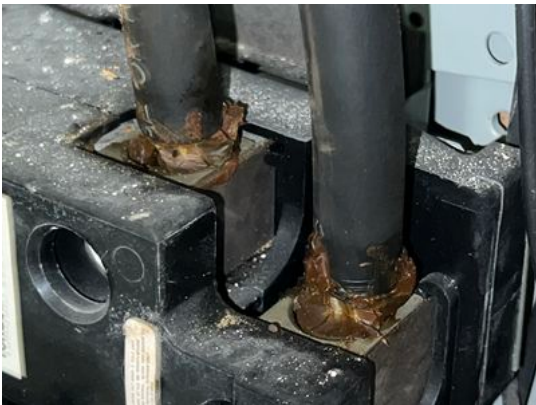
### Electrical Hazards Present

Corrosion

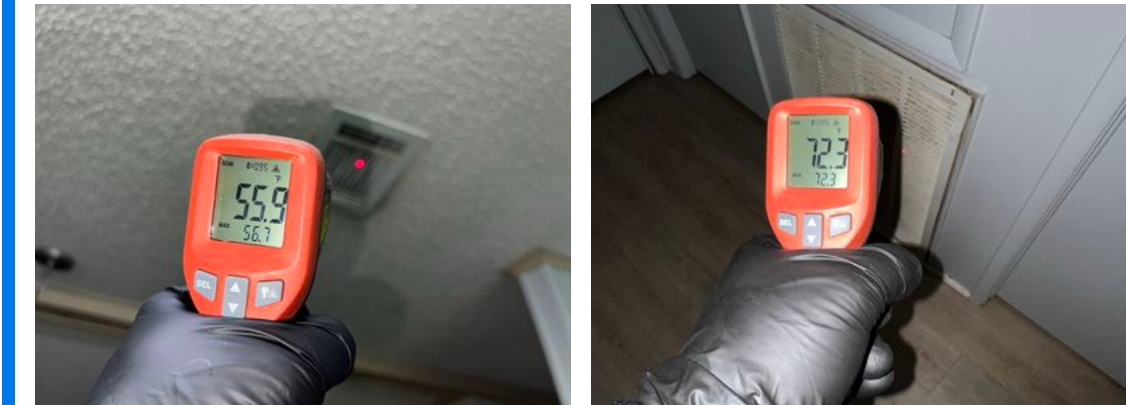
Comment 13  
Information

Ideally, there should be a temperature differential of around 14° to 20° Fahrenheit between the incoming air and the air being blown out by your air conditioner. This means that if the air entering the system is 75°F, the air coming out of the vent should be between 55°F and 61°F. The temp differential of this unit is 17°.

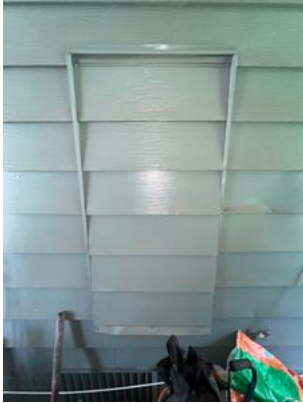
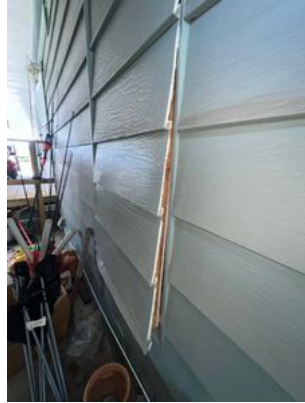
The exterior access panel for the water heater is loose and partially detached from the wall, leaving the opening exposed along the side. The panel should be properly secured and repaired to protect the water heater compartment from moisture and pest intrusion.

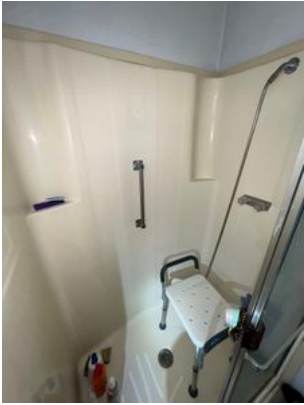
### Shower Walls

Condition: Marginal

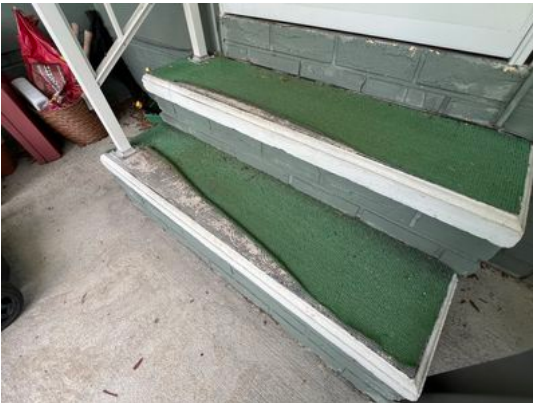
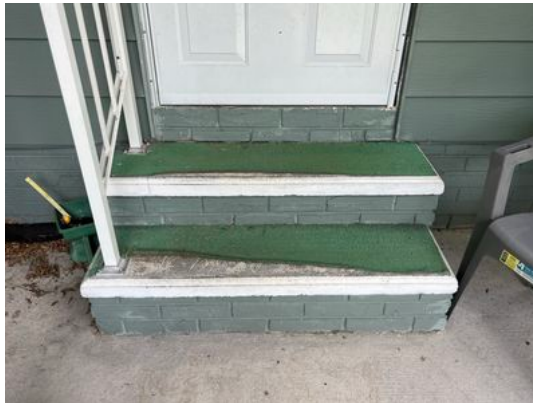
#### Site: Steps/Stoops

The exterior entry steps are covered with outdoor carpet/artificial turf, which shows visible wear and deterioration, particularly along the leading edges of the steps. The edge trim is worn and deteriorated in areas, creating an uneven walking surface and a potential trip hazard. Repair or replacement of the deteriorated covering and trim is recommended.

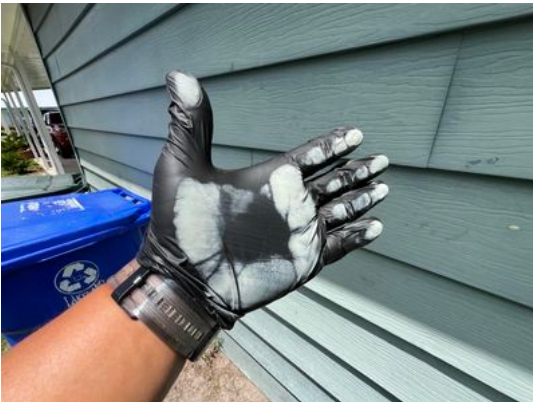
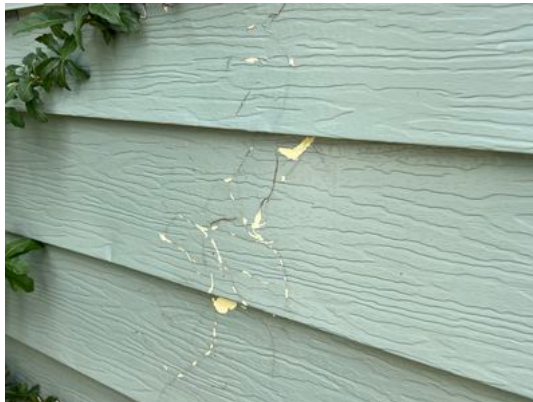
#### Exterior: Exterior Covering

The exterior is clad with lap siding, and multiple deficiencies are present throughout. Areas of the siding show organic growth/staining, peeling and damaged paint, numerous holes from previous attachments, loose or displaced siding sections, and damaged/missing corner trim pieces with exposed underlying materials. Several locations have open gaps that can allow moisture intrusion behind the siding. The siding also shows chalking/paint transfer when touched, indicating deterioration of the exterior coating. Repair of damaged and loose siding, replacement of missing or deteriorated trim, sealing of openings, cleaning of organic growth, and preparation/repainting of affected areas is recommended.

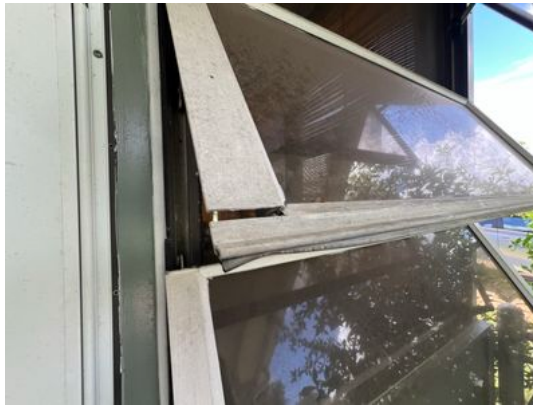
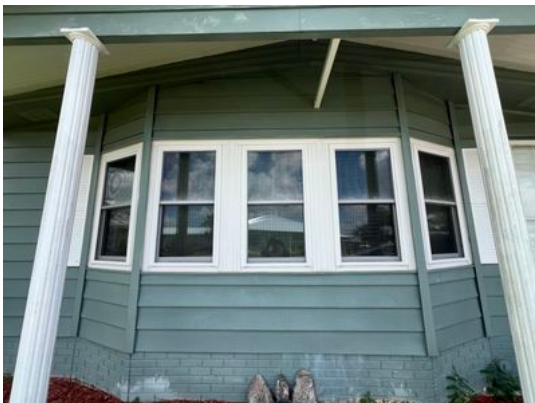
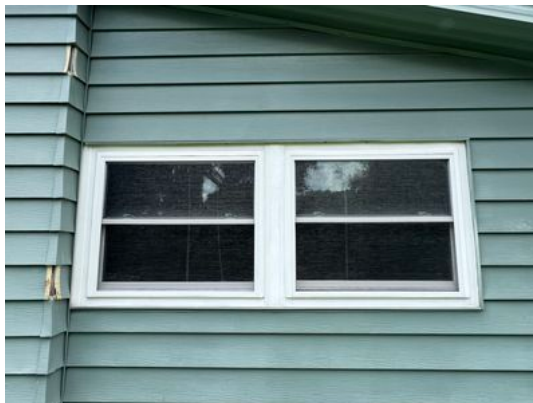
### Exterior: Windows

The majority of the exterior windows have been upgraded to newer double-pane, double-hung windows. However, jalousie-style windows original to the 1985 home remain in the patio area and bathroom. These original windows are approximately 41 years old and show greater age and wear compared with the upgraded windows.

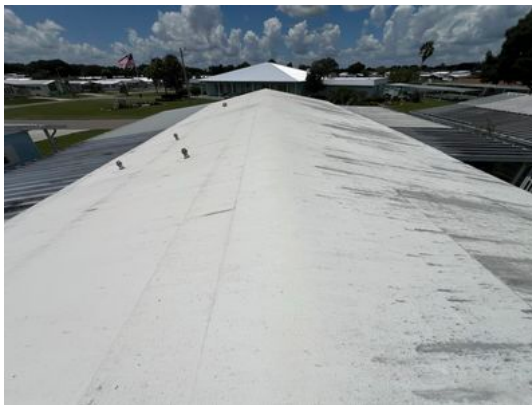
### Roofing: Roof Covering

The roof is covered with a TPO membrane roofing system. The membrane shows widespread surface discoloration, staining, and visible wear/scuffing in multiple areas. No significant open seams or large tears were visible in the areas inspected.

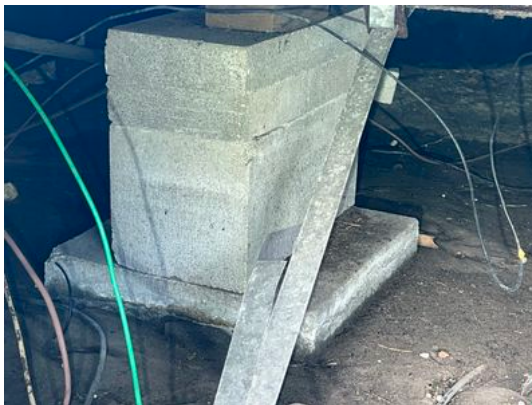
### Structure: Crawlspace

One of the manufactured home metal tie-down/hurricane straps is visibly loose and not properly tensioned, with the strap leaning away from its intended position. The anchoring/tie-down system should be evaluated and corrected as needed to ensure the home is properly secured.

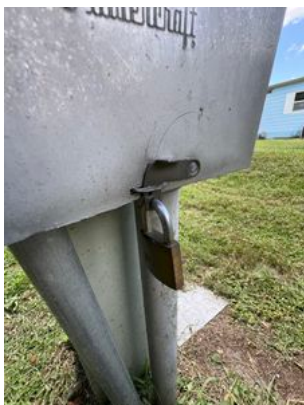
### Electrical: Main Disconnect Location

Panel door has a lock that we don't have a key for.
