## Home Inspection Report

10081 SW 100th Avenue  
Ocala, FL 34481

Inspected By: Hector Vargas, Lic. HI12079

Inspected On Fri, Jul 17, 2026 at 11:30 AM

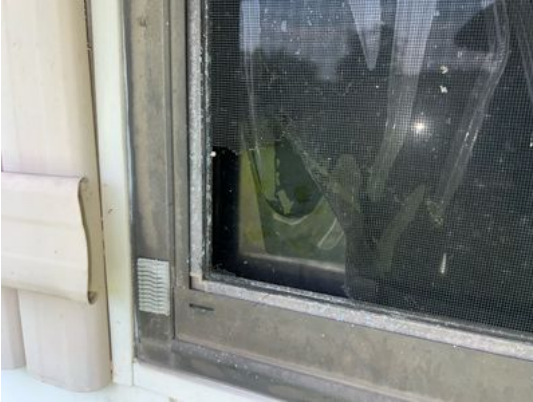
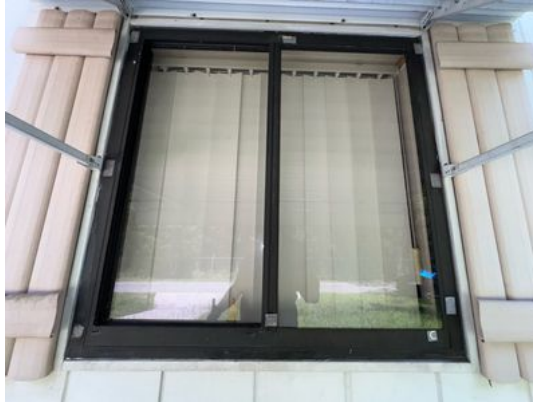
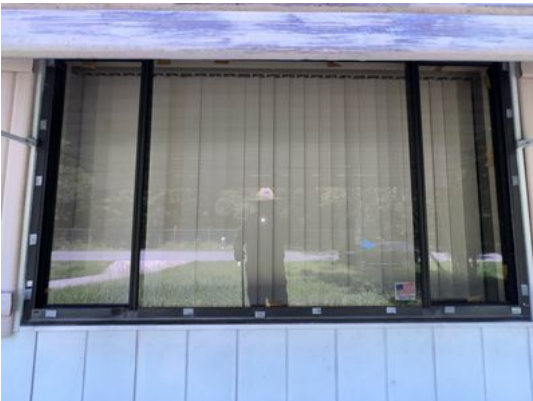
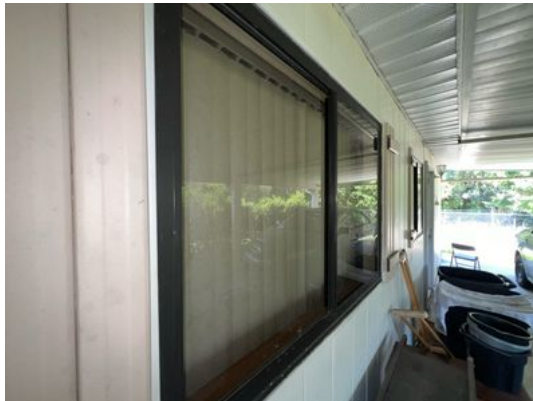
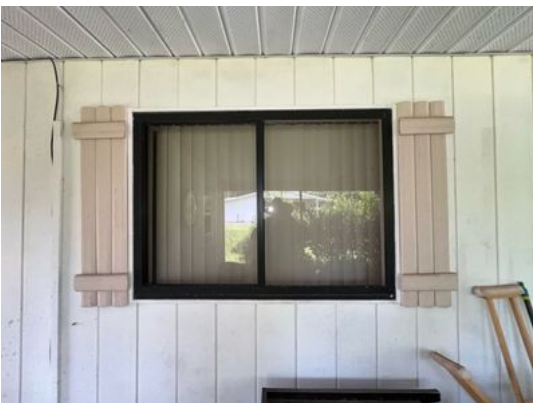
Exterior screens are missing or broken. Recommend repair or replacement

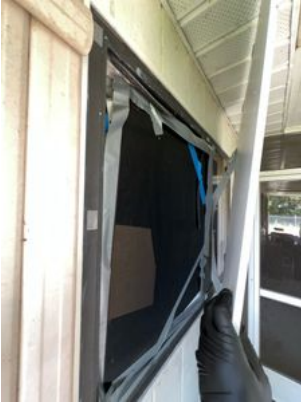
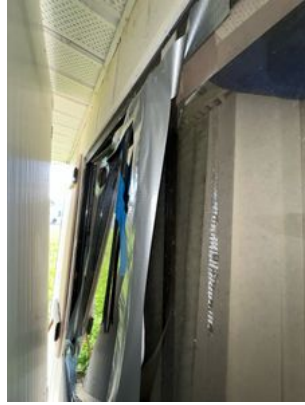
**Comment 7**

A rear window is covered with plastic board and was found to be severely damaged and displaced from its frame. The window is no longer providing a proper weather-resistant seal and should be replaced.

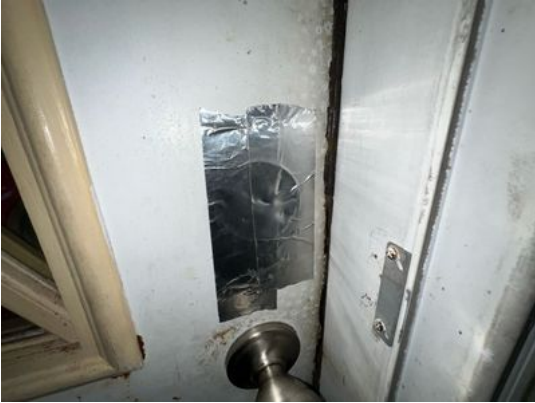
**Comment 8**

The exterior door exhibits evidence of a prior forced entry or repair at the latch area. The door jamb is damaged and has been patched with metal tape, preventing the door from latching and securing properly. Repair or replacement of the damaged door and/or frame is recommended to restore proper operation and security.

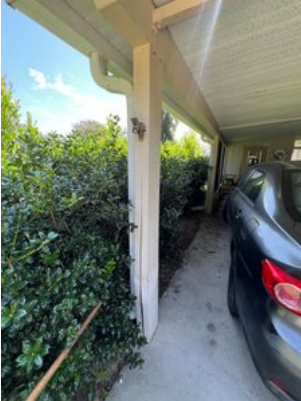
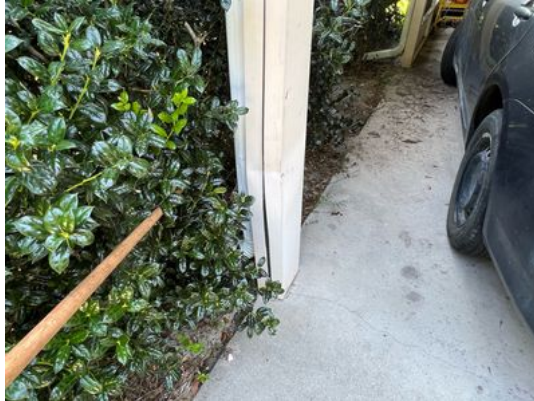
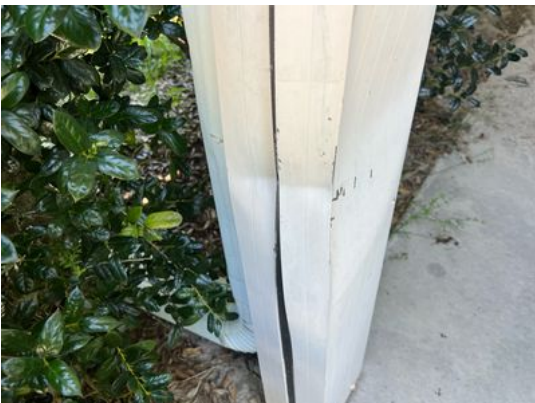
The front left carport support post, which is wrapped in aluminum siding, exhibits evidence of impact damage. Repair or replacement of the damaged post covering is recommended as needed.

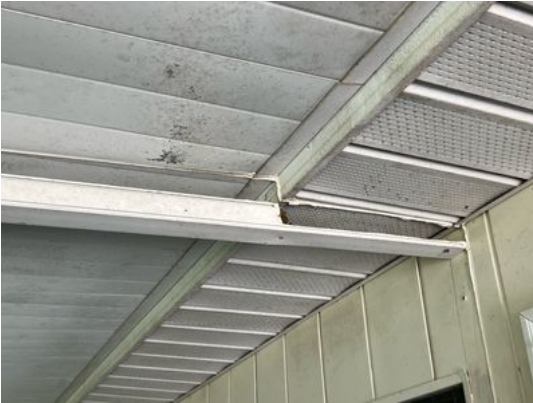
One of the carport support beams exhibits localized deterioration at the lower edge, with evidence of moisture-related damage and material loss. Repair or replacement of the affected beam is recommended to maintain the integrity of the carport structure.

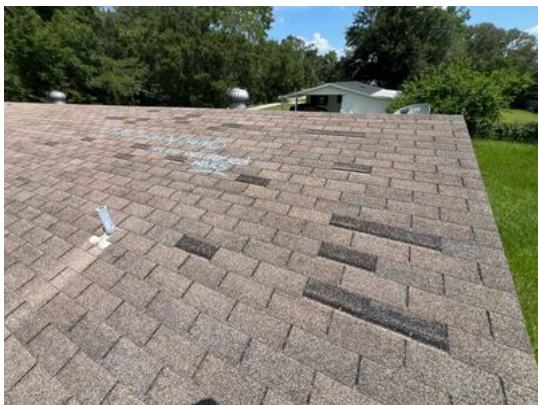
The roof covering exhibits excessive granule loss throughout, along with more than 20 cracked, broken, or missing roof tiles. Numerous exposed fasteners were also observed. These conditions increase the potential for water intrusion and indicate the roof covering is at or near the end of its serviceable life. Replacement of the roof covering is recommended.

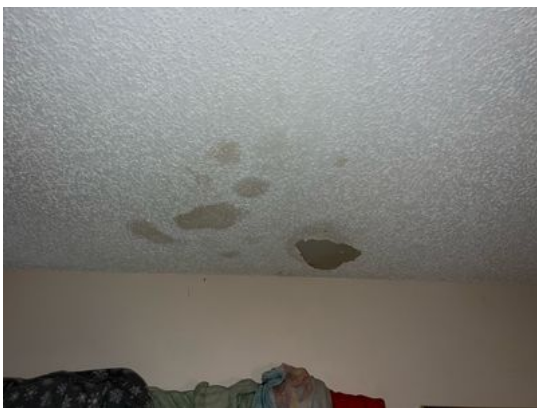
### Comment 14

Interior of ceiling

The primary bedroom ceiling exhibits multiple moisture stains and an area of peeling and missing textured ceiling finish, consistent with moisture-related damage. The source of the moisture should be identified and corrected, and the damaged ceiling materials repaired as needed.

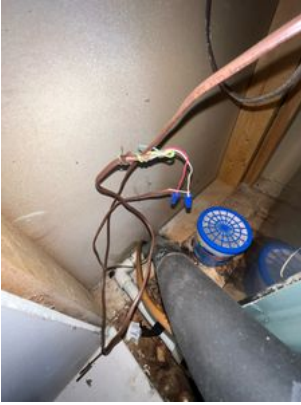
The air handler's low-voltage control wiring exhibits an open, unsupported splice outside of an approved junction box. This condition exposes the wiring to physical damage and is considered an improper installation.

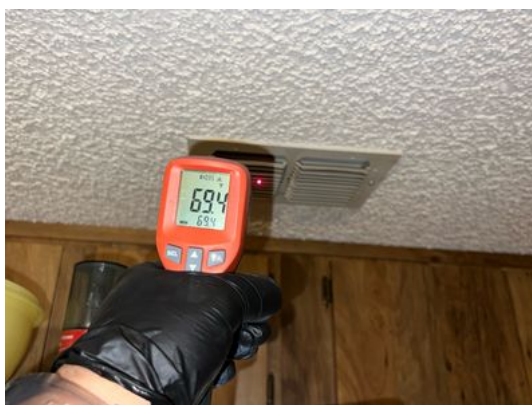
Ideally, there should be a temperature differential of around 14° to 20° Fahrenheit between the incoming air and the air being blown out by your air conditioner. This means that if the air entering the system is 75°F, the air coming out of the vent should be between 55°F and 61°F. The temp differential of this unit is 13°.

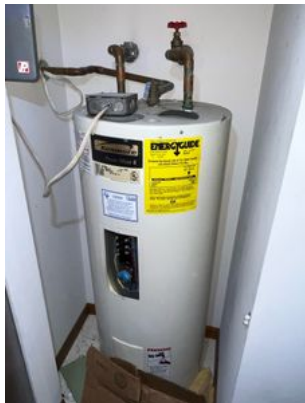
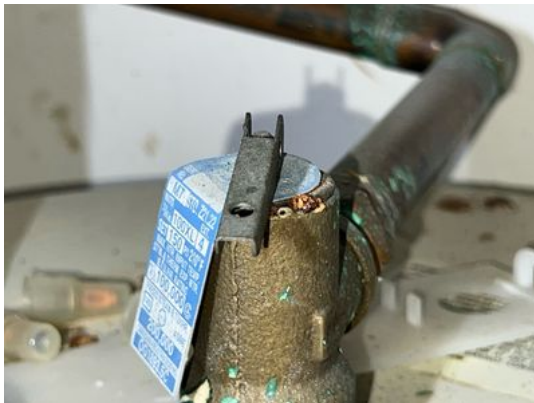
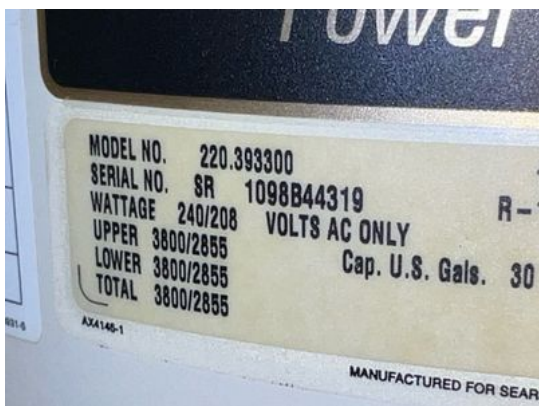
The home is equipped with a 28-year-old water heater, which is passed the upper limit of its typical life expectancy of 10 to 15 years. While it was functional at the time of inspection, water heaters of this age are more prone to failure, including

leaks or inefficiency. Additionally, many insurance companies are reluctant to provide coverage for homes with water heaters older than 15 years due to the increased risk of water damage. We recommend replacing the unit to reduce the risk of failure and to comply with potential insurance requirements.

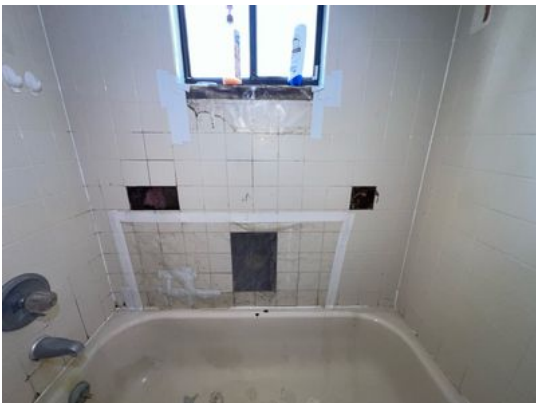
The tub/shower surround exhibits numerous deficiencies, including missing and damaged ceramic tiles, unprofessional patch repairs using tape and plastic sheeting, deteriorated grout and sealant, and exposed wall cavity materials. These conditions are indicative of previous moisture intrusion and allow water to penetrate behind the wall covering, increasing the potential for concealed damage. The tub/shower surround is in need of significant repair or replacement.

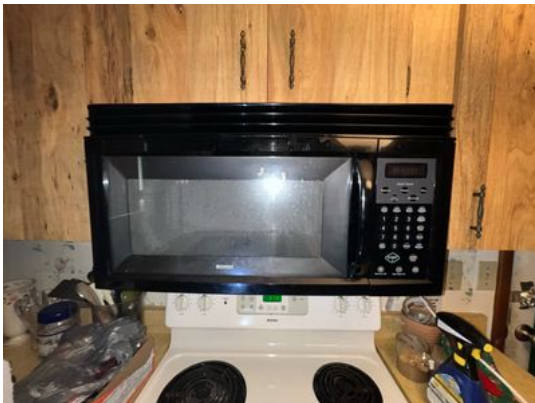
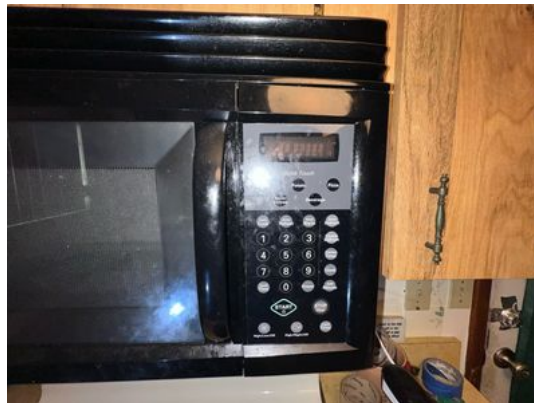
The Kenmore microwave did not power on and was non-operational at the time of the inspection.

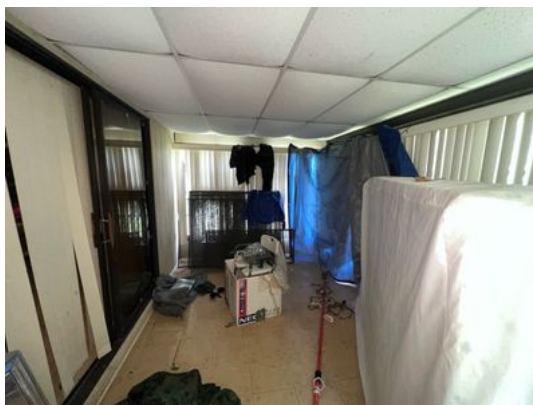
The enclosed rear patio exhibited elevated humidity levels at the time of the inspection. The suspended (drop) ceiling tiles are warped and show evidence of moisture exposure, consistent with prolonged high humidity within the space.

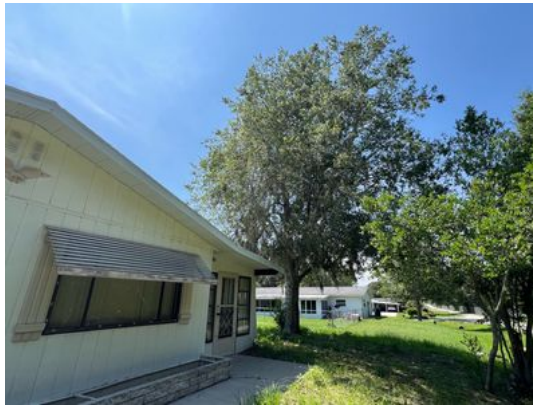
#### Site: Vegetation

The home is situated on a property with large trees that overhang the roof and surrounding areas. While these trees add aesthetic value and shade, they also pose potential risks. Overhanging branches can cause damage to the roof, gutters, and siding, especially during storms or high winds. Additionally, falling branches may create safety hazards for residents and visitors. Regular tree maintenance, including trimming and monitoring for signs of decay or disease, is recommended to mitigate these risks and protect the home.

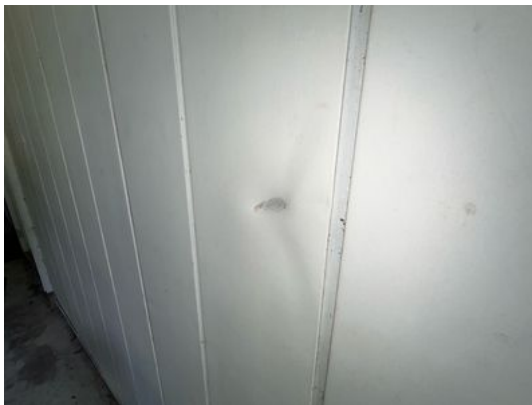
### Exterior: Exterior Covering

The vinyl siding exhibits multiple dings and areas of impact damage at various locations around the exterior of the home. The damage is cosmetic in nature and was observed throughout the siding. Repair or replacement of the affected siding sections may be needed as desired to restore the exterior finish.

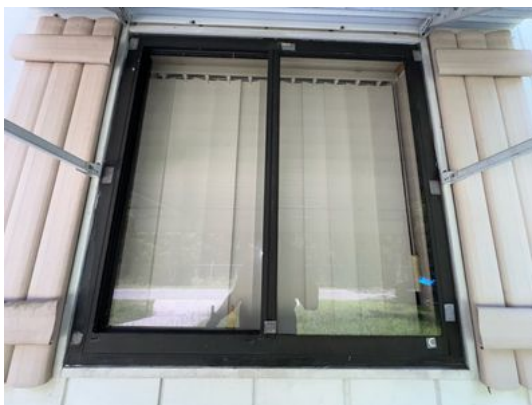
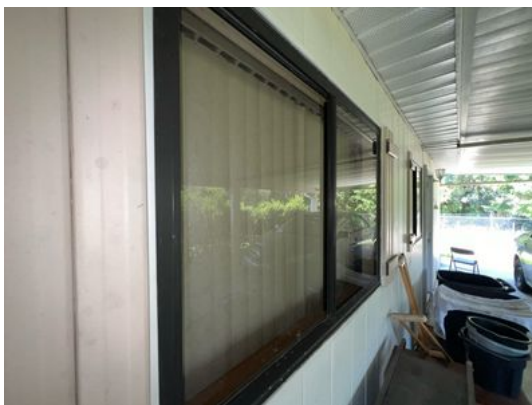
### Exterior: Windows

Exterior screens are missing or broken. Recommend repair or replacement

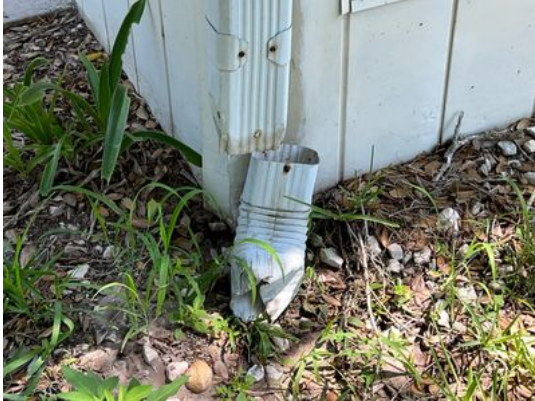
### Roofing: Gutters & Downspouts

The metal gutter downspouts exhibit damage at multiple locations. Repair or replacement of the damaged downspouts is recommended to help ensure proper drainage.

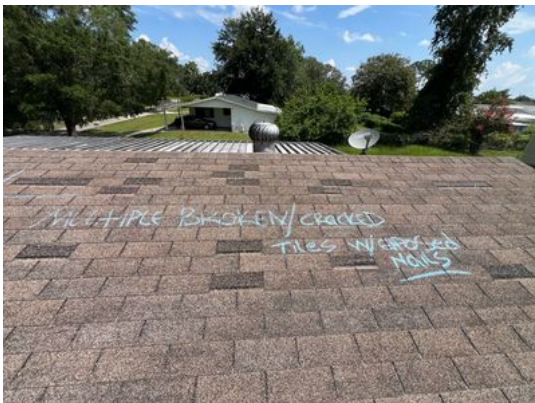
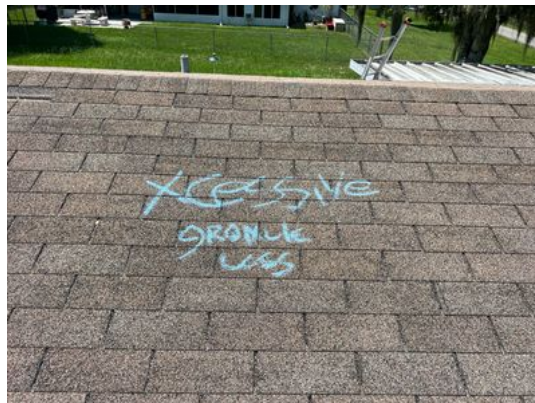
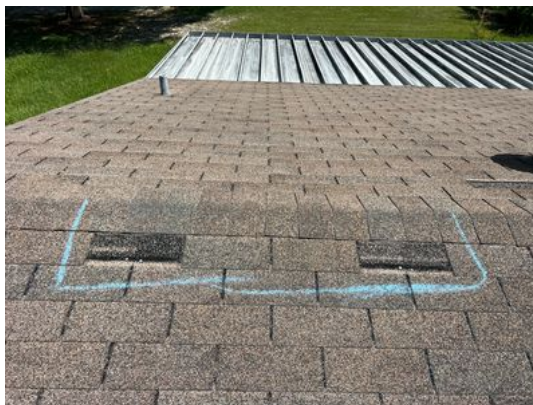
### Roofing: Visible Damage

The roof covering exhibits excessive granule loss throughout, along with more than 20 cracked, broken, or missing roof tiles. Numerous exposed fasteners were also observed. These conditions increase the potential for water intrusion and indicate the roof covering is at or near the end of its serviceable life. Replacement of the roof covering is recommended.

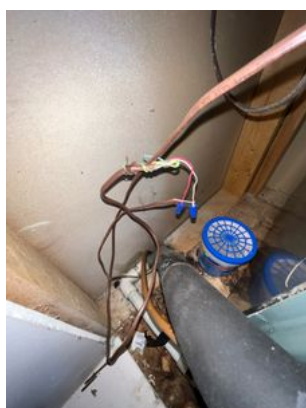
### Electrical: Electrical Hazards Present

The air handler's low-voltage control wiring exhibits an open, unsupported splice outside of an approved junction box. This condition exposes the wiring to physical damage and is considered an improper installation.

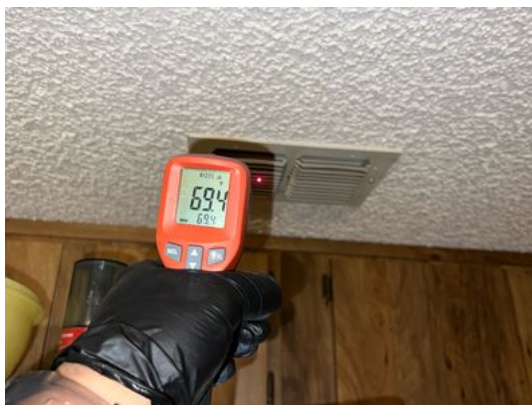
### HVAC: HVAC in Good Working Order

Ideally, there should be a temperature differential of around 14° to 20° Fahrenheit between the incoming air and the air being blown out by your air conditioner. This means that if the air entering the system is 75°F, the air coming out of the vent should be between 55°F and 61°F. The temp differential of this unit is 13°.

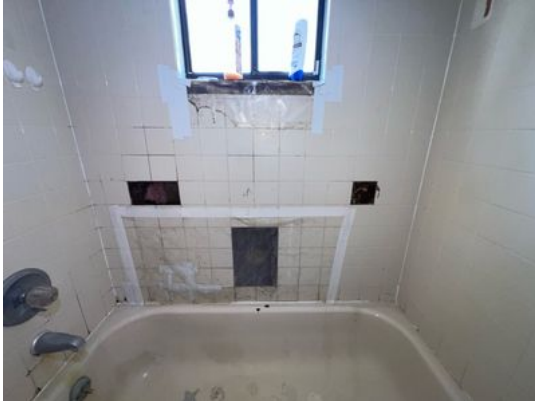
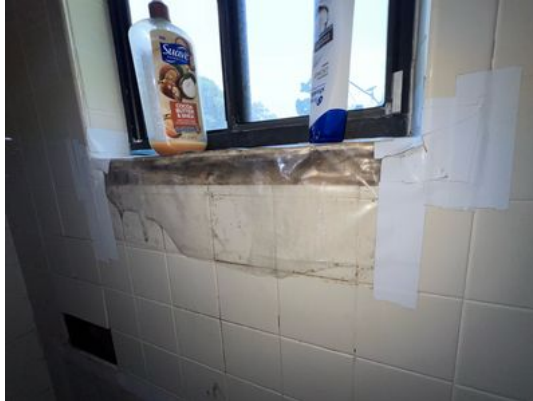
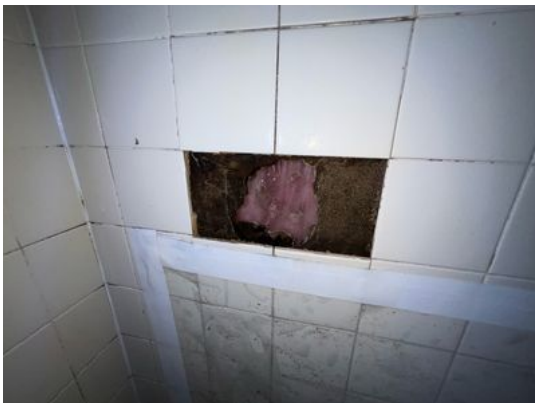
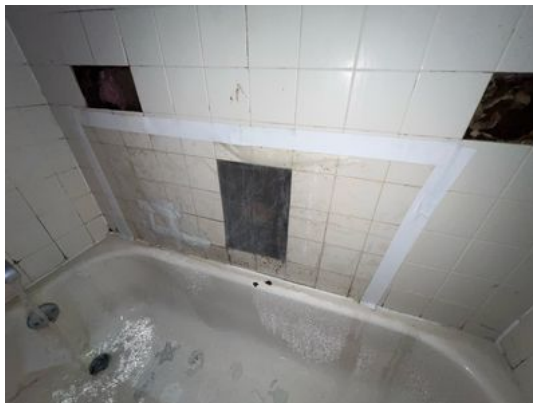
### Bathrooms: Bathroom #2: Shower Walls

The tub/shower surround exhibits numerous deficiencies, including missing and damaged ceramic tiles, unprofessional patch repairs using tape and plastic sheeting, deteriorated grout and sealant, and exposed wall cavity materials. These conditions are indicative of previous moisture intrusion and allow water to penetrate behind the wall covering, increasing the potential for concealed damage. The tub/shower surround is in need of significant repair or replacement.

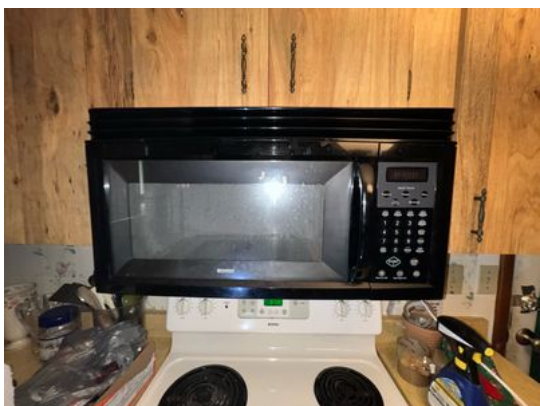
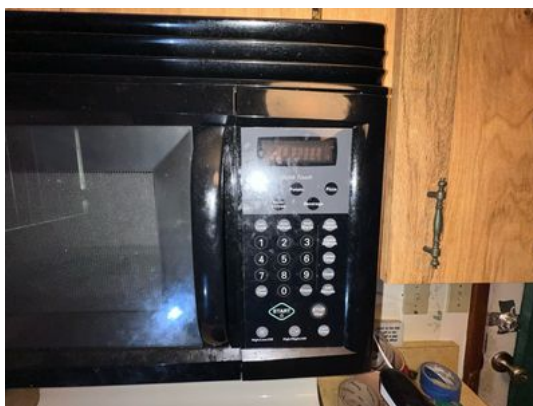
### Kitchen: Appliances: Microwave

The Kenmore microwave did not power on and was non-operational at the time of the inspection.

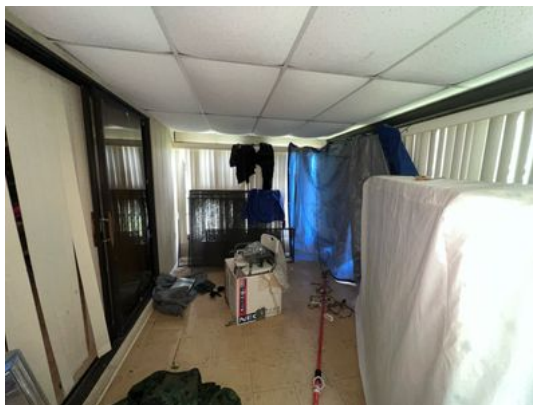
### Interior

The enclosed rear patio exhibited elevated humidity levels at the time of the inspection. The suspended (drop) ceiling tiles are warped and show evidence of moisture exposure, consistent with prolonged high humidity within the space.
