## Home Inspection Report

619 E Seventh Street  
Sanford, FL 32771

Inspected By: Hector Vargas, Lic. HI12079

Inspected On Fri, Aug 14, 2026 at 12:00 PM

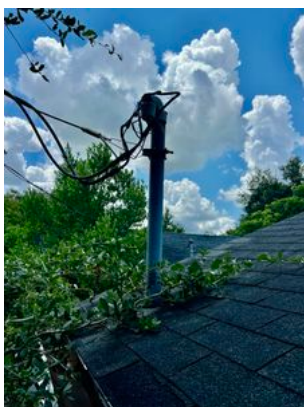
The home is situated on a property with large trees that overhang the roof and surrounding areas. While these trees add aesthetic value and shade, they also pose potential risks. Overhanging branches can cause damage to the roof, gutters, and siding, especially during storms or high winds. Additionally, falling branches may create safety hazards for residents and visitors. Regular tree maintenance, including trimming and monitoring for signs of decay or disease, is recommended to mitigate these risks and protect the home.

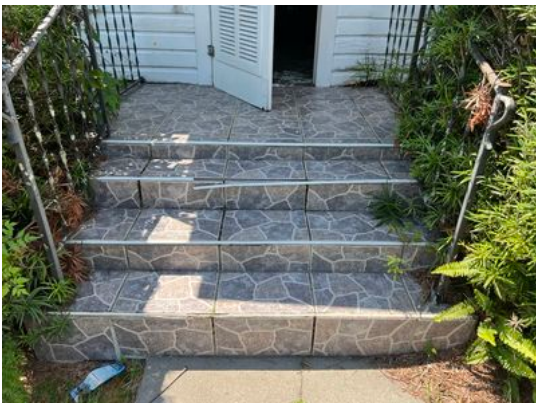
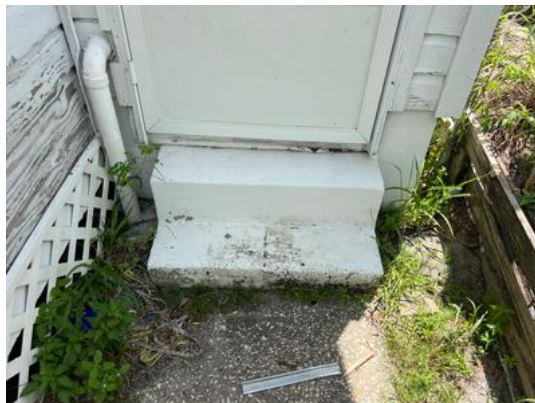
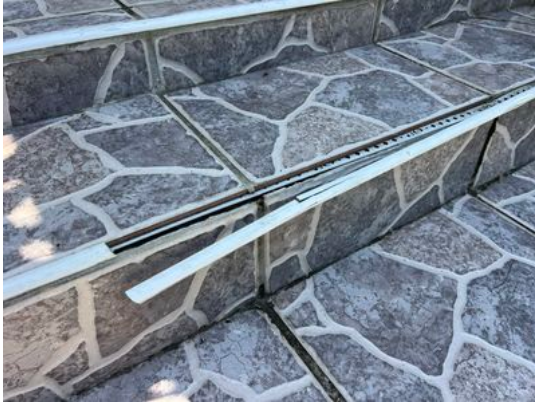
Condition: Repair or Replace

The tiled front entry steps are in poor condition. Multiple stair-nosing/edge trim pieces are loose, separated, or missing, creating exposed edges and a potential trip hazard. Repair and secure the damaged stair edging and any loose tile components as needed.

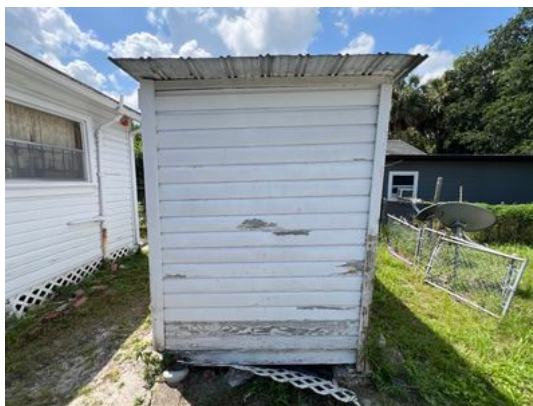
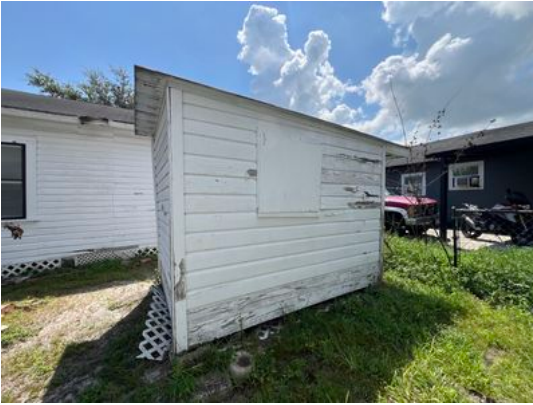
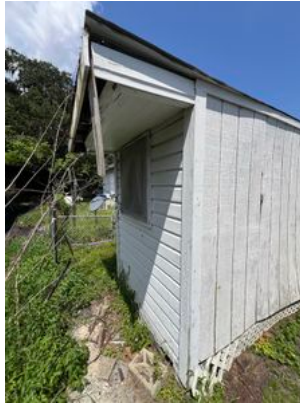
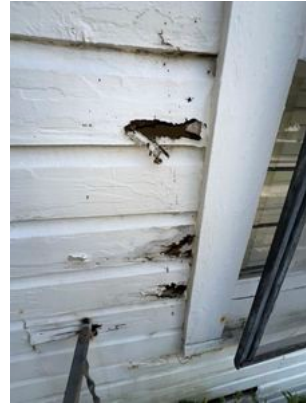
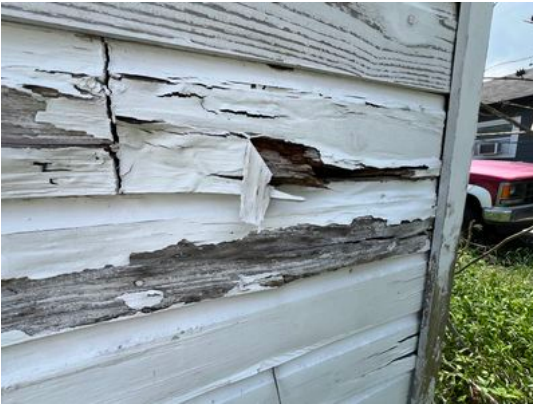
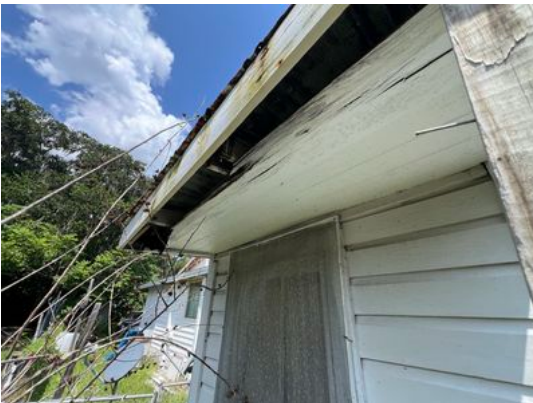
The exterior wood siding and trim on the detached structure are in poor condition, with widespread peeling paint, moisture deterioration, wood rot, open holes, damaged/missing sections, and deterioration along the lower wall areas and roof overhang. Portions of the siding are soft and deteriorated enough that the underlying material is exposed. The structure will require substantial repair, including replacement of deteriorated siding and trim and correction of the damaged roof-edge/overhang components.

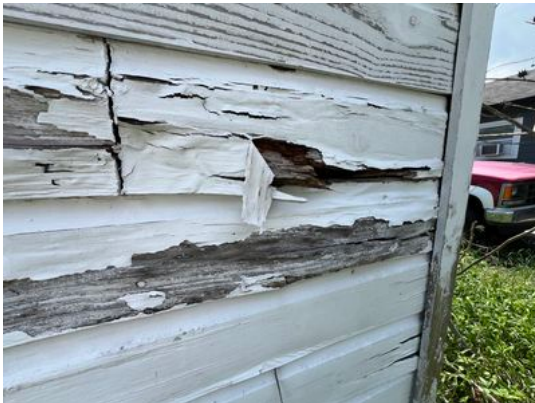
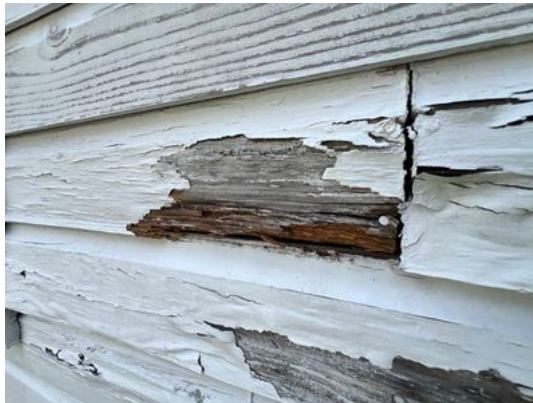
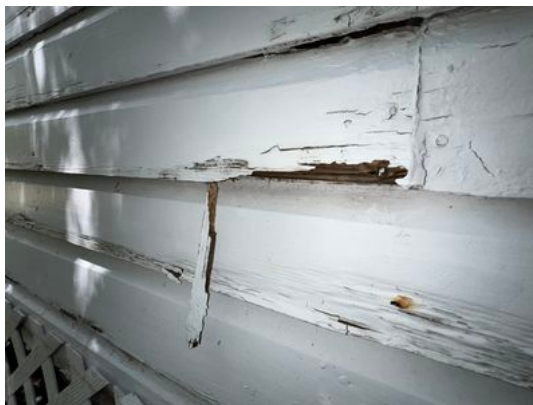
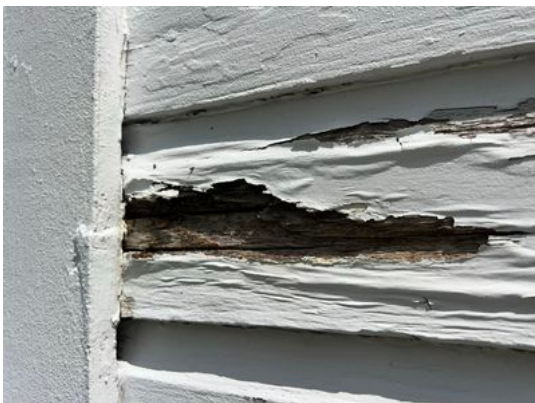
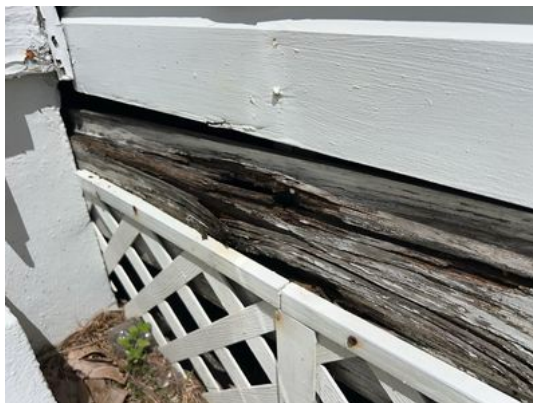
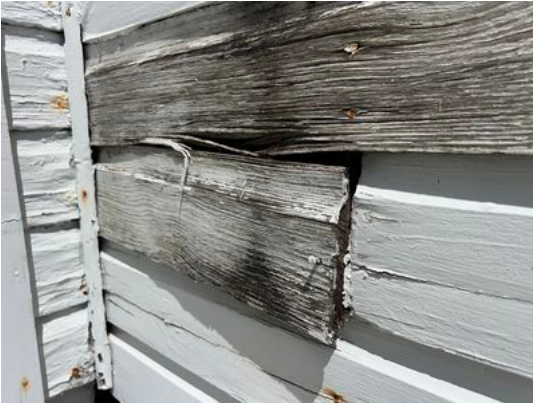
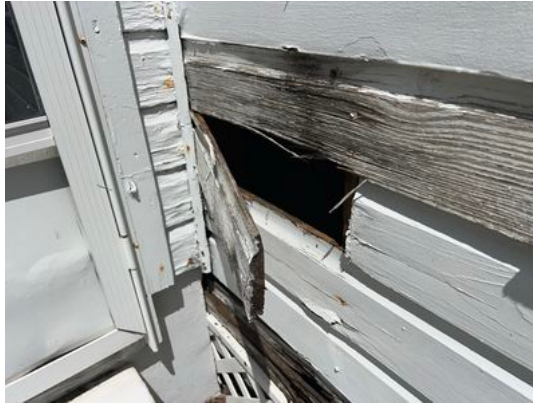
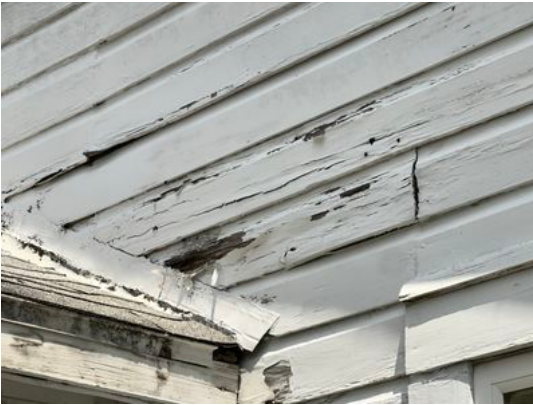
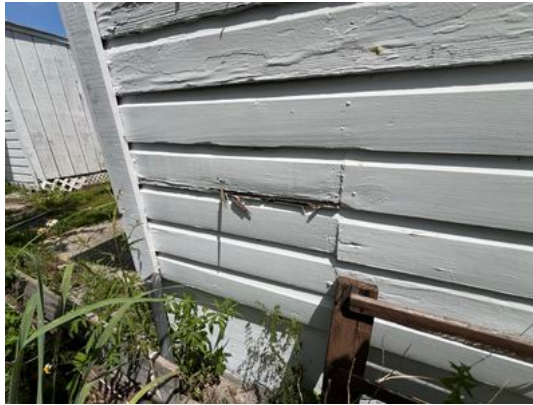
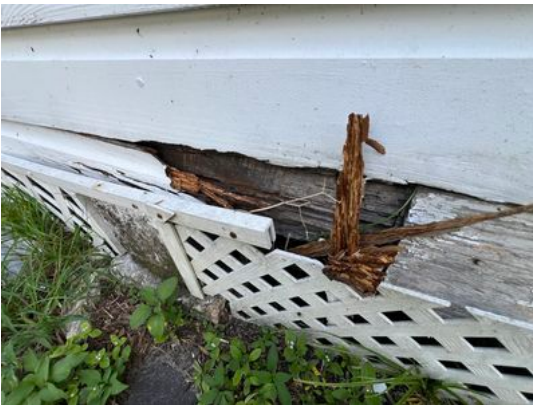
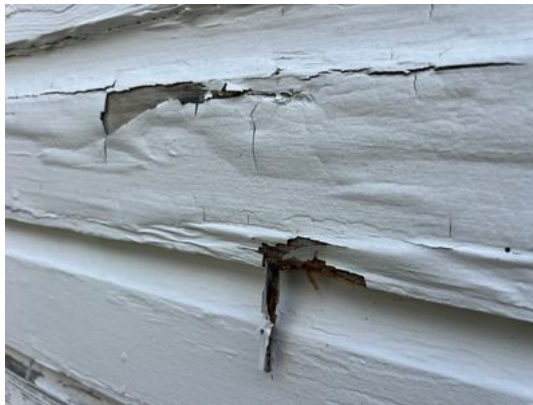
Condition: Repair or Replace

The exterior wood siding on the home is in poor condition, with widespread deterioration including wood rot, splitting, cracking, delamination, loose and broken sections, open holes, and areas where the siding has deteriorated completely through. Several lower wall sections are severely decayed with exposed underlying materials. Extensive repair and replacement of the deteriorated wood siding is needed.

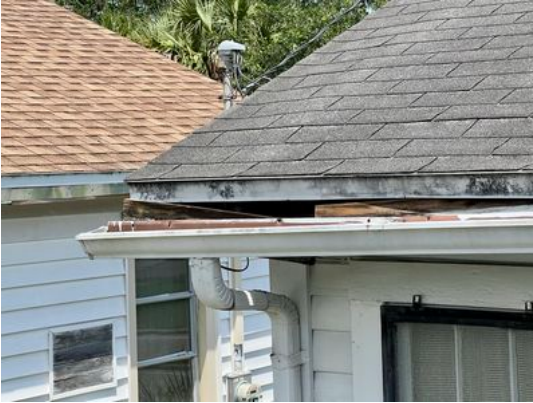
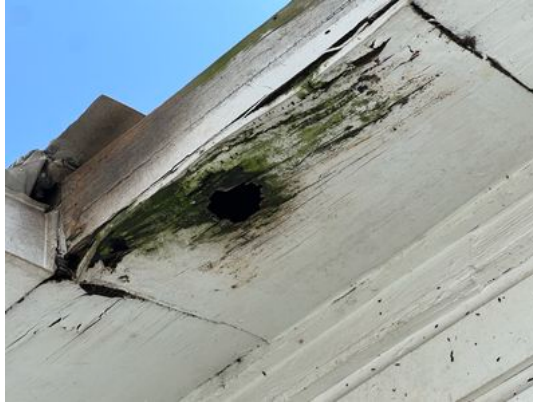
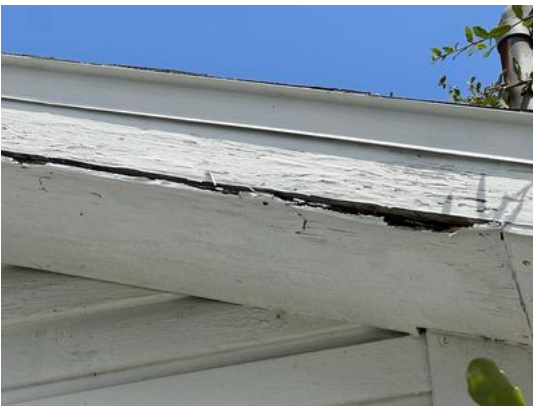
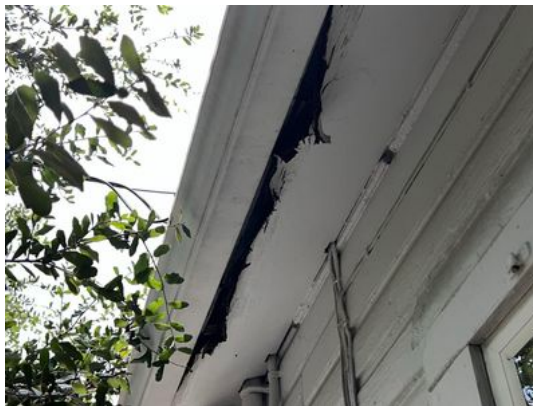
Condition: Repair or Replace

The exterior wood trim, fascia, and soffit components are in poor condition, with multiple areas of severe wood rot, splitting, separation, and missing/deteriorated sections. Several locations have open gaps exposing the underlying roof-edge framing. Extensive repair and replacement of the deteriorated trim, fascia, and soffit materials is needed.

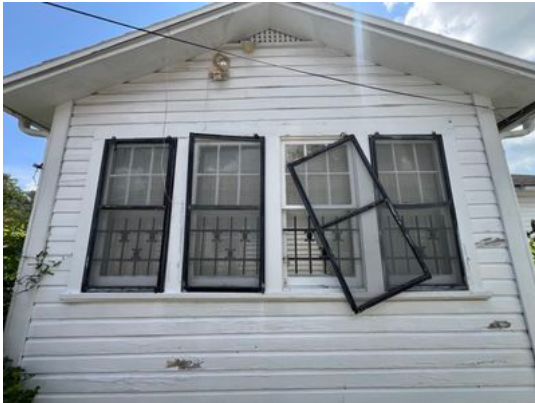
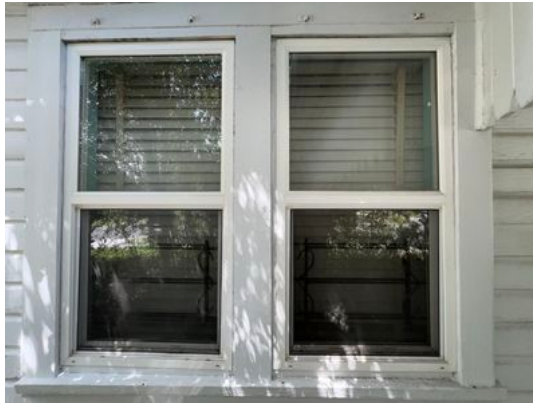
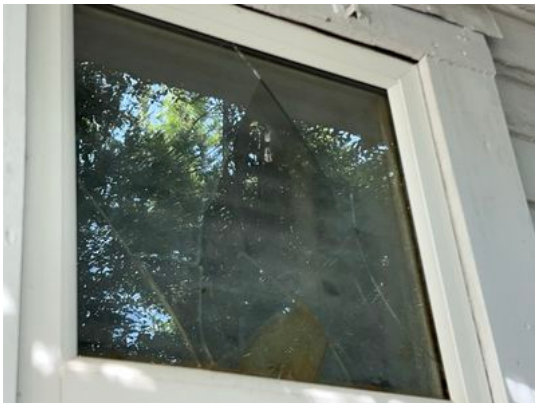
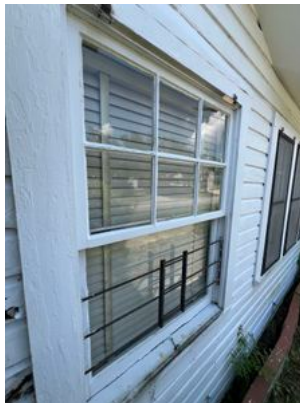
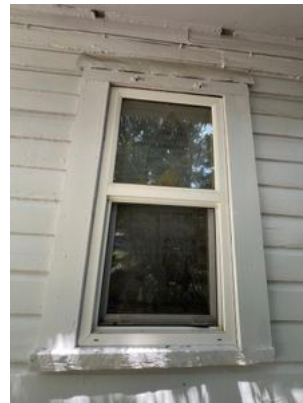
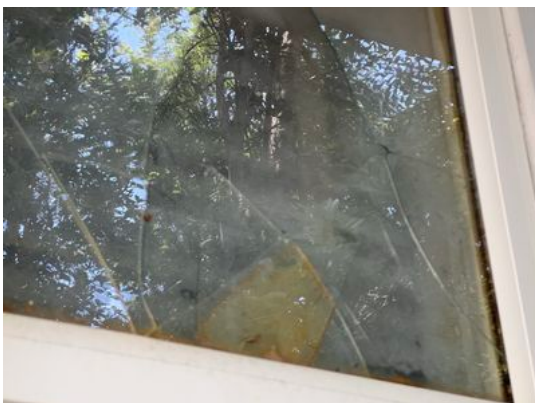
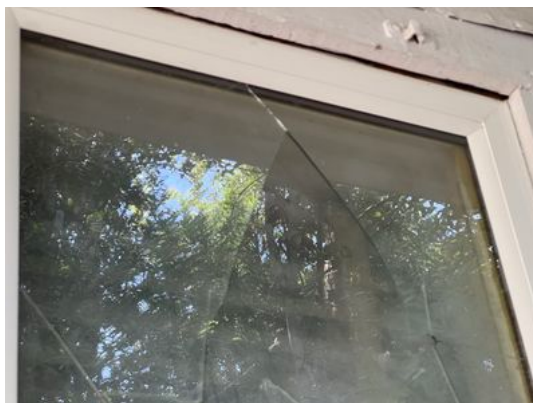
The home is fitted with a mixture of newer double-pane windows and older wood-framed windows that appear to be original to the 1940 construction. The original wood-framed windows are significantly aged and deteriorated, with cracked glazing, deteriorated frames, and damaged or loose exterior storm/screen panels noted. Due to their age and condition, the original windows have exceeded their typical service life and should be repaired or replaced as needed.

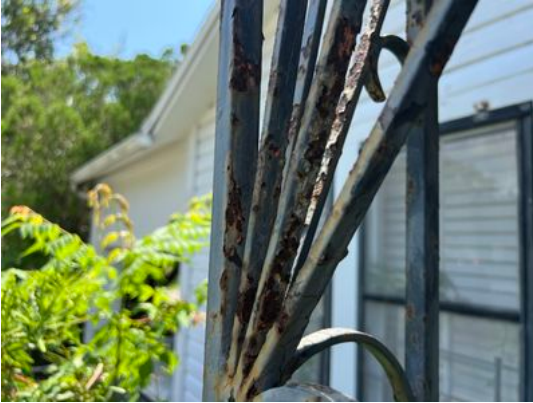
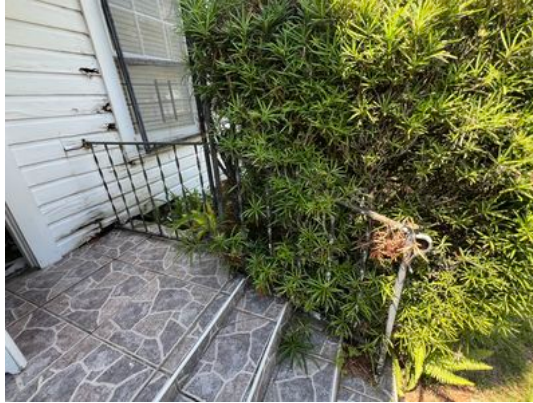
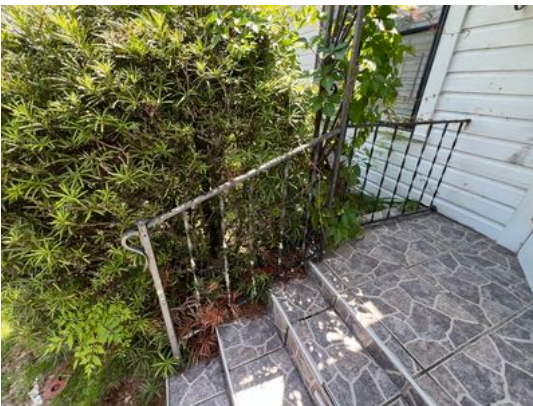
The metal railings at the front entry are in poor condition, with widespread surface rust, corrosion, peeling paint, and deterioration of multiple railing components. Vegetation is also heavily overgrown around and through portions of the railing. Repairs are needed to address the corrosion and restore the railings to a secure and serviceable condition.

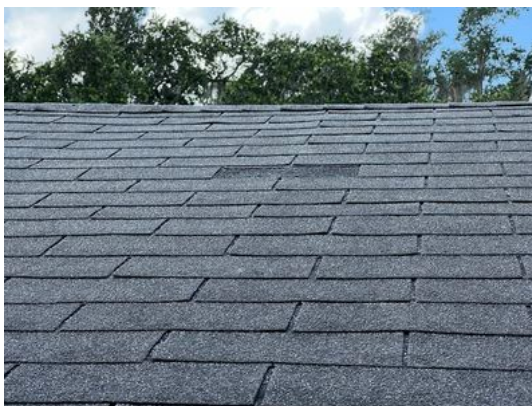
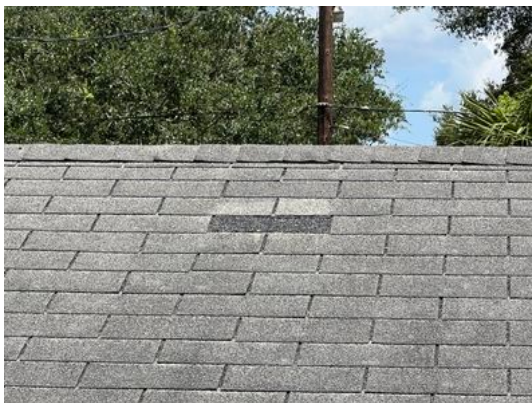
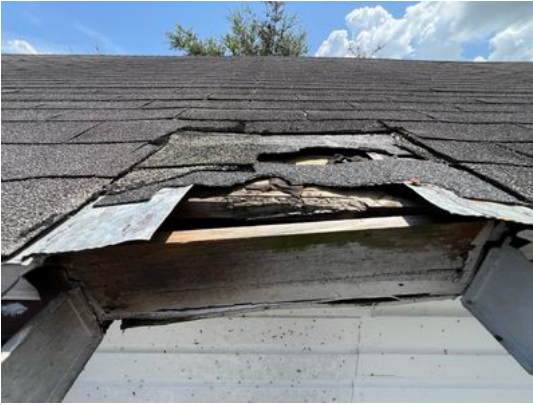
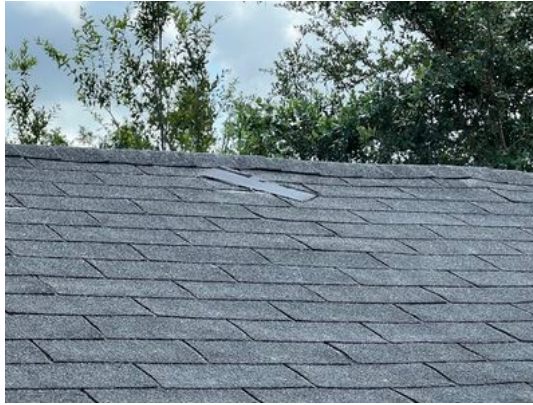
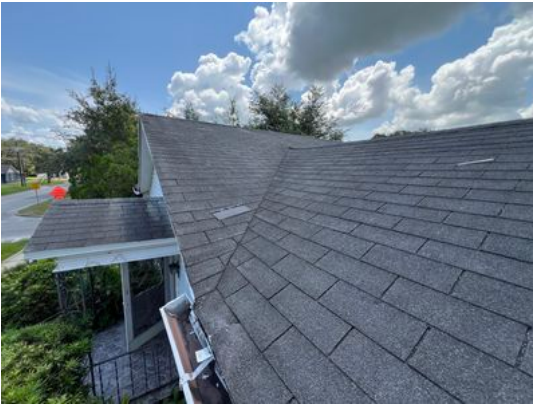
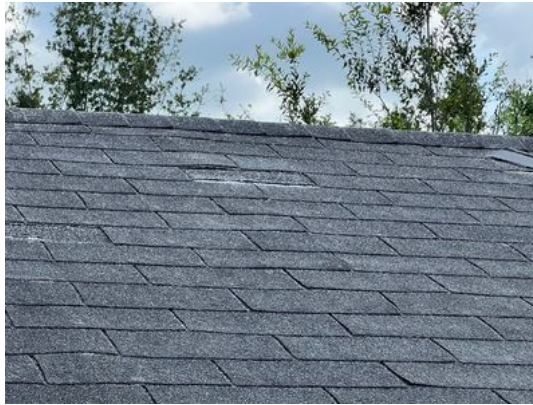
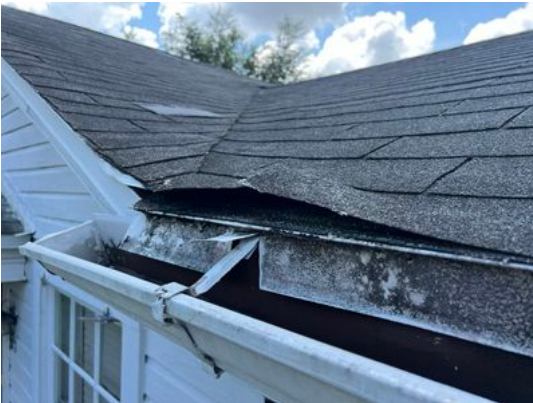
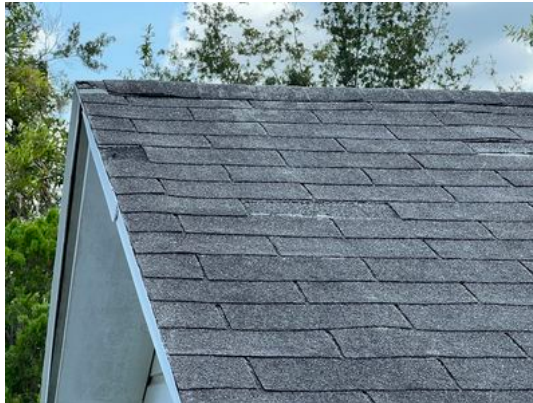
The asphalt shingle roof is in poor condition. Multiple shingles are lifted, curled, loose, damaged, and missing, with areas of exposed underlayment and previous patching visible. Significant deterioration is also present along portions of the roof edge/eaves, including open sections with exposed and deteriorated wood components. Due to the extent of deterioration, the roof covering should be considered near or at the end of its serviceable life and replacement is recommended.

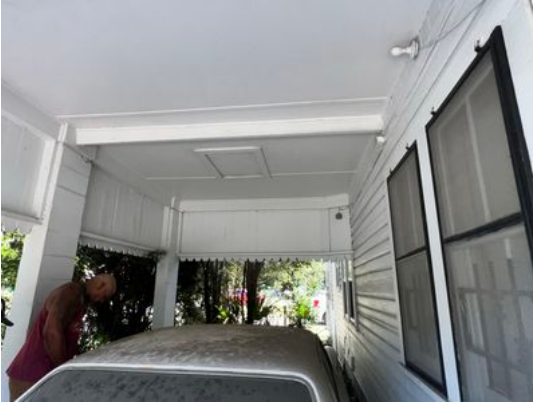
The home has two attic access openings. One attic access is located in the carport and was not accessible at the time of inspection due to a vehicle parked directly beneath the opening, preventing safe access.

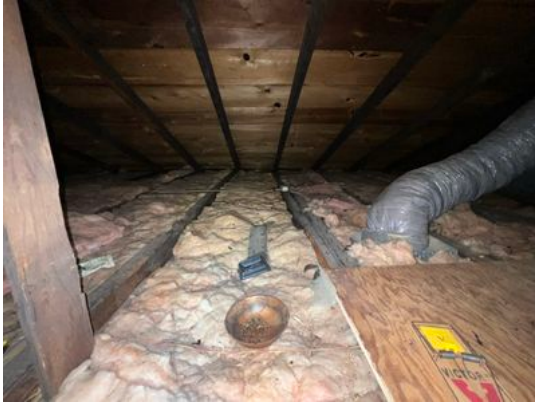
### Insulation

The attic is insulated with fiberglass batt insulation that appears to be original to the home. A strong urine-like odor was present within the attic space, which may be associated with animal or rodent activity.

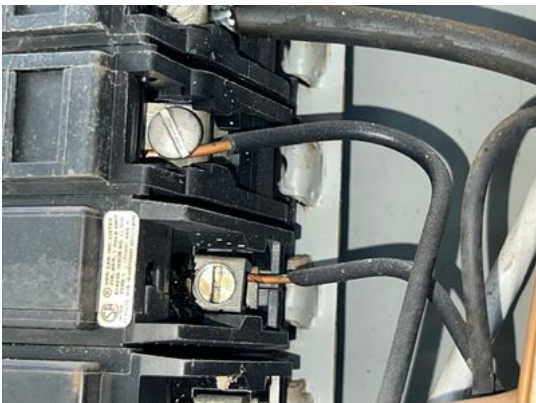
### Overcurrent Protection

The electrical panel is in poor condition and exhibits multiple installation and safety concerns. Significant rust/corrosion and accumulated debris are present inside the cabinet, along with evidence of insect nesting. Multiple conductors/cables enter the panel without proper fittings or protection, and several cable jackets have been stripped back excessively, leaving individual conductors exposed within the cabinet. The wiring is generally disorganized and appears to include improper or questionable terminations. Due to the overall condition of the panel and the electrical power being unavailable for functional testing, evaluation and necessary repairs by a licensed electrician are recommended prior to restoring power to the property.

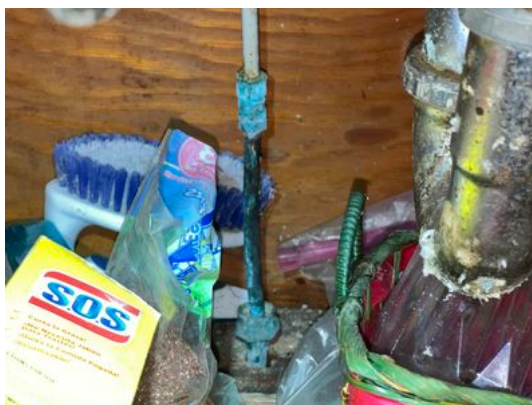
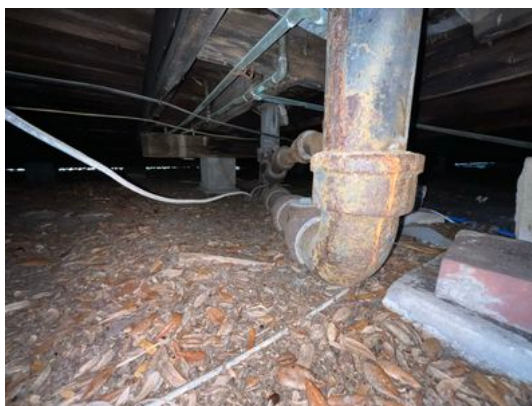
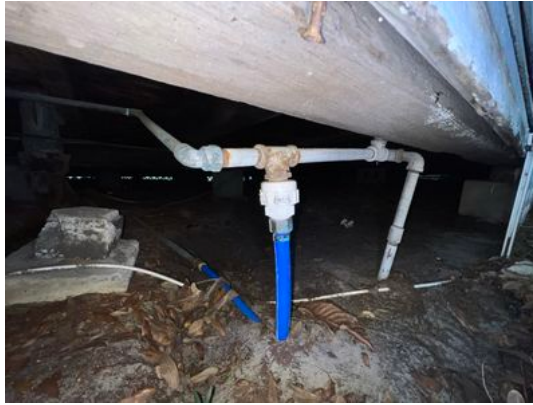
The plumbing appears to be a mixture of copper and galvanized steel piping, with some newer blue plastic piping/repair sections visible in the crawlspace.

There is significant corrosion/oxidation at multiple copper fittings and connections, especially around the water heater and fixture supply piping. The galvanized piping also shows surface rust and age-related deterioration. Given the mixed materials and visible corrosion, I would document it as an older, partially modified plumbing system and recommend further evaluation for leakage and serviceability once the water is restored.

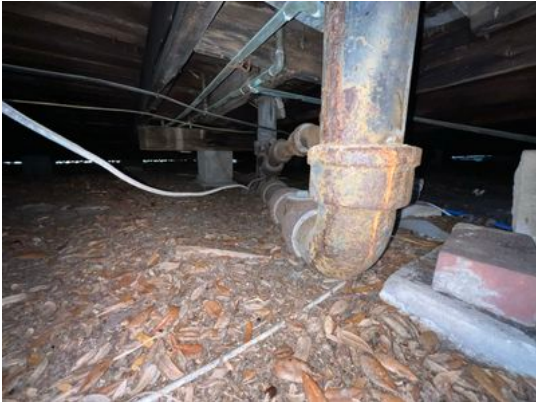
### Comment 19

The exterior plumbing vent pipe is severely corroded and deteriorated, with a large section of the pipe wall rusted through and missing. This condition can allow sewer gases to escape and may affect proper venting of the plumbing drainage system. Repair or replacement of the damaged vent piping by a licensed plumber is recommended.

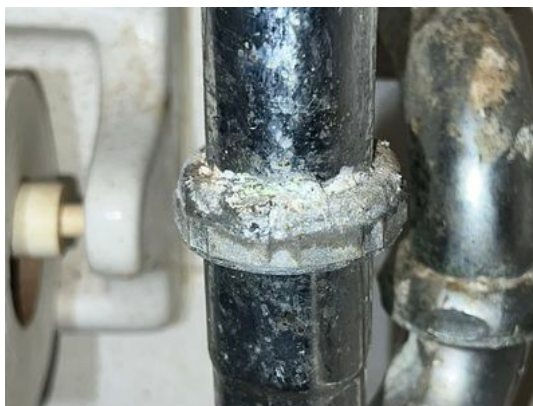
### Comment 21

The bathroom sink drain piping exhibits significant corrosion and mineral buildup at the connection below the sink. This condition may indicate leakage or deterioration of the fitting. Due to the water service being unavailable, the drain could not be functionally tested. Further evaluation and repair by a licensed plumber is recommended once water service is restored.

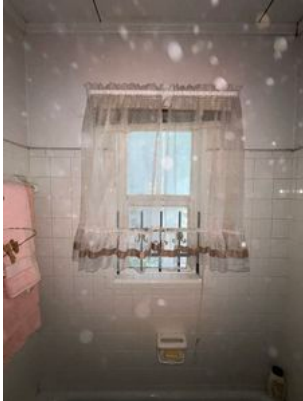
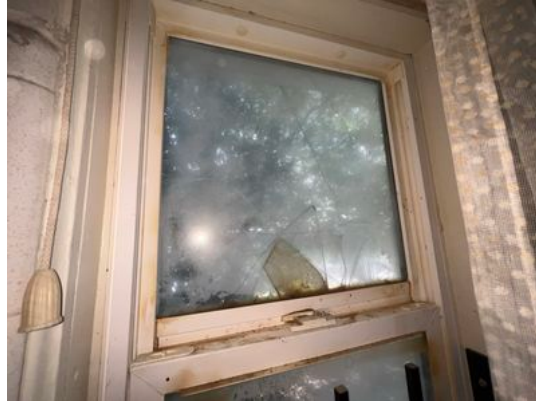
### Ventilation Type

The bathroom window, which serves as the bathroom's only source of ventilation, has a broken window pane. The damaged glazing should be repaired or replaced to restore the window to a safe and serviceable condition.

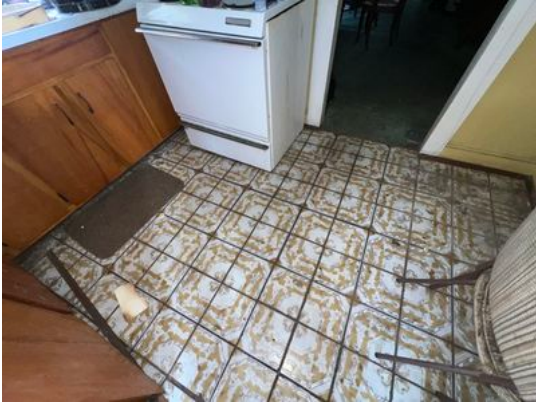
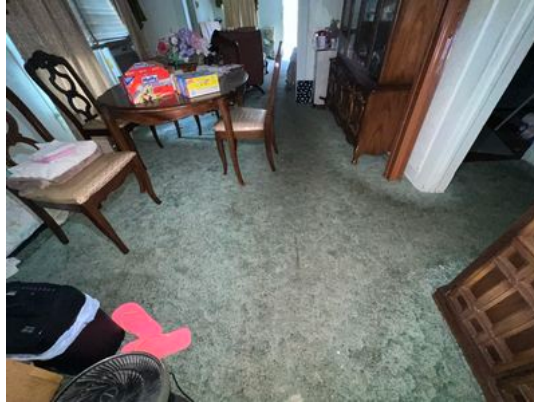
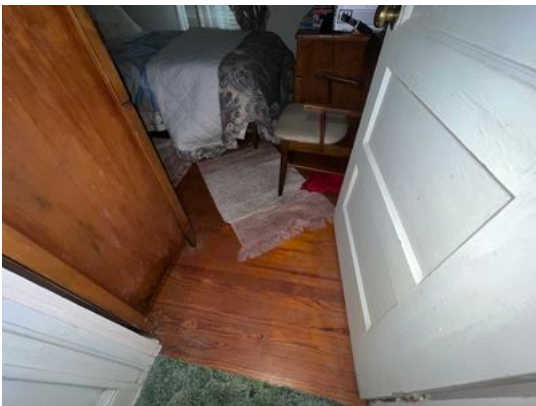
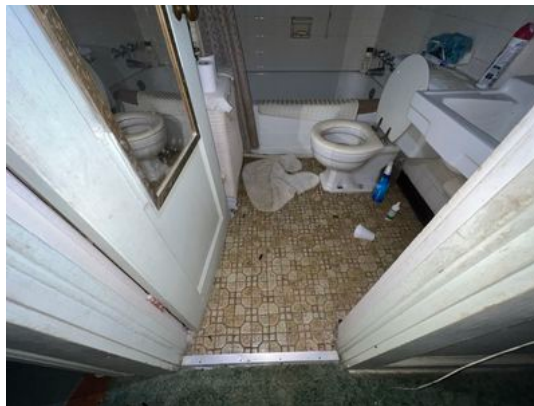
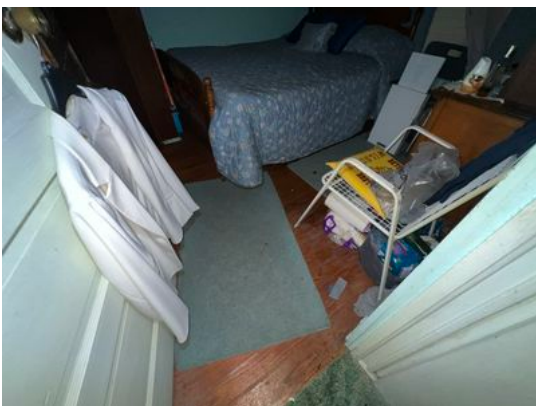
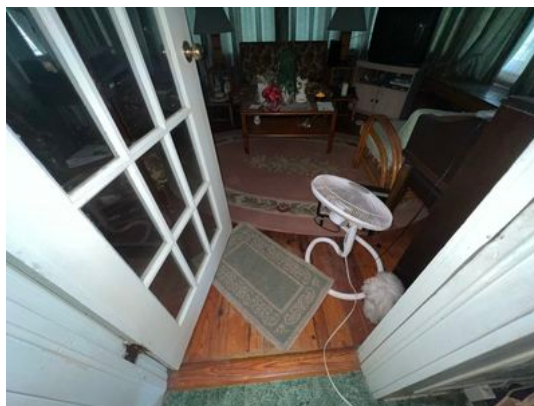
Tile, Carpet, Wood

Condition: Marginal

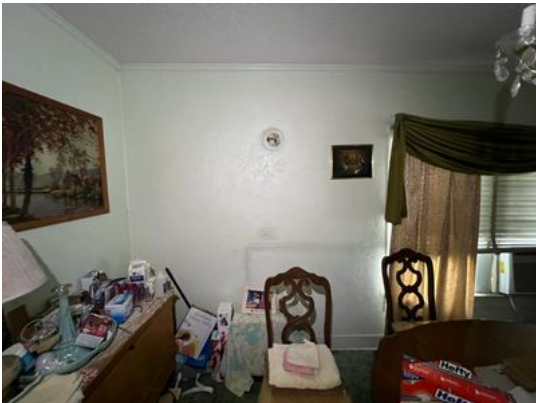
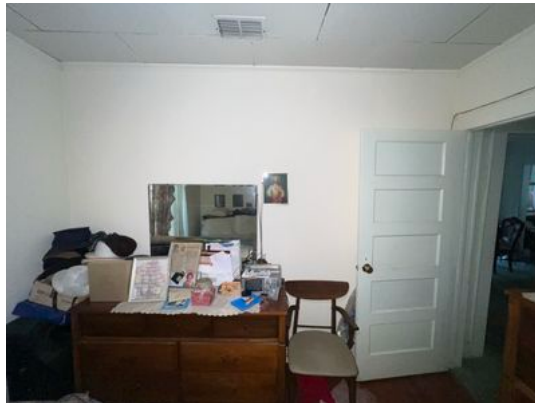
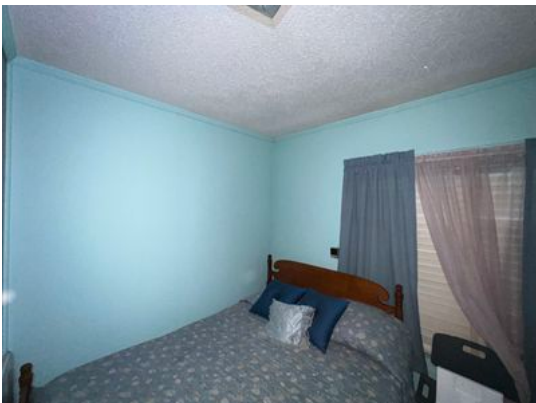
### Walls

Condition: Marginal

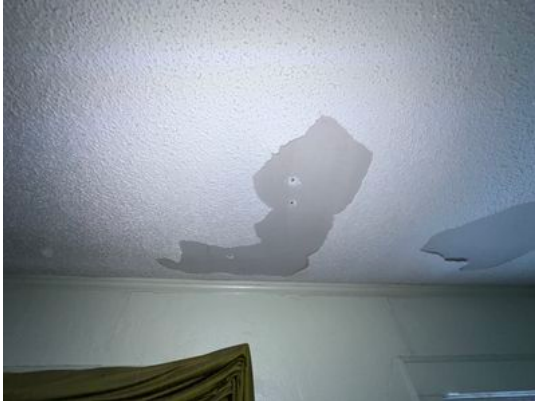
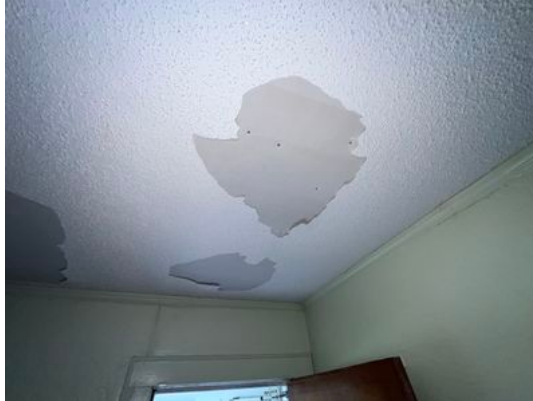
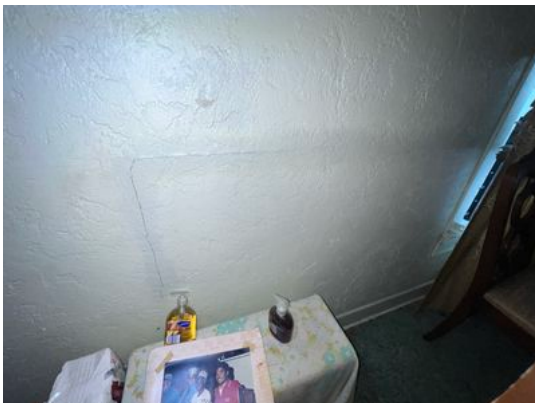
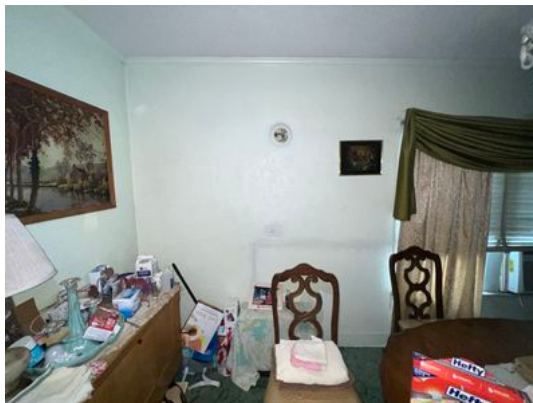
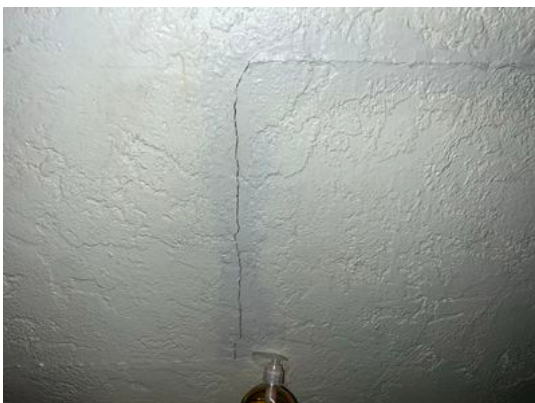
**Comment 24**

The ceiling popcorn texture is peeling and separating in multiple areas, exposing the underlying ceiling surface. Additionally, the blue wall shows evidence of a previous repair where the repaired seam has reopened and is cracking. Repair and refinishing of the affected wall and ceiling surfaces are recommended.

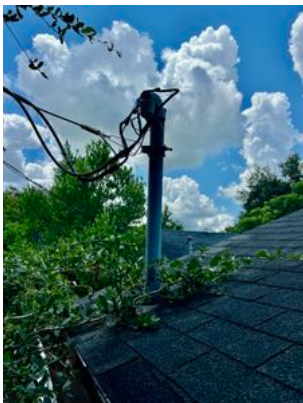
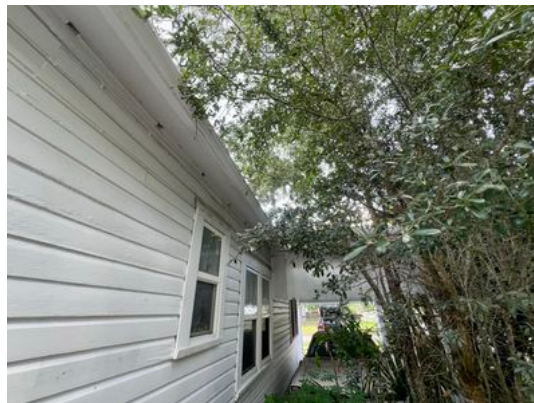
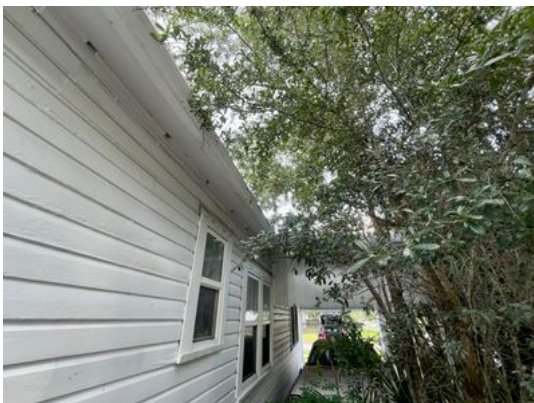
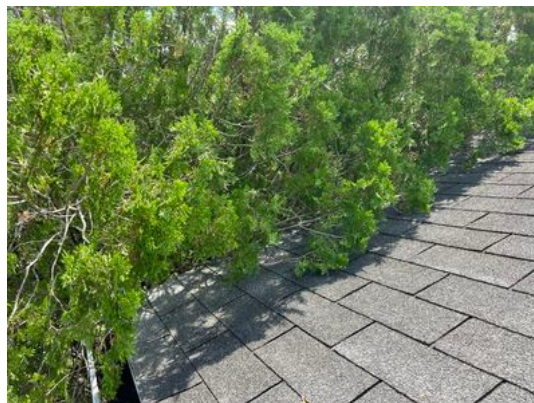
#### Site: Vegetation

The home is situated on a property with large trees that overhang the roof and surrounding areas. While these trees add aesthetic value and shade, they also pose potential risks. Overhanging branches can cause damage to the roof, gutters, and siding, especially during storms or high winds. Additionally, falling branches may create safety hazards for residents and visitors. Regular tree maintenance, including trimming and monitoring for signs of decay or disease, is recommended to mitigate these risks and protect the home.

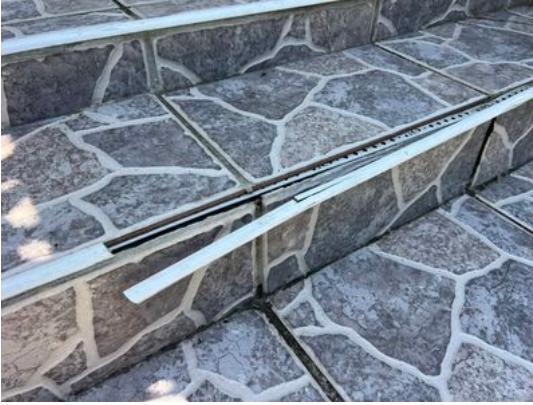
### Site: Steps/Stoops

The tiled front entry steps are in poor condition. Multiple stair-nosing/edge trim pieces are loose, separated, or missing, creating exposed edges and a potential trip hazard. Repair and secure the damaged stair edging and any loose tile components as needed.

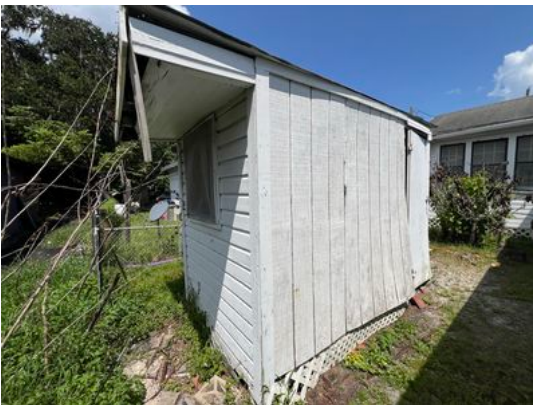
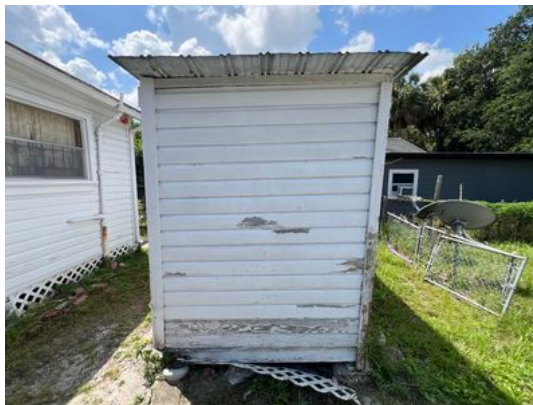
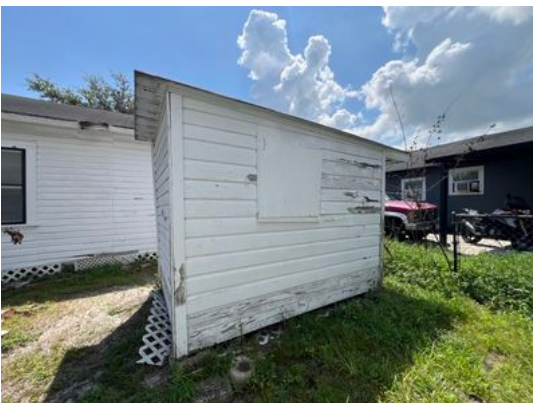
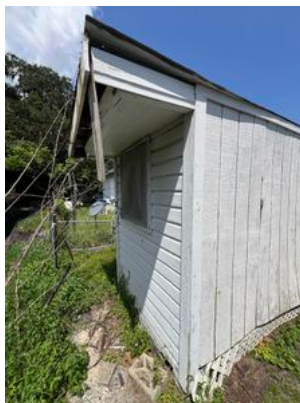
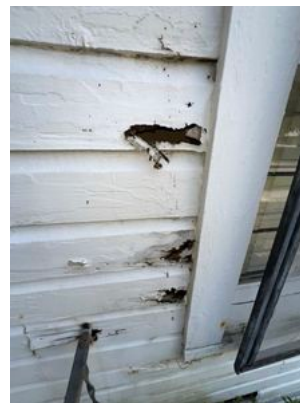
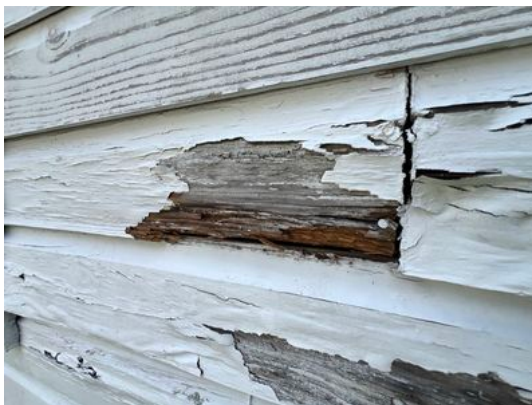
### Site

The exterior wood siding and trim on the detached structure are in poor condition, with widespread peeling paint, moisture deterioration, wood rot, open holes, damaged/missing sections, and deterioration along the lower wall areas and roof overhang. Portions of the siding are soft and deteriorated enough that the underlying material is exposed. The structure will require substantial repair, including replacement of deteriorated siding and trim and correction of the damaged roof-edge/overhang components.

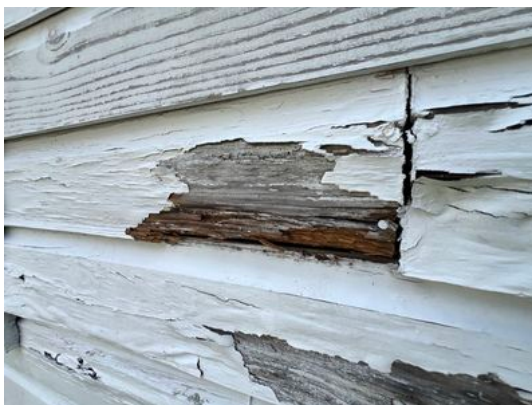
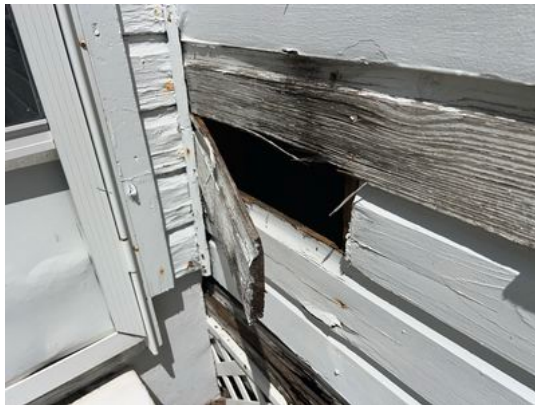
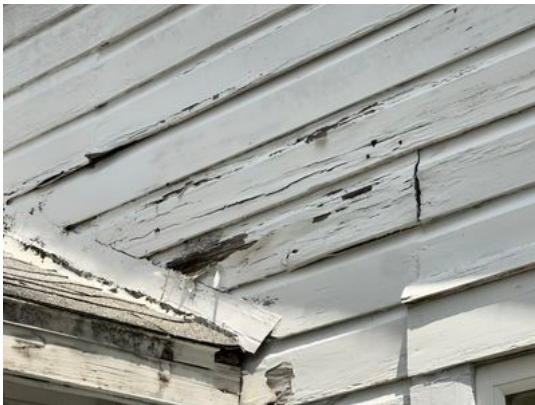
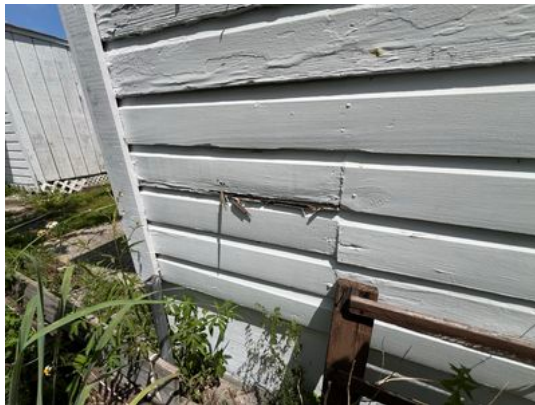
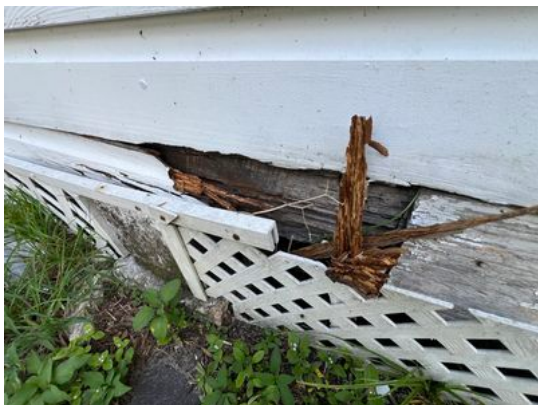
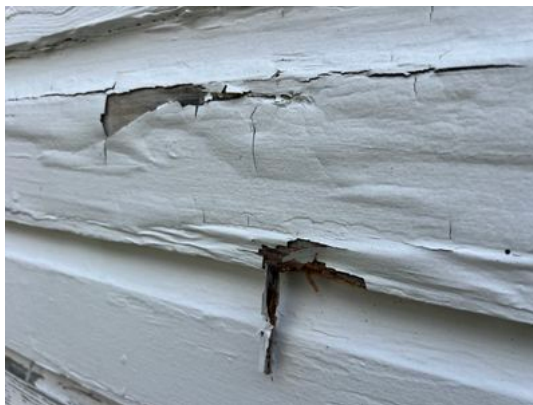
#### **Exterior: Exterior Covering**

The exterior wood siding on the home is in poor condition, with widespread deterioration including wood rot, splitting, cracking, delamination, loose and broken sections, open holes, and areas where the siding has deteriorated completely through. Several lower wall sections are severely decayed with exposed underlying materials. Extensive repair and replacement of the deteriorated wood siding is needed.

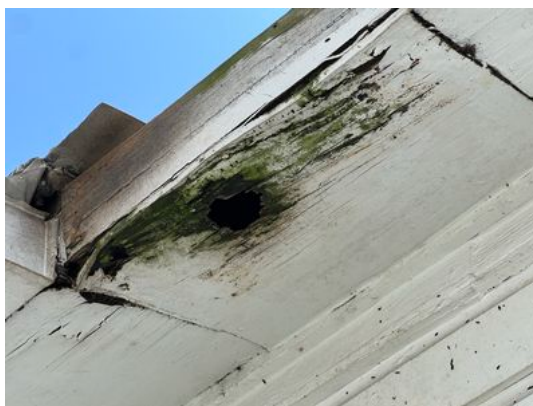
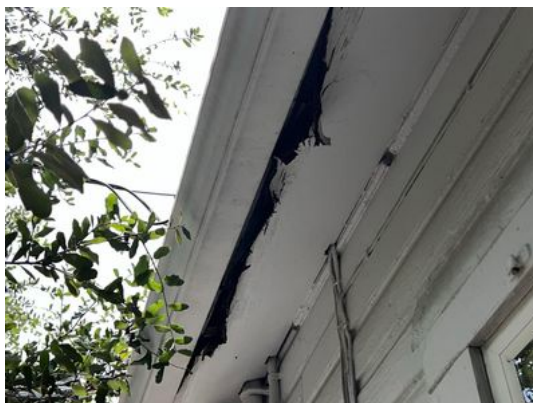
#### Exterior: Exterior Trim Material

The exterior wood trim, fascia, and soffit components are in poor condition, with multiple areas of severe wood rot, splitting, separation, and missing/deteriorated sections. Several locations have open gaps exposing the underlying roof-edge framing. Extensive repair and replacement of the deteriorated trim, fascia, and soffit materials is needed.

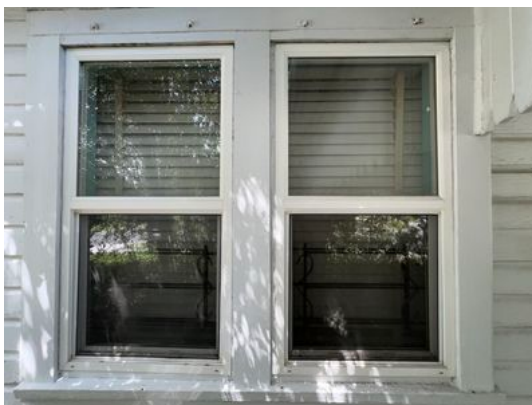
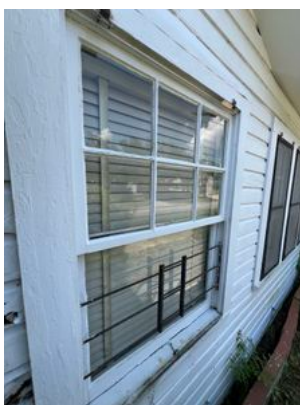
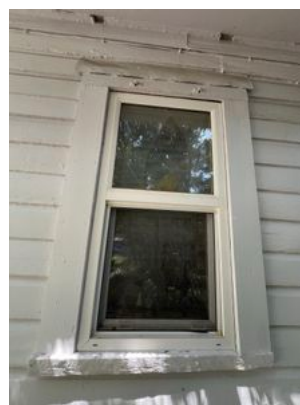
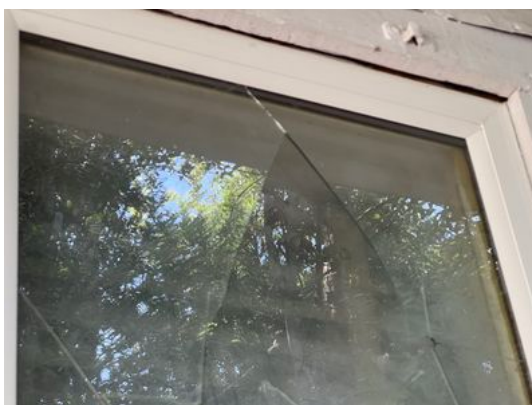
### Exterior: Windows

The home is fitted with a mixture of newer double-pane windows and older wood-framed windows that appear to be original to the 1940 construction. The original wood-framed windows are significantly aged and deteriorated, with cracked glazing, deteriorated frames, and damaged or loose exterior storm/screen panels noted. Due to their age and condition, the original windows have exceeded their typical service life and should be repaired or replaced as needed.

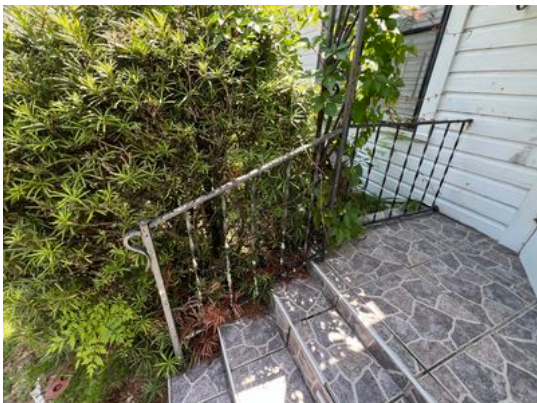
### Exterior: Railings

The metal railings at the front entry are in poor condition, with widespread surface rust, corrosion, peeling paint, and deterioration of multiple railing components. Vegetation is also heavily overgrown around and through portions of the railing. Repairs are needed to address the corrosion and restore the railings to a secure and serviceable condition.

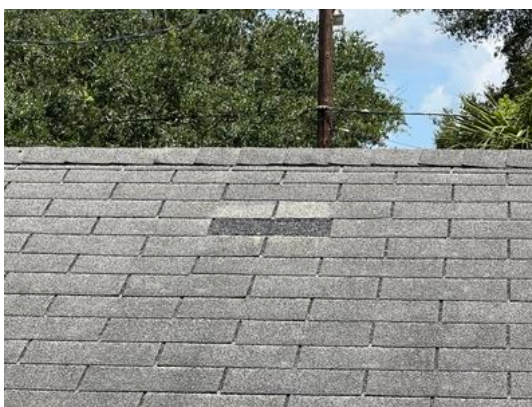
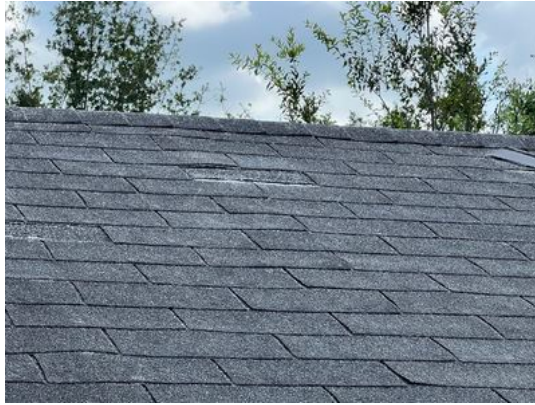
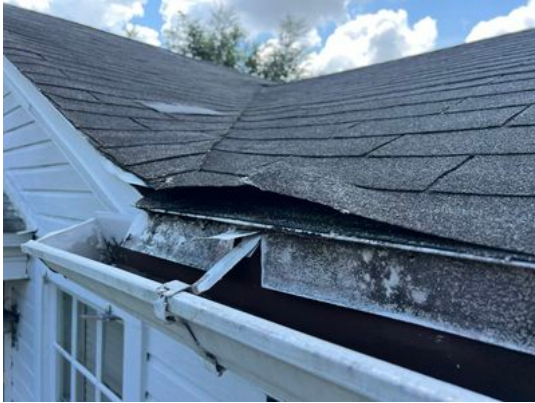
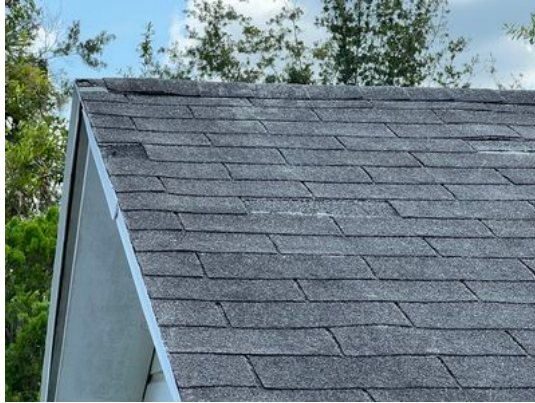
### Roofing: Visible Damage

The asphalt shingle roof is in poor condition. Multiple shingles are lifted, curled, loose, damaged, and missing, with areas of exposed underlayment and previous patching visible. Significant deterioration is also present along portions of the roof edge/eaves, including open sections with exposed and deteriorated wood components. Due to the extent of deterioration, the roof covering should be considered near or at the end of its serviceable life and replacement is recommended.

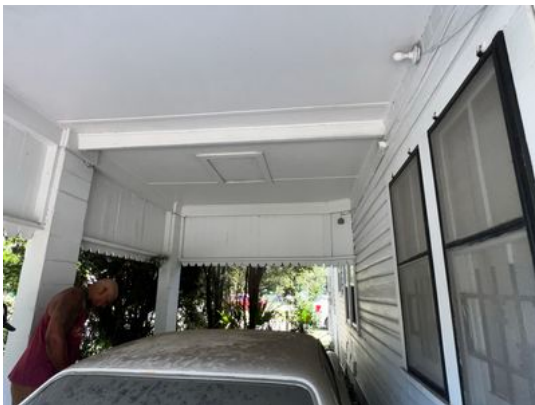
#### **Structure: Attic: Attic Entry**

The home has two attic access openings. One attic access is located in the carport and was not accessible at the time of inspection due to a vehicle parked directly beneath the opening, preventing safe access.

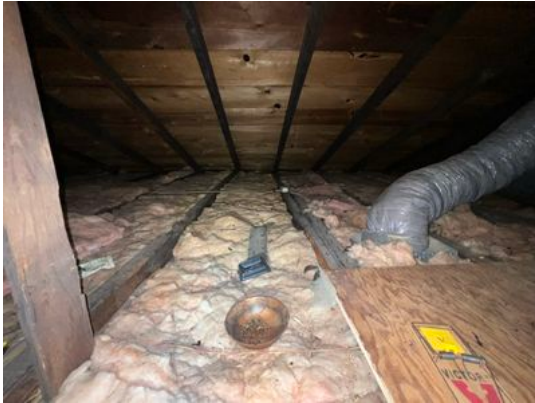
### Structure: Attic: Insulation

The attic is insulated with fiberglass batt insulation that appears to be original to the home. A strong urine-like odor was present within the attic space, which may be associated with animal or rodent activity.
