## Home Inspection Report

619 E Seventh Street  
Sanford, FL 32771

Inspected By: Hector Vargas, Lic. HI12079

Inspected On Fri, Aug 14, 2026 at 12:00 PM

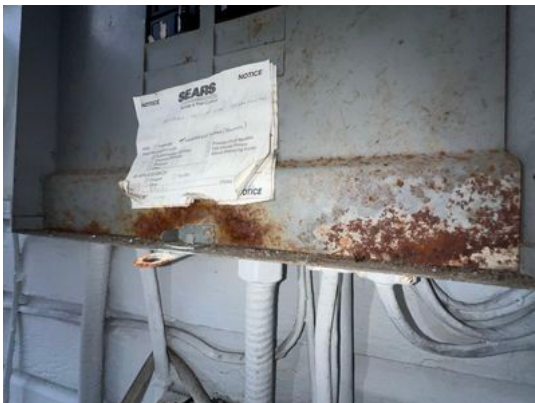
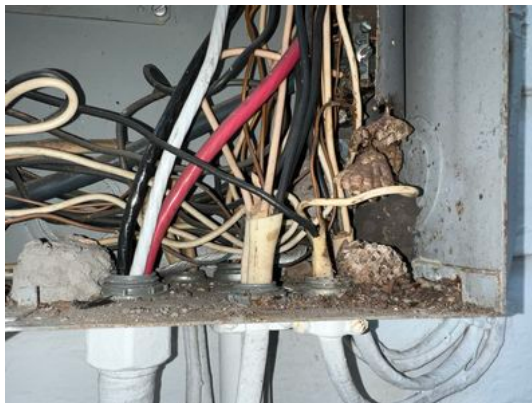
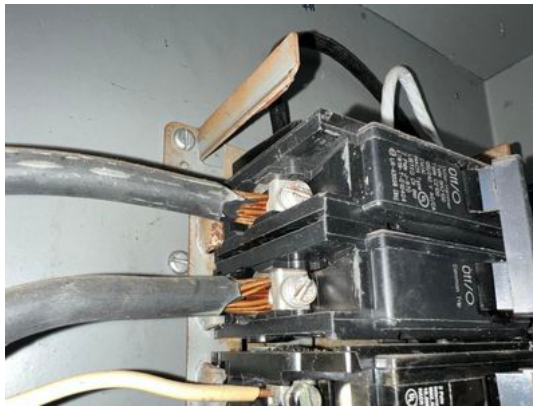
### Electrical

The electrical panel is in poor condition and exhibits multiple installation and safety concerns. Significant rust/corrosion and accumulated debris are present inside the cabinet, along with evidence of insect nesting. Multiple conductors/cables enter the panel without proper fittings or protection, and several cable jackets have been stripped back excessively, leaving individual conductors exposed within the cabinet. The wiring is generally disorganized and appears to include improper or questionable terminations. Due to the overall condition of the panel and the electrical power being unavailable for functional testing, evaluation and necessary repairs by a licensed electrician are recommended prior to restoring power to the property.

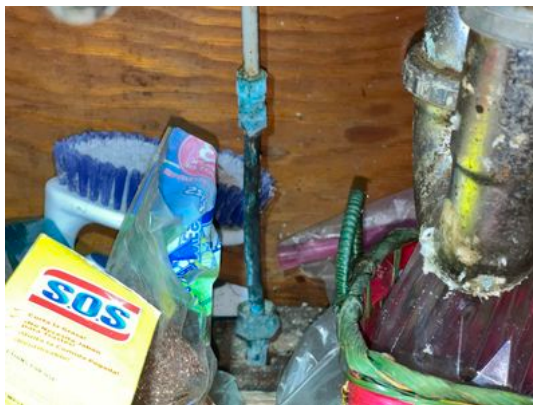
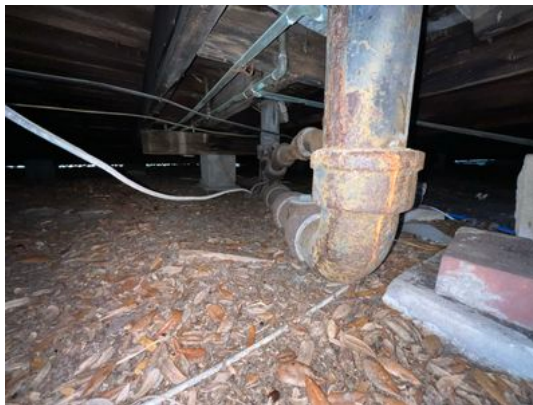
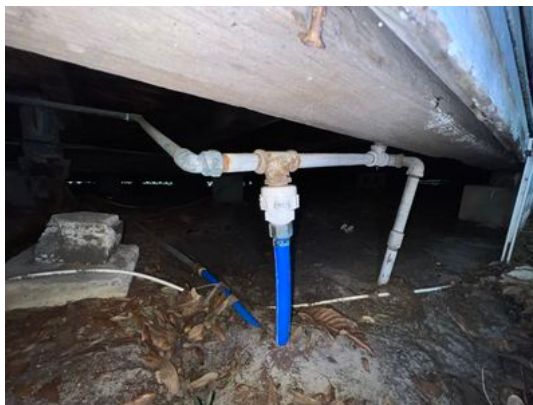
### Plumbing: Supply Pipe Material

The plumbing appears to be a mixture of copper and galvanized steel piping, with some newer blue plastic piping/repair sections visible in the crawlspace.

There is significant corrosion/oxidation at multiple copper fittings and connections, especially around the water heater and fixture supply piping. The galvanized piping also shows surface rust and age-related deterioration. Given the mixed materials and visible corrosion, I would document it as an older, partially modified plumbing system and recommend further evaluation for leakage and serviceability once the water is restored.

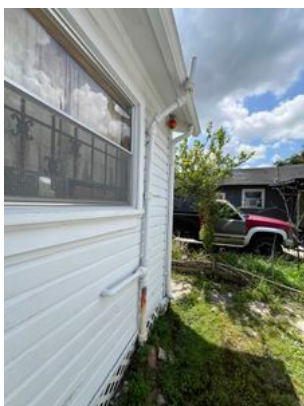
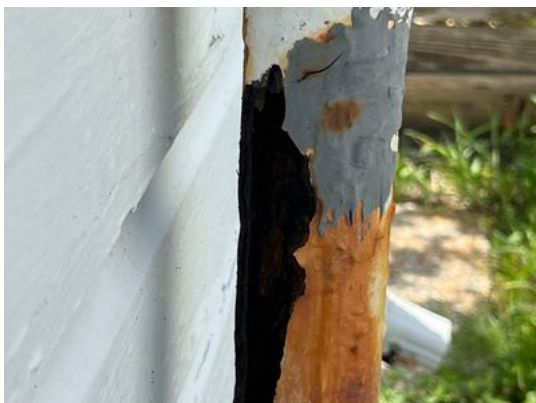
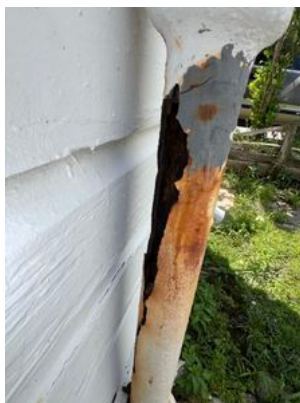
### Plumbing: Waste Pipe Material

The exterior plumbing vent pipe is severely corroded and deteriorated, with a large section of the pipe wall rusted through and missing. This condition can allow sewer gases to escape and may affect proper venting of the plumbing drainage system. Repair or replacement of the damaged vent piping by a licensed plumber is recommended.

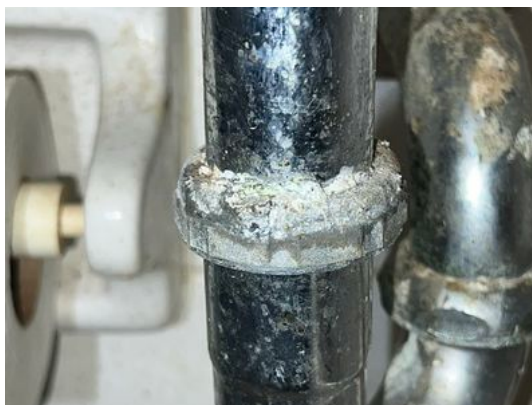
### **Bathrooms: Bathroom #1: Sink(s)**

The bathroom sink drain piping exhibits significant corrosion and mineral buildup at the connection below the sink. This condition may indicate leakage or deterioration of the fitting. Due to the water service being unavailable, the drain could not be functionally tested. Further evaluation and repair by a licensed plumber is recommended once water service is restored.

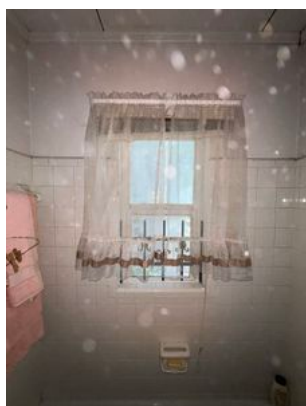
### **Bathrooms: Bathroom #1: Ventilation Type**

The bathroom window, which serves as the bathroom's only source of ventilation, has a broken window pane. The damaged glazing should be repaired or replaced to restore the window to a safe and serviceable condition.

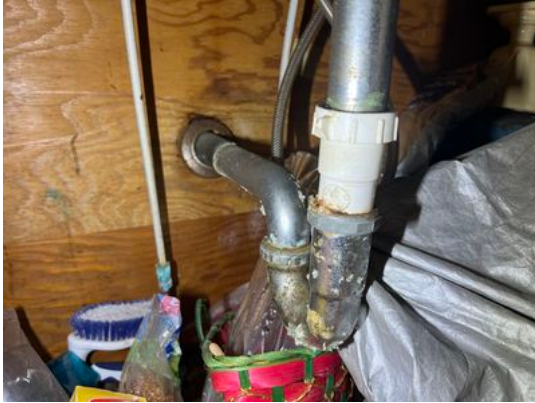
### Kitchen: Sink

The kitchen sink drain piping shows significant corrosion, mineral buildup, and deterioration at multiple connections, including the trap assembly and transition fitting. The mixed piping and visible buildup are consistent with aging and possible past leakage. Due to the water service being unavailable, the drain could not be functionally tested. Further evaluation and repair by a licensed plumber is recommended once water service is restored.

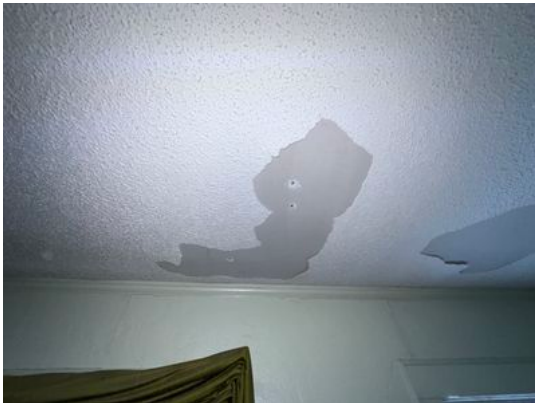
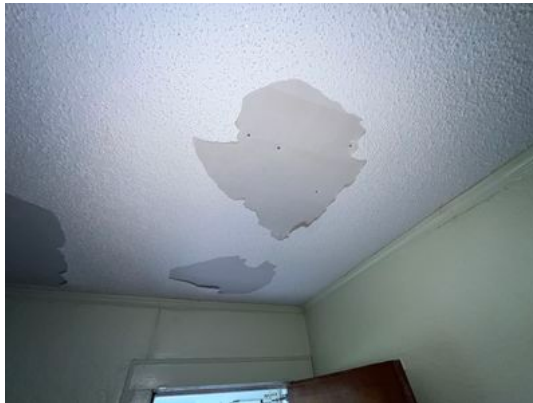
### Interior: Walls

The ceiling popcorn texture is peeling and separating in multiple areas, exposing the underlying ceiling surface. Additionally, the blue wall shows evidence of a previous repair where the repaired seam has reopened and is cracking. Repair and refinishing of the affected wall and ceiling surfaces are recommended.
