# 11732 Triskett Rd Cleveland, Ohio 44111

Client	<b>Josh Usher</b>
Type	<b>Major System Plus Report</b>
Scheduled	<b>May 12, 2026, 12:00 PM EDT</b>
Completed	<b>May 12, 2026, 1:16 PM EDT</b>

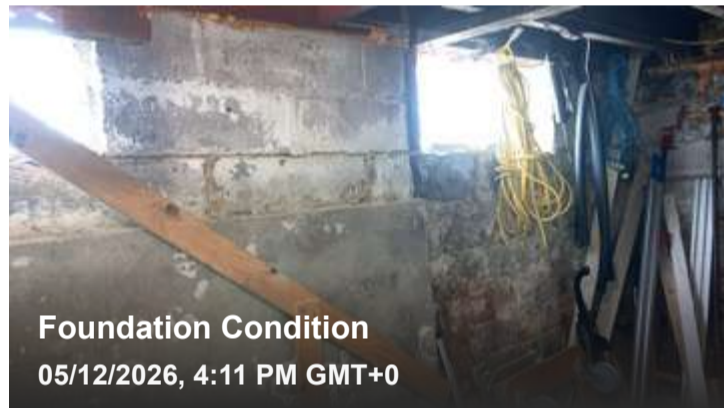
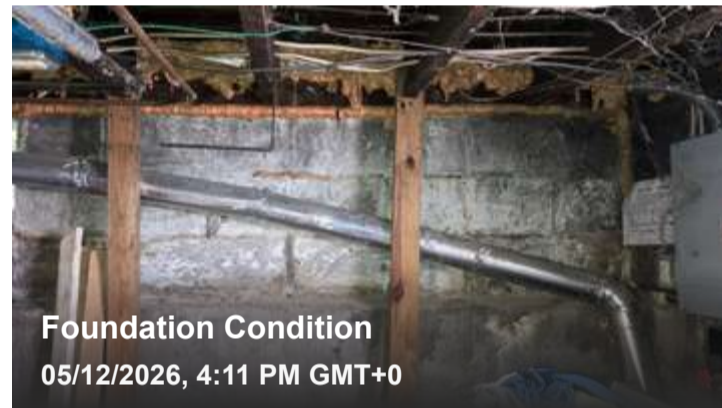
Foundation Condition

**Fair (Some Repairs)**

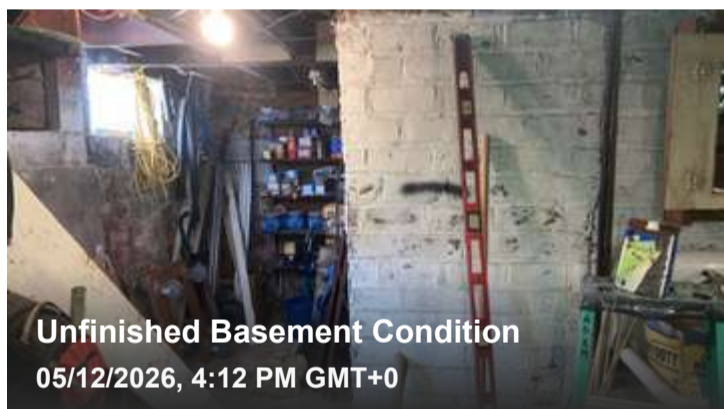
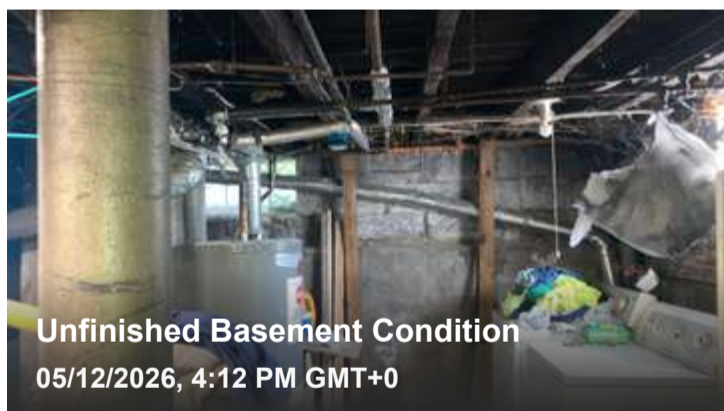
Unfinished Basement Condition

**Fair (Some Repairs)**

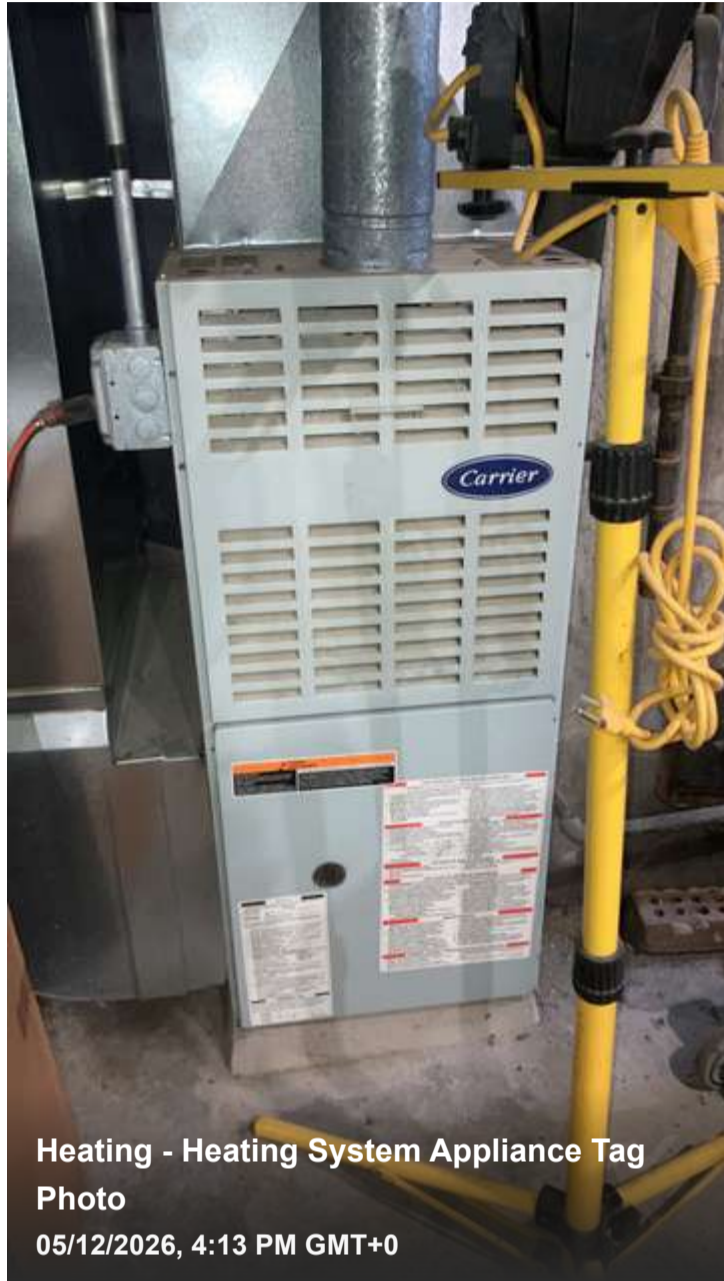
Heating - Heating System Appliance Tag  
Photo  
05/12/2026, 4:13 PM GMT+0

**26.04 years**

**0 years**

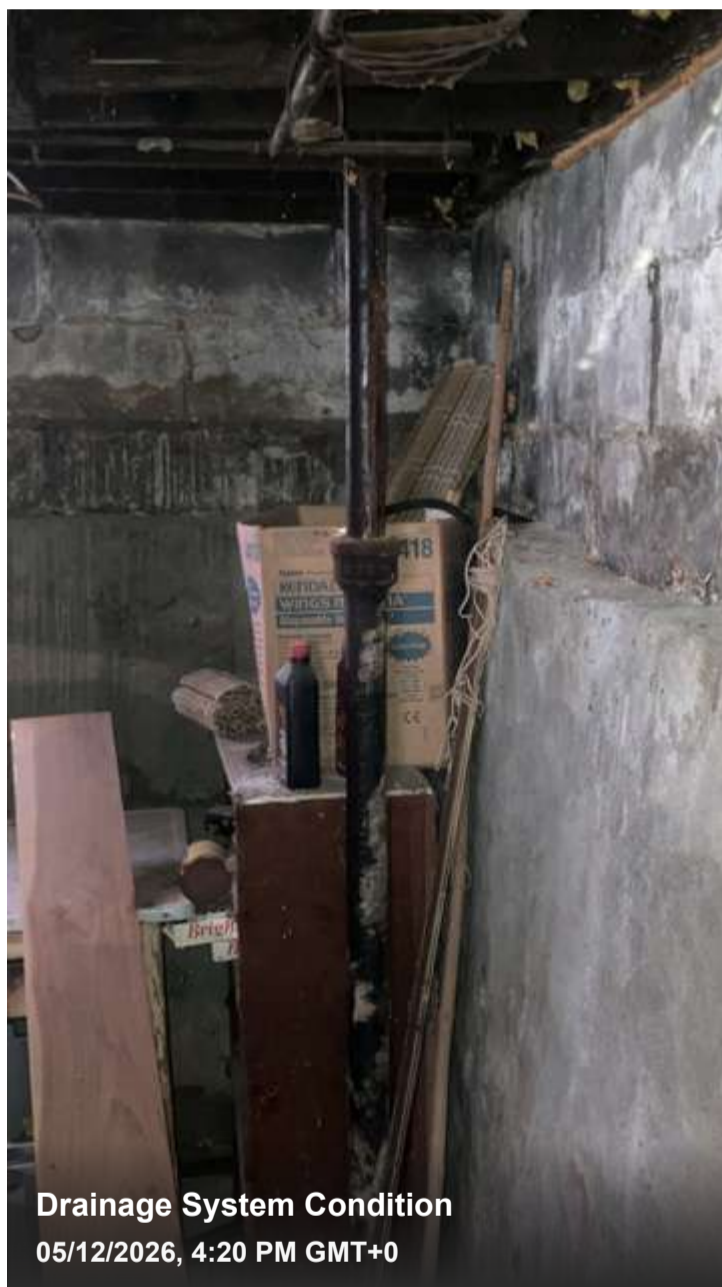
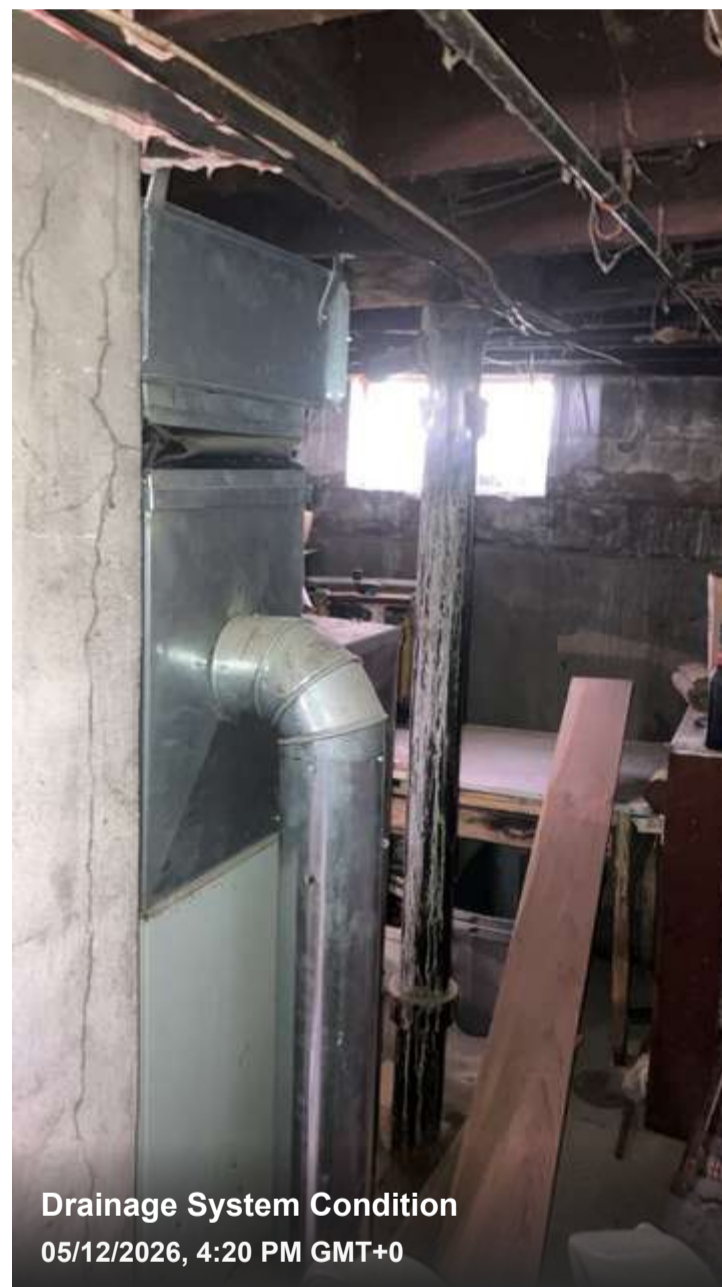
Drainage System Condition

**Fair (Some Repairs)**

**Damaged Cast Iron Drain Line**

The cast iron drain lines may be damaged. Recommend repairs or replacing by a qualified professional.

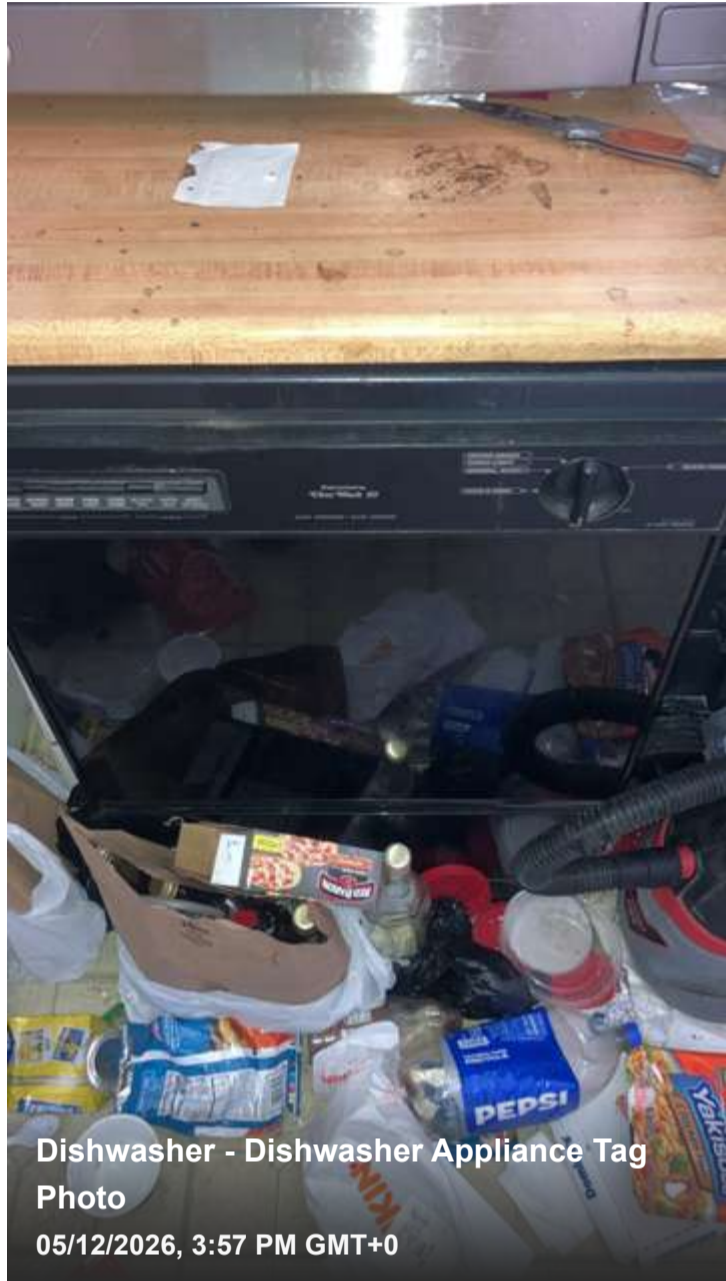
Dishwasher - Dishwasher Appliance Tag Photo  
05/12/2026, 3:57 PM GMT+0

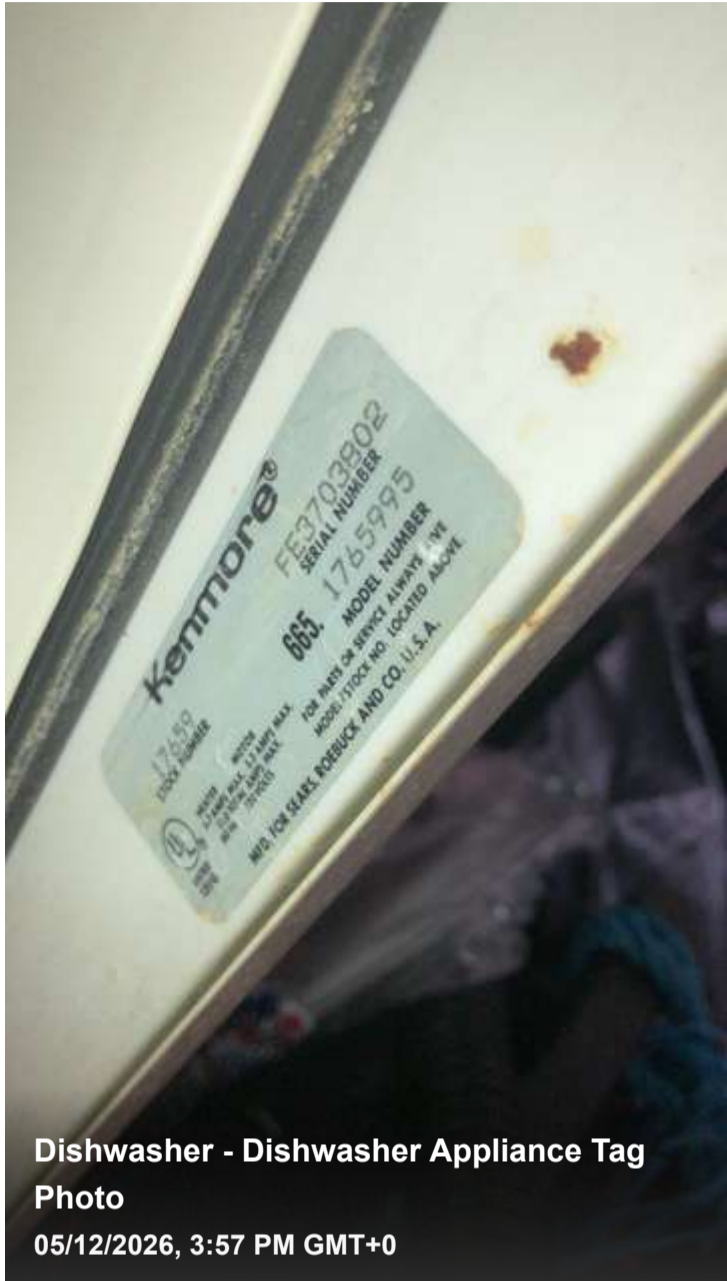
Dishwasher - Dishwasher Appliance Tag Photo  
05/12/2026, 3:57 PM GMT+0

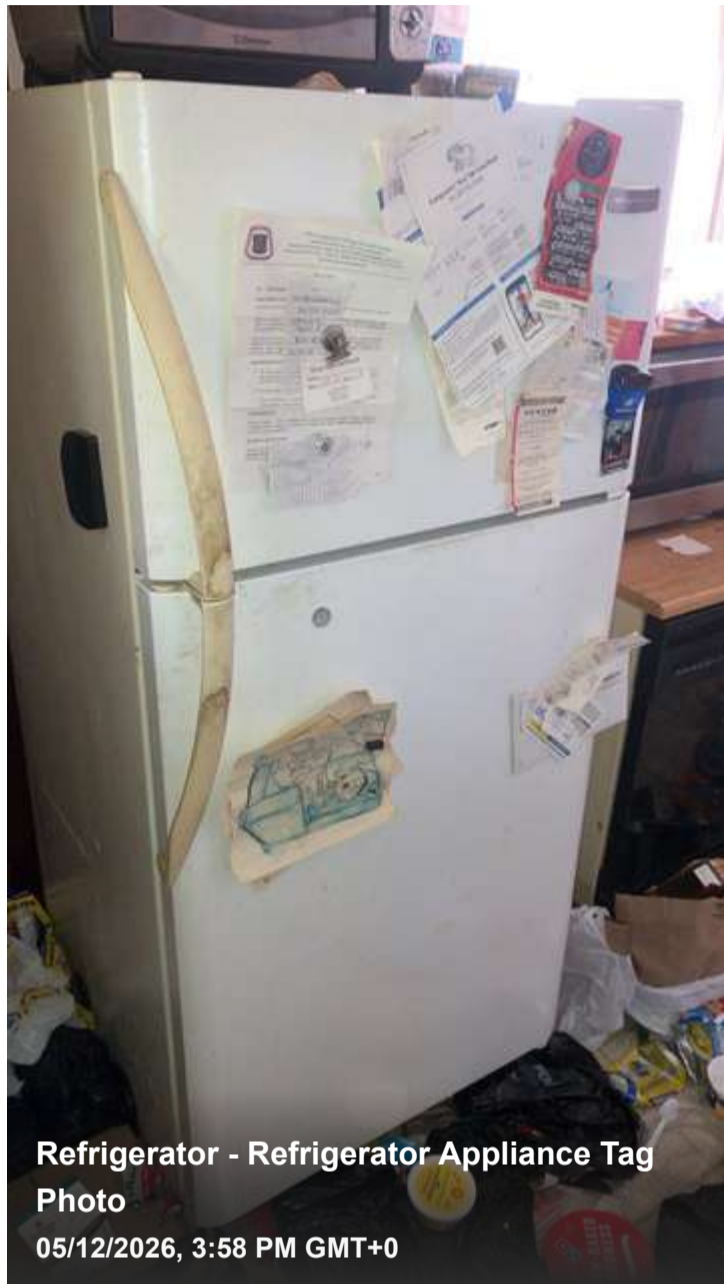
Refrigerator - Refrigerator Appliance Tag Photo  
05/12/2026, 3:58 PM GMT+0

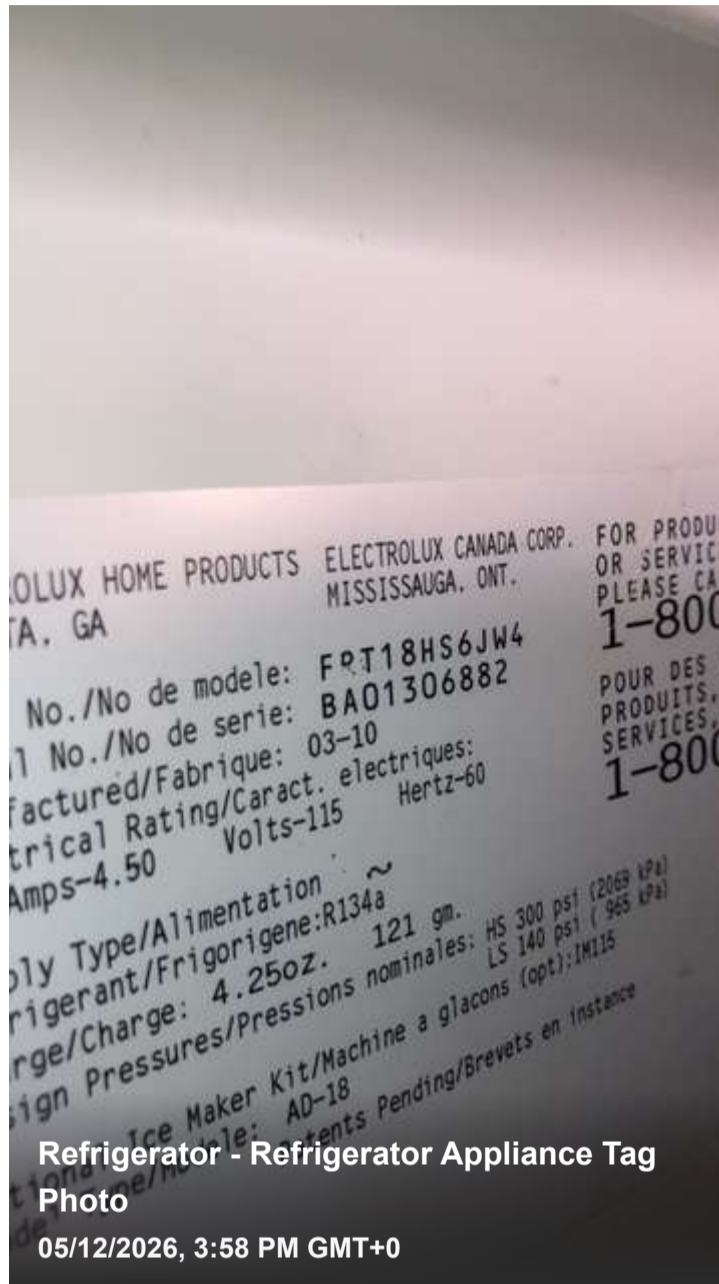
Refrigerator - Refrigerator Appliance Tag Photo  
05/12/2026, 3:58 PM GMT+0

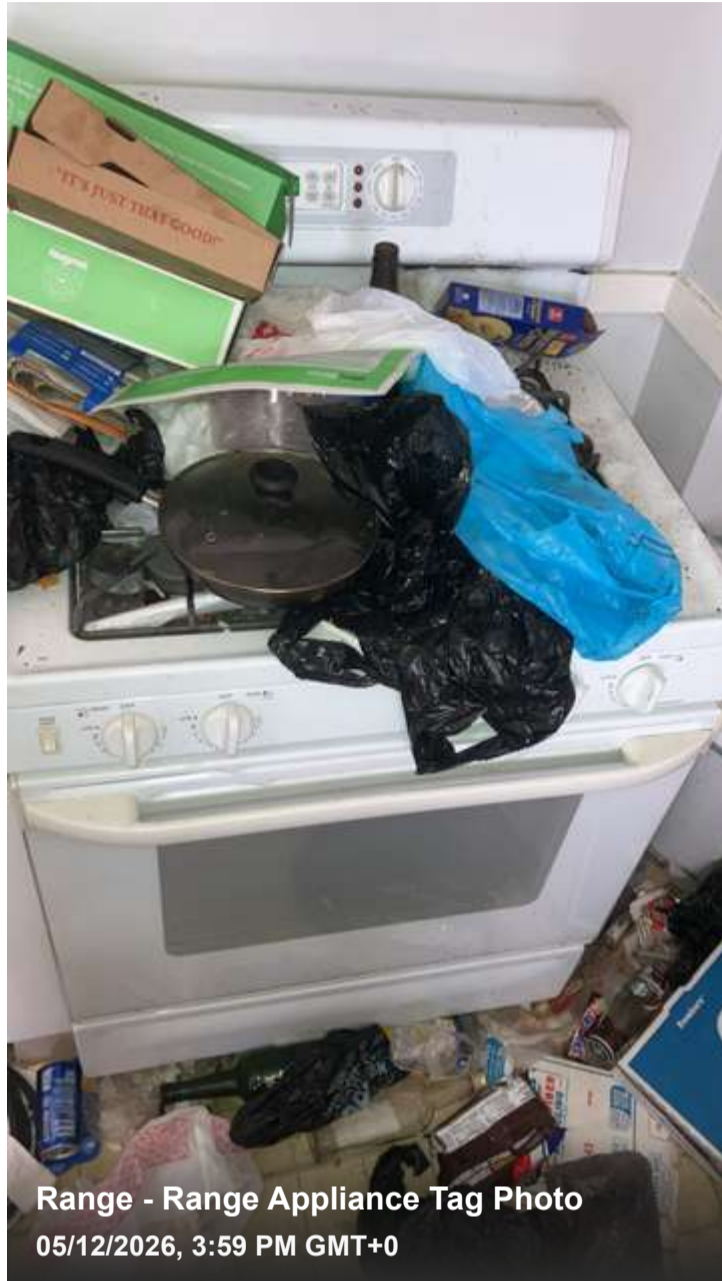
Range - Range Appliance Tag Photo  
05/12/2026, 3:59 PM GMT+0

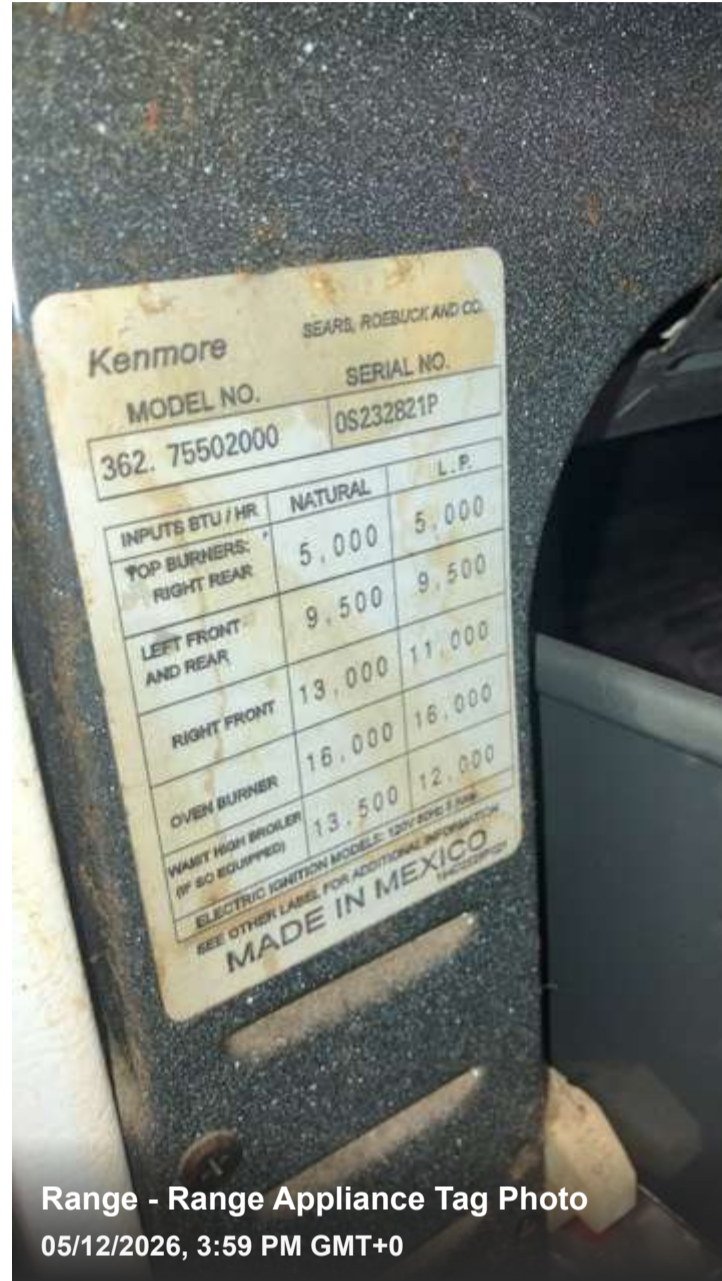
Range - Range Appliance Tag Photo  
05/12/2026, 3:59 PM GMT+0
