# 1449 E 172nd St

## Cleveland, Ohio 44110

| Type | Major Systems Plus Report - |

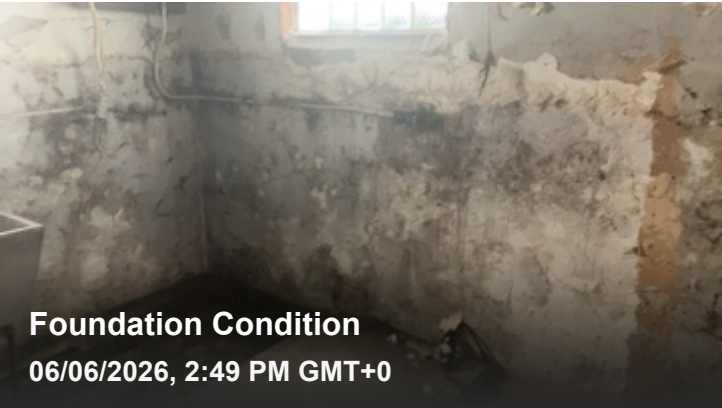
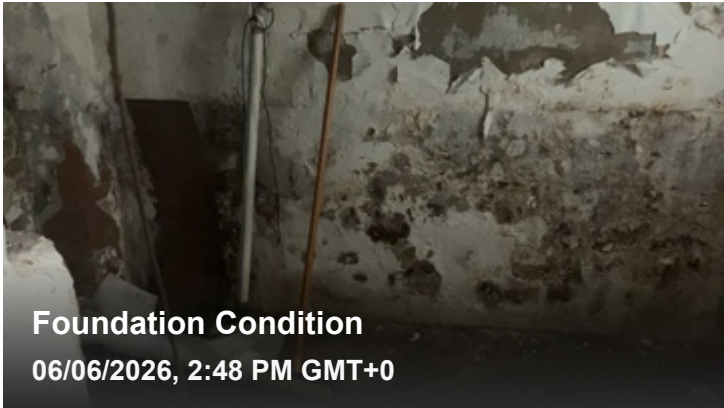
The wall structure showed signs of water intrusion. Recommend repairs or replacing by a qualified professional.

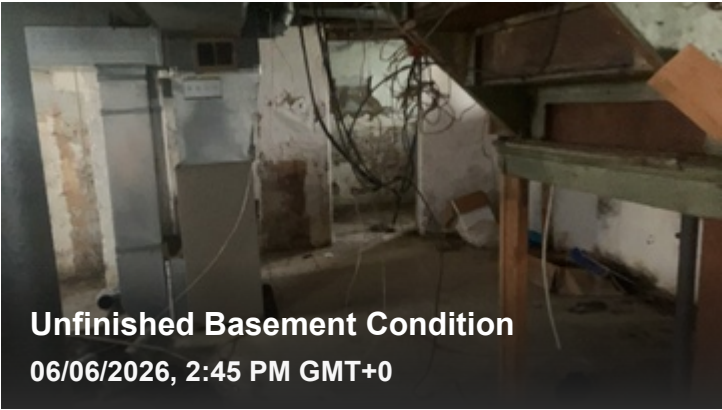
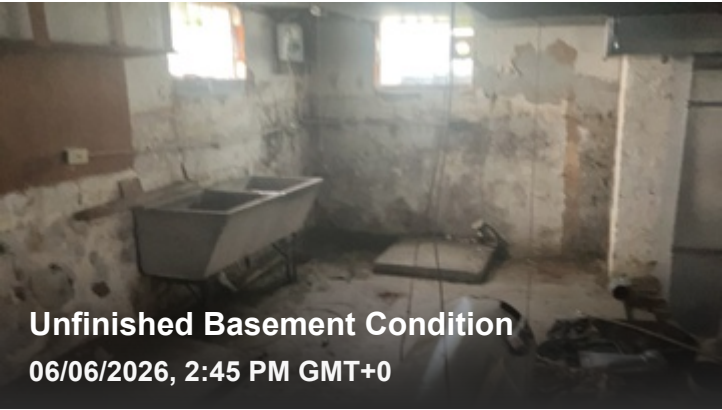
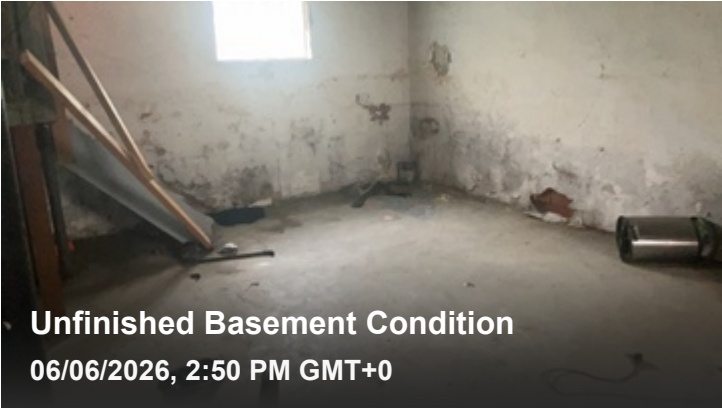
There is a mold-like substance on one or more areas of the wall(s). Recommend repairs or replacing by a qualified professional.

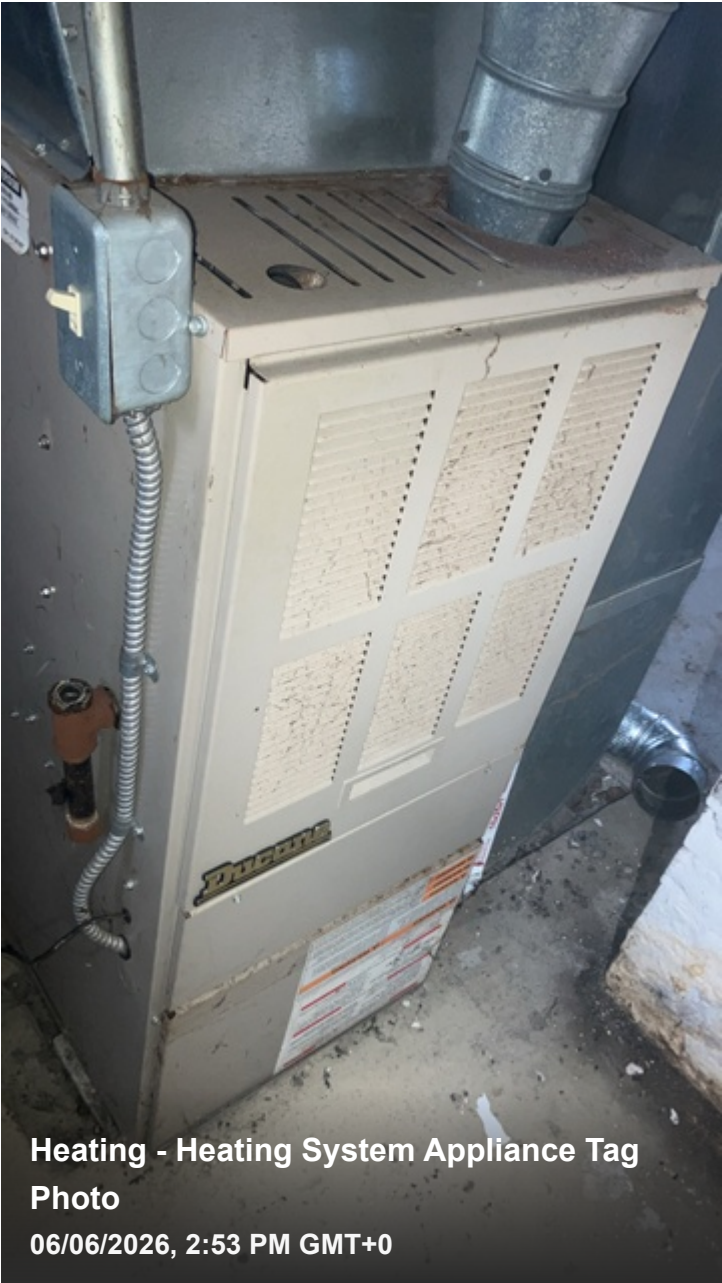
The furnace / boiler / heater is inoperable. Recommend repairs or replacing by a qualified professional.

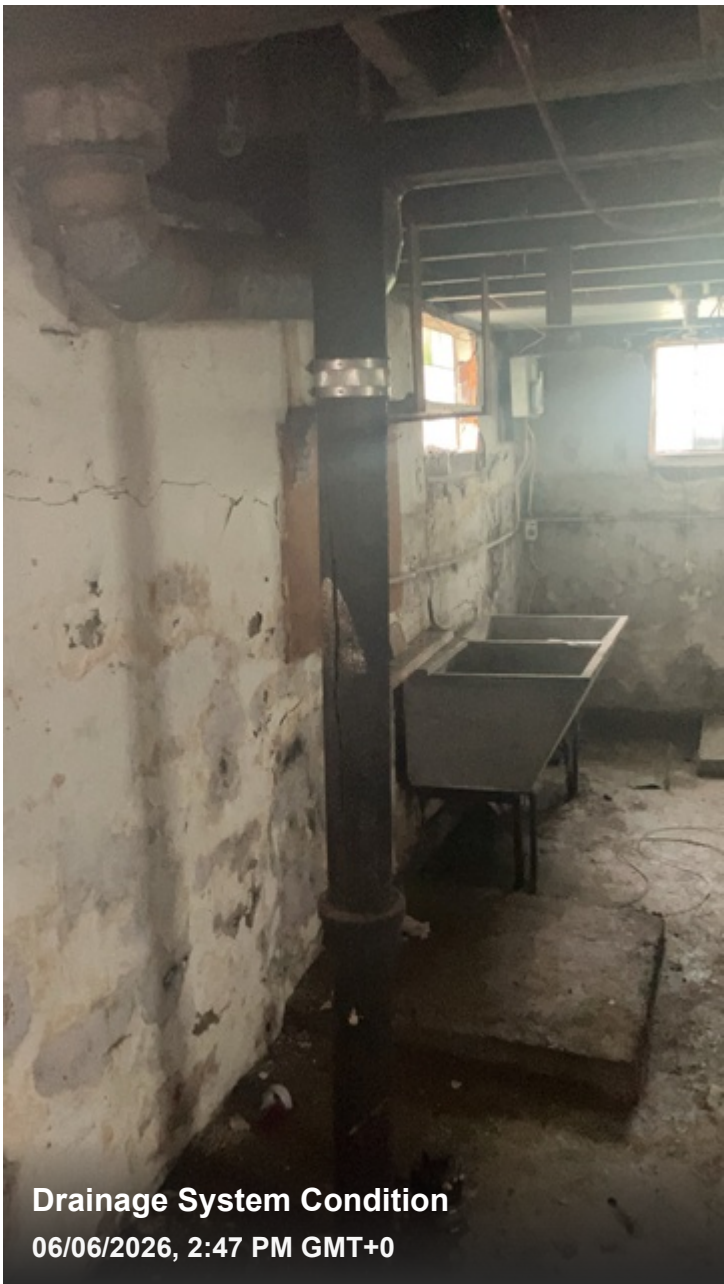
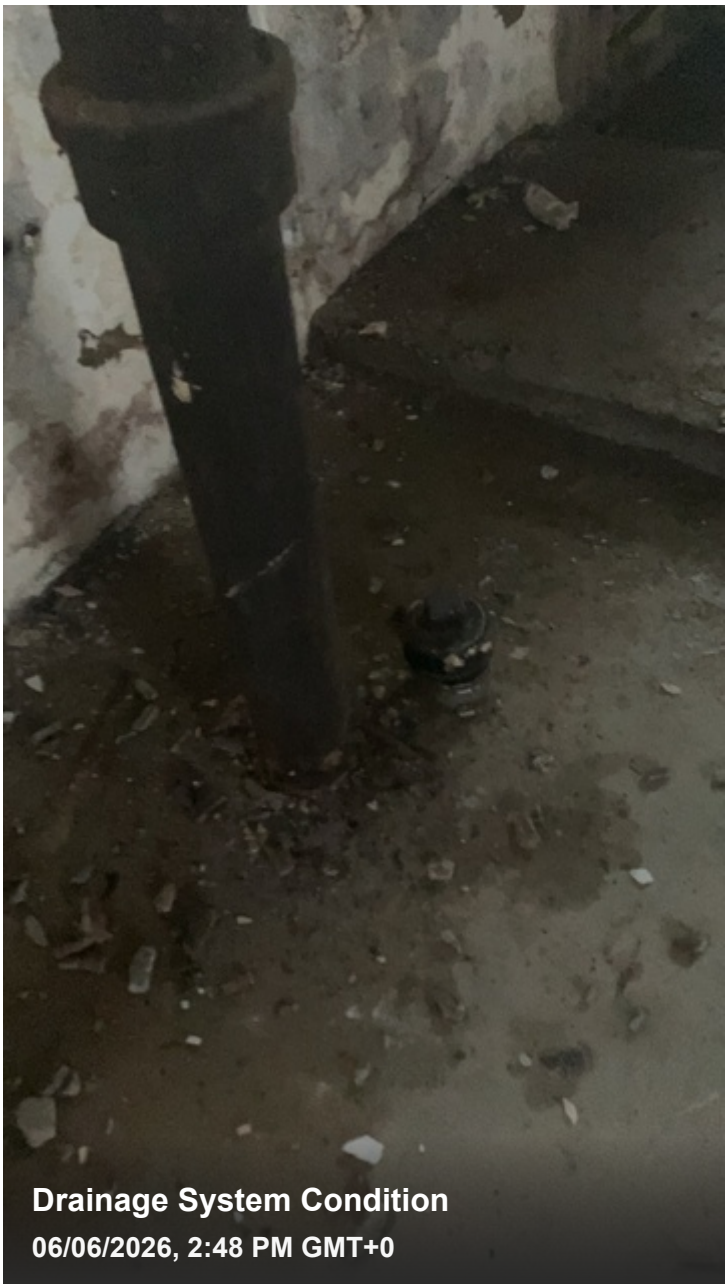
### Damaged Cast Iron Drain Line

The cast iron drain lines may be damaged. Recommend repairs or replacing by a qualified professional.

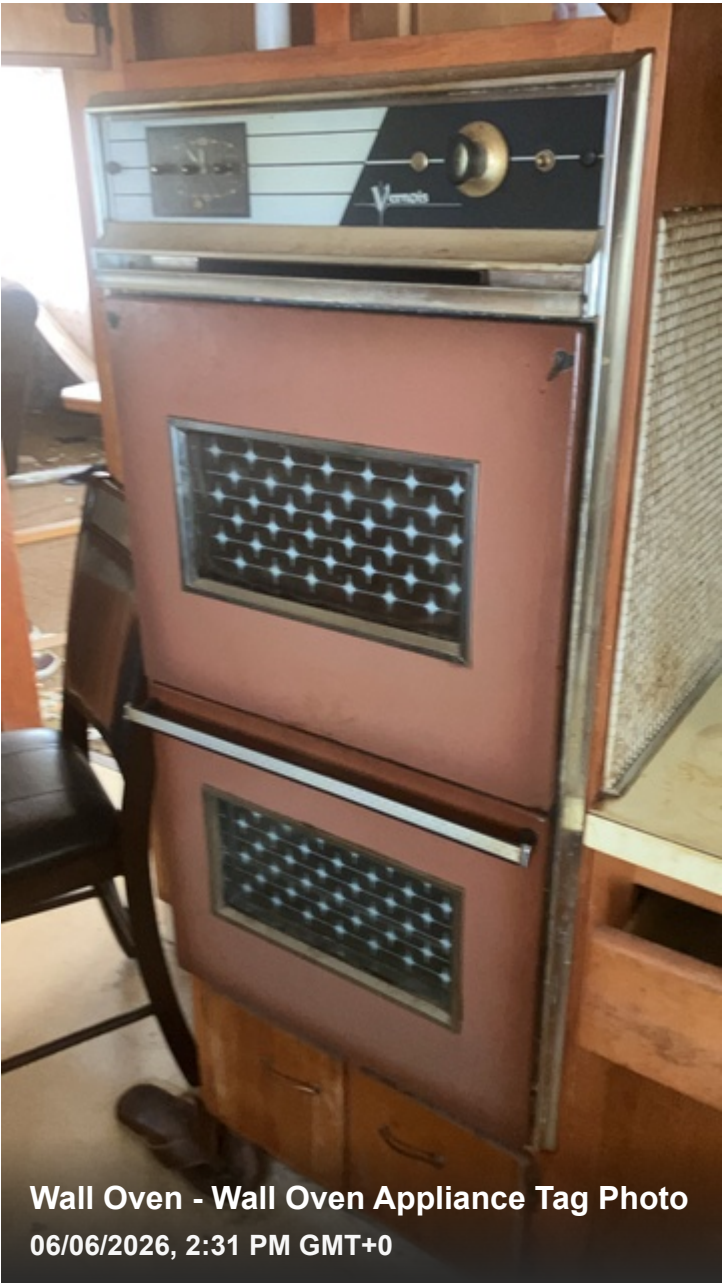
## Wall Oven Appliance Tag Photo: No Access
