# 922 Peckham St

## Akron, Ohio 44320

| Type | Major Systems Plus Report - 922 Peckham St |
| Scheduled | October 15, 2026, 10:30 AM EDT |

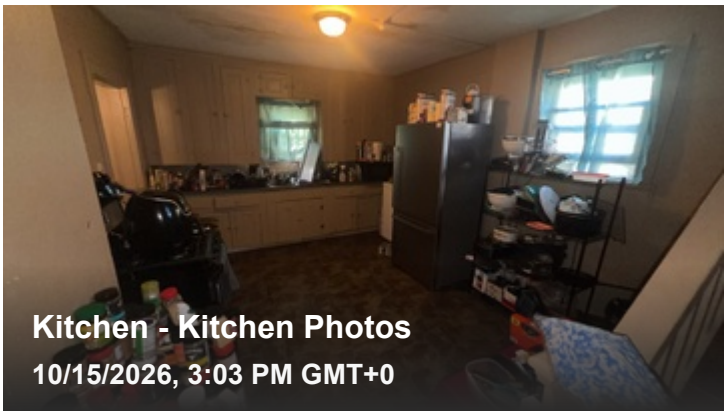
## Kitchen photos / videos

✓ No issues
